## **Phase I Environmental Site Assessment**

3865 Old Richmond Road  
Ottawa, Ontario

Anglican Diocese of Ottawa

Report: PE4798-1

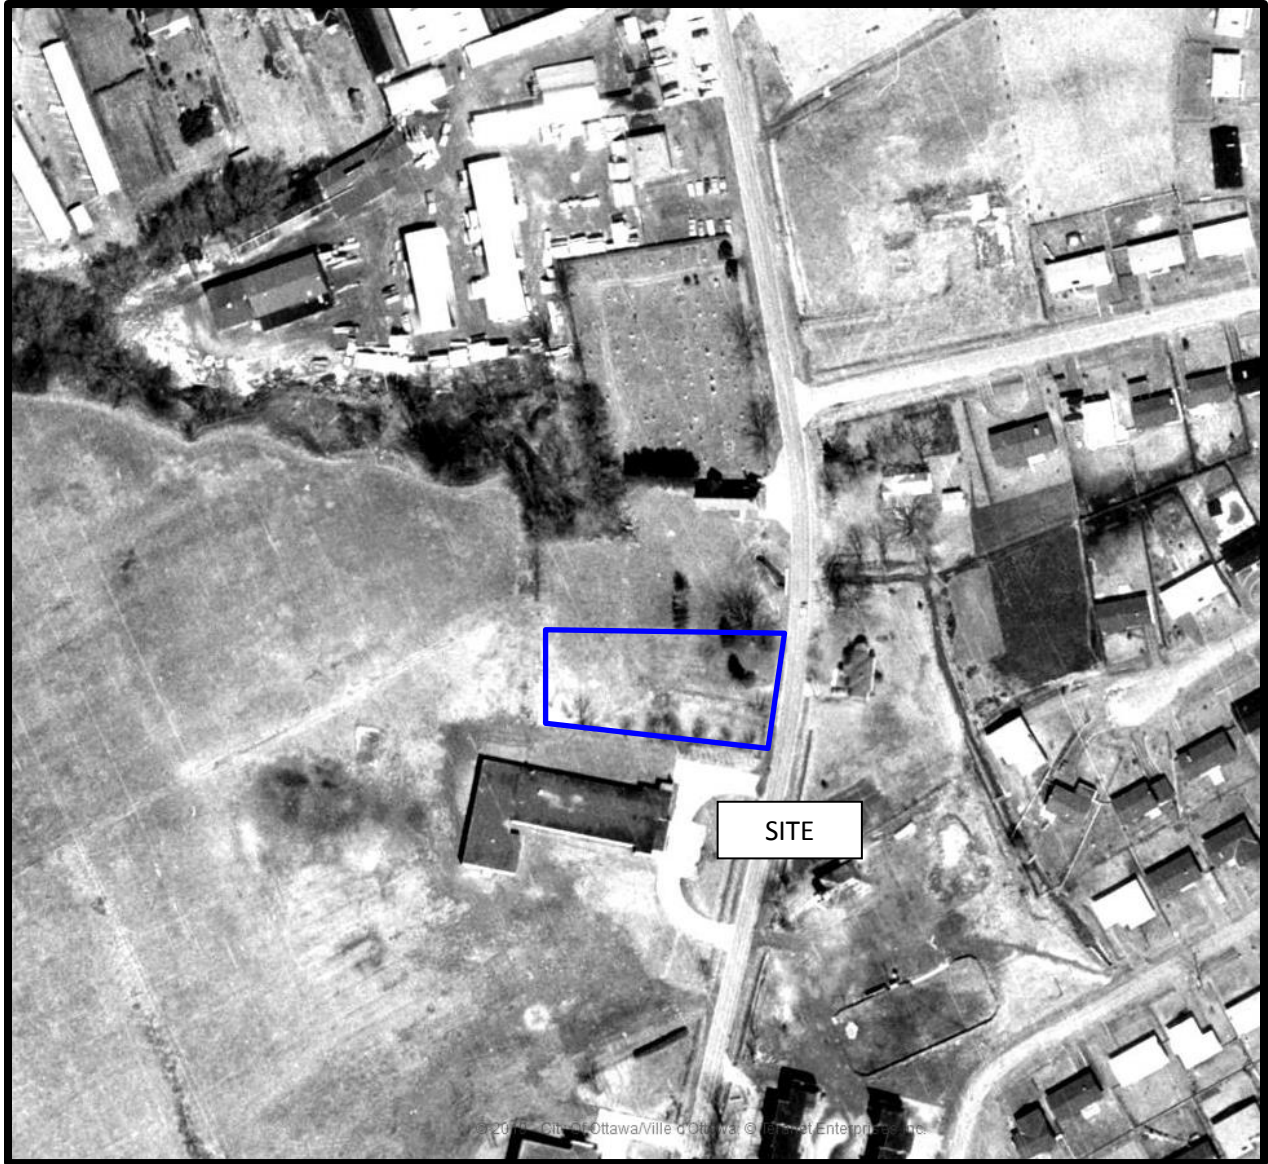
AERIAL PHOTOGRAPH  
1965

| 1965 | The Phase I Property is vacant at this time. North of the Phase I Property, a church can be seen with a graveyard beyond that. Further north, the land appears to be commercial in its use. Housing can be identified to the east of the Phase I Property with a school occupying land to the south. |

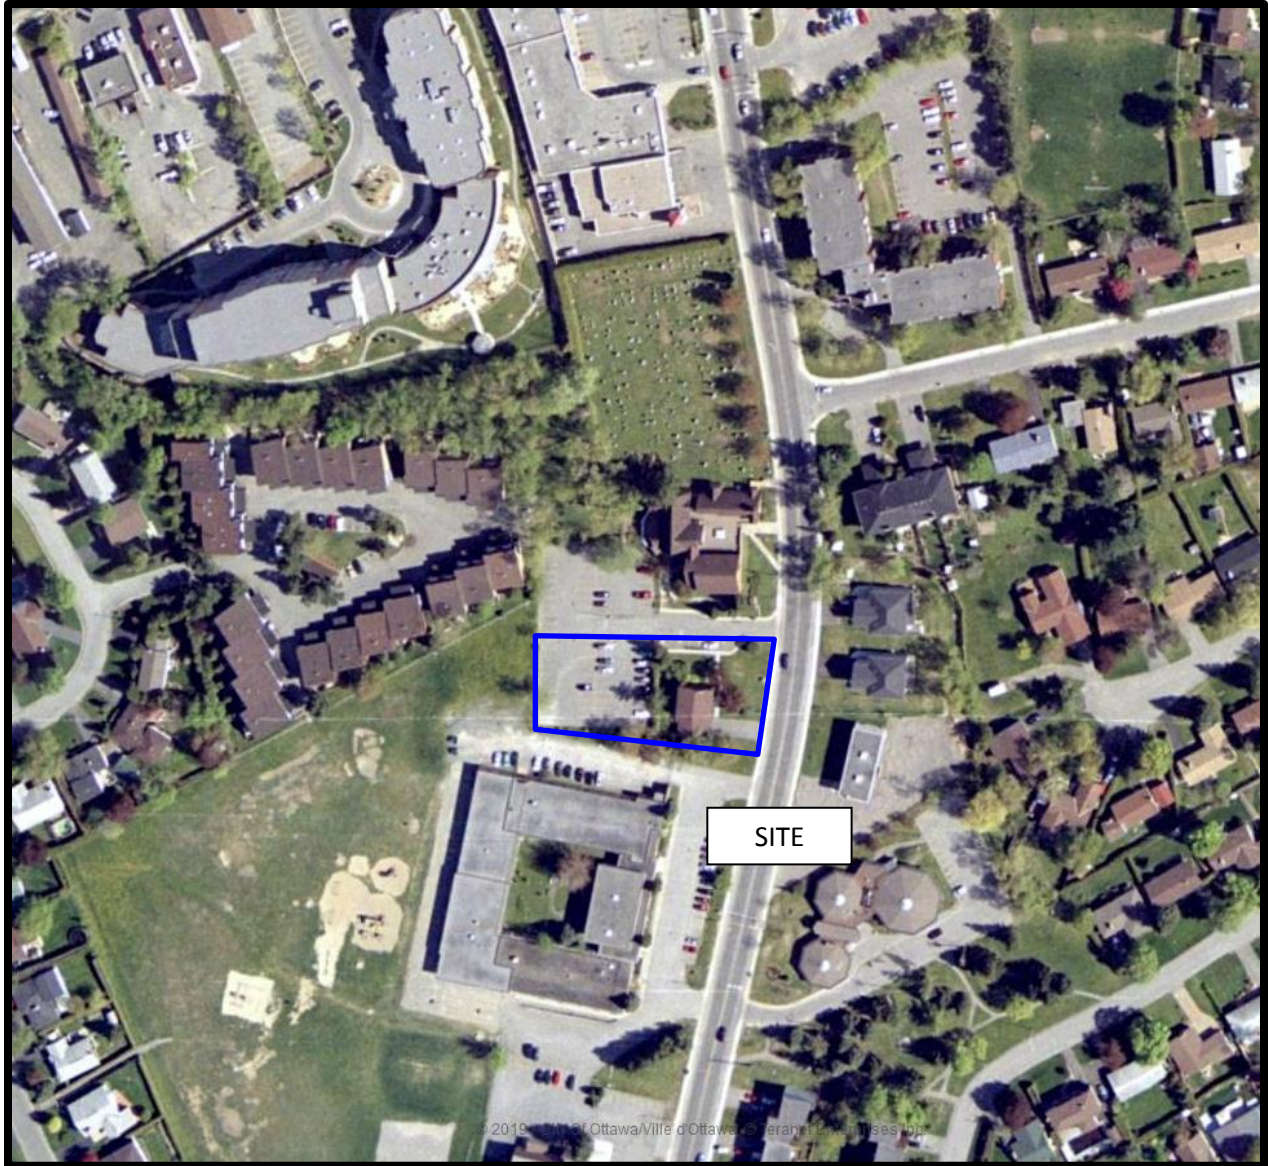
## AERIAL PHOTOGRAPH 2002

| 2002 | No significant changes have been made to the Phase I Property. Northwest of the Phase I Property, a retirement community has been constructed. |

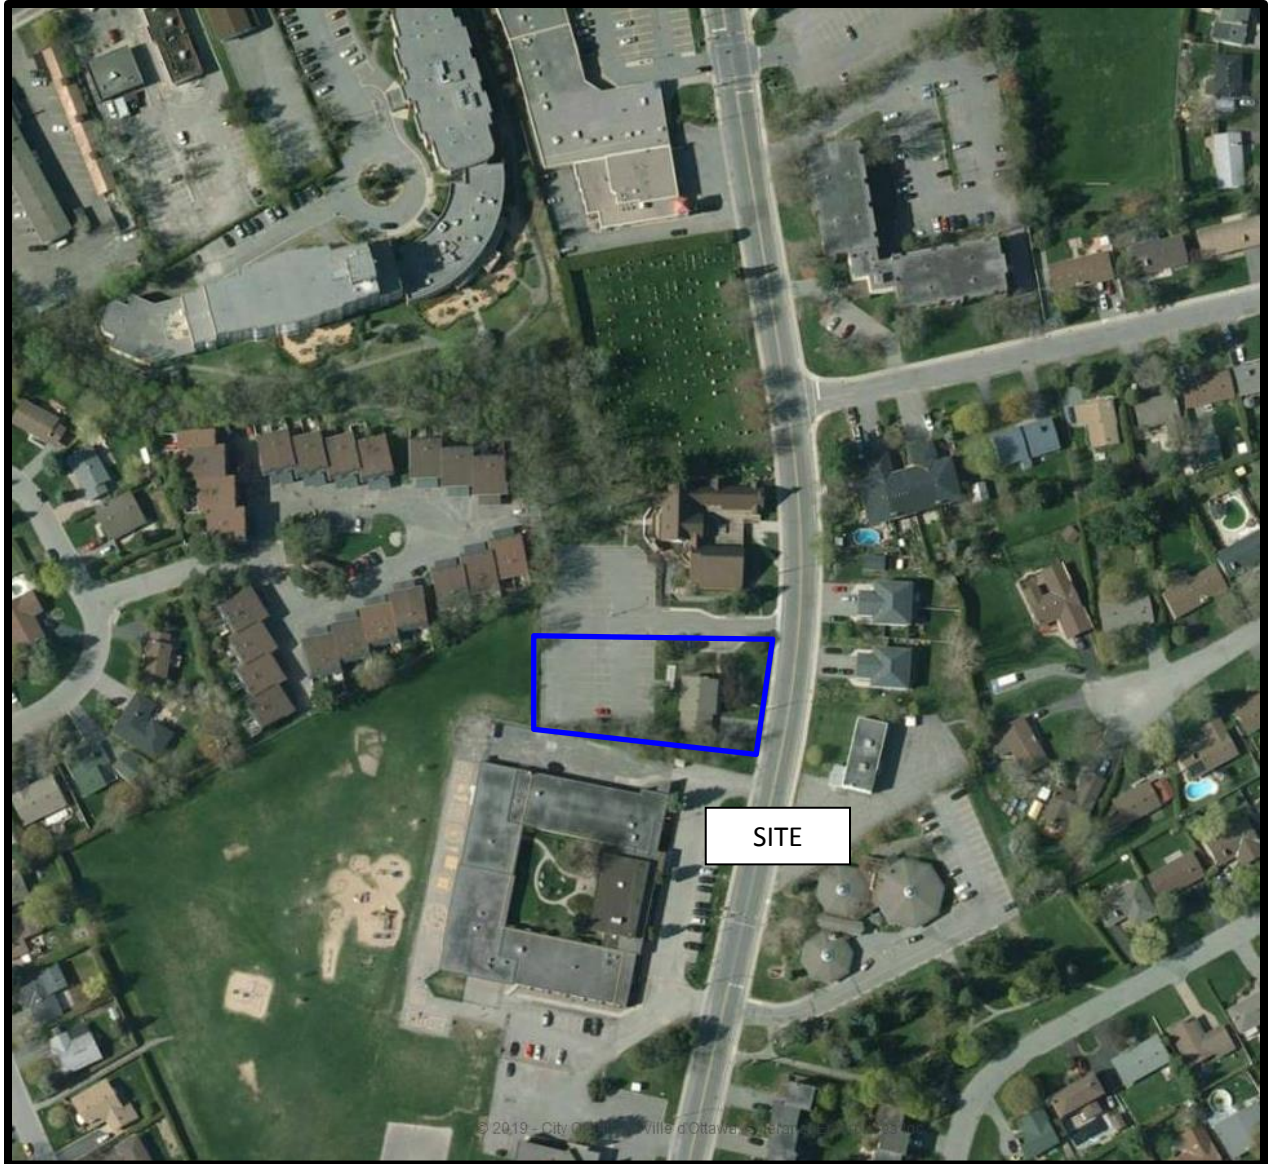
AERIAL PHOTOGRAPH  
2011

| 2011 | No significant changes have been made to the Phase I Property or surrounding properties. |

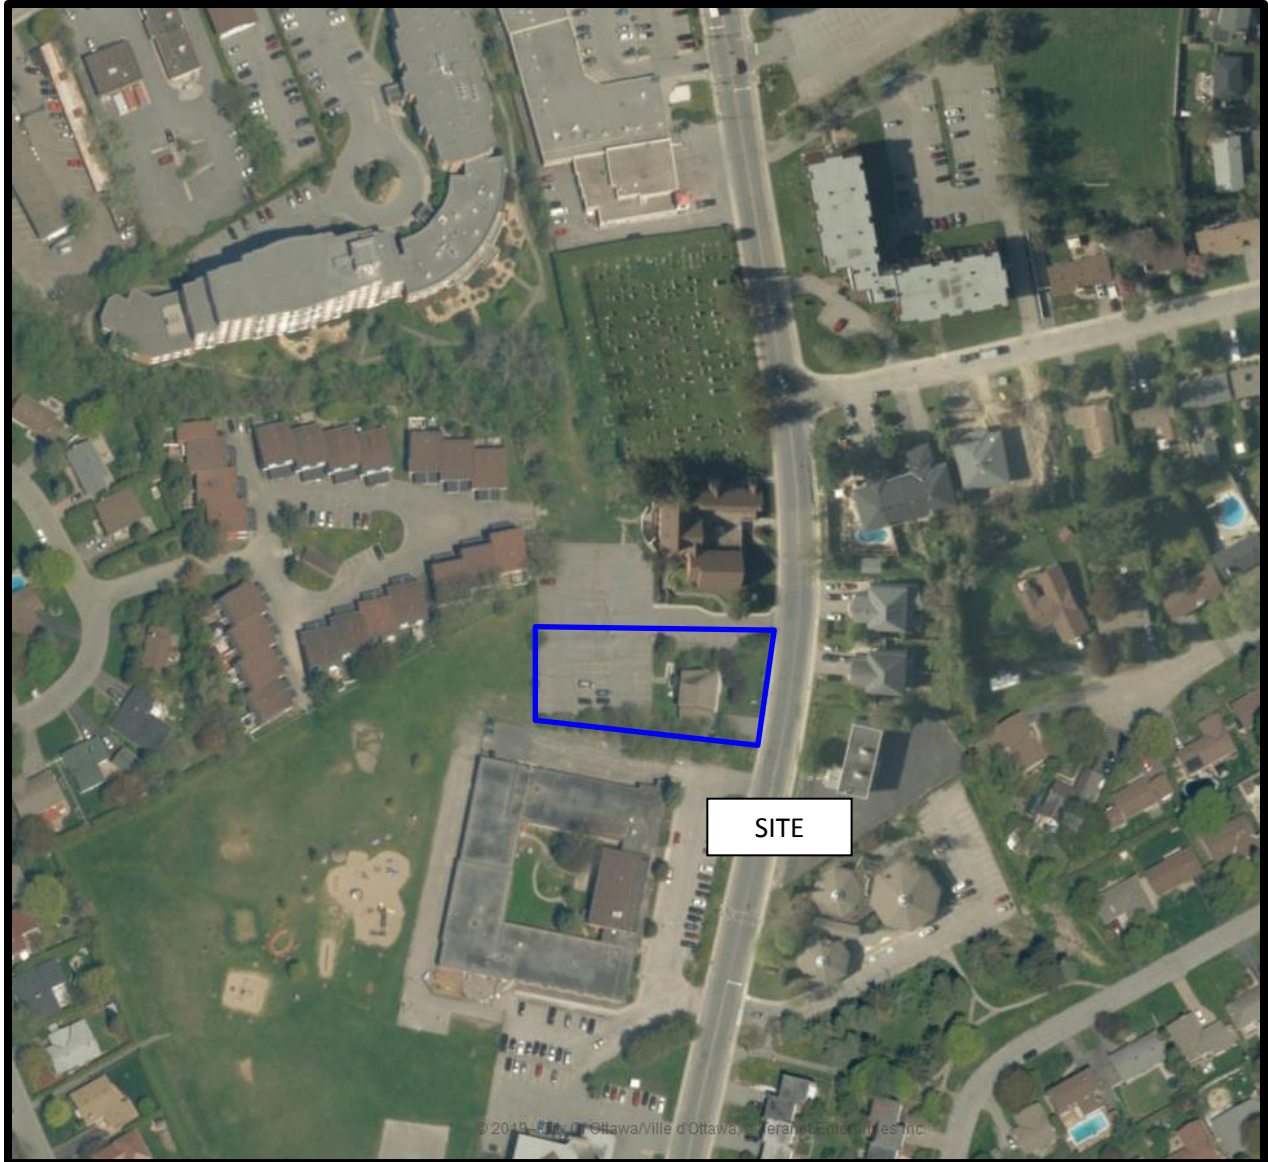
AERIAL PHOTOGRAPH  
2017

| 2017 | No significant changes have been made to the Phase I Property or surrounding properties. |

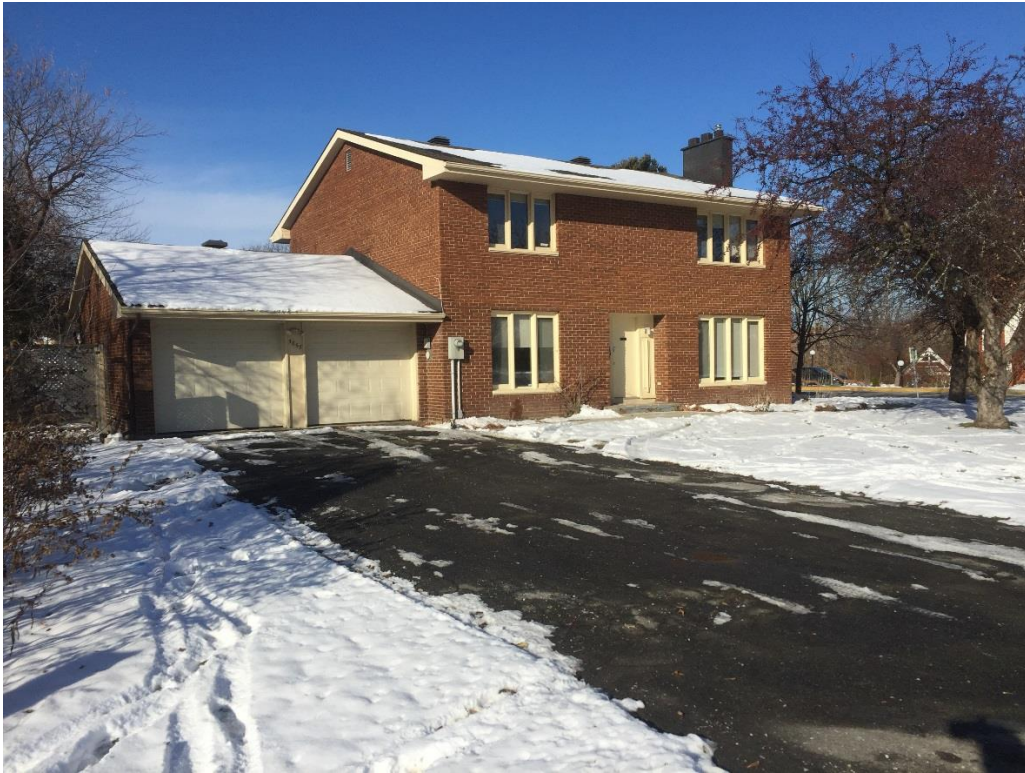
The main building was constructed on a concrete foundation, finished with brick and with a sloped shingled roof. The building is heated by a gas-fired furnace. Given the age of the building, it is not expected to have been originally heated by oil.

Photograph 1: Front of the property facing west.

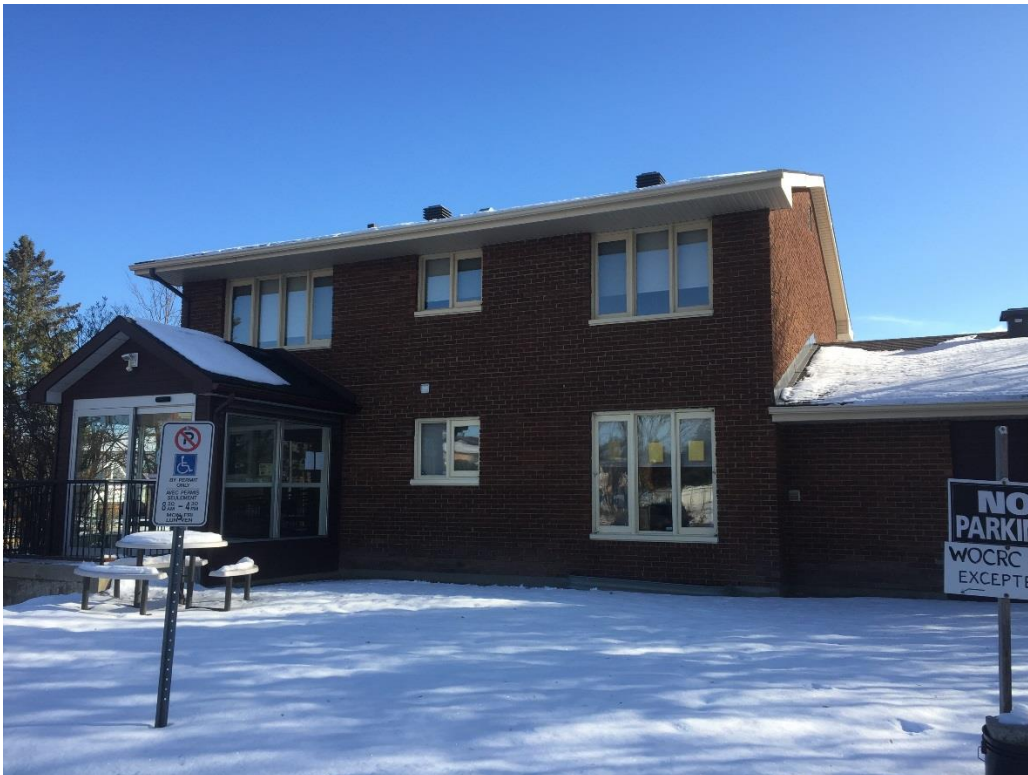
Photograph 2: Rear of the property facing east.
