PHASE ONE ENVIRONMENTAL SITE ASSESSMENT

1040 BANK STREET,
OTTAWA, ONTARIO

May 15, 2017

Project no: 161-17230-00
Date: May 15, 2017

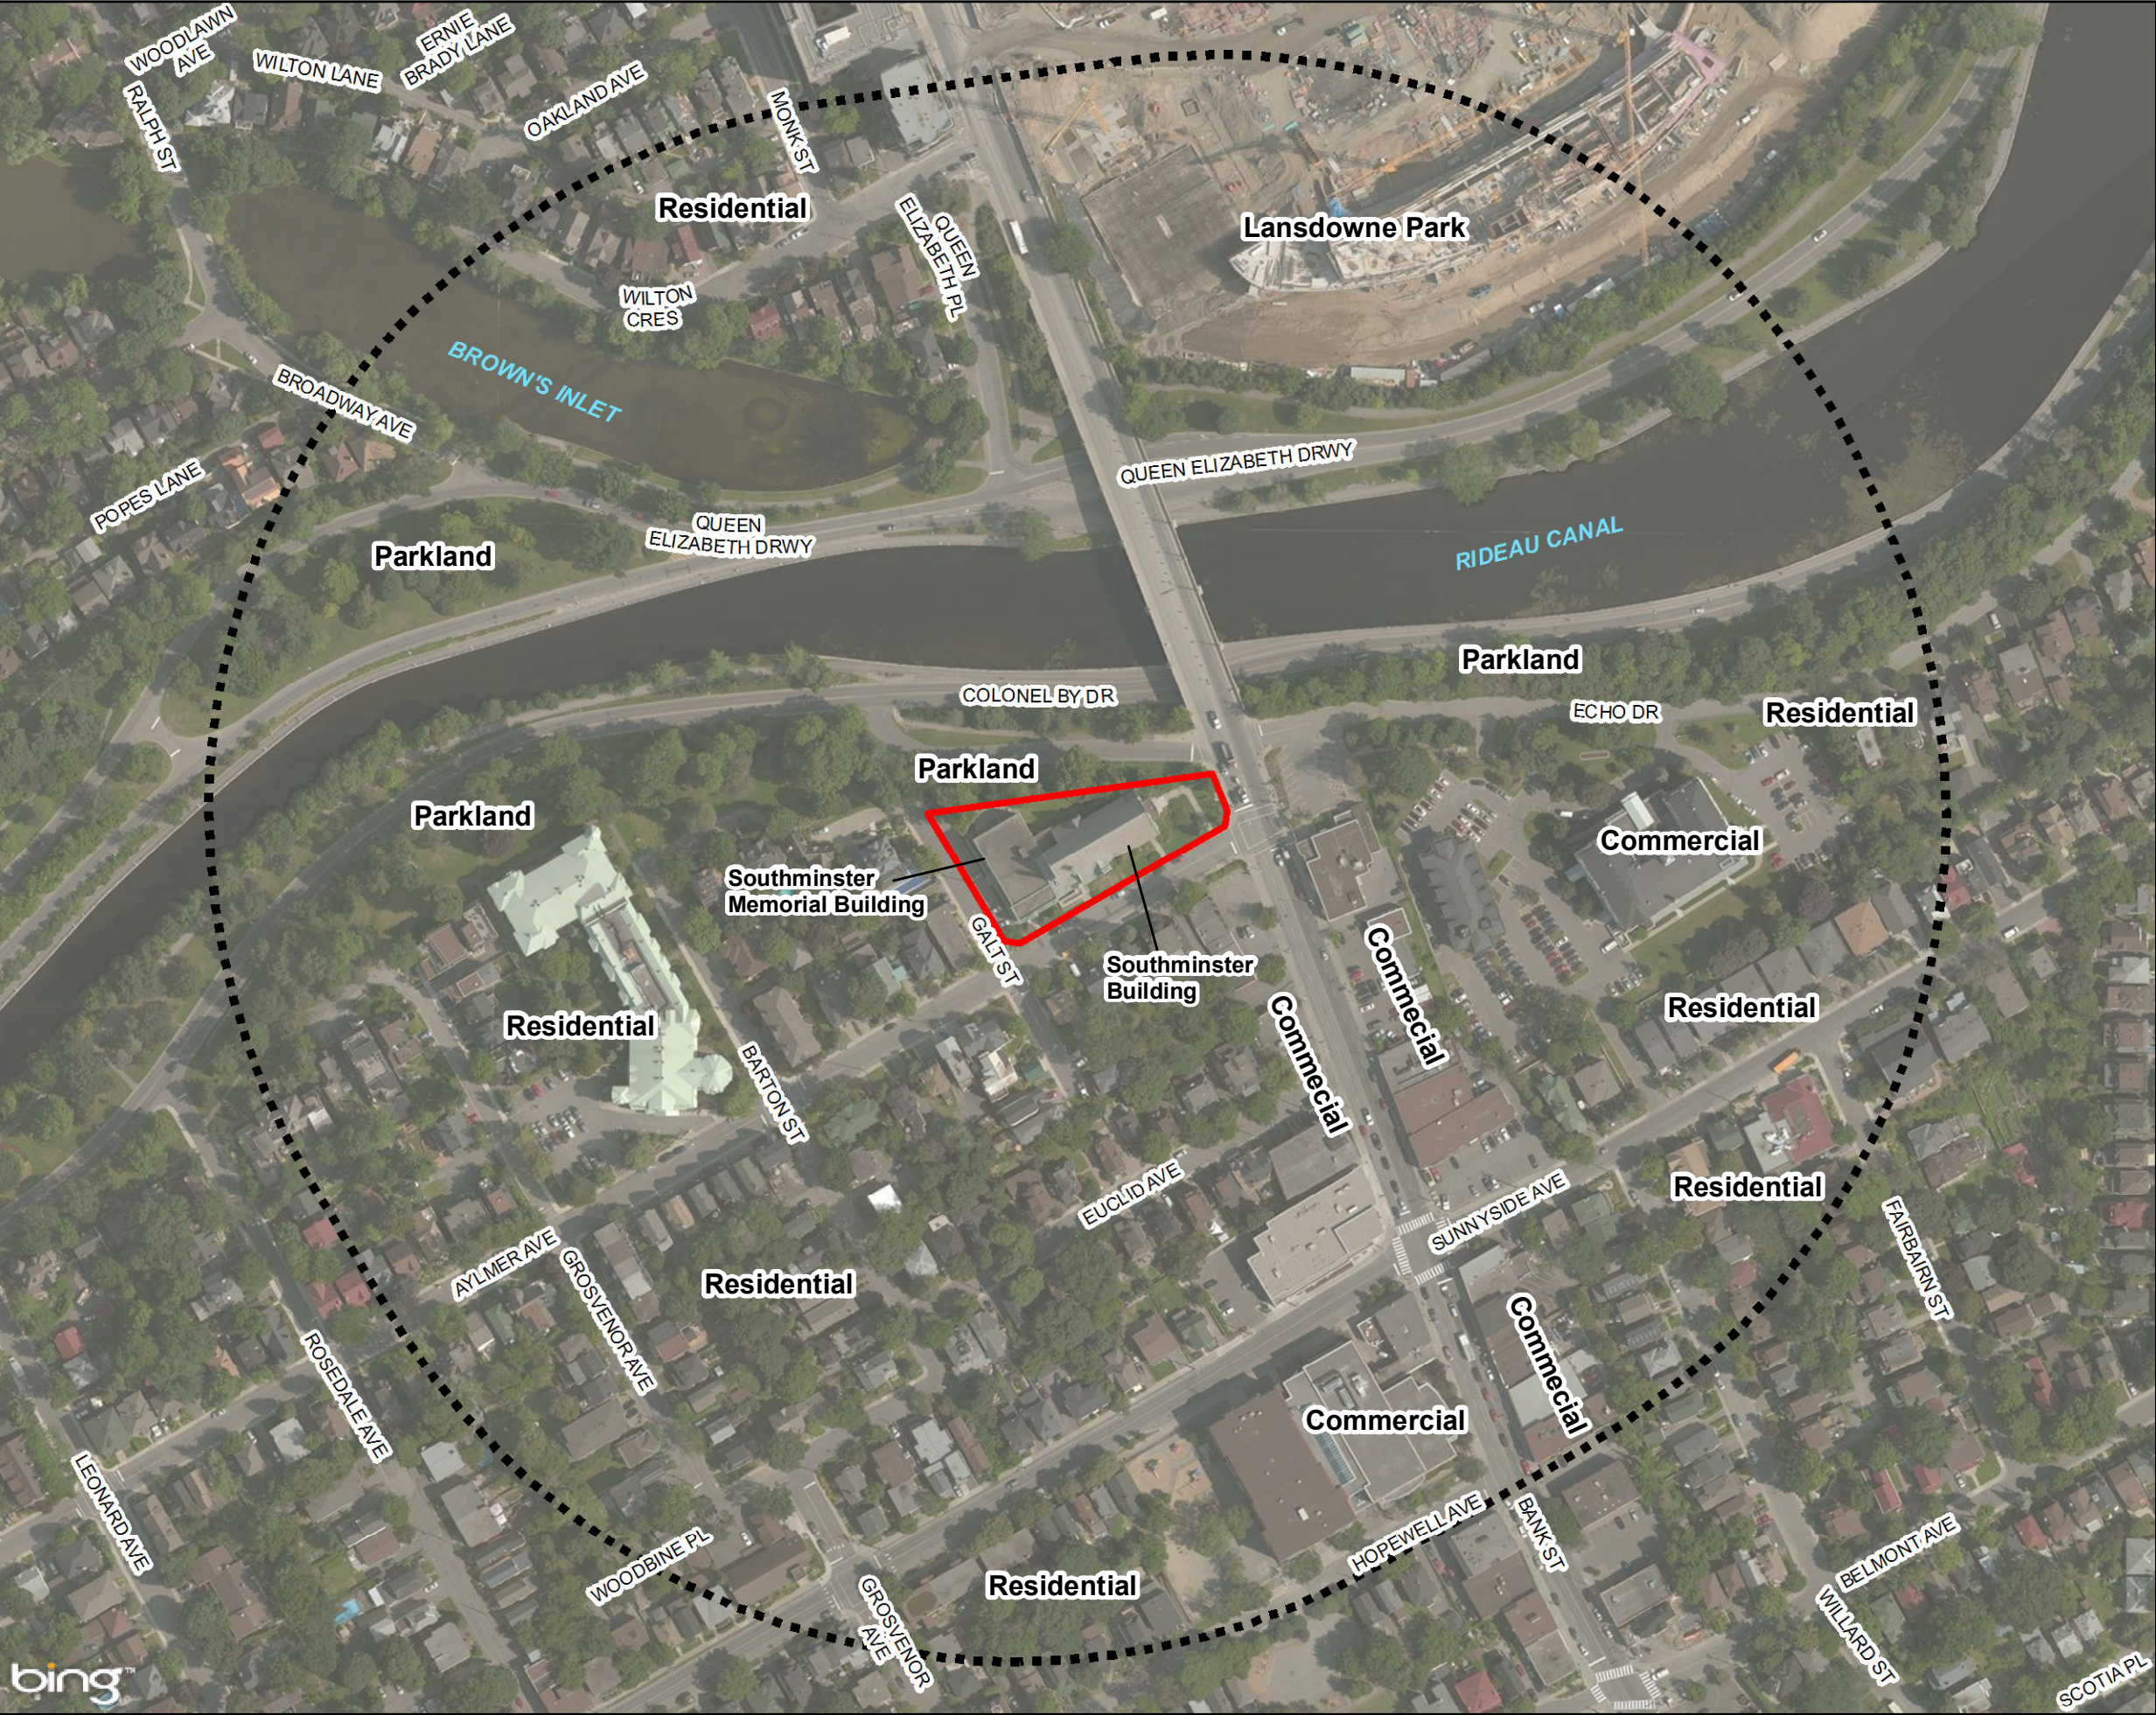
FIGURE 3

TITLE
POTENTIALLY CONTAMINATING ACTIVITIES
IN THE PHASE ONE ESA STUDY AREA

During the Phase One ESA, four PCAs were identified on the Site, and 32 PCAs were identified at 28 properties present in the Phase One Study Area (see Table 6 and Figure 3).

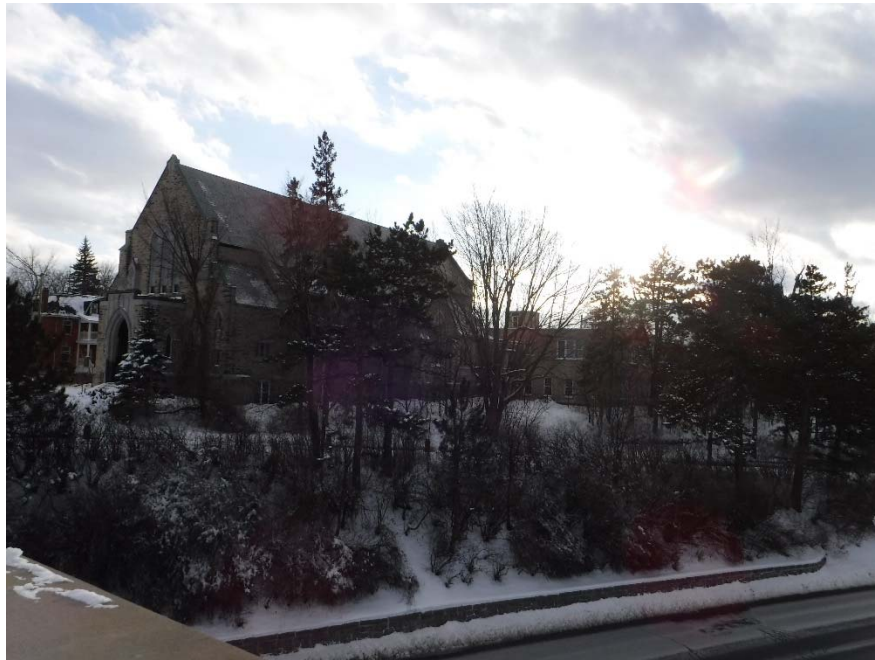
**Photo 1. North and east sides of the Site building.
Looking southwest from the Bank Street bridge over the Rideau Canal.**

- The east side of the 'Southminster building' has one story. This part of the building is used for congregation services. The second story of the building on the west side contains church offices. A finished basement is present, with an unfinished boiler room one level below, which is used for storage at the time of the Site visit. A plaque on the west church exterior indicates that it was built in 1931. The building was observed to be a wood frame construction with stone block walls and a slate roof with copper trim (Photo 1).

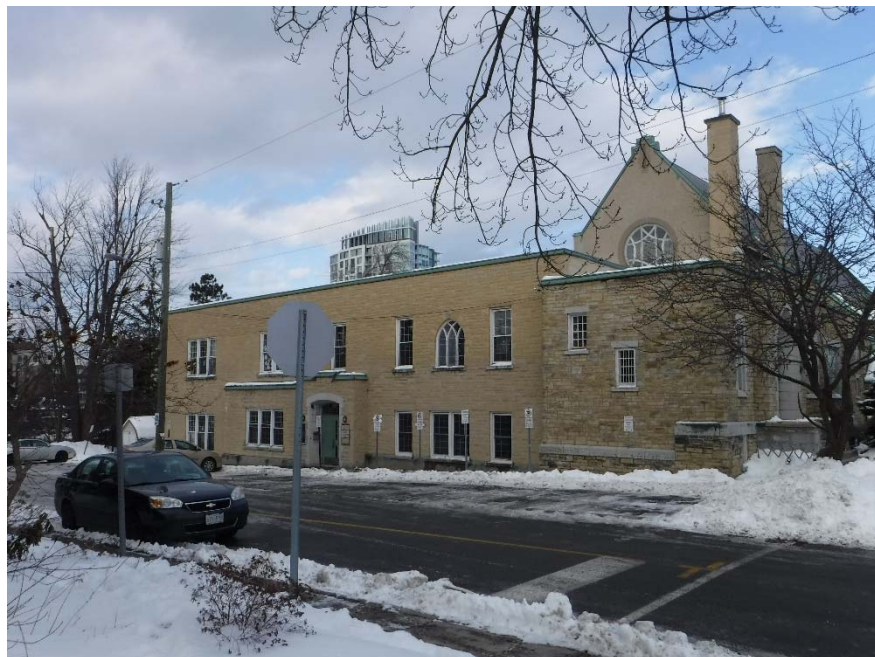
Photo 2. West side of the Site building. Looking northeast.

- The 'Southminster Memorial building' is one storey with a finished walk out basement, with the walk out portion on the north side (Photo 2). The building has a boiler room, one storey below the basement with a crawl space which has an exposed sand floor. The building was observed to be metal frame construction with stone block walls and a flat roof with copper trim. A plaque on the southwest corner of the building indicated that it was built in 1955.

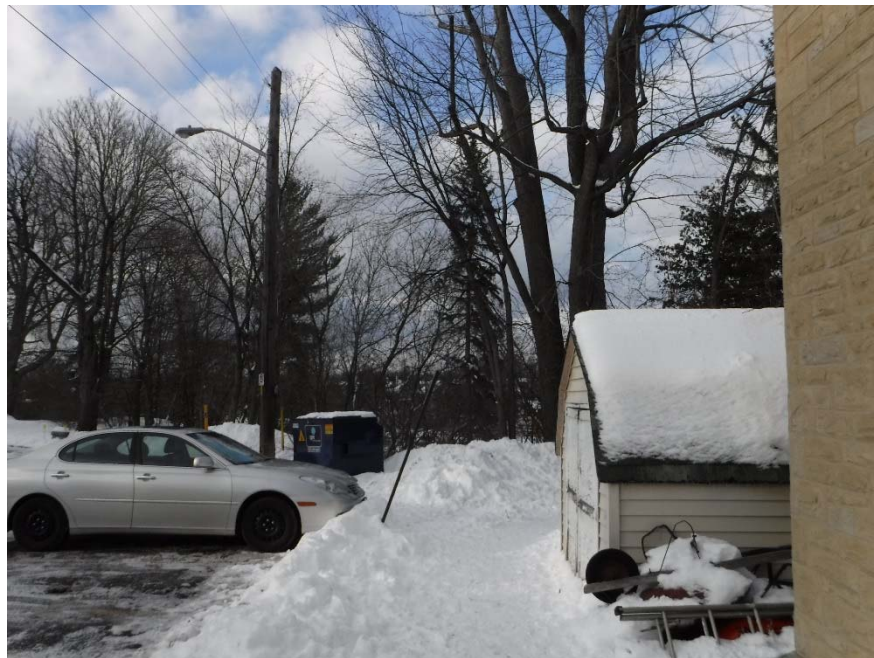
Photo 8. The northwest corner of the Site. Looking north from the middle of the west property line.

- A locked dumpster labelled 'Progressive' is located in the northeast corner of the Site, along with a small shed used for storage (Photo 8).
- Suspected asbestos-containing materials were observed throughout both buildings, which have 9"x9" vinyl floor tiles, ceiling tiles, plaster (Photo 9 and 10), pipe wrap insulation and ceiling texture coat (Photo 11).

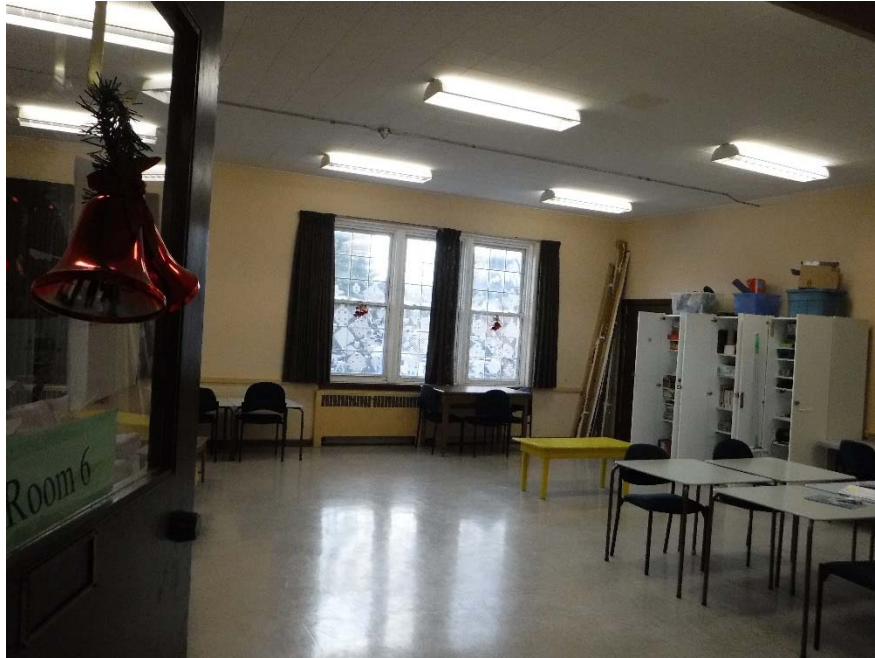
Photo 9. Interior of the building on the west side of the Site.

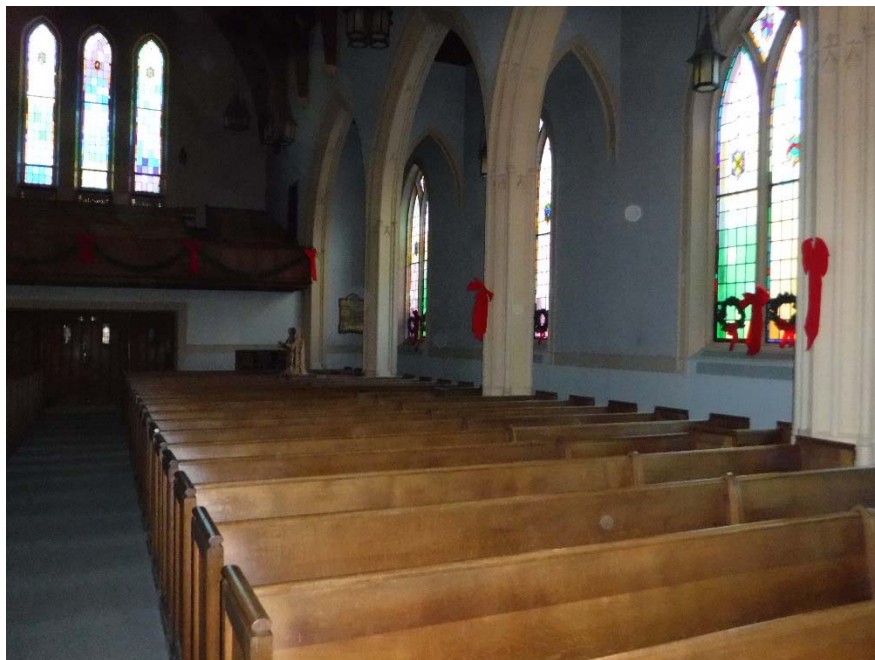
Photo 10. Interior of the east church building. Looking east from the building interior.

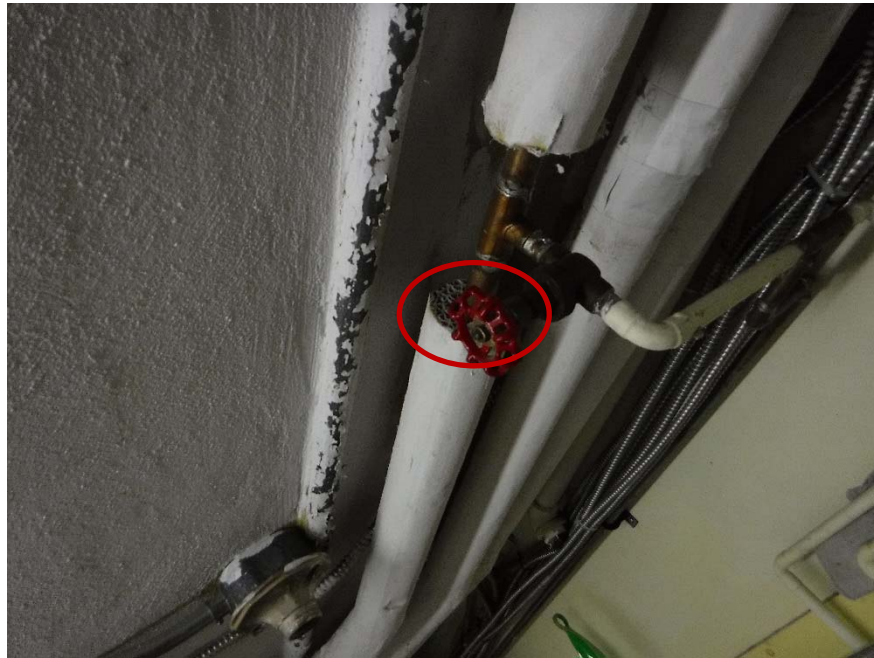
Photo 11. Pipe wrap suspected to contain asbestos and ceiling texture coat, located in the boiler room.

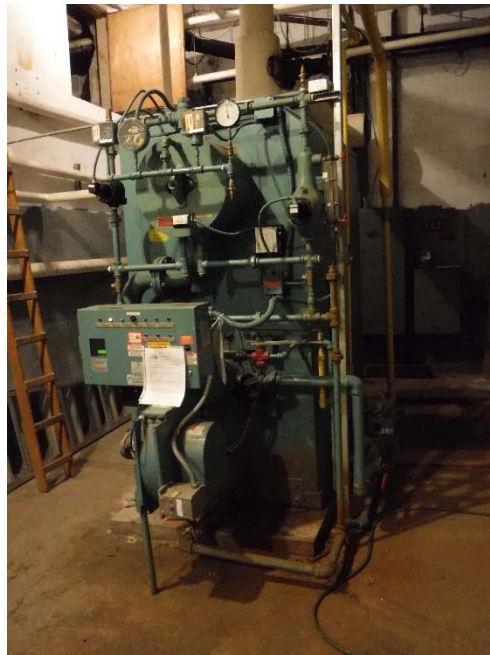
Photo 12. Boiler in the boiler room of the building, located on the west side of the Site.

- A natural gas fired boiler is located in the basement boiler room of the 'Southminster Memorial building' (Photo 12), which was manufactured in 2005. The boiler appeared to be in good condition, with no evidence of staining or leaking on the surrounding concrete floor.

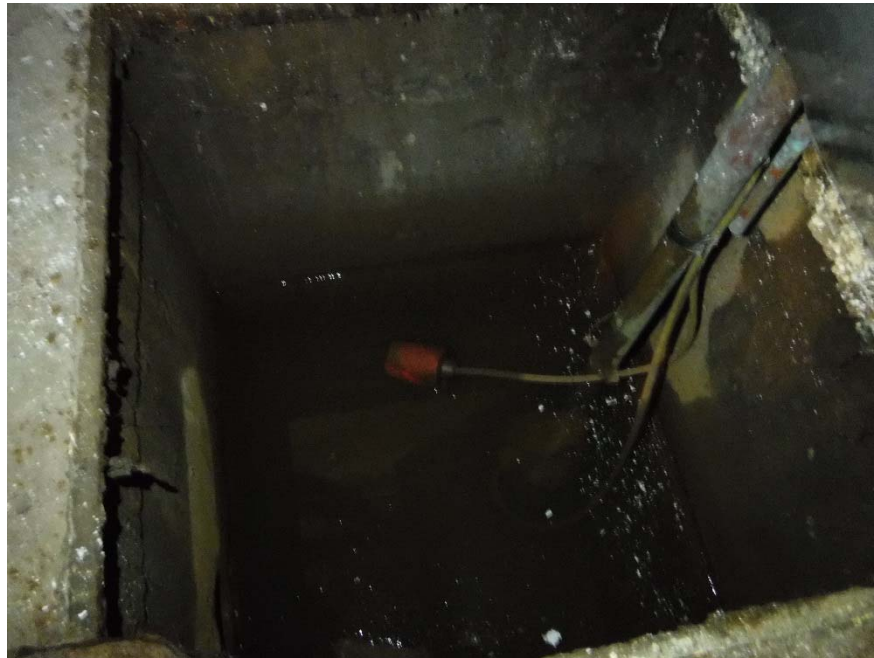
Photo 13. Water in sump pit, located in the boiler room.

- A sump pit with one electric pump was observed in the boiler room. The water in the sump pit had no evidence of impacts on the water or the concrete surface surrounding the pit (Photo 13).

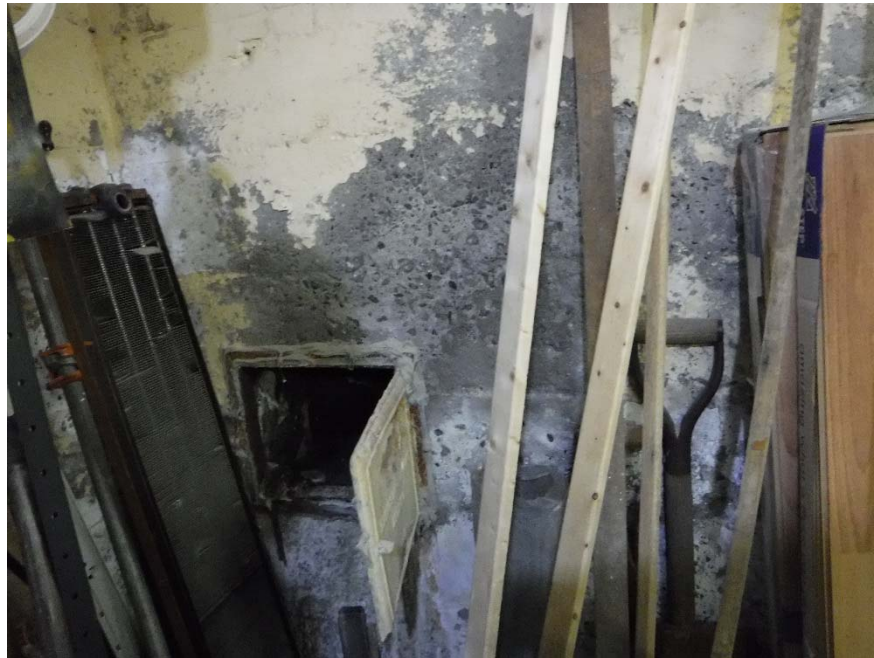
Photo 15. Chute observed in the old boiler room, located below the basement of the west church building.

- A chute / chimney was observed in the storage room, located below the basement in the 'Southminster Memorial building' with visible ashes inside (Photo 14). The chute was historically used for burning wood for building heating purposes. Based on WSP's observations, and the uncertainty of historical heating of the building, it is possible the chute was also used for coal.

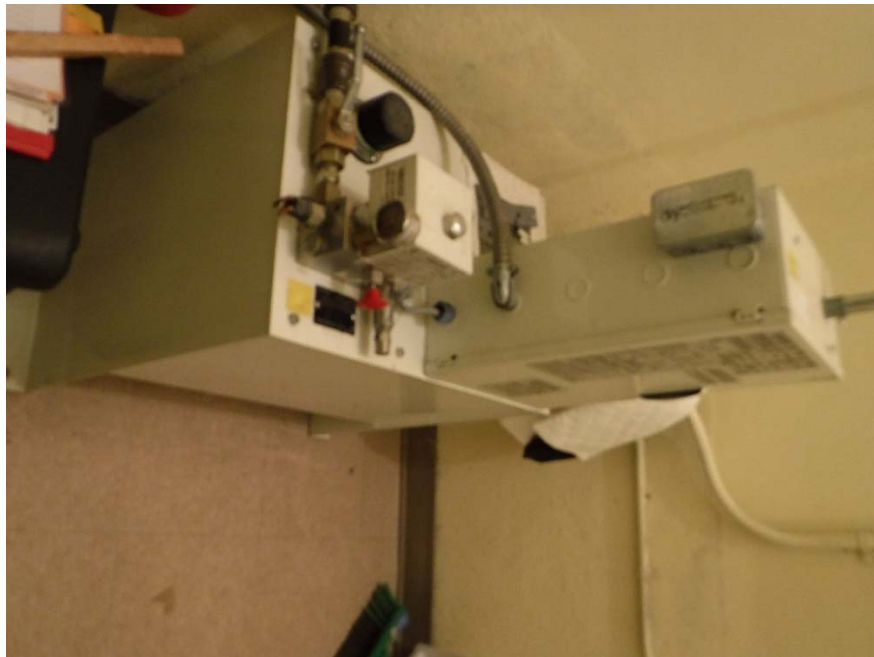
Photo 16. Hydraulic oil tank for the hydraulic elevator of the building, present on the west side of the Site.

- A hydraulic elevator was located in the 'Southminster Memorial building'. The tank date of manufacture was observed to be July 2002. The tank appeared to be in good condition with no evidence of leaking or staining on the surrounding vinyl floor tiles (Photo 16).
