#### **REPORT**

Phase One Environmental Site Assessment, Redevelopment Parcel, Northeast Part of Merivale Mall, 1642 Merivale Road, Ottawa, Ontario

### First Capital Asset Management LP

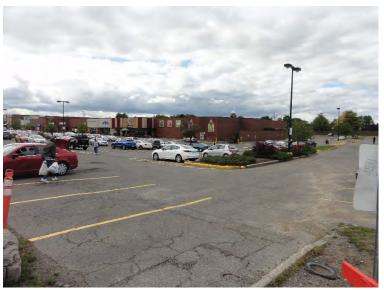
Photo 1 – General view of the northern portion of the Site occupied by asphalt paved parking area and driveway, looking southwest.

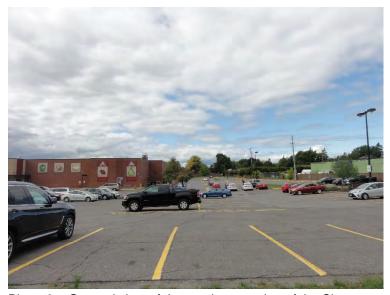
Photo 2 – General view of the southern portion of the Site occupied by asphalt paved parking area and driveway, looking northwest.

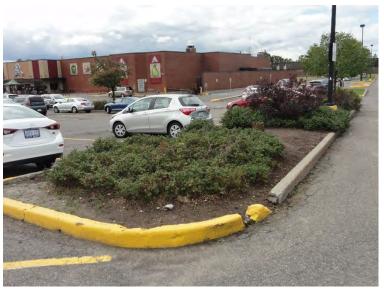
Photo 3 – View of typical landscaping in the parking area of the Site.

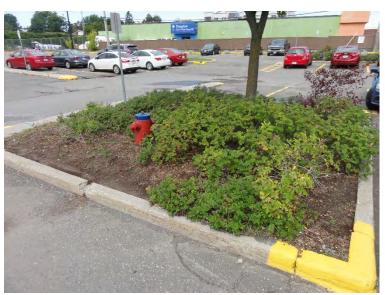
Photo 4 - View of a fire hydrant located on the western portion of the Site.

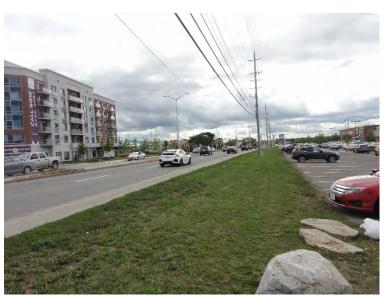
Photo 5 – View of typical landscaping observed along eastern Site perimeter (along Merivale Road).

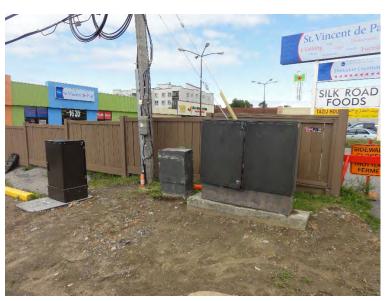
Photo 6 – View of communication boxes located on the northeast corner of the Site (no evidence of presence of electrical transformer observed).

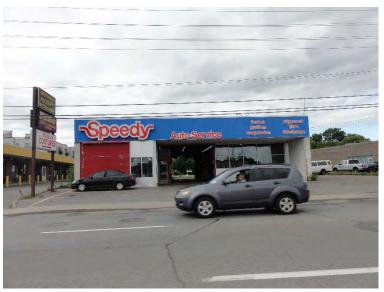
Photo 7 – View auto service garage located at 1608 Merivale Road (approximately 130 m north of the Site), looking northwest..

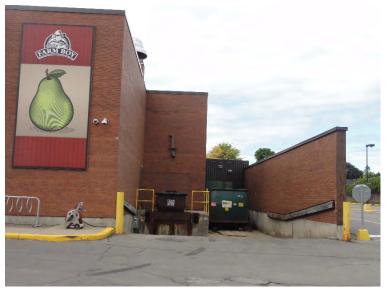
Photo 11 – View garbage compactor and waste oil bin associated with Merivale Mall building, located west of the Site.

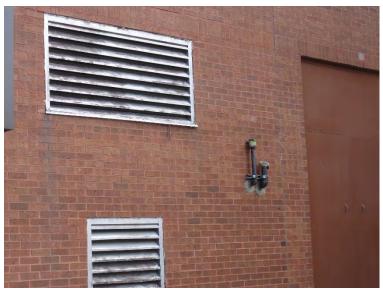
Photo 12 – View of vent and fill pipe associated with AST for backup power generator in the Merivale Mall building (located approximately 200 m southwest of the Site).
