Combined Environmental Impact Statement &  
Tree Conservation Report  
910/920 March Road Development (Revised)

June 2020

Prepared for Wexford Commercial Developments Ltd.

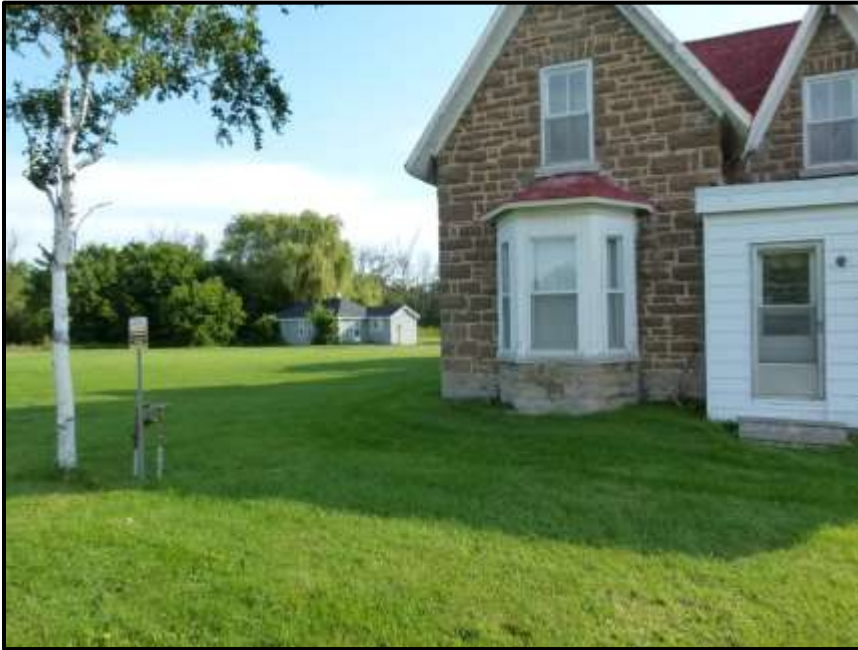
**Photograph 1:** Looking northeast at 910 March Road (Building #1) (foreground) and 920 March Road (Building #5) (background). Note the manicured lawn in the western part of the Site (August 14<sup>th</sup>, 2017).

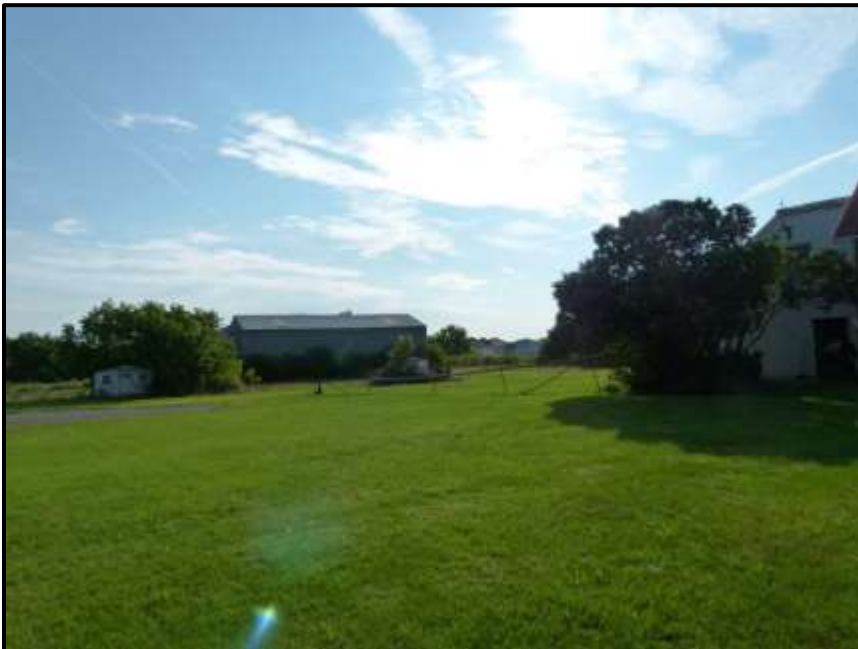
**Photograph 2:** Looking east at Building #6 (far left) and Building #7 (center). Note the manicured lawn in the western part of the Site (August 14<sup>th</sup>, 2017).

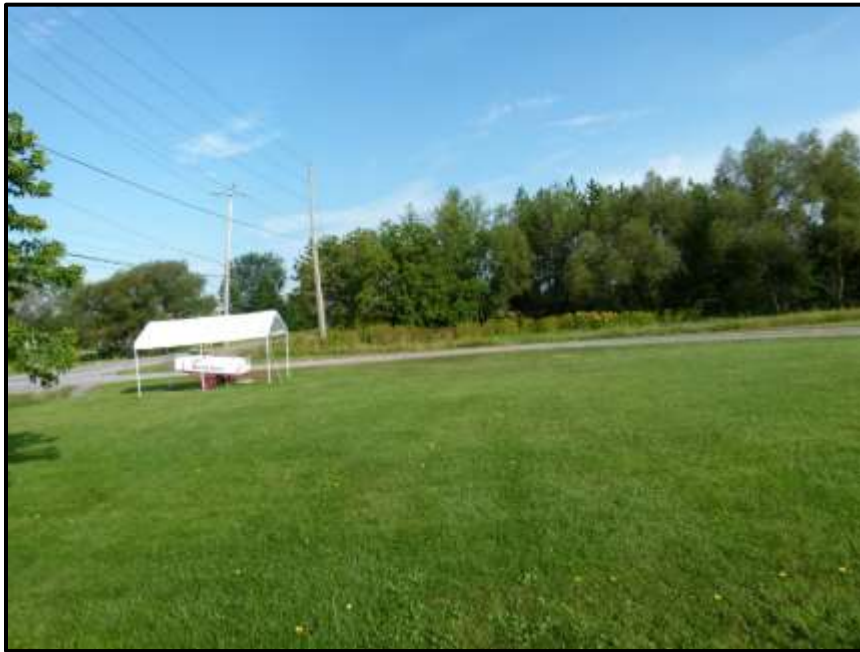
**Photograph 3:** Looking north at the northwest property corner. March Road is visible to the left. Note the Deciduous Hedgerow, located along the northern property line (on the north bank of Tributary #3) (August 14<sup>th</sup>, 2017).

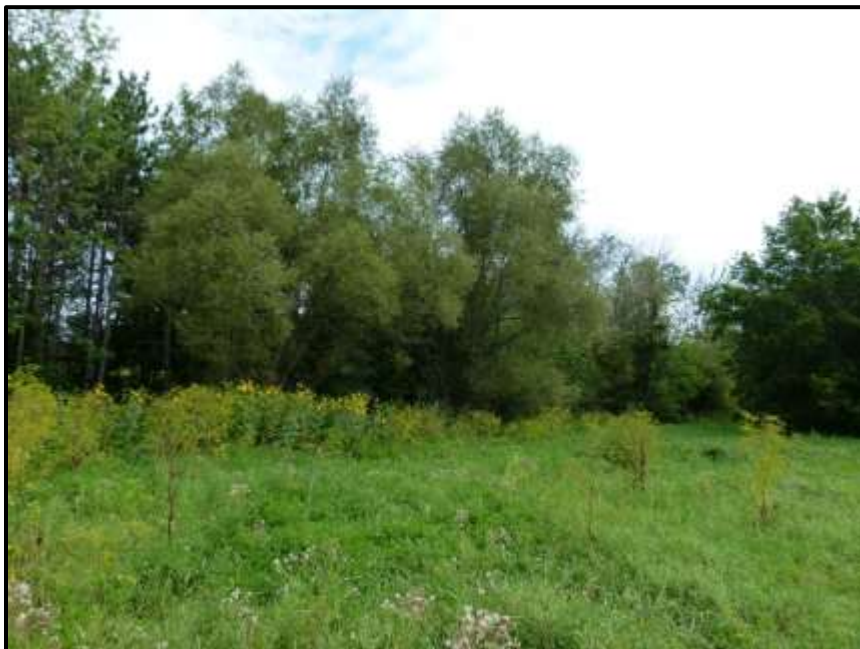
**Photograph 4:** Looking north at the Deciduous Hedgerow, located along the northern property line (on the north bank of Tributary #3) (August 14<sup>th</sup>, 2017).

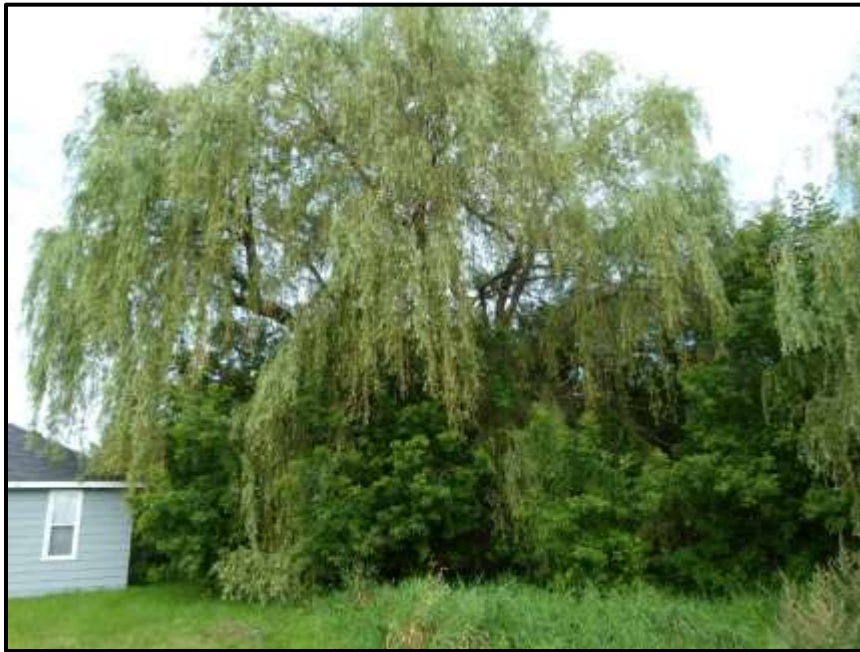
**Photograph 5:** Mature Weeping Willow (70 cm dbh) and Manitoba Maples behind 920 March Road (Building #5) (August 14<sup>th</sup>, 2017).

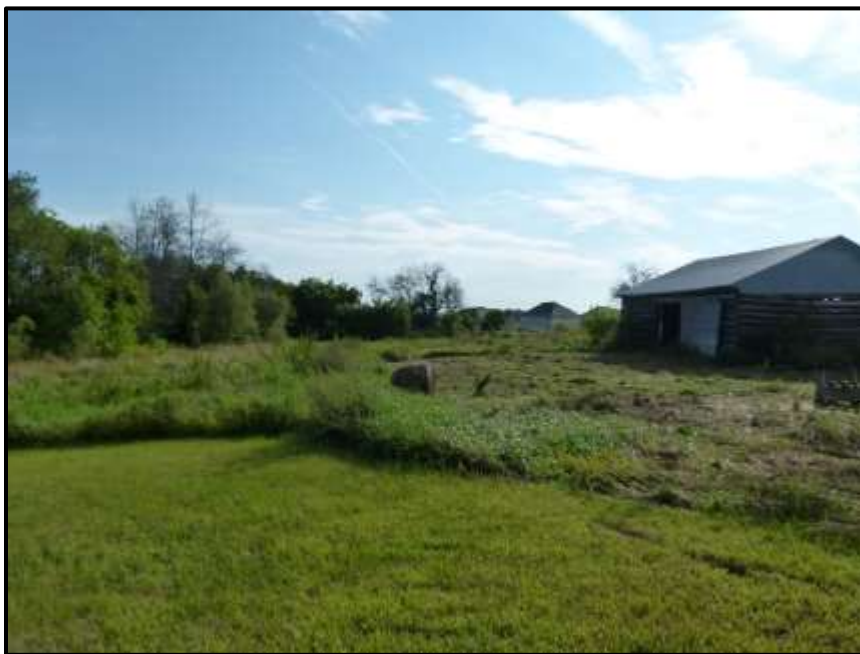
**Photograph 6:** Looking east towards the northeast corner of the Site. The Deciduous Hedgerow is visible to the left, the Brookside Subdivision is visible in the background, and Building #8 is visible to the right (August 14<sup>th</sup>, 2017).

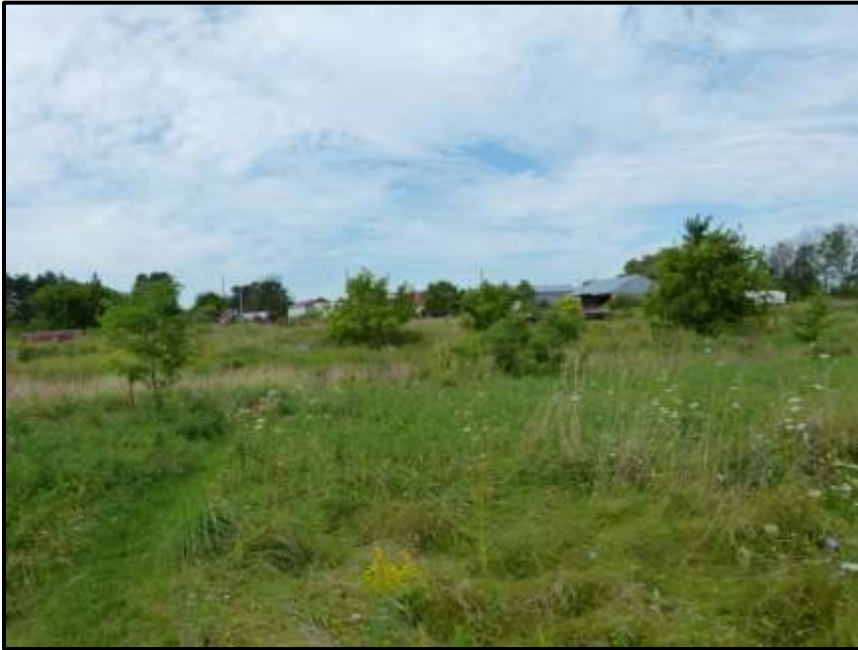
**Photograph 7:** Looking west at the Site from the adjacent City of Ottawa watercourse corridor. Note the young planted trees within the City of Ottawa corridor. Tree cover is otherwise sparse within the watercourse corridor (August 14<sup>th</sup>, 2017).

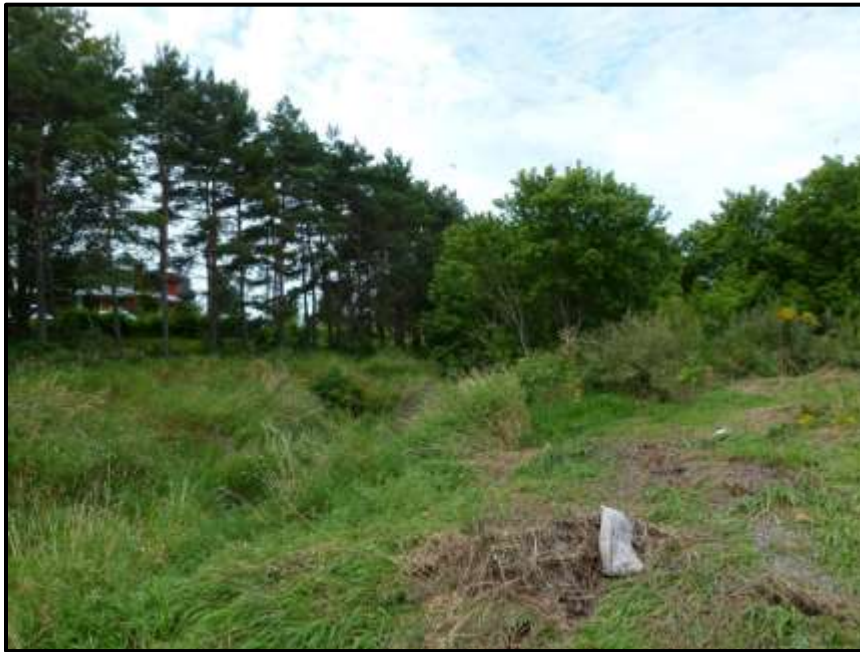
**Photograph 8:** Looking southwest at the row of planted Red Pines located on the adjacent fast food restaurant property (left), and the row of Manitoba Maple within the southern part of the Site (right) (August 14<sup>th</sup>, 2017).

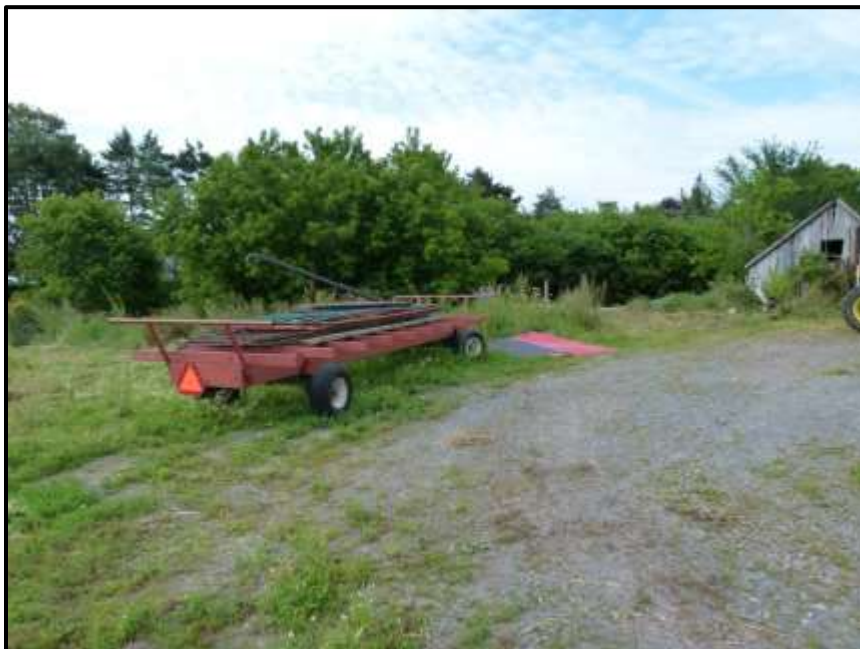
**Photograph 9:** Looking south at the row of Manitoba Maples within the southern part of the Site. Building #4 is visible to the right (August 14<sup>th</sup>, 2017).

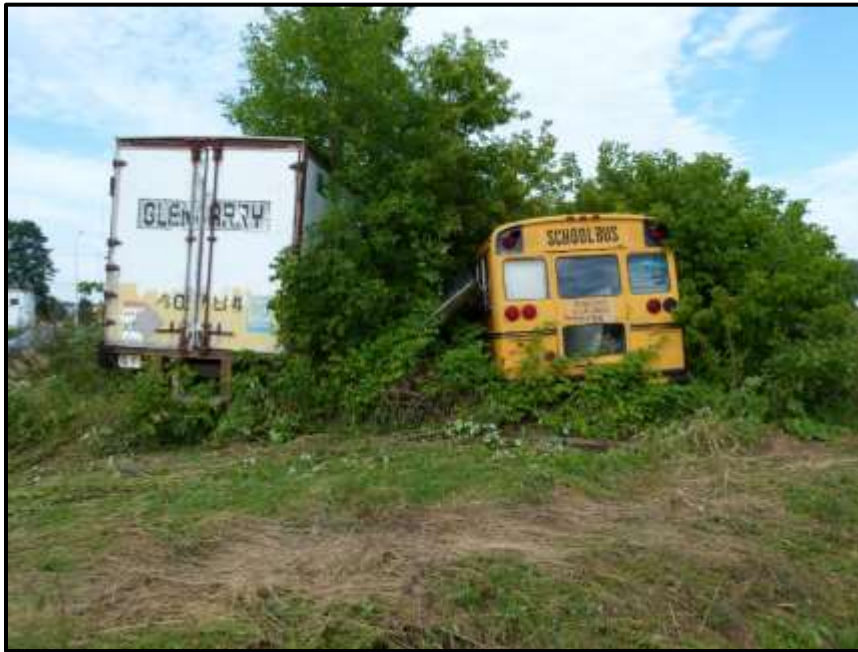
**Photograph 10:** Example of vehicle storage and recent regrowth shrub/tree cover within the central part of the Site (August 14<sup>th</sup>, 2017).

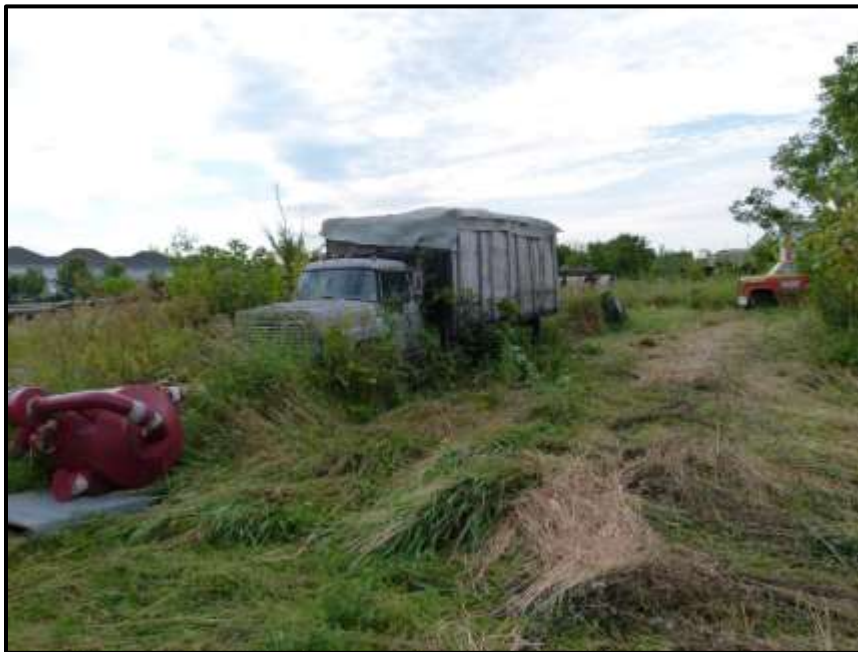
**Photograph 11:** Example of vehicle storage and recent regrowth shrub/tree cover within the central part of the Site (August 14<sup>th</sup>, 2017).

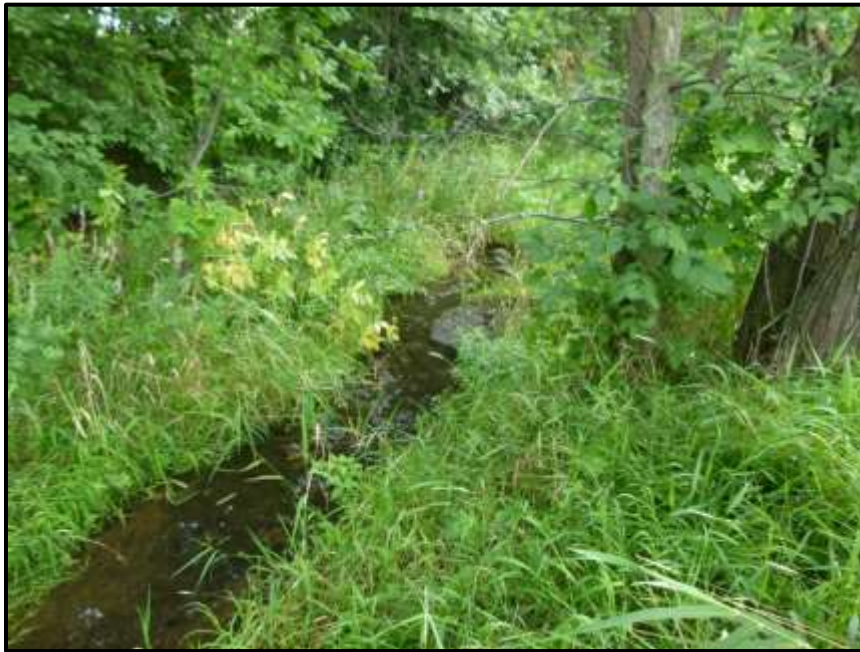
Photograph 12: Shirley's Brook Tributary #3 in the northern part of the Site (August 14<sup>th</sup>, 2017).

The tributaries flowing parallel to the northern and eastern property lines (Tributary #3 and the combined flow of Tributary #2 and #3) showed similar habitat characteristics. Both tributaries were observed to have a shallow channel 1 m to 2 m wide, with flowing water (approx. 20 cm deep on August 14<sup>th</sup>, 2017). Both Tributary #3 (north) and the combined Tributary #2 and #3 (east) had Spotted Jewelweed, Spotted Joe Pye Weed and Reed Canary Grass growing on their banks. Common Cattail and Purple Loosestrife were noted in some areas within the channels, although the channels were predominantly open and sparsely vegetated. The sparse aquatic vegetation coverage within the channels suggests that Tributary #3 (north) and the combined Tributary #2 and #3 (east) remain wet and flowing throughout most of the year. The substrate in the channels consisted primarily of mud bottom with some larger rocks and cover objects. As noted above in Section 3.2, there is very little riparian tree cover within the Site adjacent to the tributaries of Shirley's Brook. The northern Deciduous Hedgerow provides shade on the north side of Tributary #3, but the south side of the tributary predominantly lacks tree cover. The combined Tributary #2 and #3 (east) is predominantly without tree cover, with only a few young Manitoba Maple stems present within the Site, and a few recently planted trees present on the City of Ottawa owned side of the watercourse.

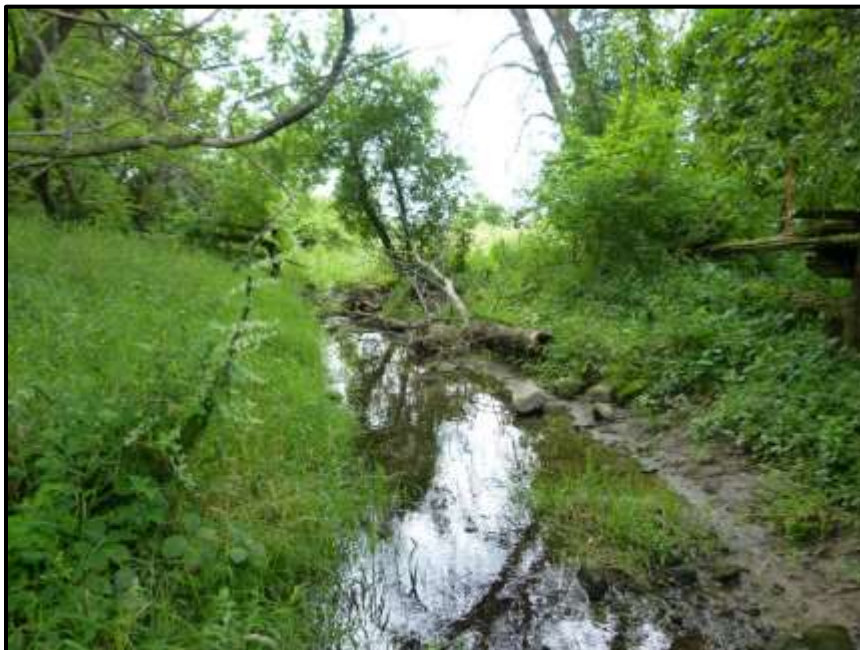
Photograph 13: Shirley's Brook Tributary #2, as seen in the adjacent property to the north of the Site (August 14<sup>th</sup>, 2017).

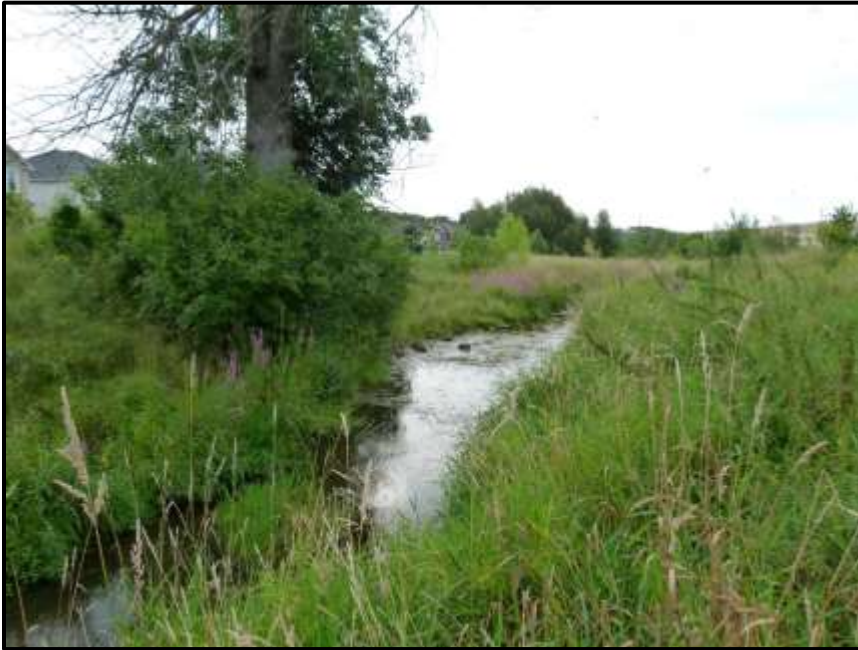
**Photograph 14:** Combined flow of Tributary #2 and #3, within the eastern part of the Site (facing south) (August 14<sup>th</sup>, 2017).

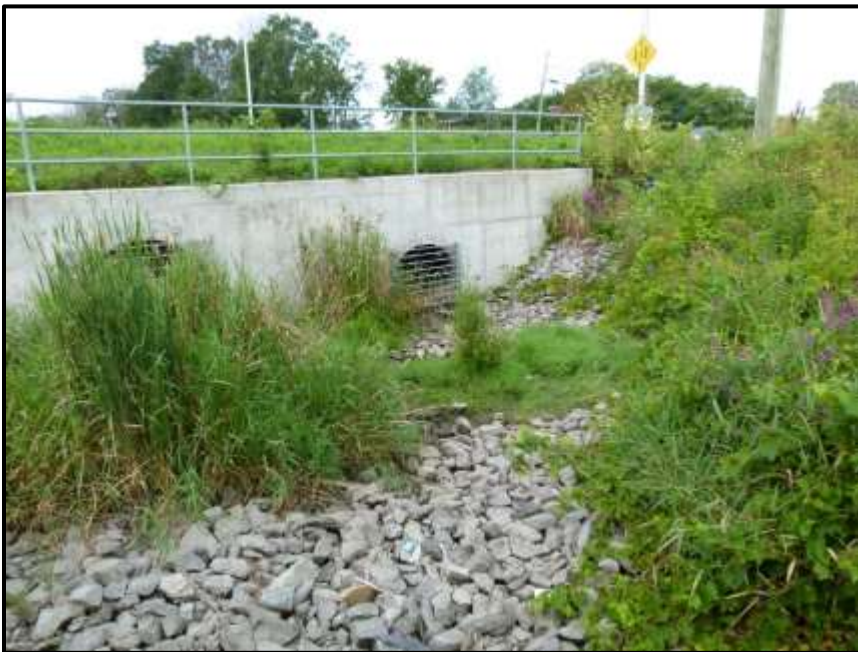
**Photograph 15:** Stormwater pipes outletting to the southern stormwater swale (Tributary #4) (facing west towards March Road). Note the lack of surface water (August 14<sup>th</sup>, 2017).

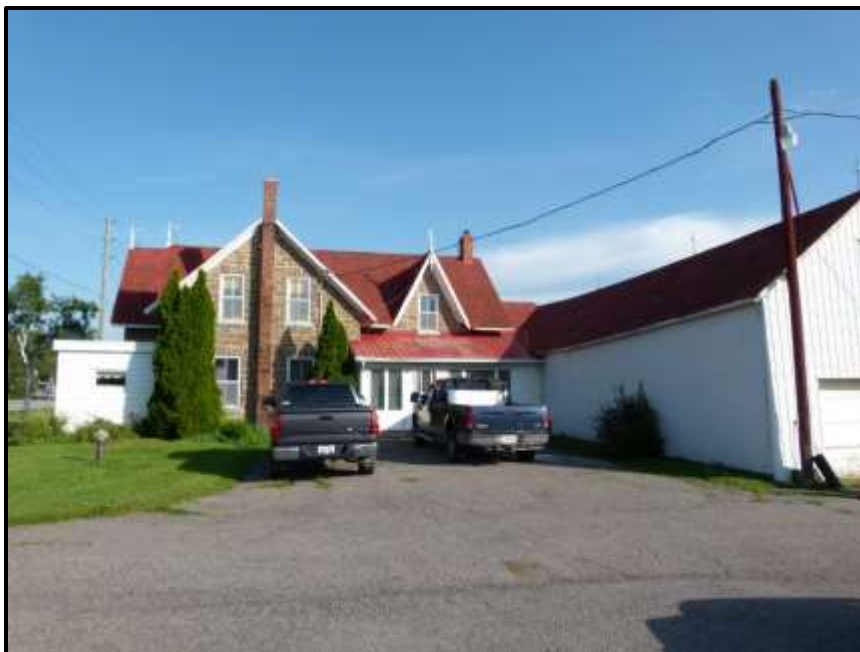
**Photograph 18:** Looking north at 910 March Road (Building #1). One (1) intact and one (1) degraded Barn Swallow nest were noted in the barn/garage on the right (August 14<sup>th</sup>, 2017).

- **Building 1:** Building #1 includes the house at 910 March Road, which has brick walls and a metal tiled roof. A wooden barn/garage with a tin roof is attached to the house. One (1) intact nest and one (1) degraded nest were noted within the barn/garage.

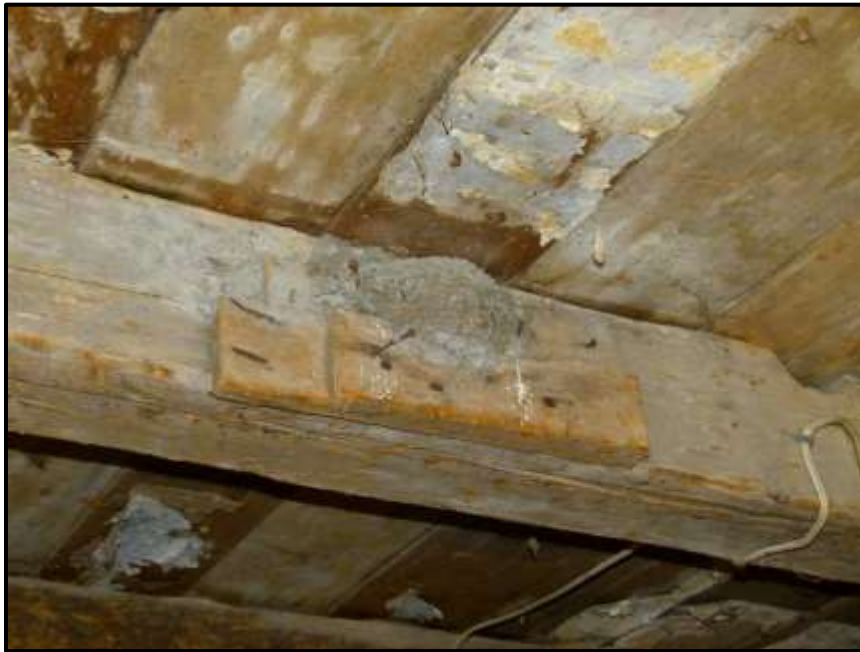
Photograph 19: Intact Barn Swallow nest within the garage/barn of Building #1 (August 14<sup>th</sup>, 2017).

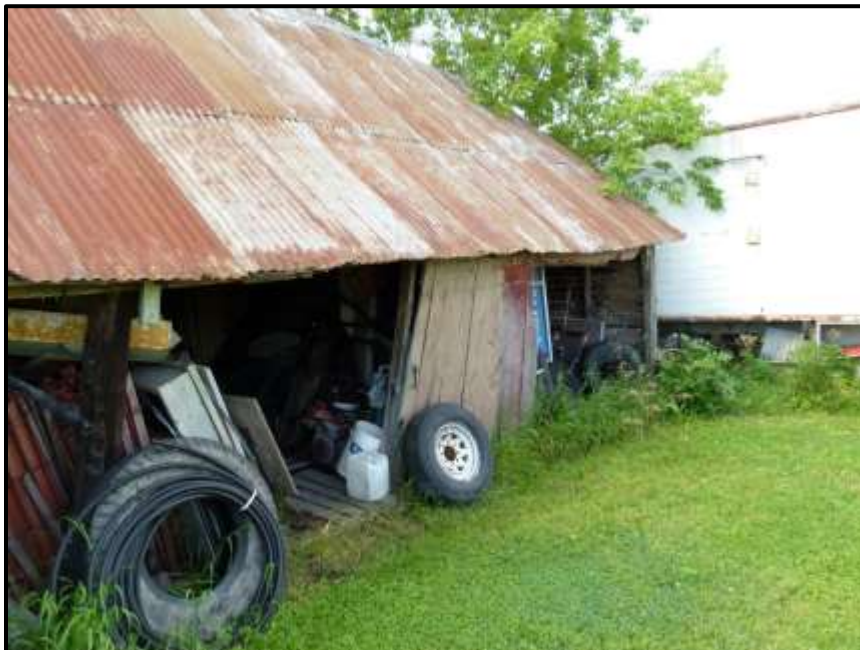
Photograph 22: Building #4 – one (1) intact and one (1) degraded Barn Swallow nest were noted (August 14<sup>th</sup>, 2017).

- **Building 4:** Building #4 is a small collapsing barn with a tin roof. The middle section of the building has a raised wooden steeple roof. One (1) intact nest and one (1) degraded nest were noted within the middle section of the building.

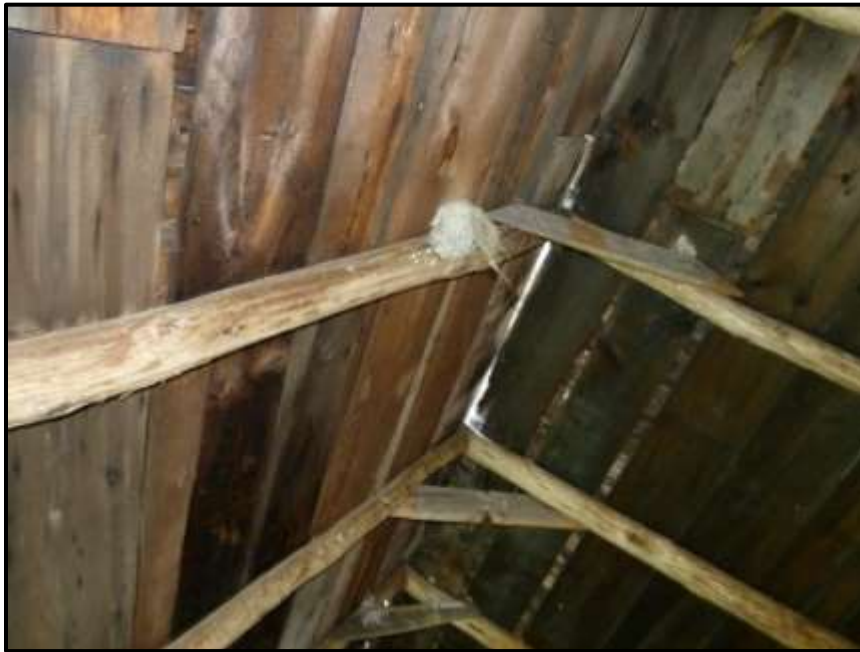
Photograph 23: Intact Barn Swallow nest within Building #4 (August 14<sup>th</sup>, 2017).

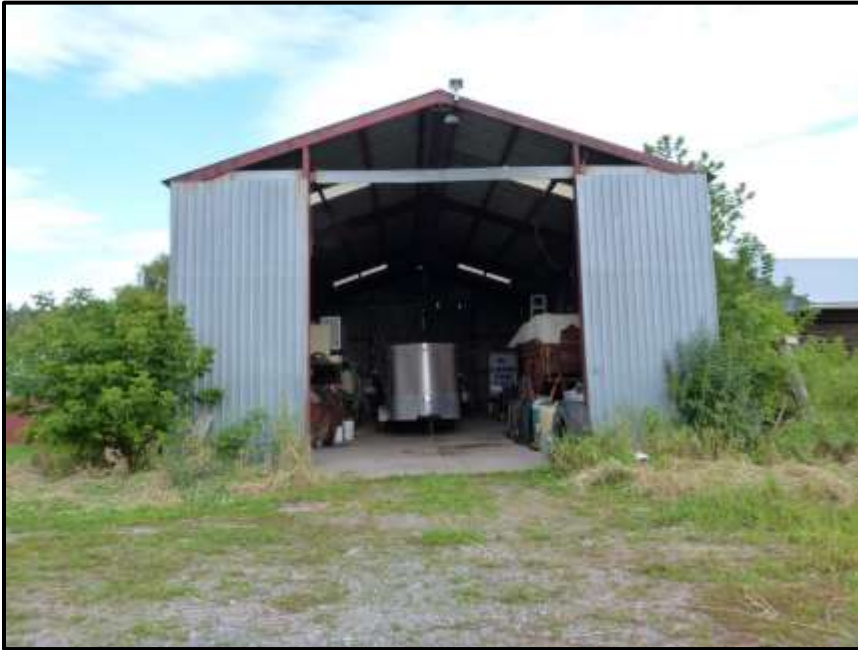
Photograph 25: Building #7 – one (1) intact Barn Swallow nest with adult/baby birds in attendance and one (1) degraded nest were noted (August 14<sup>th</sup>, 2017).

- **Building 7:** Building #7 is a large steel garage with parked tractors. One (1) intact nest was observed with a baby bird present and parents in attendance. One (1) degraded nest was also observed.

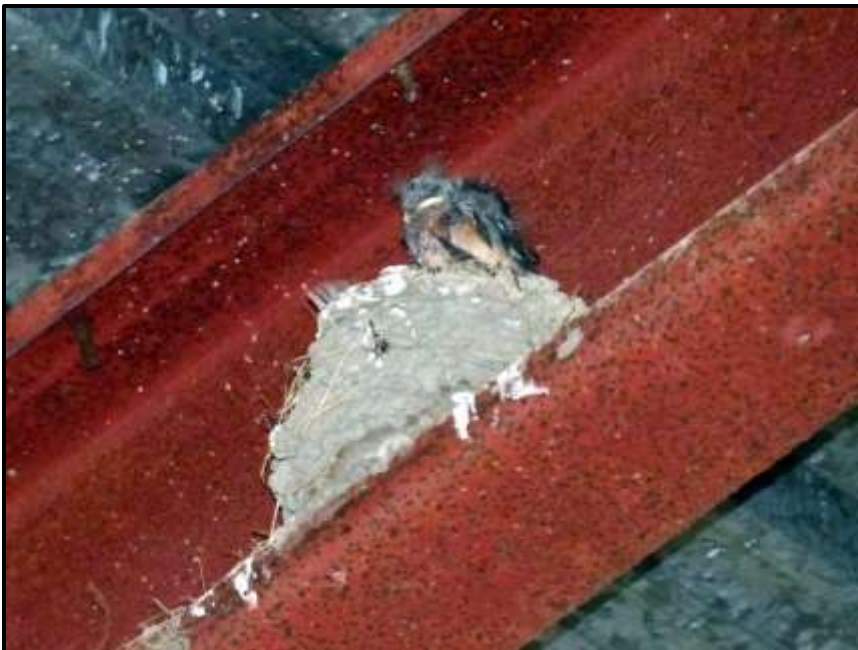
Photograph 26: Active Barn Swallow nest in Building #7 with baby bird visible (August 14<sup>th</sup>, 2017).

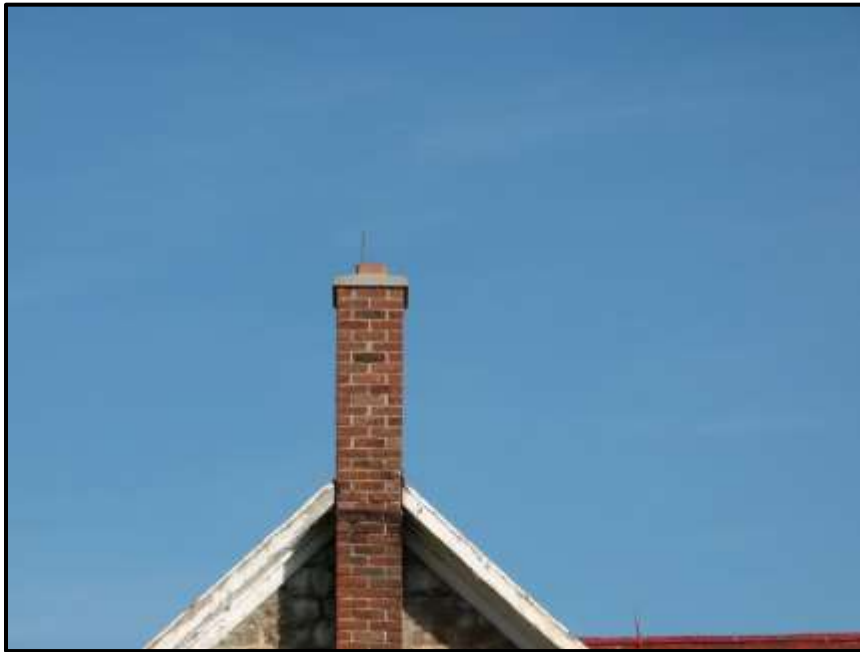
Photograph 29: 910 March Road (Building #1) chimney with ceramic liner (August 14<sup>th</sup>, 2017).

- **Chimney Swift:** Chimney Swifts nest in open chimneys with rough interior surfaces made from brick and/or stone (SARO 2020). There are three (3) chimneys found within the Site. Photographs of the chimneys are included below. 910 March Road includes a brick chimney with a ceramic liner and a second brick chimney with a metal cap. 920 March Road has a concrete chimney with a metal cap. Chimney Swifts will not nest in chimneys with ceramic liners, as they are unable to affix their nests to the smooth interior surface (SARO 2020). Chimney Swifts are unable to enter chimneys with metal caps. There are therefore no chimneys within the Site which may be suitable for Chimney Swift nesting.

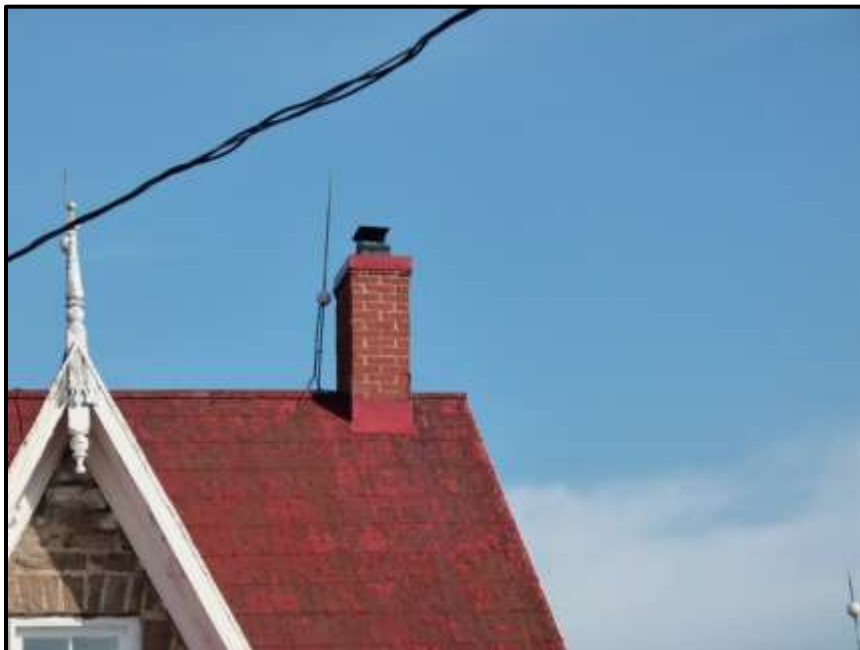
Photograph 30: 910 March Road (Building #1) chimney with metal cap (August 14<sup>th</sup>, 2017).

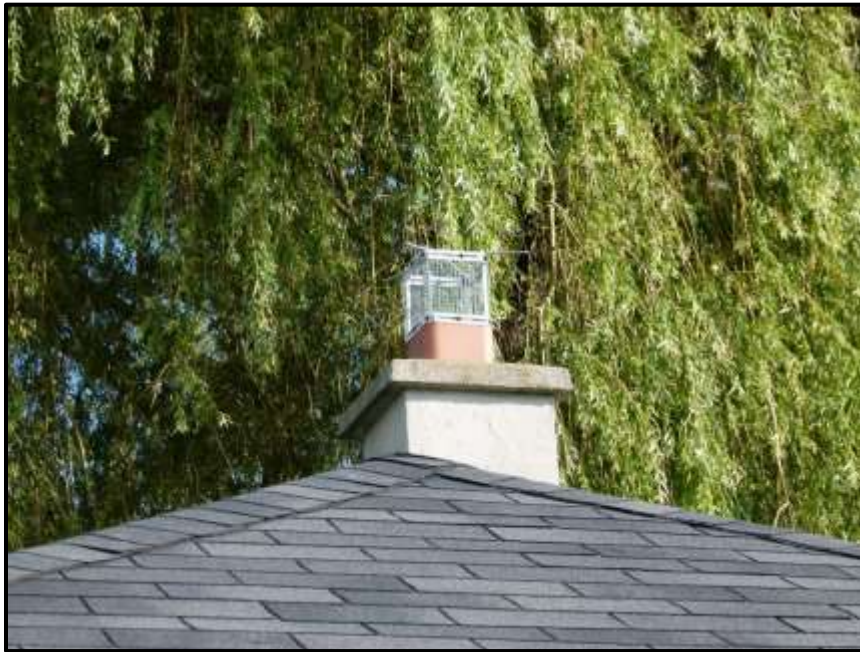
**Photograph 31:** 920 March Road (Building #5) chimney with metal cap (August 14<sup>th</sup>, 2017).

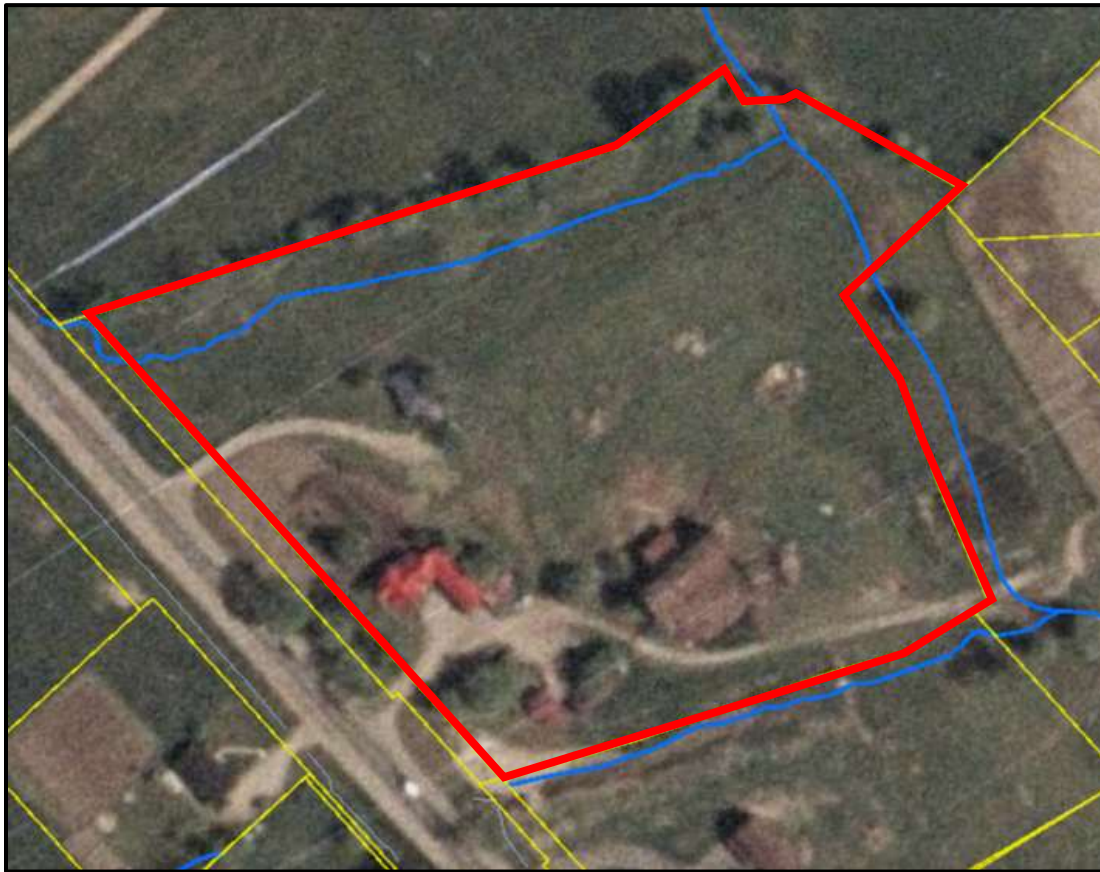
**Photograph 1:** Historic Air Photo from 1976 (property boundary shown in red). Note that the Site is predominantly cleared and devoid of mature trees. Surrounding areas appear to be farmed and/or rural residences. A few mature trees are present around the house at 910 March Road and along the northern property boundary (Photo from City of Ottawa 2020).

Air photos from 1976, 1991 and 2002 are included below (Photos from City of Ottawa 2020). A recent air photo is included in Figure 2. The oldest available historic air photo (from 1976), shows that the Site has been predominantly cleared and devoid of mature trees since at least 1976. The areas surrounding the Site appear to be farmed and/or rural residences in 1976. In 1976, a few mature trees are present around the house at 910 March Road and along the northern property boundary. This suggests that some of the older trees in the Deciduous Hedgerow have been growing since before 1976. Conditions within the Site appear similar in 1991, although a few additional mature trees are present around the houses at both 910 and 920 March Road, and along the northern property boundary in 1991. The Site layout and usage in 2002 is similar to current conditions. In 2002, the Site was predominantly cleared and devoid of mature trees. Surrounding areas appear to be farmed and/or rural residences. In 2002, a few mature trees are present surrounding the house at 920 March Road and along the northern property boundary. The historic air photos indicate that the only older trees found within the Site include those growing within the Deciduous Hedgerow along the northern Site boundary. Some of the Deciduous Hedgerow trees have been growing since before 1976. A few older trees are also shown to be present around the house at 920 March Road, and have been growing there since before 1991. The majority of other trees found within the Site, including the Manitoba Maples growing along the southern Site boundary, are comparatively young recent regrowth.

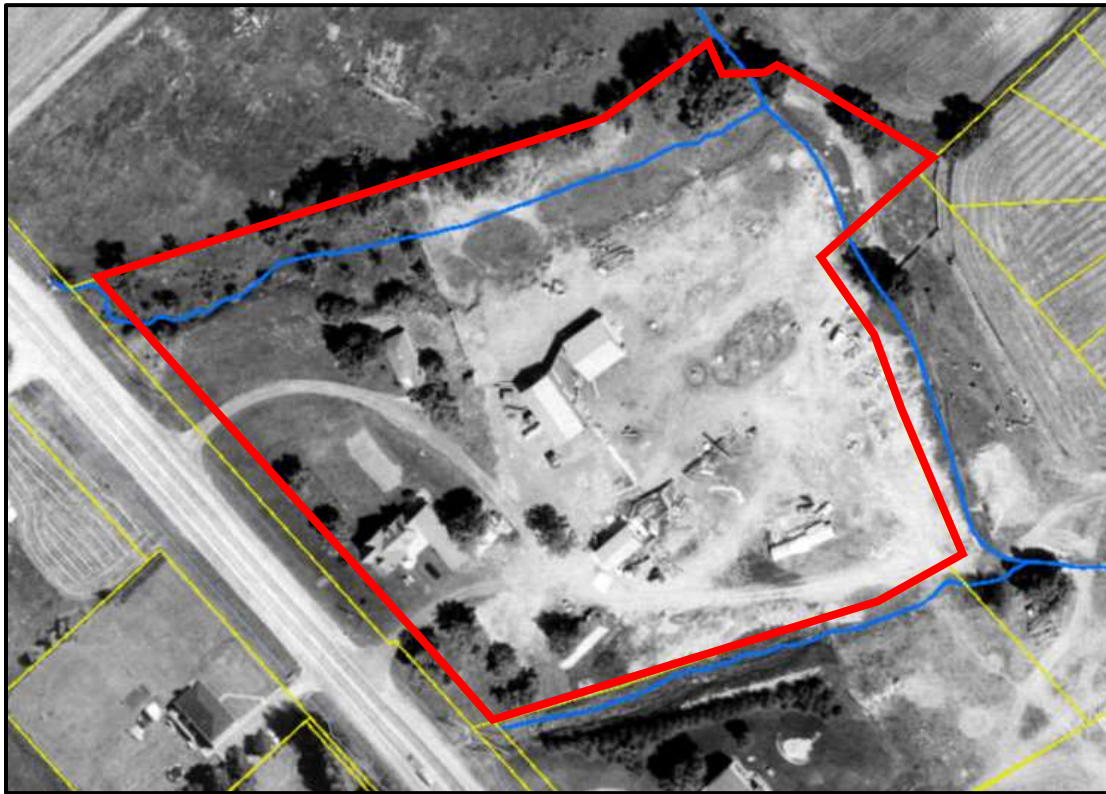
**Photograph 2:** Historic Air Photo from 1991 (property boundary shown in red). Note that the Site is predominantly cleared and devoid of mature trees. Surrounding areas appear to be farmed and/or rural residences. A few mature trees are present around the houses at 910 and 920 March Road, and along the northern and southern property boundaries (Photo from City of Ottawa 2020).

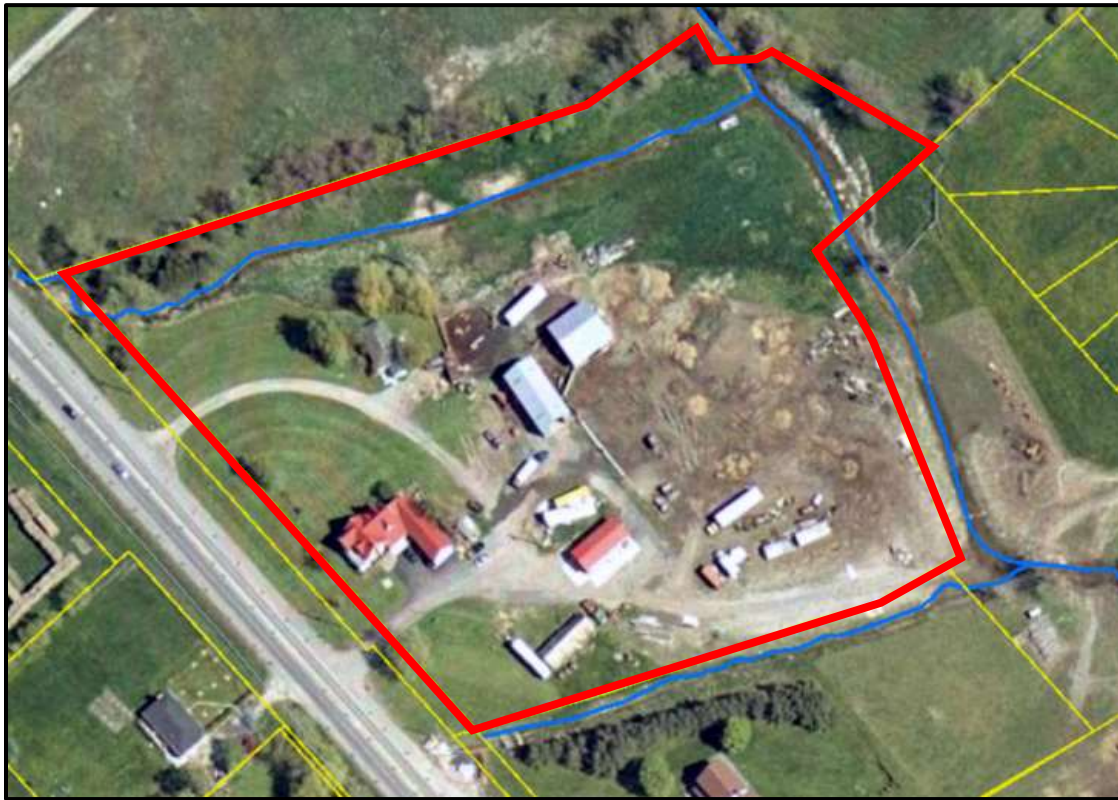
**Photograph 3:** Historic Air Photo from 2002 (property boundary shown in red). The Site layout and usage in 2002 is similar to current conditions. Note that the Site is predominantly cleared and devoid of mature trees. Surrounding areas appear to be farmed and/or rural residences. A few mature trees are present surrounding the house at 920 March Road and along the northern property boundary (Photo from City of Ottawa 2020).
