**Phase I Environmental Site Assessment**

Vacant Property  
850 Champlain Street  
Ottawa, Ontario

August 8, 2016

Report: PE3846-1

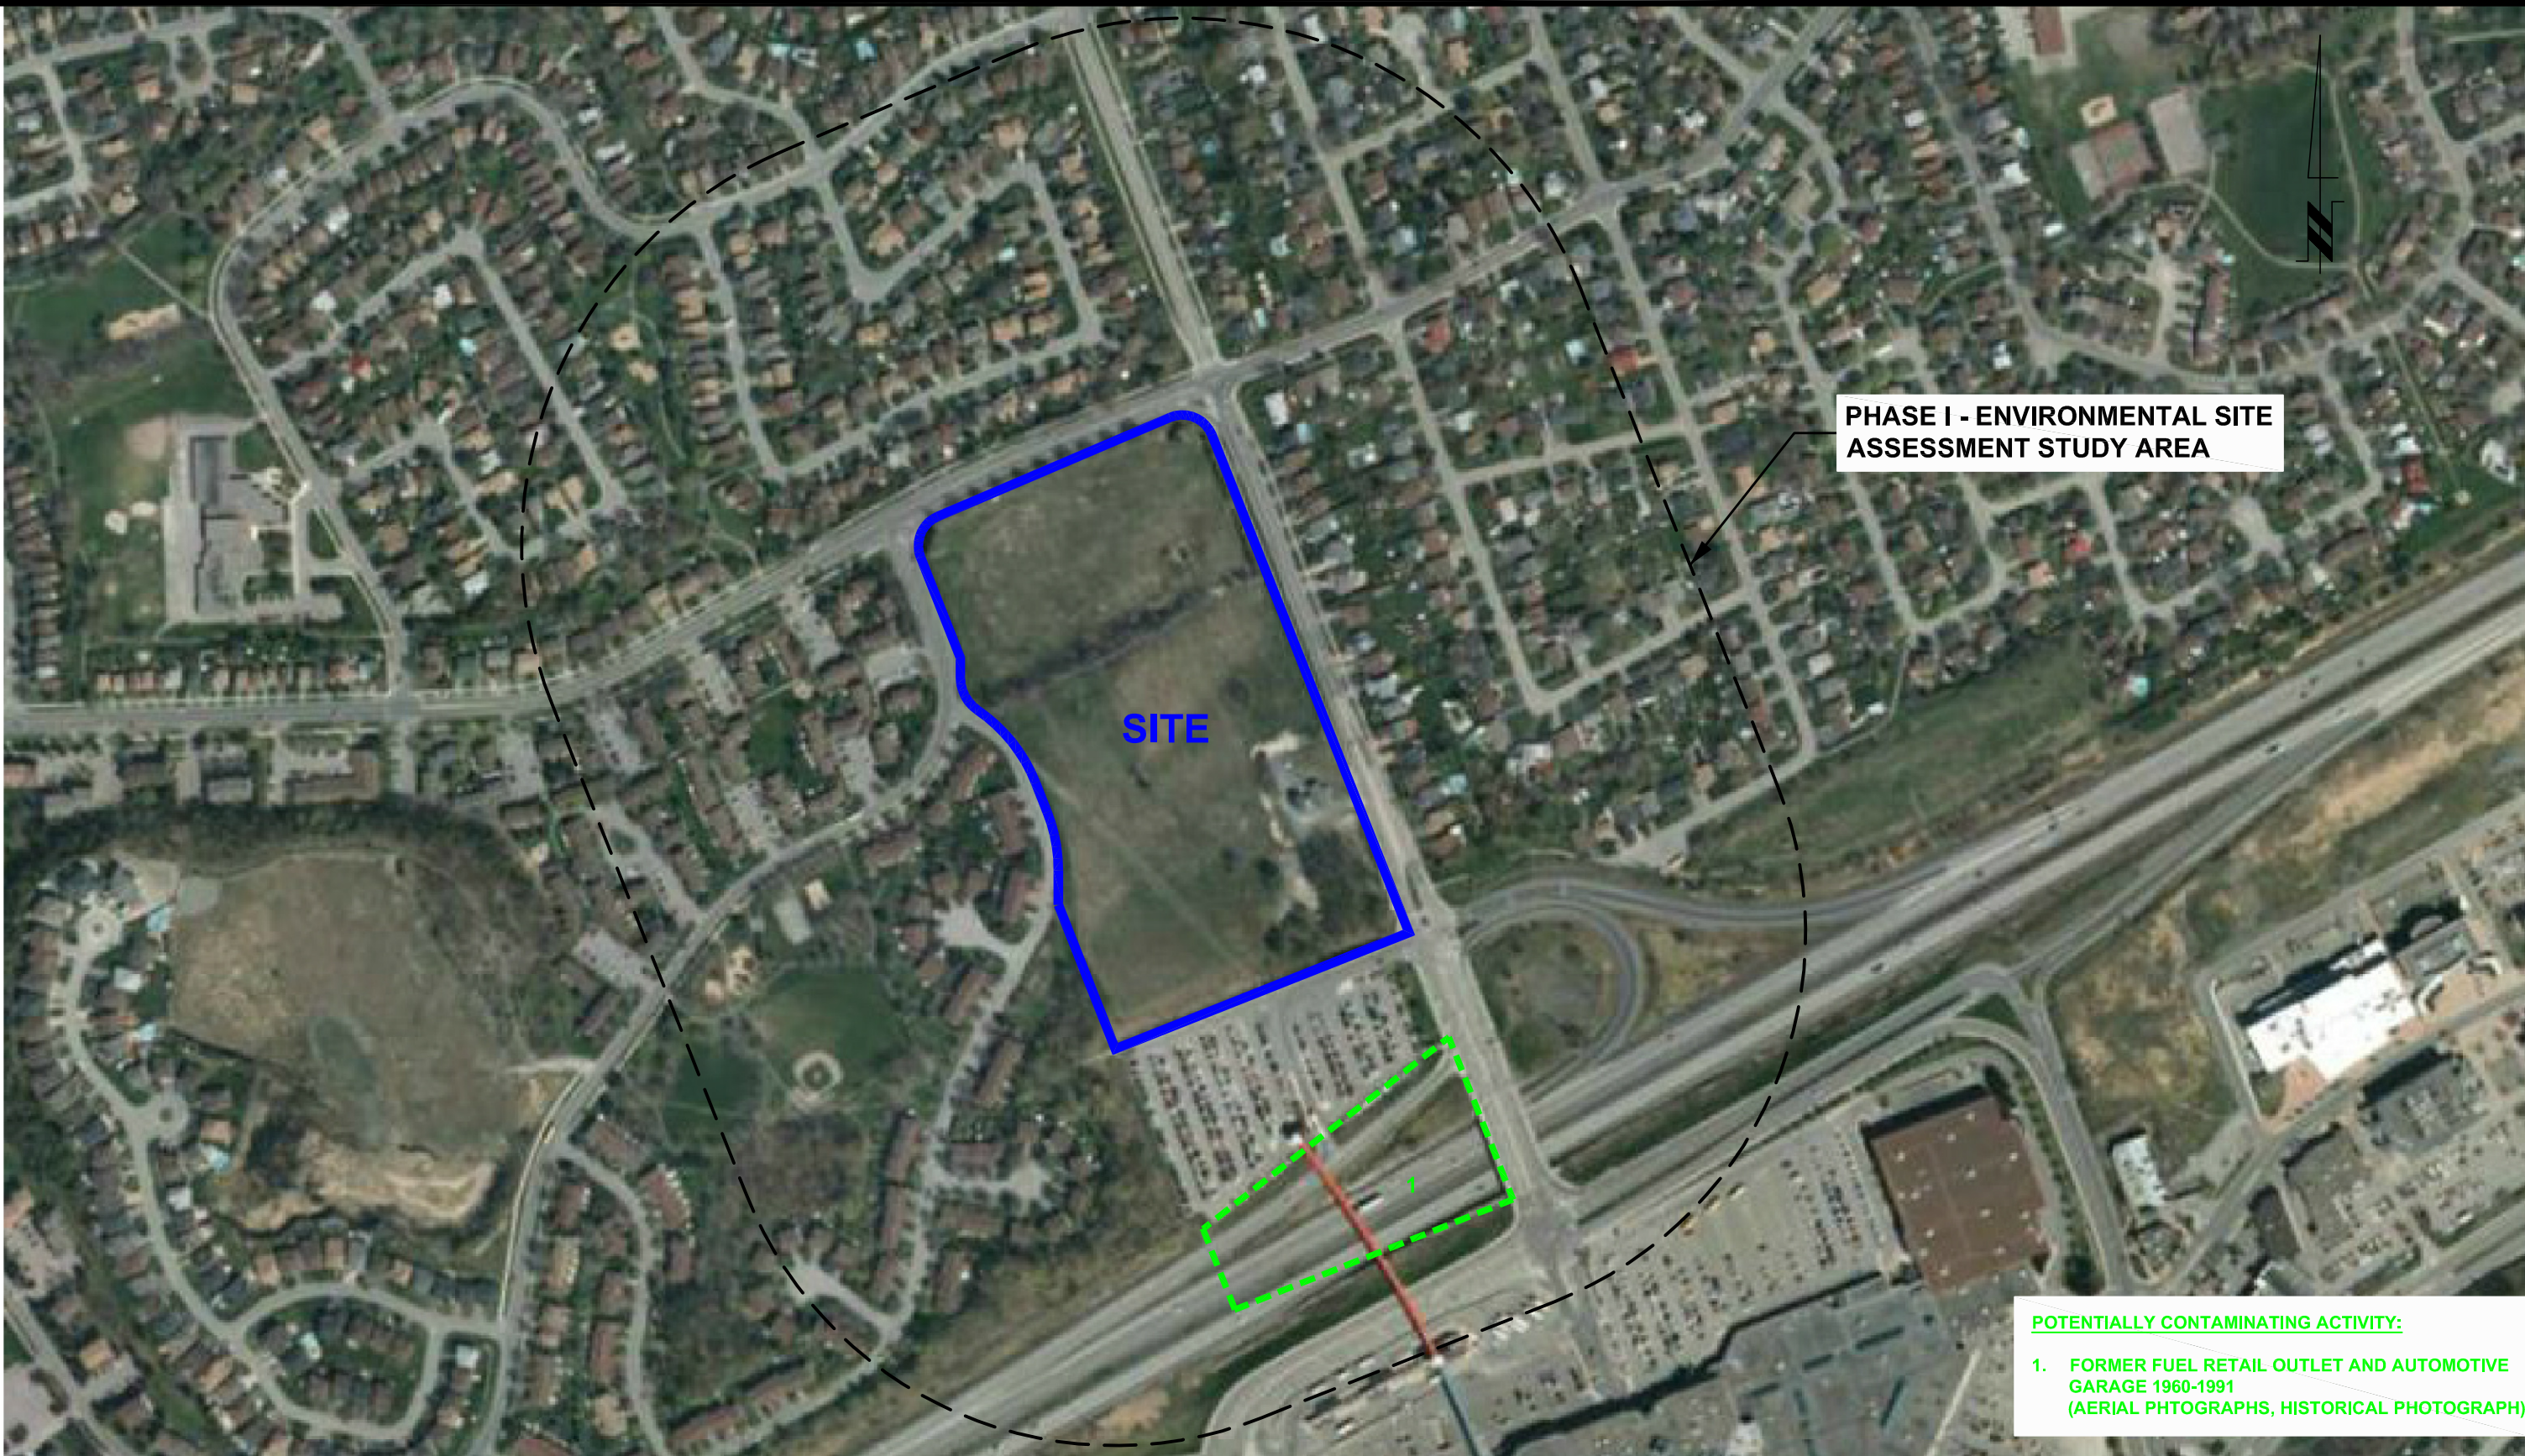
**DRAWING PE3846-2 – SURROUNDING LAND USE PLAN**

Historically, one (1) potentially contaminating activity was identified within the study area, at a property located approximately 80 meters to the south of the subject site. As per Column A of Table 2, from Ontario Regulation 153/04, amended by Ontario Regulation 296/11, the following was identified: Gasoline and Associated Projects Stored in Fixed Tanks (Item 28) and Garages and Maintenance and Repair of Railcars, Marine Vehicles and Aviation Vehicles (Item 27). Based on aerial photographs, and a photograph taken of the property in 1982, it appears as though a retail fuel outlet and service station was located to the south of the subject site.

Based on the soil conditions in the area (typically grey silty clay), and the distance (80 m) between the retail fuel outlet and the subject site, the retail fuel outlet is not expected to pose an environmental concern to the subject site.

PHASE I - ENVIRONMENTAL SITE ASSESSMENT STUDY AREA

**POTENTIALLY CONTAMINATING ACTIVITY:**  
1. FORMER FUEL RETAIL OUTLET AND AUTOMOTIVE GARAGE 1960-1991  
(AERIAL PHOTOGRAPHS, HISTORICAL PHOTOGRAPH)

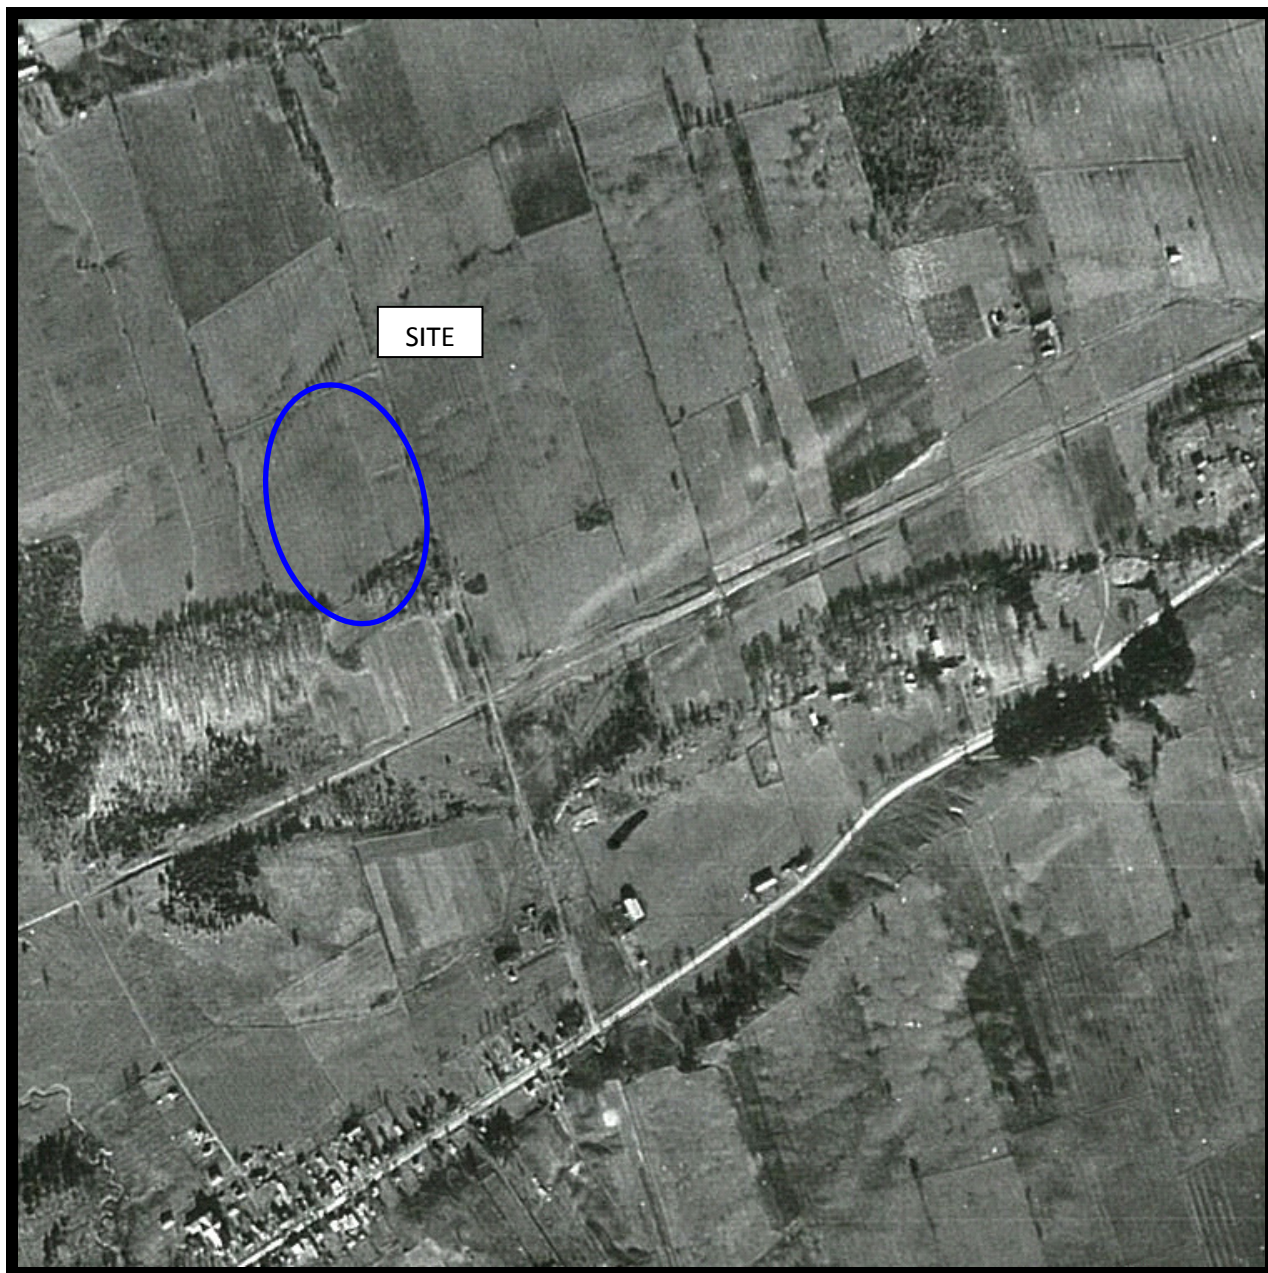
AERIAL PHOTOGRAPH  
1945

| 1945 | The subject property appears to be vacant and used for agriculture. Neighbouring properties are either treed or used for agricultural purposes. Further to the south, a roadway is visible in the current location of Highway 174. |

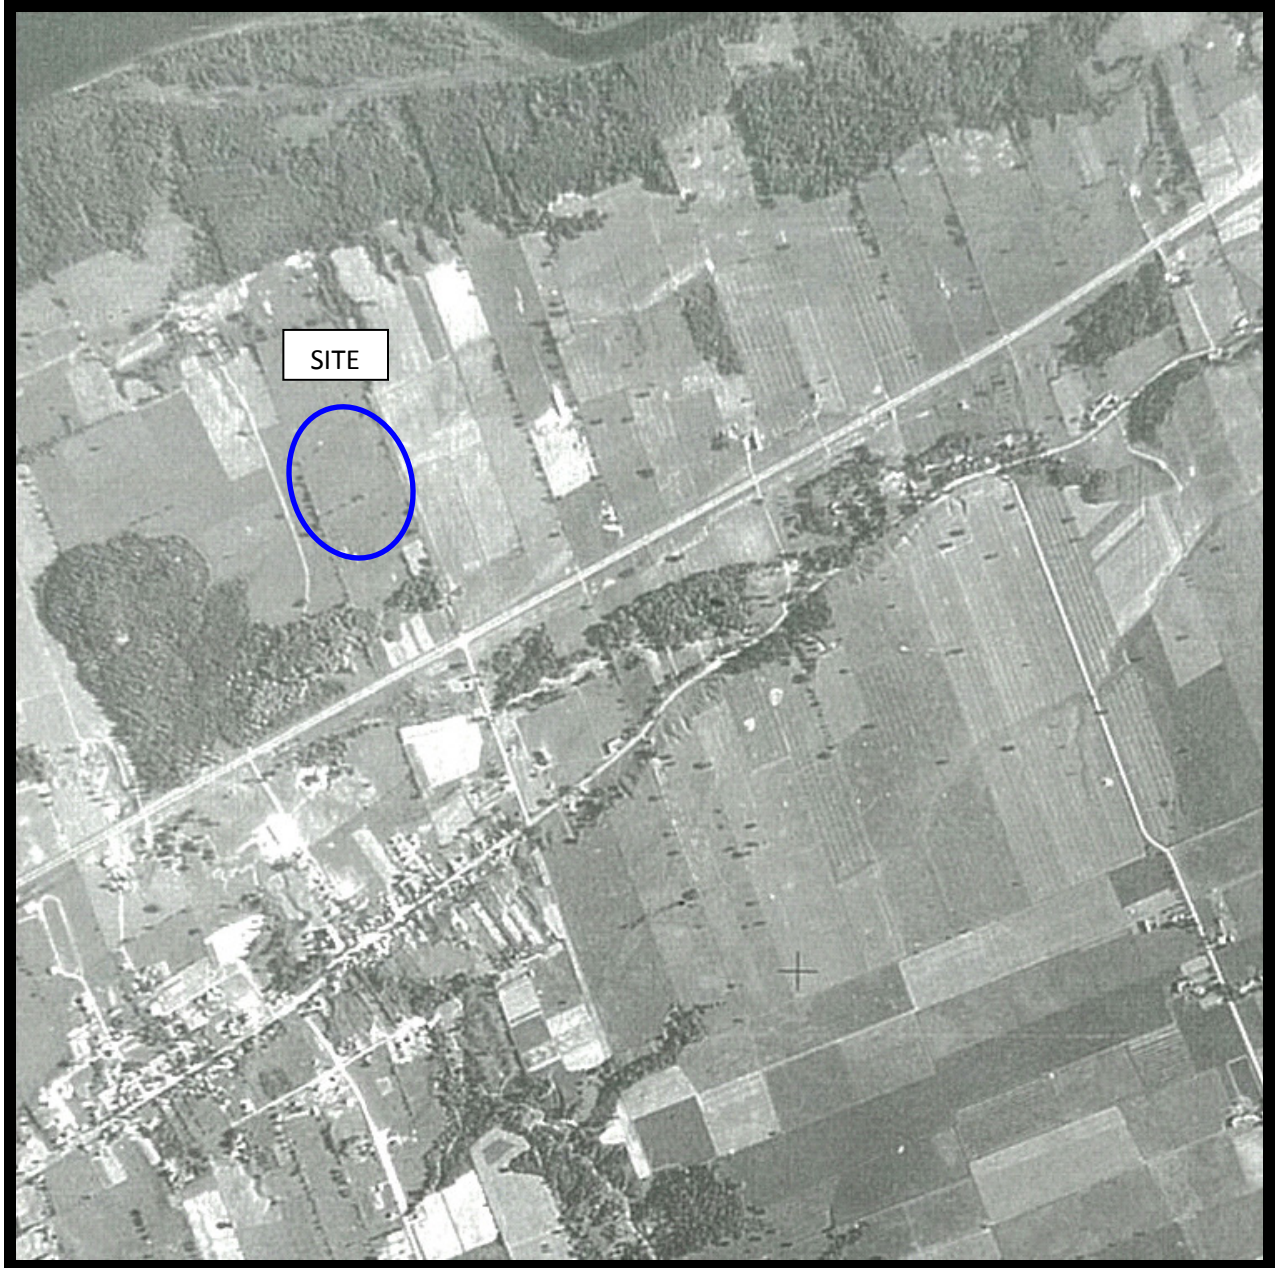
AERIAL PHOTOGRAPH  
1955

| 1955 | No significant changes appear to have been made to the subject site or neighbouring properties. |

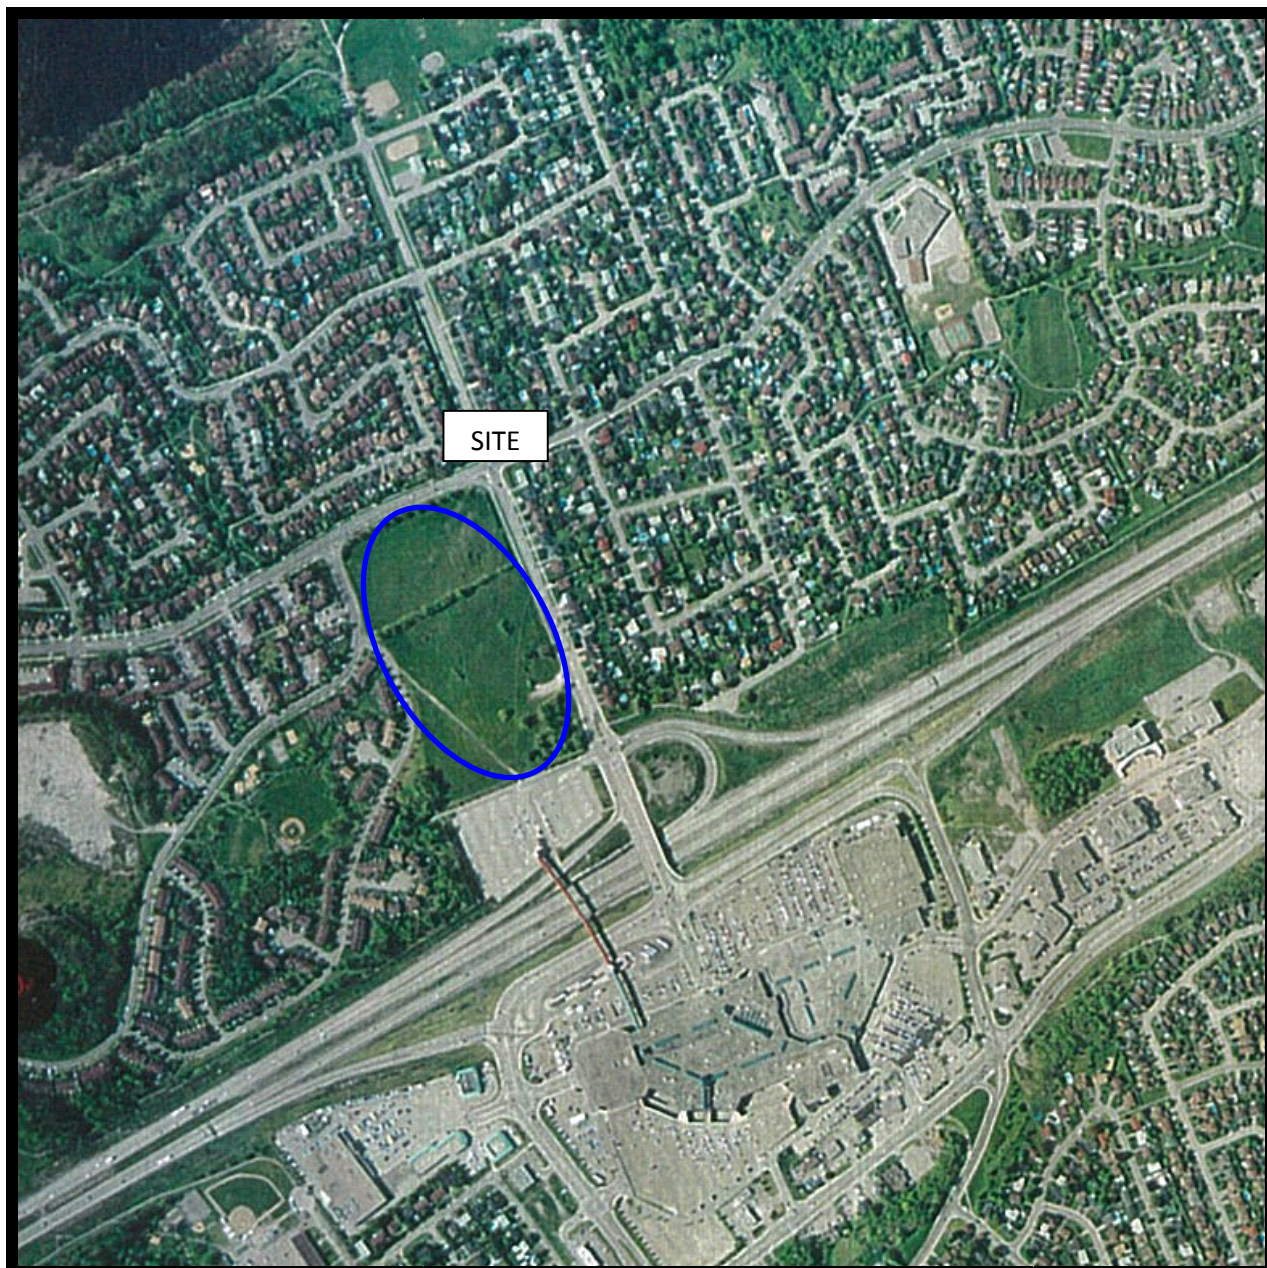
AERIAL PHOTOGRAPH  
2002

| 2002 | The subject site appears to be vacant and grassed. The OC Transpo Park and Ride has now been constructed immediately to |

the south. No other significant changes appear to have been made to adjacent properties.

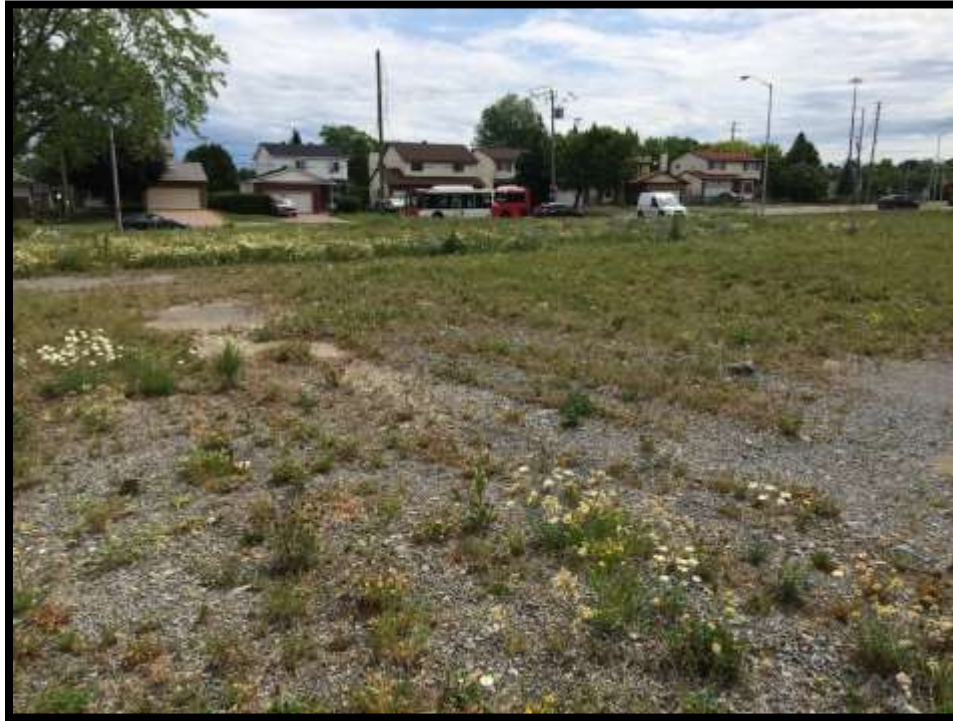
Photograph 1: Location of former showroom building.
