## **Phase I Environmental Site Assessment**

Vacant Land  
Trim Road and Portobello Boulevard  
Ottawa, Ontario

**January 20, 2018**

Report: PE4111-1

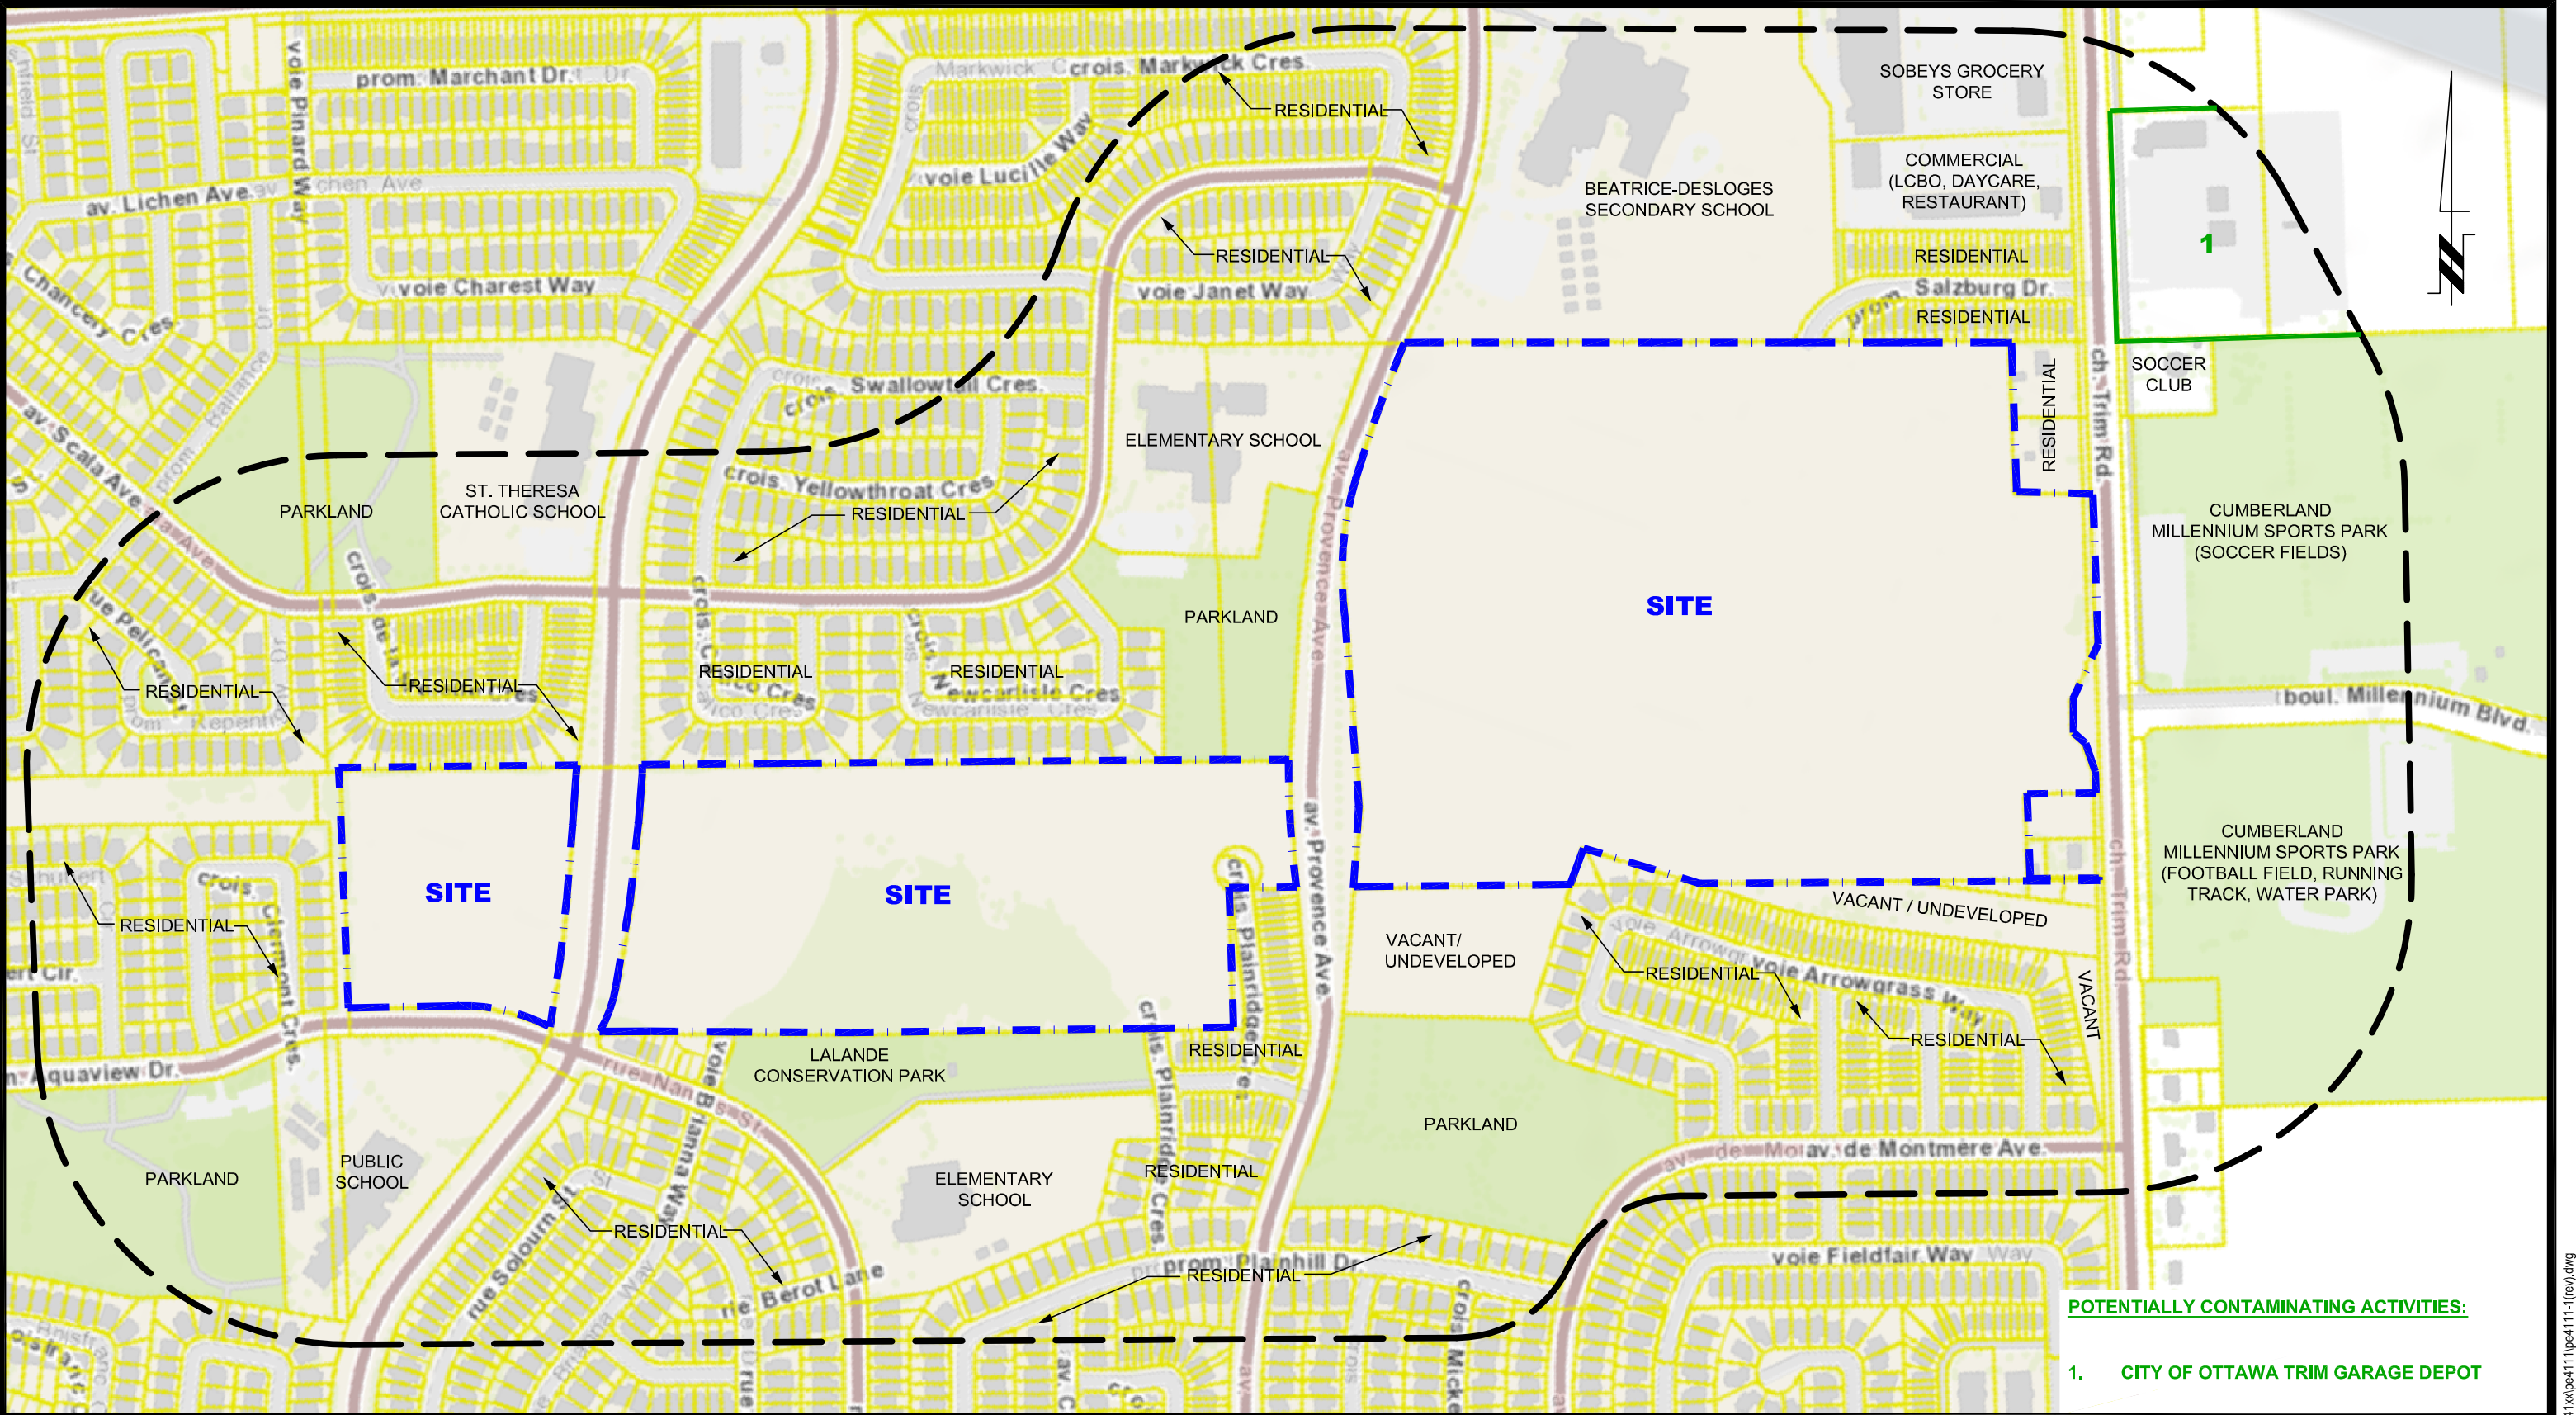
**DRAWING PE4111-2 – SURROUNDING LAND USE PLAN**

**POTENTIALLY CONTAMINATING ACTIVITIES:**

1. CITY OF OTTAWA TRIM GARAGE DEPOT

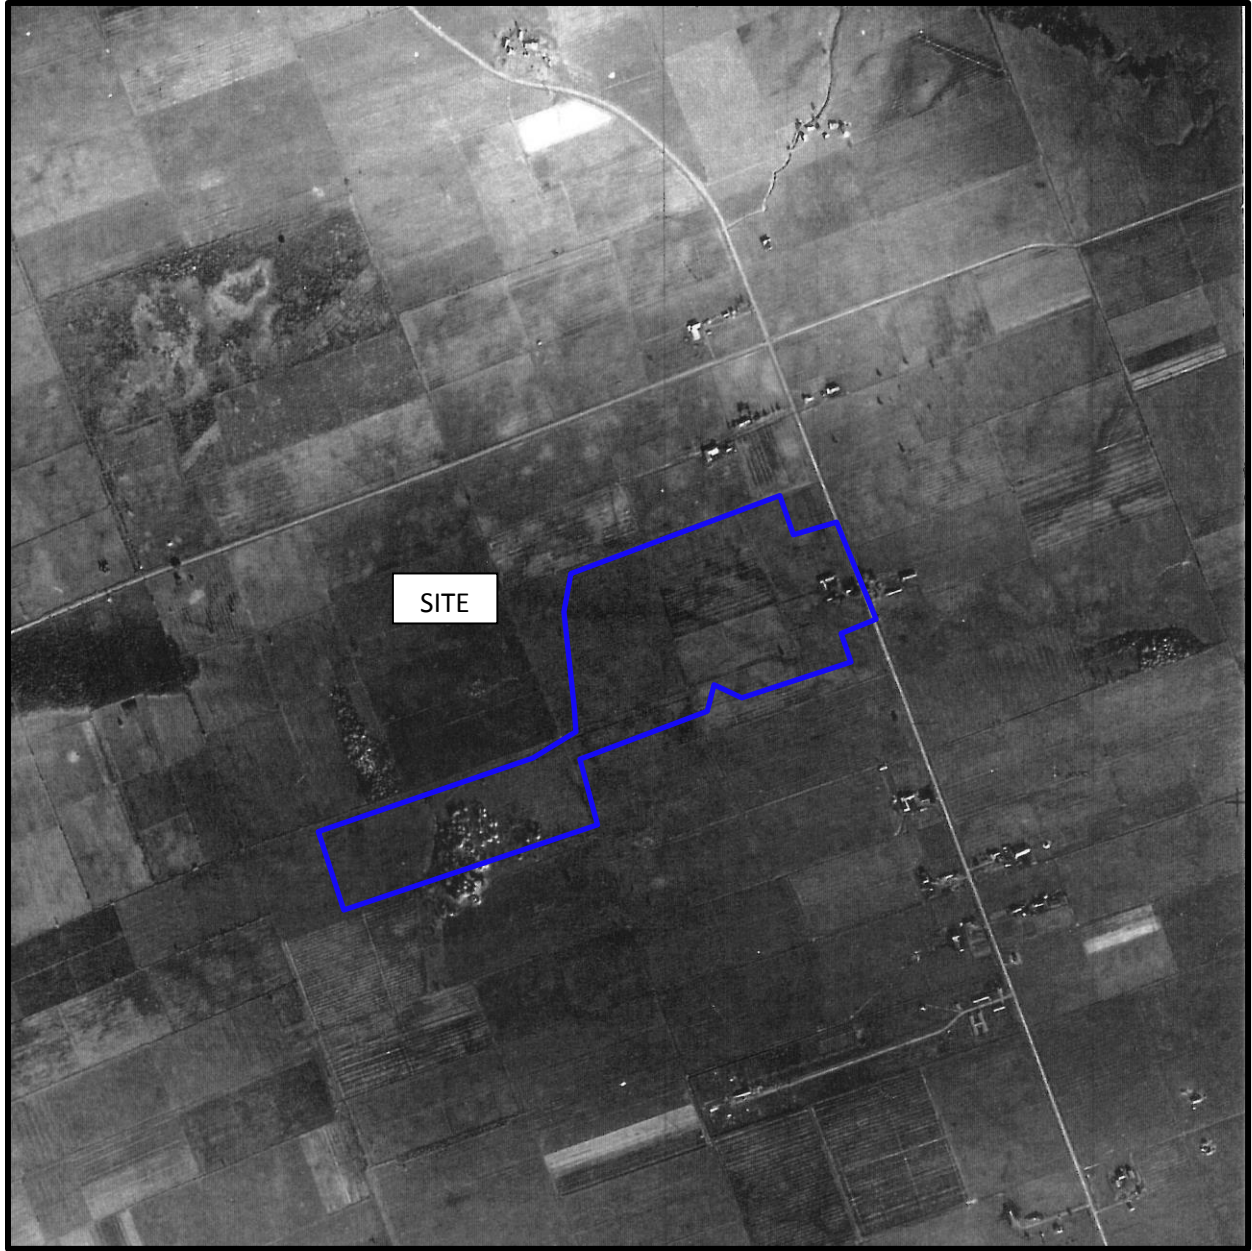
AERIAL PHOTOGRAPH  
1945

| 1945 | The subject site appears mainly vacant or used for agricultural purposes. The eastern perimeter of the subject site is occupied by a farmstead, a barn and several small garages or sheds (adjacent to Trim Road). Agricultural lands surround the subject site and farmsteads are visible along Trim Road. A small forested area is visible in the southwest portion of the subject property. |

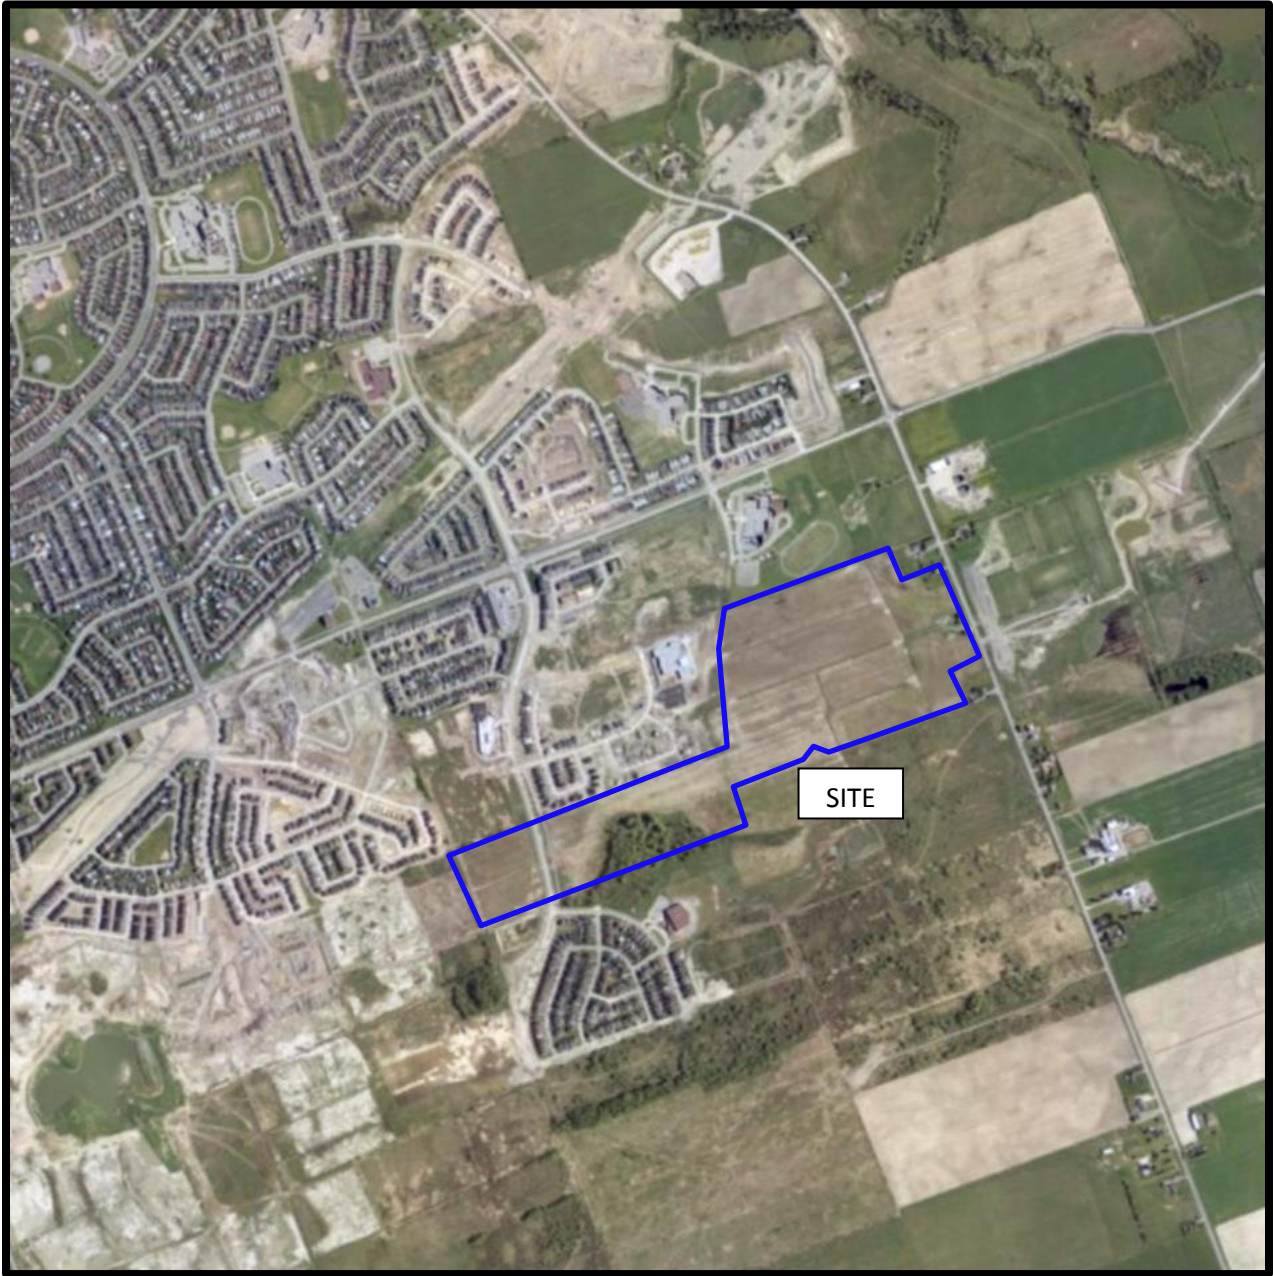
AERIAL PHOTOGRAPH  
2002

| 2002 | (City of Ottawa website) The structures on the subject site have been demolished. A pile of rubble is visible on the subject site in the former location of the structures. Several residential developments have been constructed north and south of the subject site. Two (2) schools have been constructed north of the subject site. Soil grading (for soccer fields and additional developments) is visible north and west of the subject site, as well as on the east side of |

Trim Road. Additional residential dwellings are being constructed north of the subject site, along Portobello Boulevard and Scala Avenue.

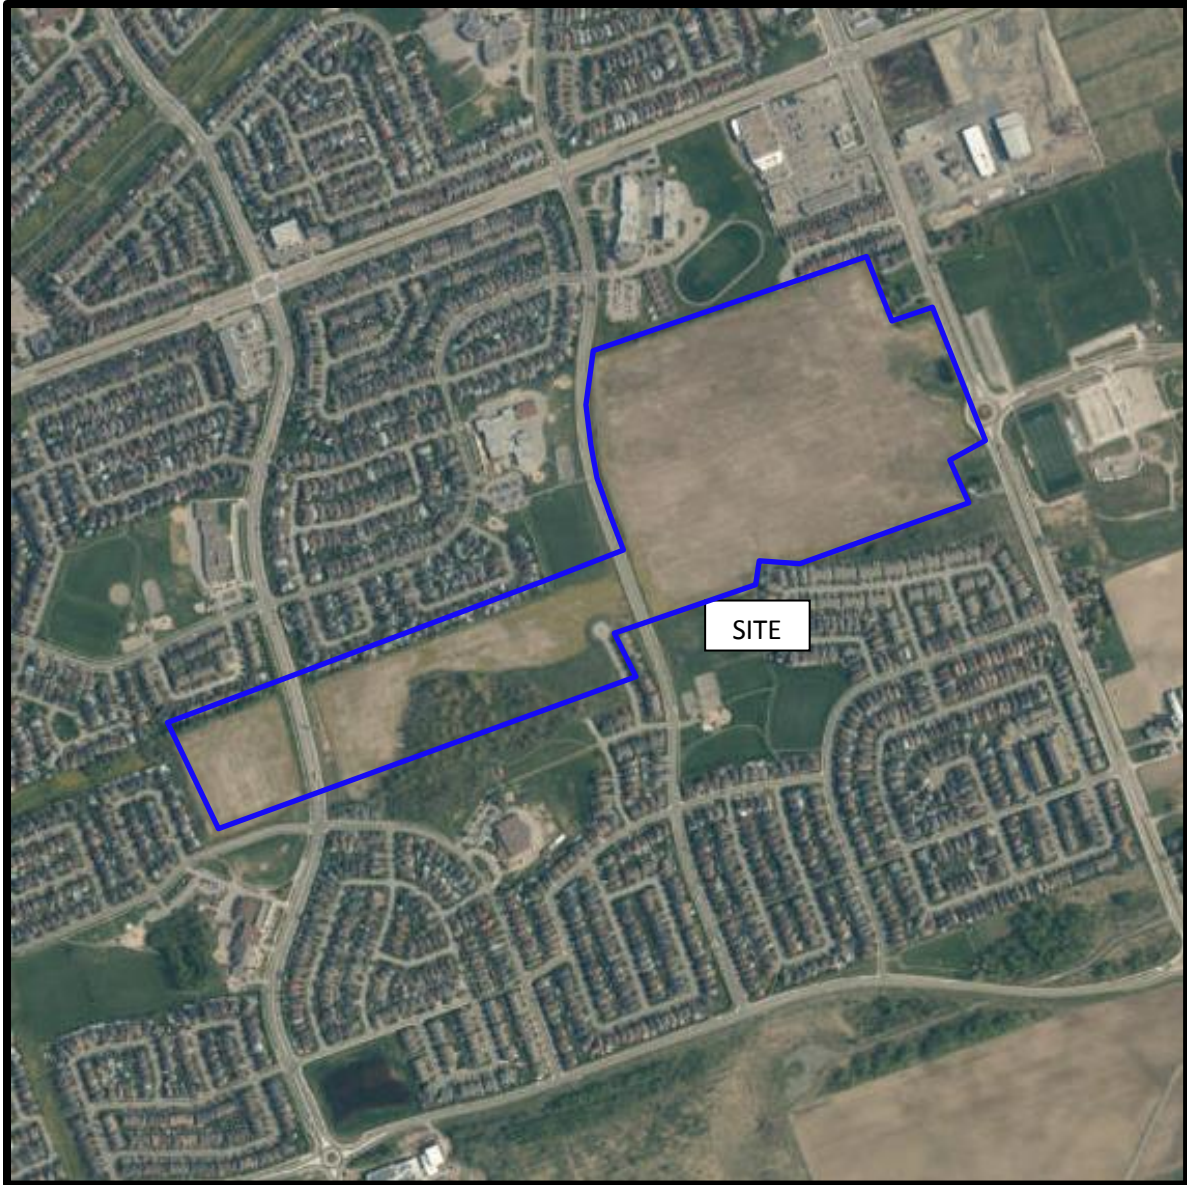
AERIAL PHOTOGRAPH  
2017

2017 (City of Ottawa website) The subject site and neighbouring properties appear as they do today. Residential dwellings have been constructed south (north of Montmère Avenue and east of Provence Avenue) and north (along Scala Avenue) of the subject site. The City of Ottawa's Trim Road Garage Depot is visible further to the northeast, on the east side of Trim Road (2035 Trim Road and 5300 Innes Road.

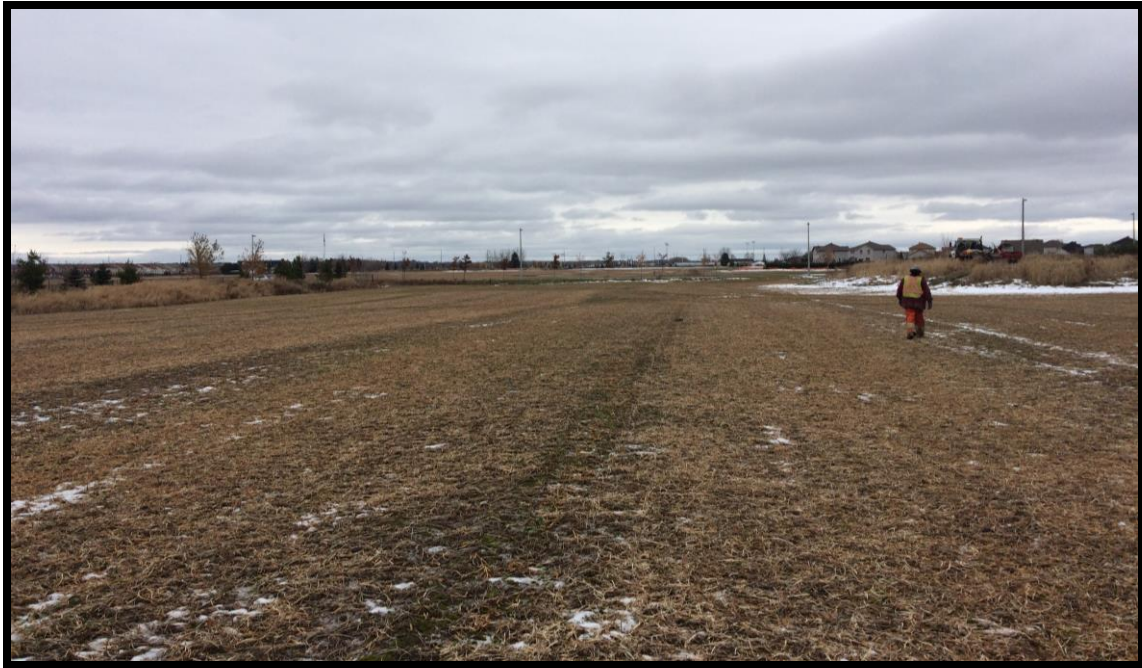
Photograph 1: View of the southwestern portion of the site, facing east. Photograph depicts an agricultural field, the main land cover on the site.

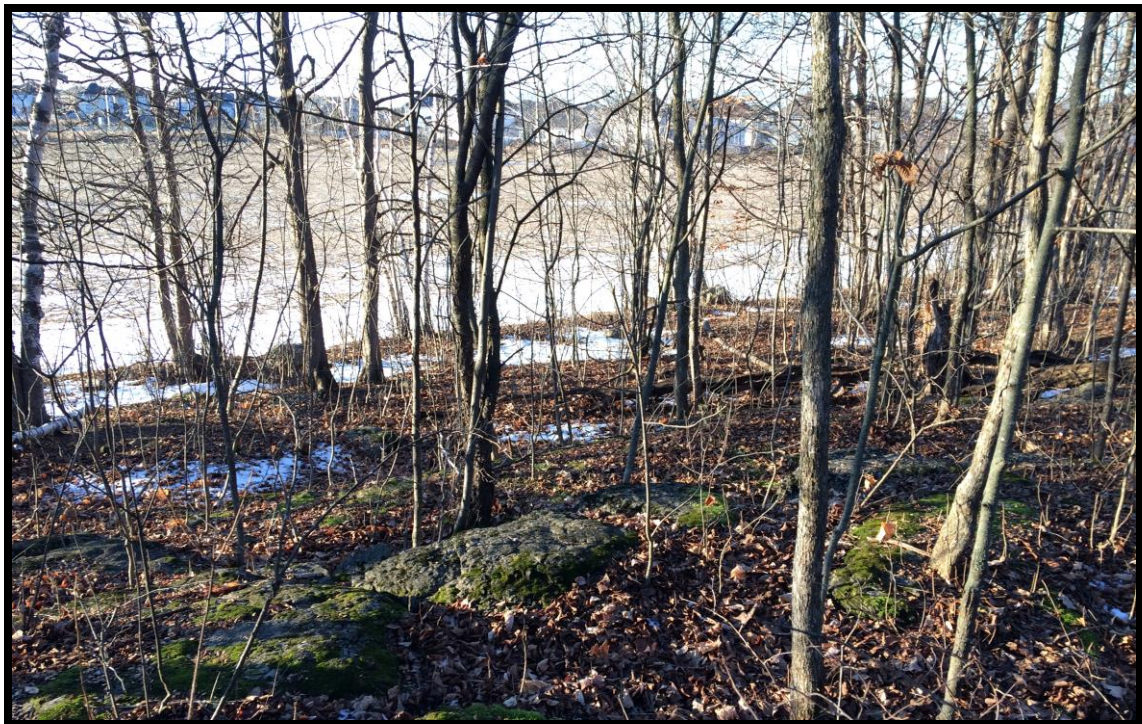
Photograph 2: View of the forested area with outcropping bedrock on the southwest portion of the subject site, facing north.

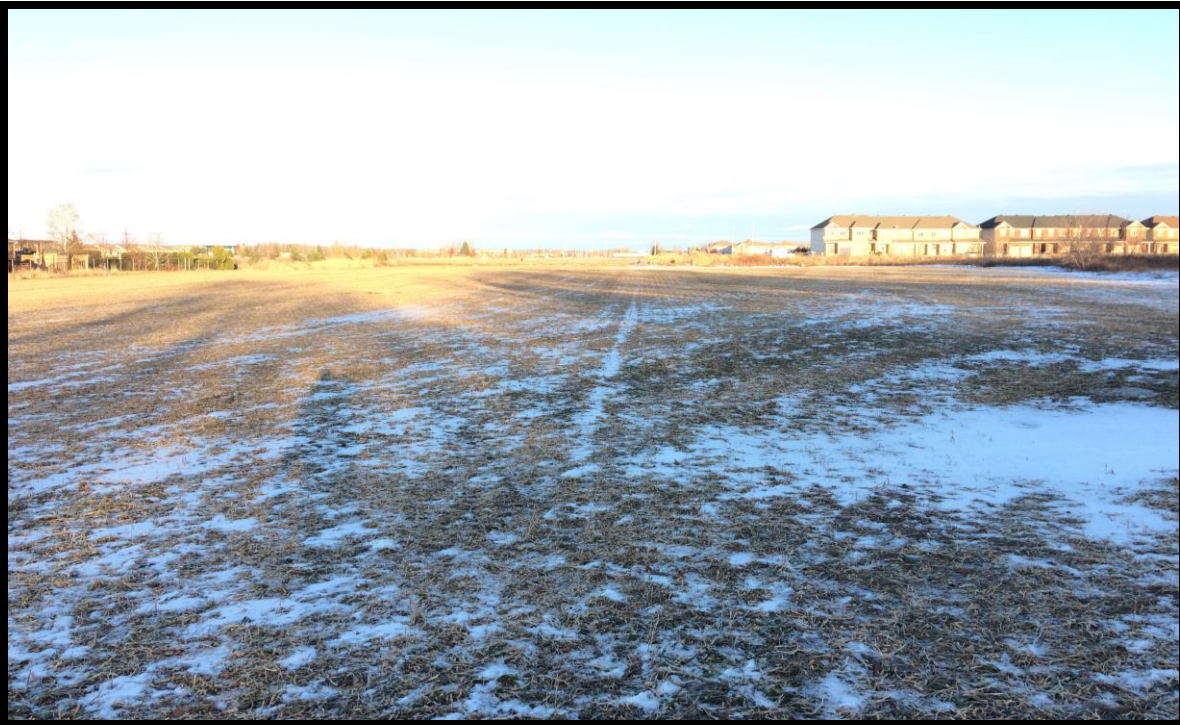
Photograph 3: View of the central portion of the subject site, facing southwest.

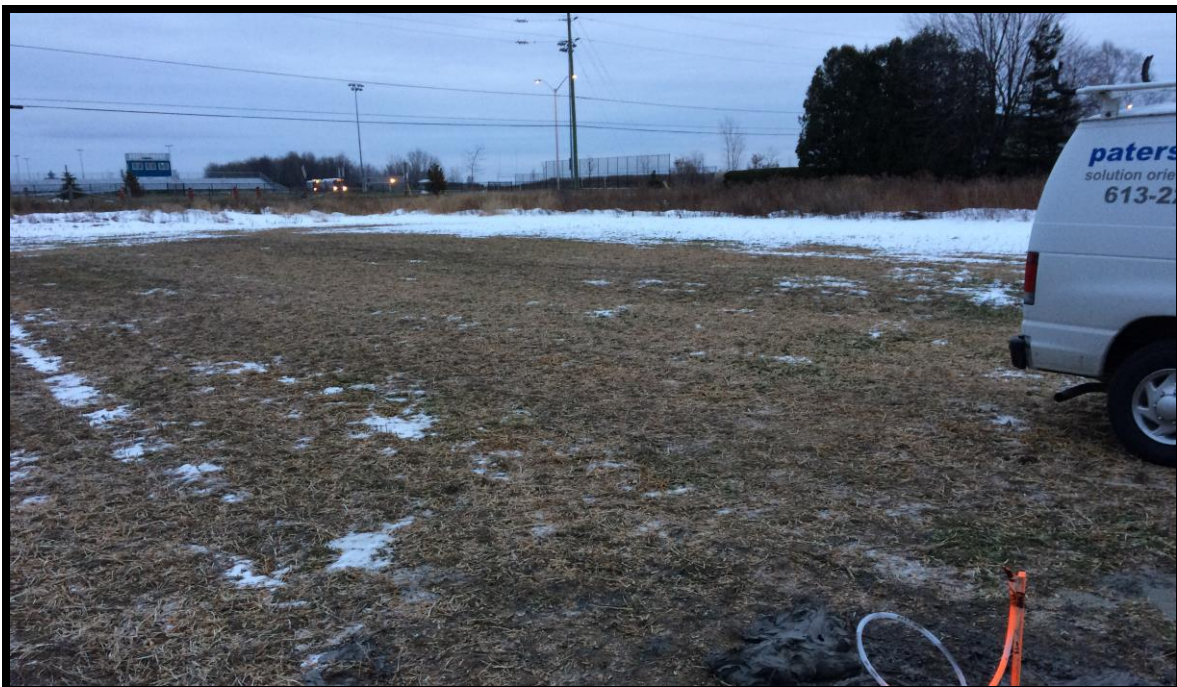
Photograph 4: View of eastern portion of the site, adjacent to Trim Road. Photograph taken facing northeast.
