RE: Integrated Environmental Impact Statement, Tree Conservation Report & Wildlife Mitigation and Monitoring Plan - Zibi Development Phase 1 & 2 - Addendum #2

FIGURE 1: SITE OVERVIEW

Zibi Phase 1 & 2 Development

Project:
ZIBI ONTARIO BLOCK 206

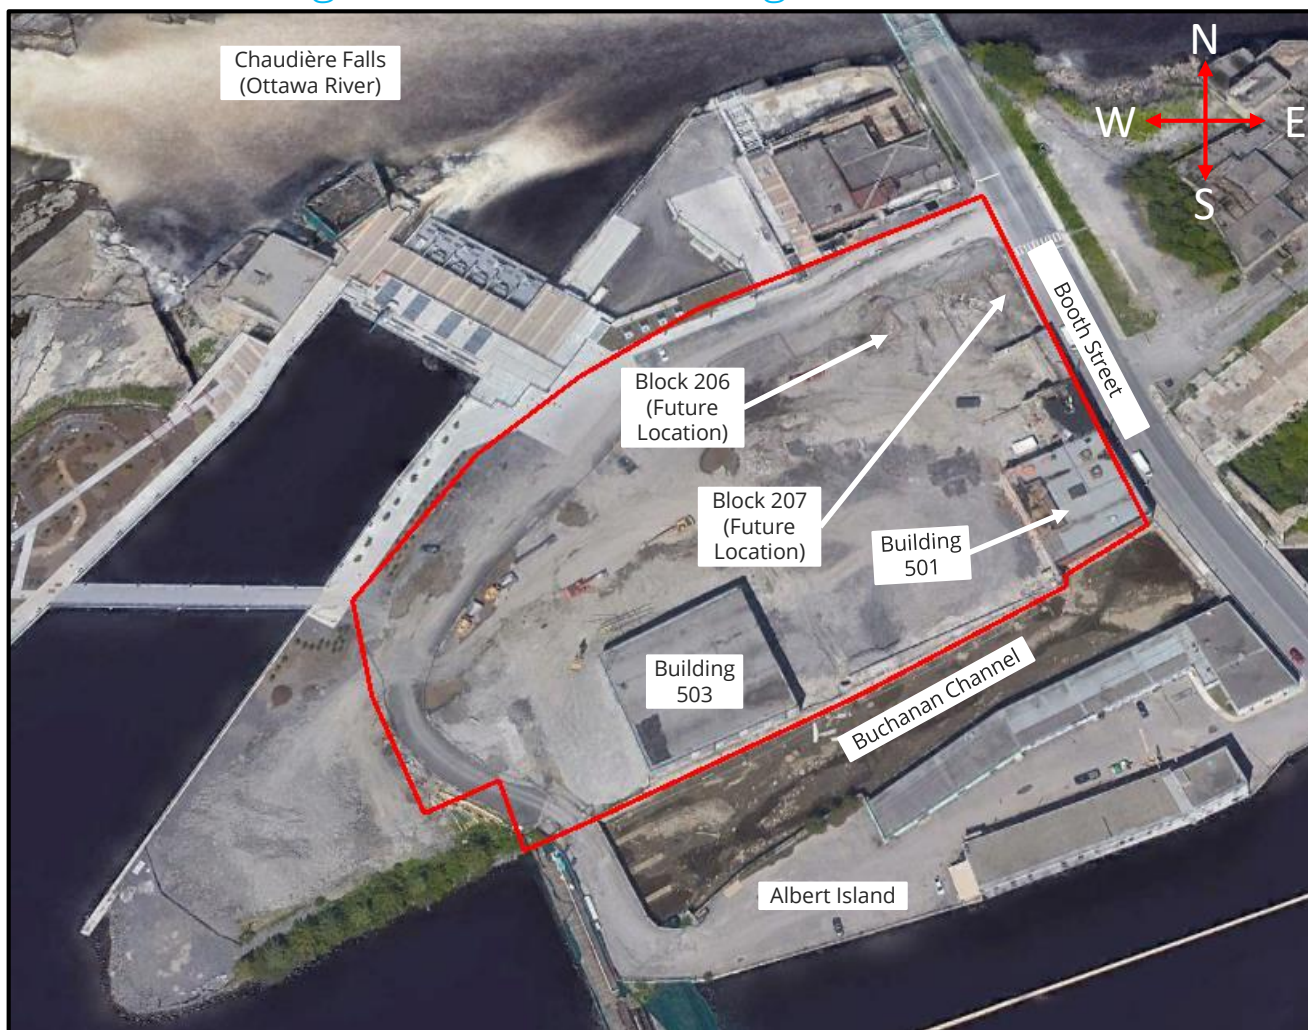
— - Phase 1 & 2 Study Area

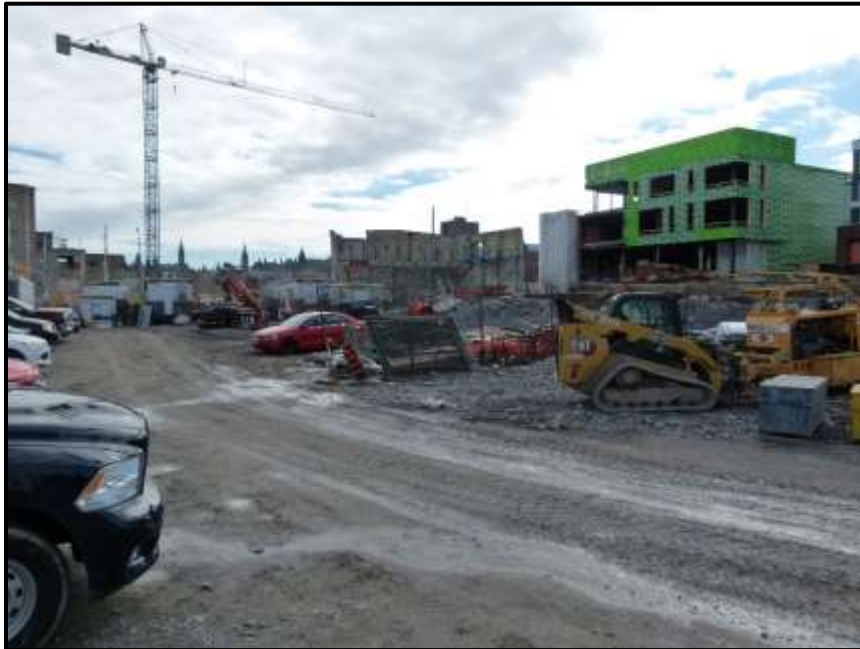
Photograph 1: Looking southeast at Block 207 (April 4th, 2020).

A site visit was completed on April 4th, 2020 in order to provide an update of the conditions of the proposed Block 206 and Block 207 development areas. Weather conditions during the site visit included partly cloudy skies and 9 °C. Photographs from the April 4th, 2020 site visit are included below. The Block 206 and Block 207 development areas were observed to consist primarily of compacted gravel, crushed concrete, and stockpiles. Construction equipment, site trailers, and materials that are currently being utilized to construct buildings in the adjacent areas of the Zibi Phase 1 and 2 development were also present within Block 206 and Block 207. Demolition activities within the Block 206 and Block 207 development areas appeared to be substantially complete, with no derelict structures remaining. There were no vegetation features, trees, natural habitats, wildlife, or wildlife habitat features observed within the Block 206 and Block 207 development areas. As such, no new concerns with respect to natural heritage features were identified.

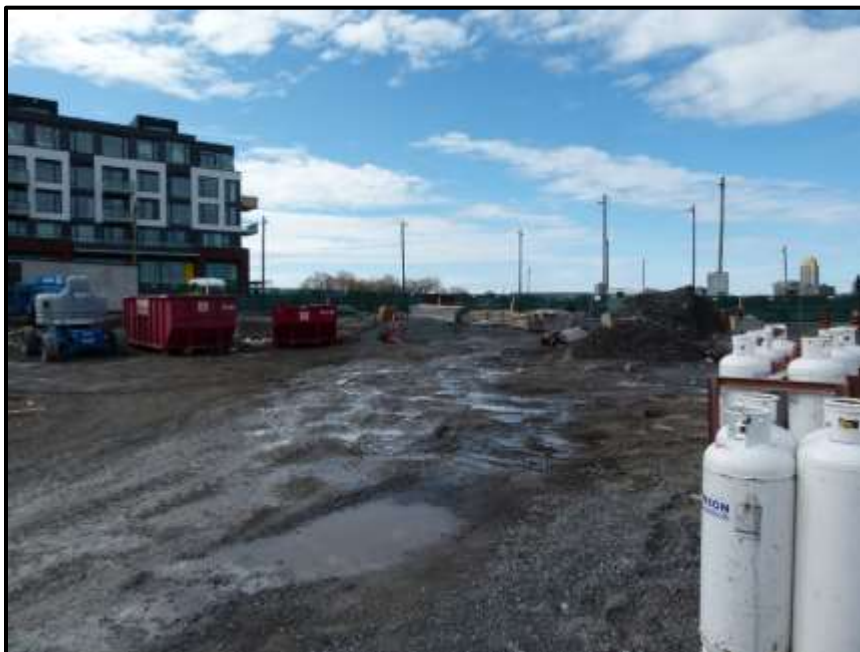
Photograph 2: Looking southwest at Block 206 (April 4th, 2020).
