# **Phase I Environmental Site Assessment**

280 Eric Czapnik Way  
Ottawa, Ontario

## EXECUTIVE SUMMARY

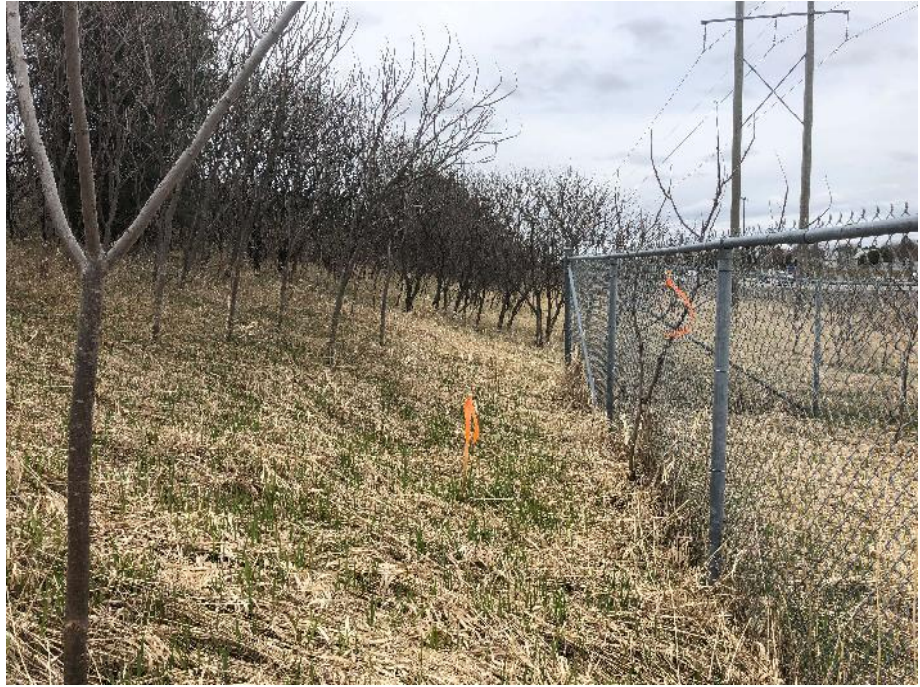
General Site conditions along the northern extent of the Site, from west facing east. The large fill mound is visible along the right limit of the photograph.

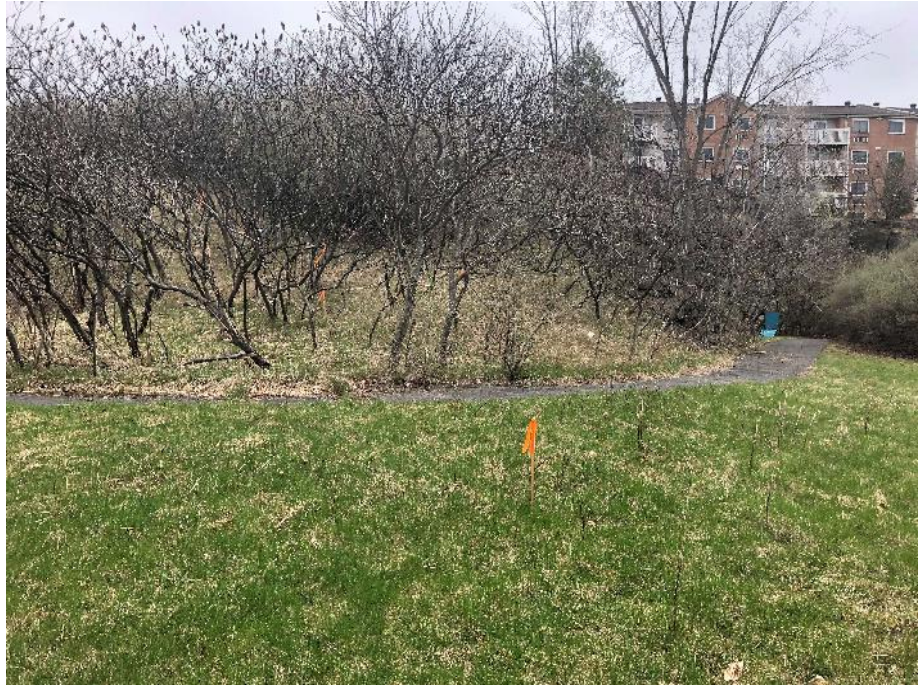
Southwestern portion of the Site facing east. Large fill mound is present in the background.

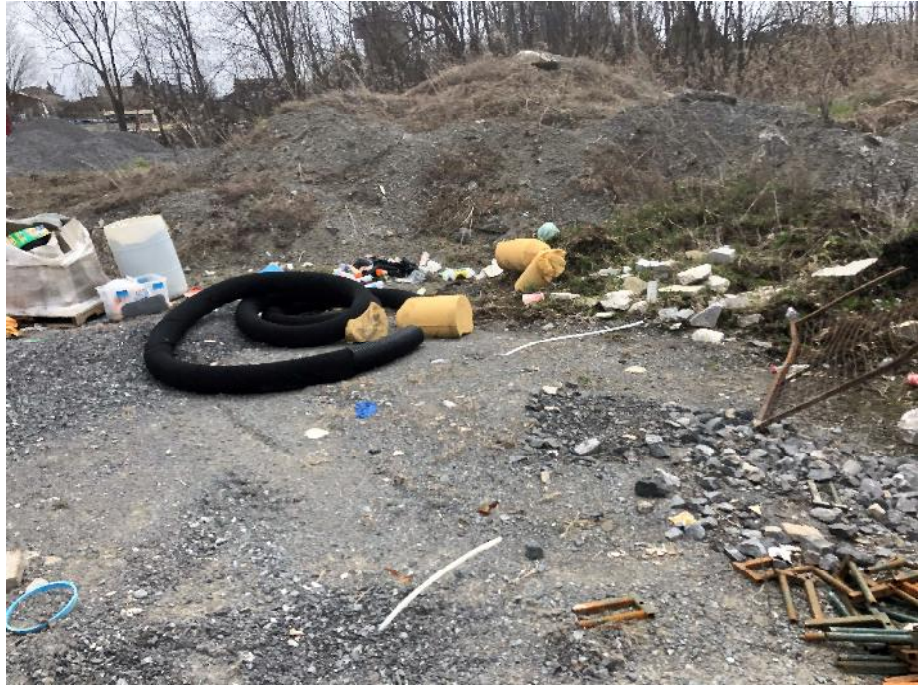
Construction staging yard at the eastern portion of the Site. General material observed include modu-loc fencing, water and sanitary/storm sewer utility piping and components.

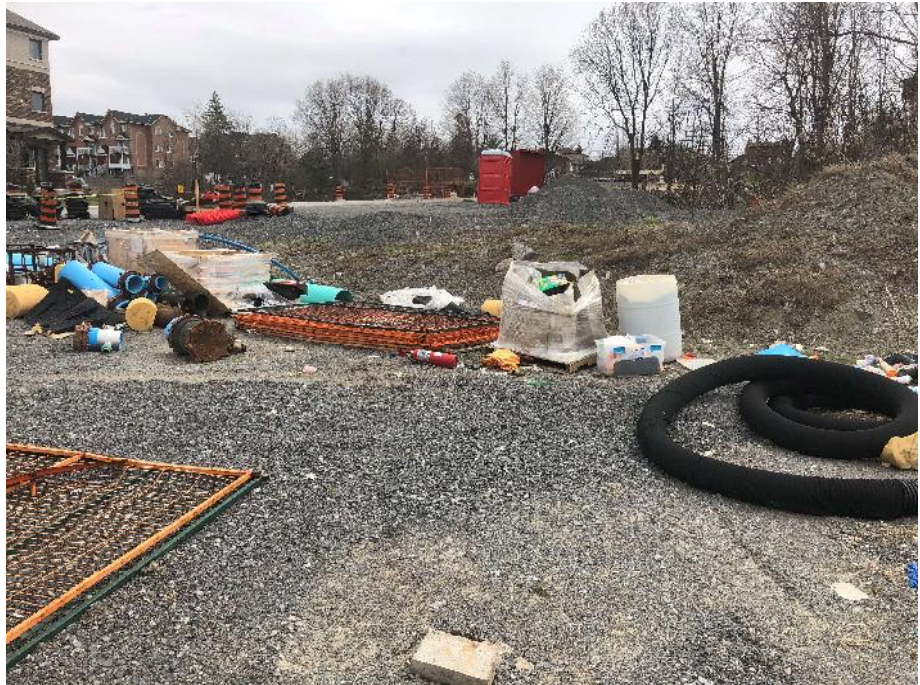
| PEC | Location | Comments | Contaminants of Potential Concern | Media Potentially Impacted | Level of Risk |
|---|--|---|---|---|---|
| Asphalt debris | Eastern portion of the Site. | Small quantities observed at the time of the Site visit within the granular crushed stone piles | PHC, VOC | Soil | Low |

Granular and traces of asphalt debris pile at the eastern portion of the Site.

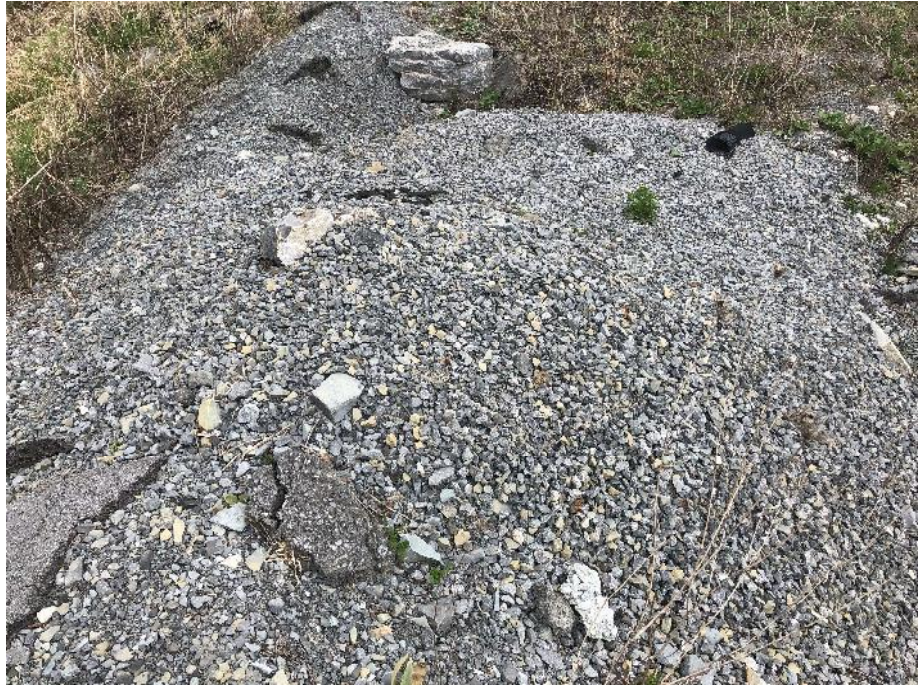
Cement, granular and traces of asphalt debris across the northeastern portion of the Site.
