Kollaard Associates

200143

RE: LIMITED SUBSURFACE INVESTIGATION
FOR PROPOSED ROADWAY EXTENSION
FROM FRONTAGE OF 340 LOWE ROAD
FOR 100 METRES NORTHWEST
LOT 3, CONCESSION 11, WEST CARLETON (HUNTLEY)
CITY OF OTTAWA, ONTARIO

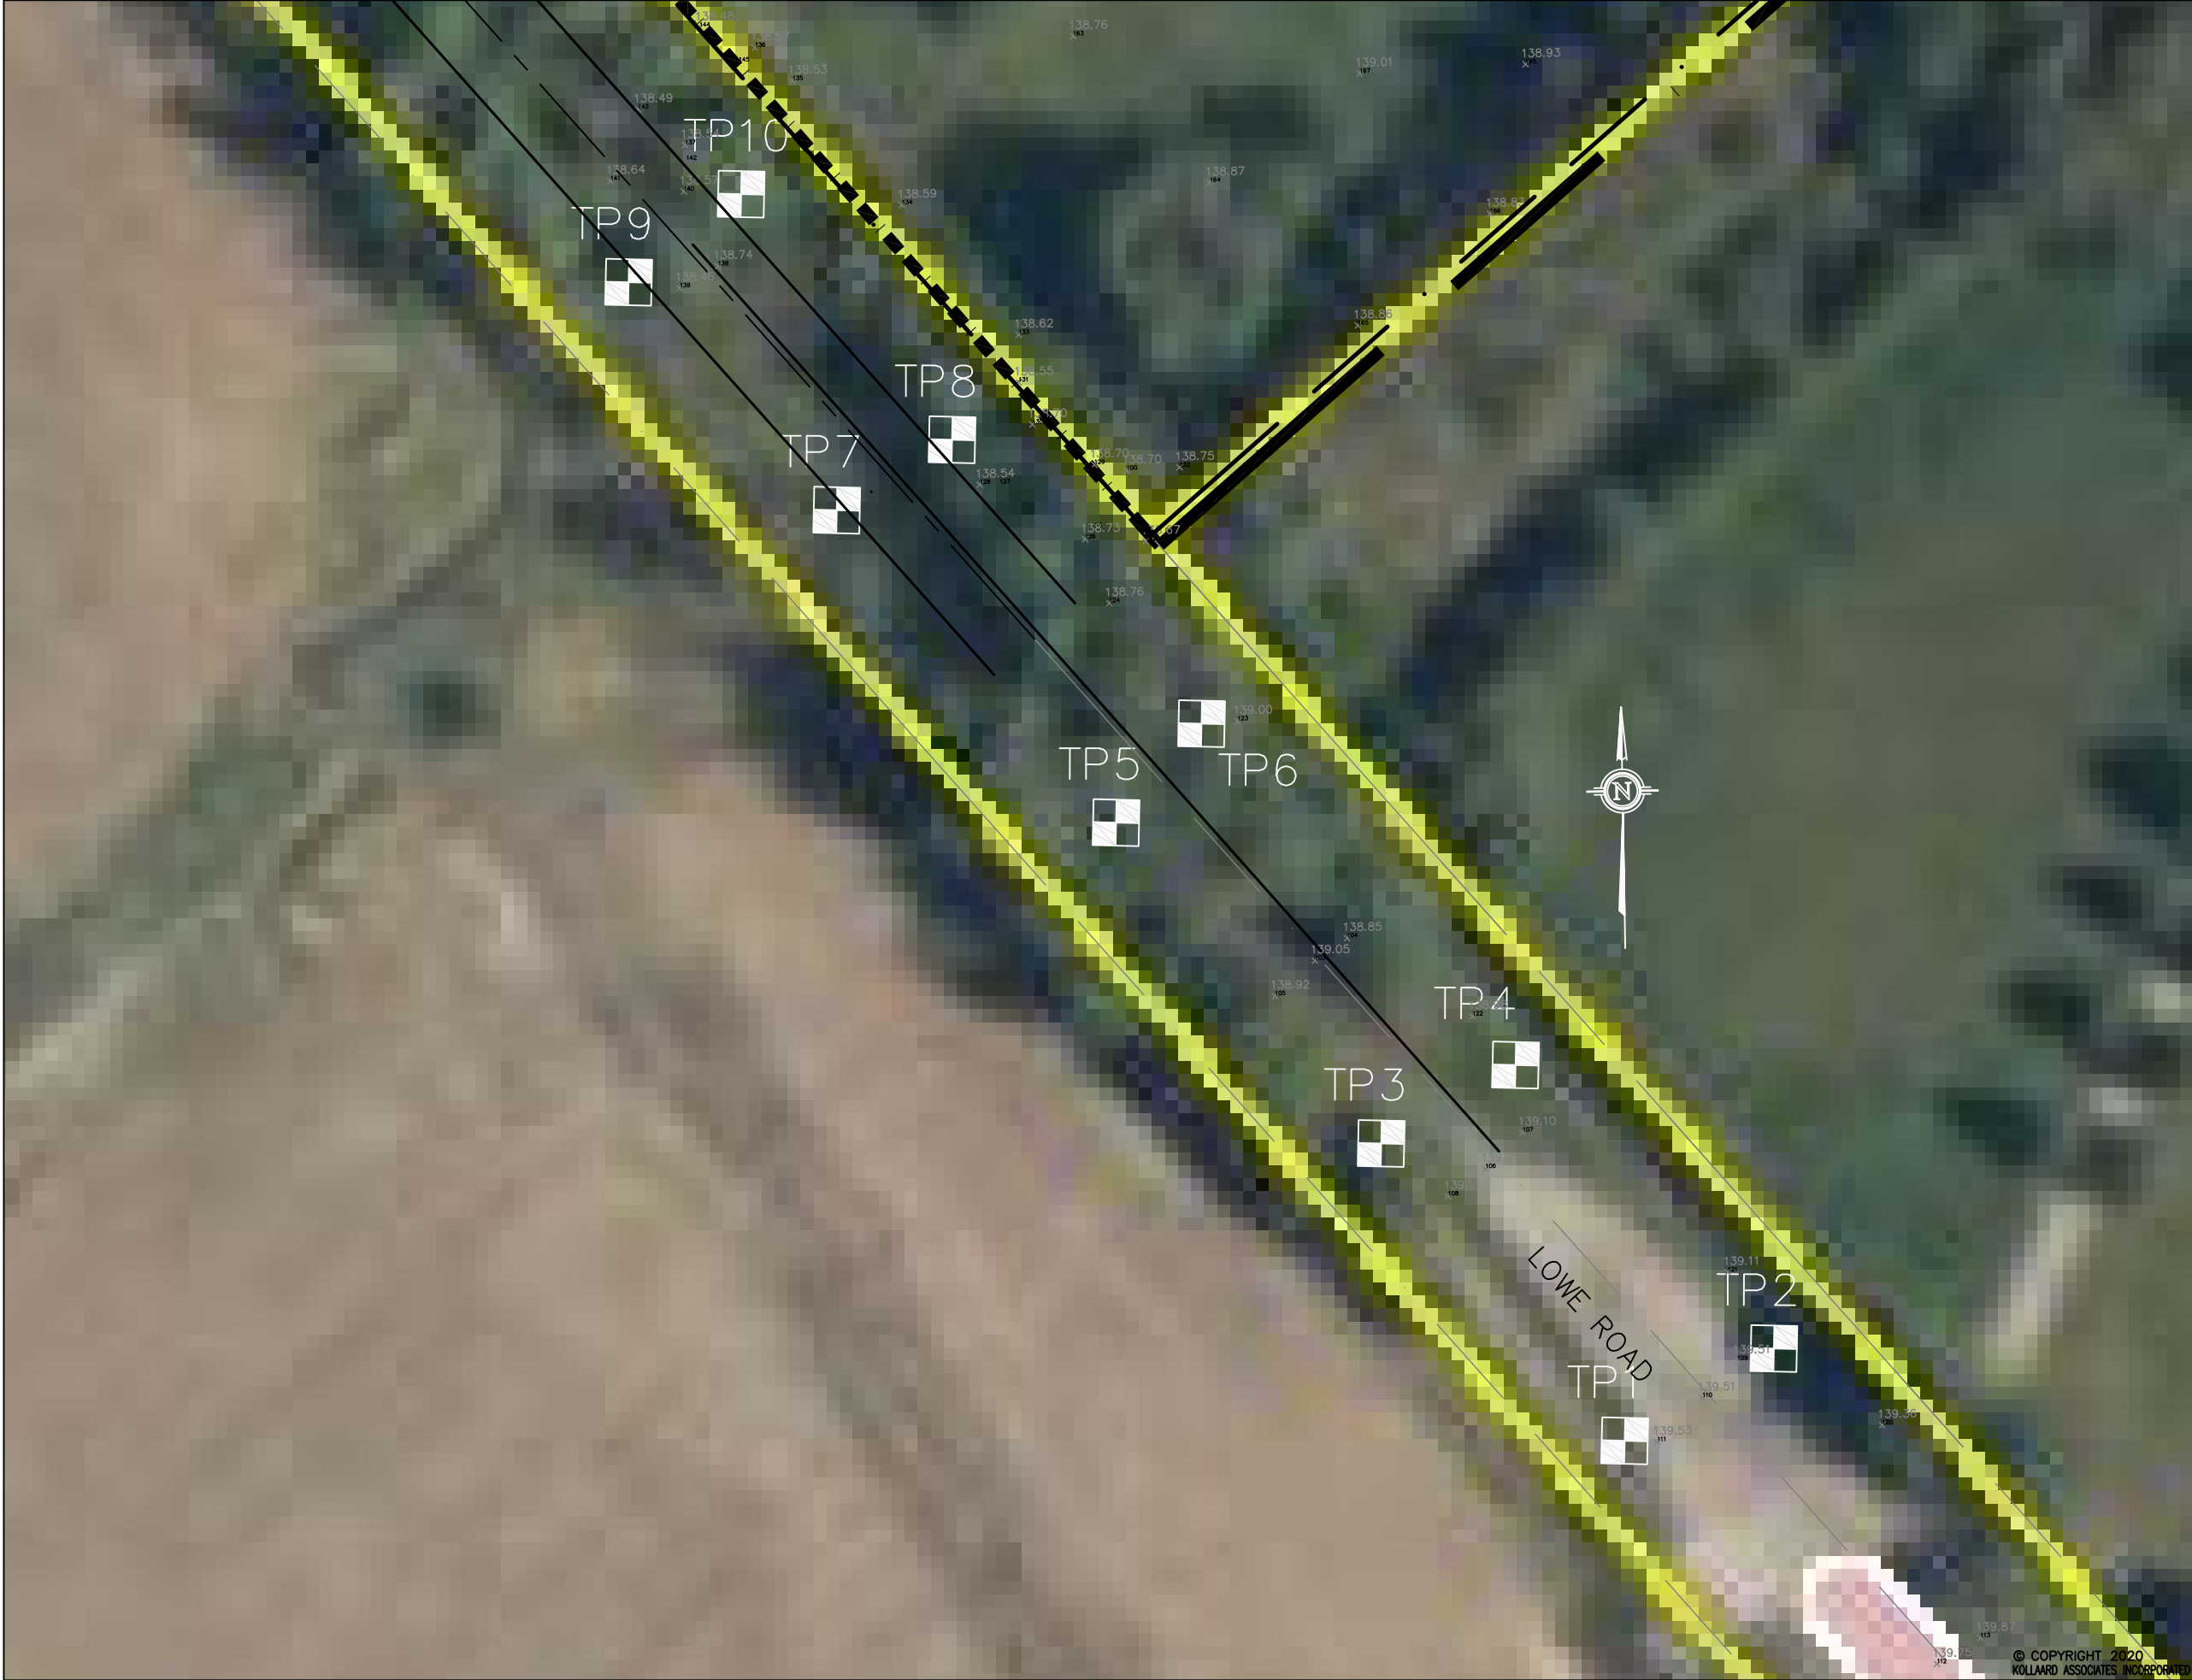
DRAWING NUMBER:
SITE PLAN, FIGURE 2

LEGEND:
TP1 APPROXIMATE TEST PIT LOCATION

The field work for this investigation was carried out on May 28, 2020 at which time observations were made within 10 test pits put down along the temporary road. The test pits were placed in pairs with one on either side of the existing trail along the unopened road allowance. The test pits were placed at intervals of about 25 metres beginning at about 3 m beyond the end of the existing roadway.

The location of the test pits are shown on the attached drawing Site Plan Figure 2. The test pits were advanced to bedrock at depths of about 0.15 to 1.2 metres below the existing ground surface using a hand shovel and probe operated by a member of Kollaard Associates professional staff. The soil conditions observed in the test pits were classified based on visual and tactile examination of the materials on the walls and bottom of the test pits. The water conditions were observed in the open test pits at the time of the field work.
