**Phase One Environmental Site Assessment
5455 Boundary Road
Navan, Ontario**

January 10, 2020
Project: 61774.48

**Re: Phase One Environmental Site Assessment
5455 Boundary Road
Navan, Ontario**

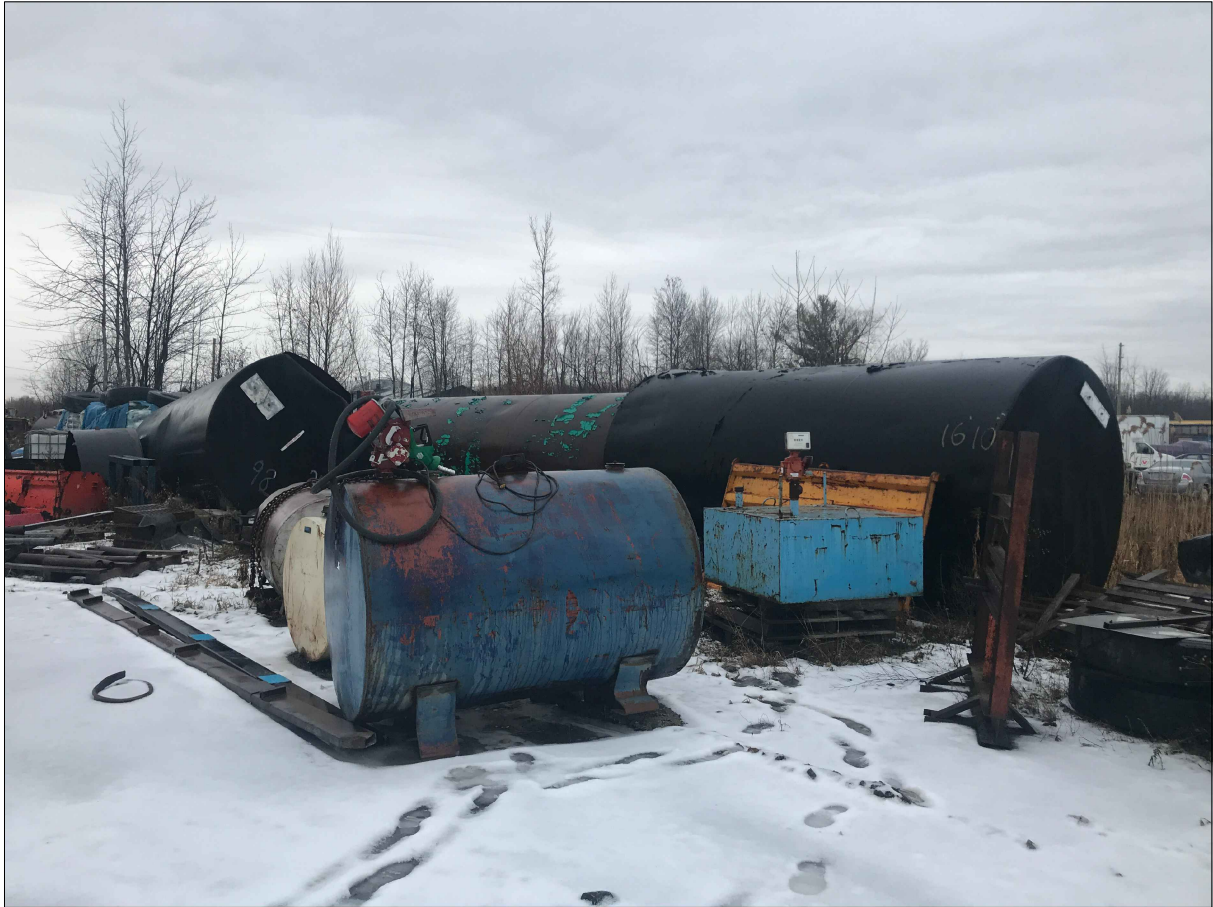
FIGURE I.1

Plate Number	Compass Orientation	Description
I1	Southwest	Storage tanks identified on the subject property.
I2	Northeast	One storage tank cut in half identified on the subject property.
I3	Northeast, Southeast	Carboys identified across the subject property with unidentified substances.
I4	Northwest	Metals waste identified in the large white garage cover on the subject property.
I5	Northwest, Southeast	Transformer items identified on the subject property – no staining was identified.
I6	Northeast	An old Traxon 80W-90 lubricant container identified on the subject property.
I7	Southwest, Southeast	Fill material identified on the subject property during the site reconnaissance. Some deleterious material including red brock, concrete, and wood was identified in the fill material.
I8	Southwest	Two garbage dumpsters identified on the subject property at the time of site visit.
I9	Northwest	Seacans identified on the subject property at the time of site reconnaissance – the contents of each seacan is currently unknown.

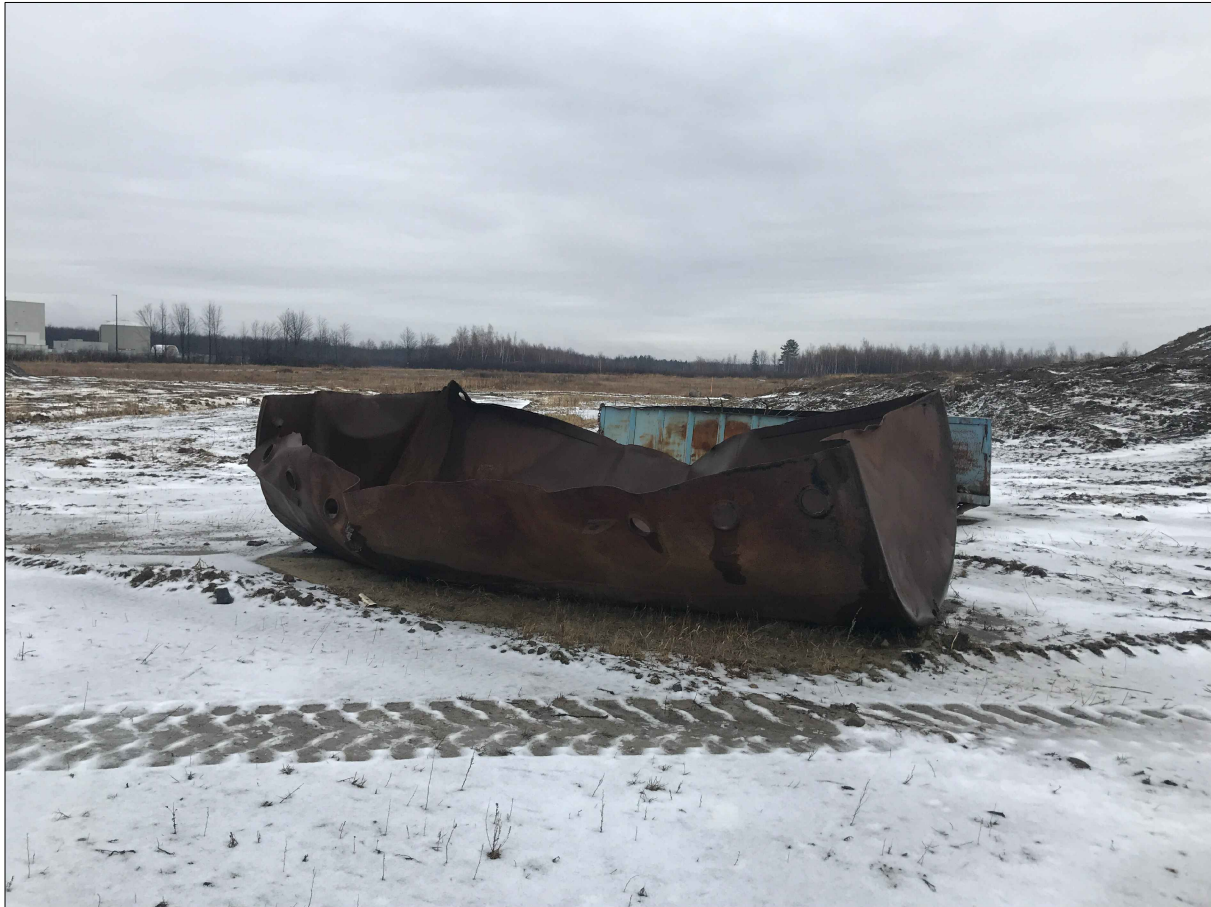
FIGURE I.2

ONE STORAGE TANK CUT IN HALF IDENTIFIED ON THE SUBJECT PROPERTY

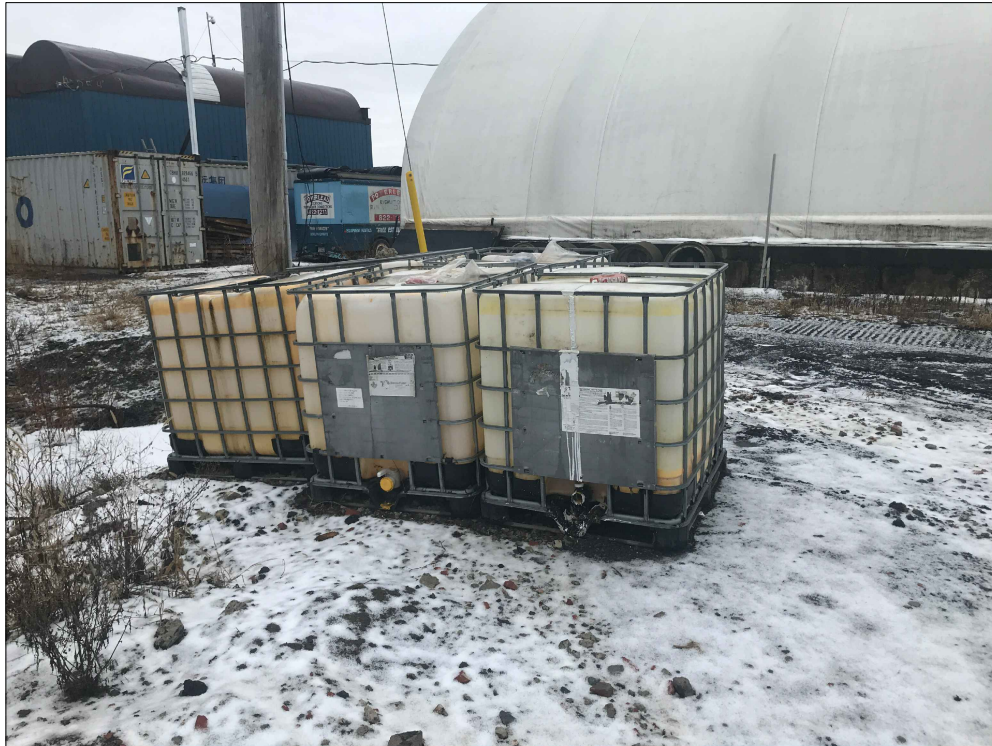
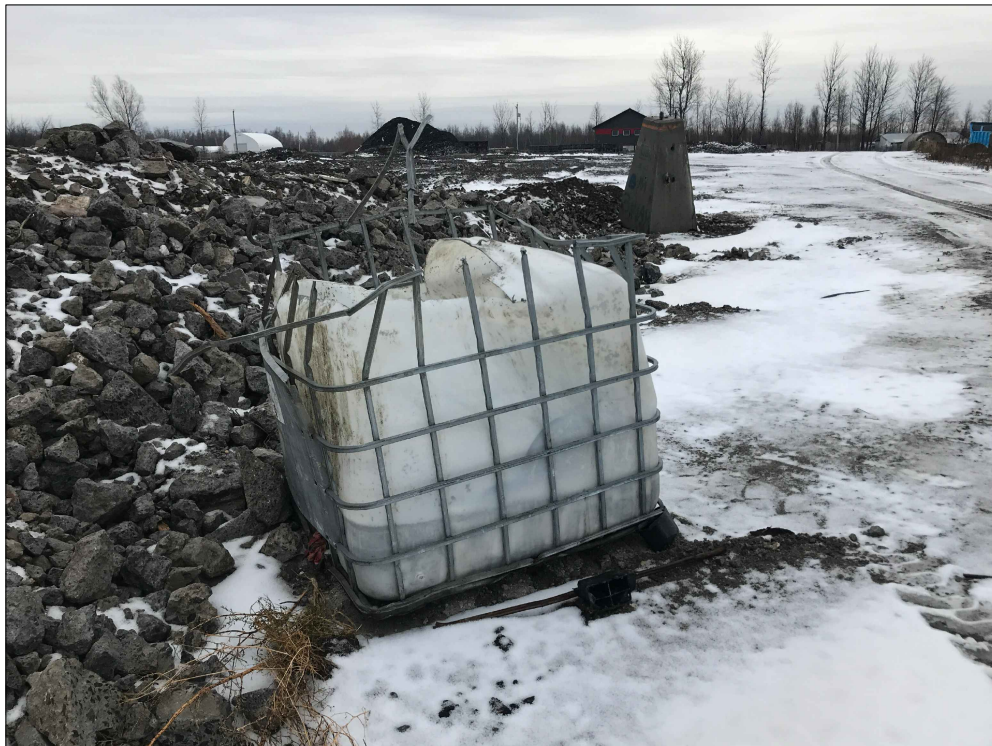
FIGURE I.3

Unidentified liquid substances were identified at the time of the site reconnaissance in many large totes throughout the subject property. The totes appeared to be in good condition, with no evidence of leaking at the time of site reconnaissance.

CARBOYS IDENTIFIED ACROSS THE SUBJECT PROPERTY WITH UNIDENTIFIED SUBSTANCES

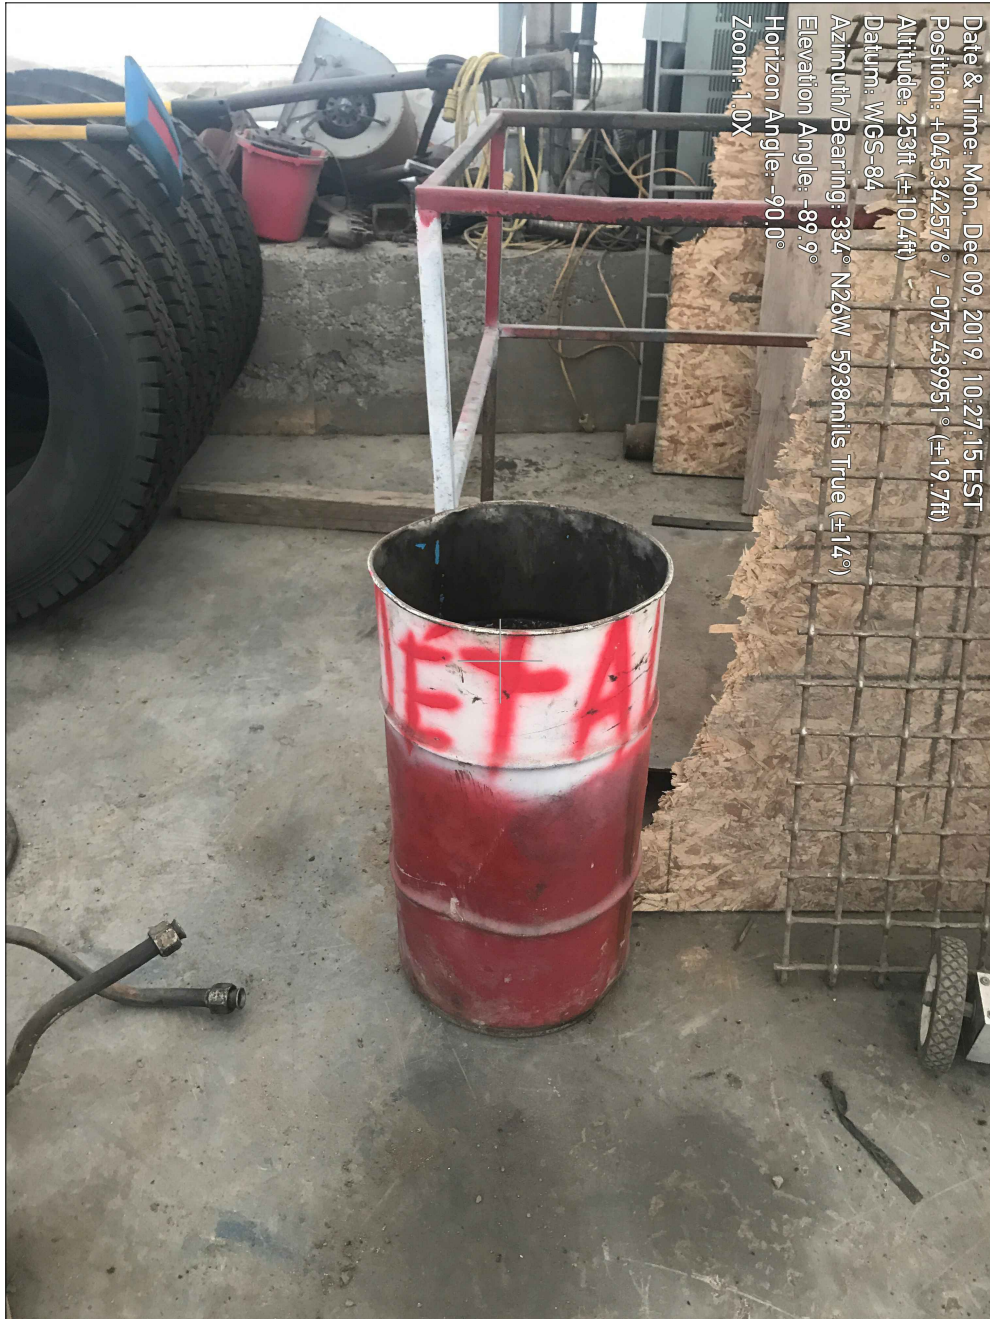
FIGURE I.4

METALS WASTE IDENTIFIED IN THE LARGE WHITE GARAGE
 COVER ON THE SUBJECT PROPERTY

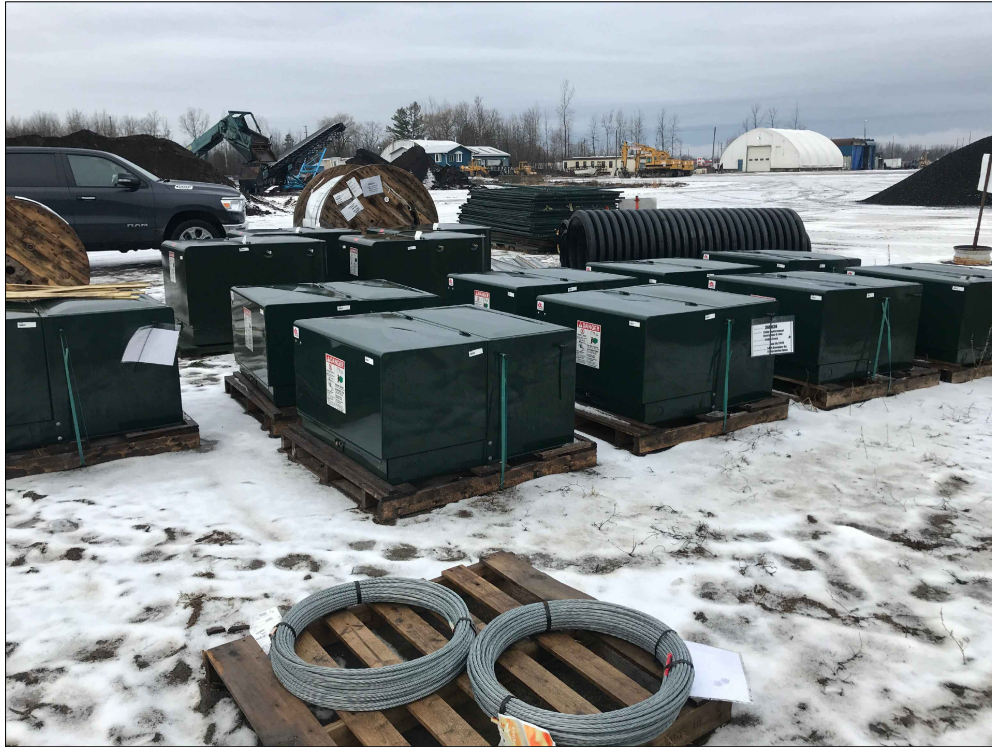
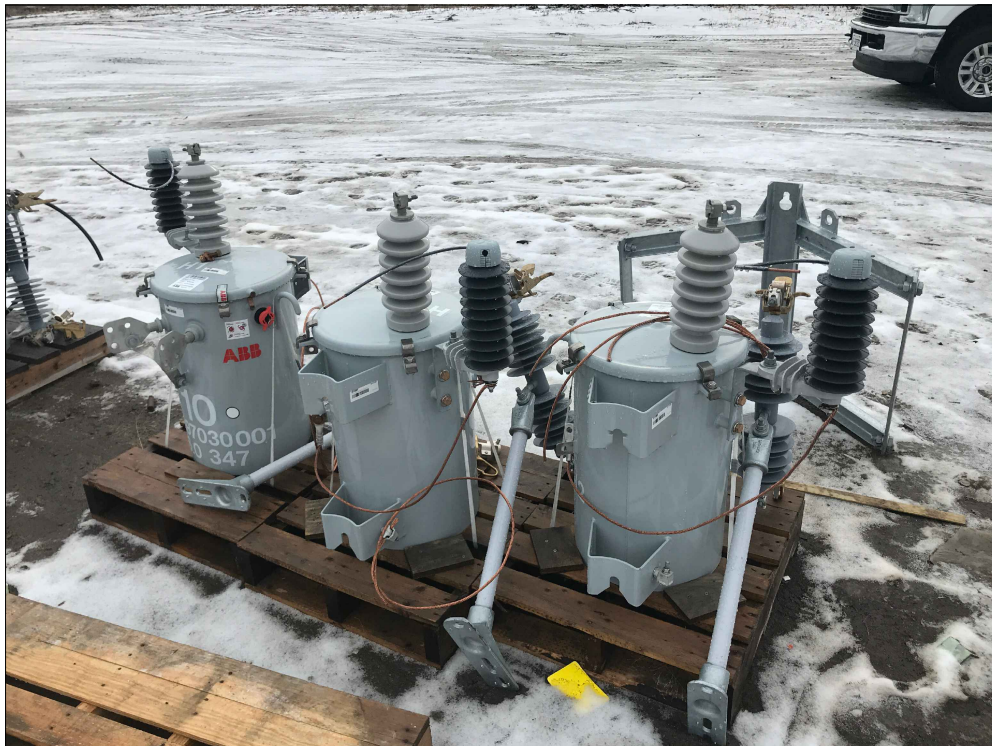
FIGURE I.5

Multiple transformers were identified on the subject property at the time of site reconnaissance. The transformers identified on the subject property at the time of site reconnaissance appeared to be new, and being stored until they could be installed, off the subject property. The transformers appeared to be in good condition with no evidence of leaking.

TRANSFORMER ITEMS IDENTIFIED ON THE SUBJECT
PROPERTY - NO STAINING WAS IDENTIFIED

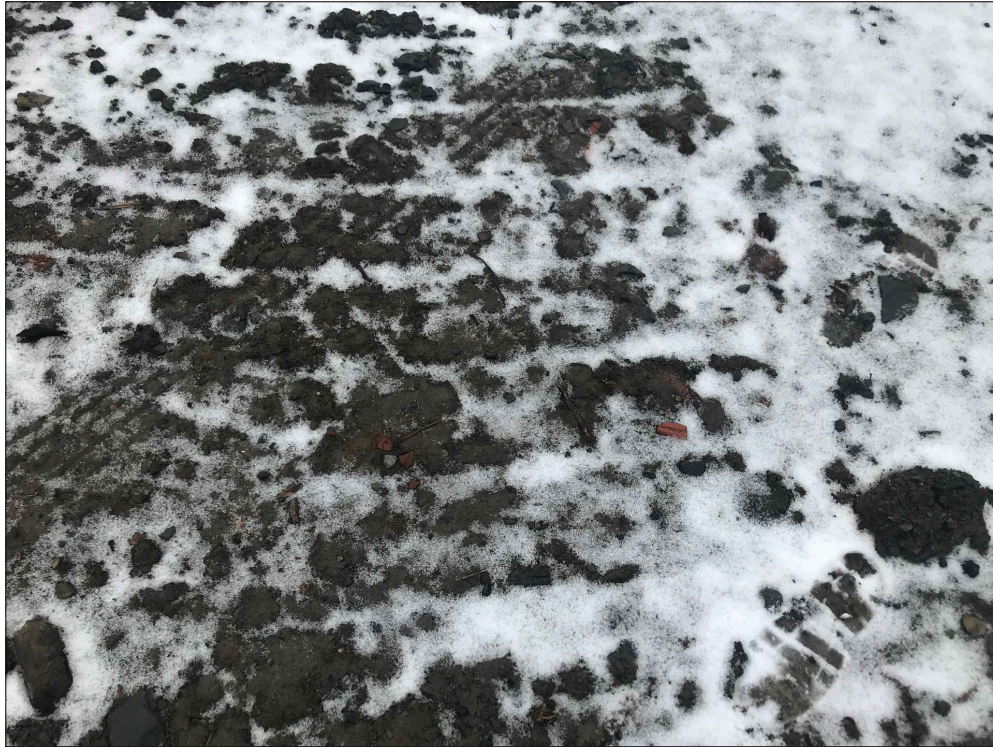
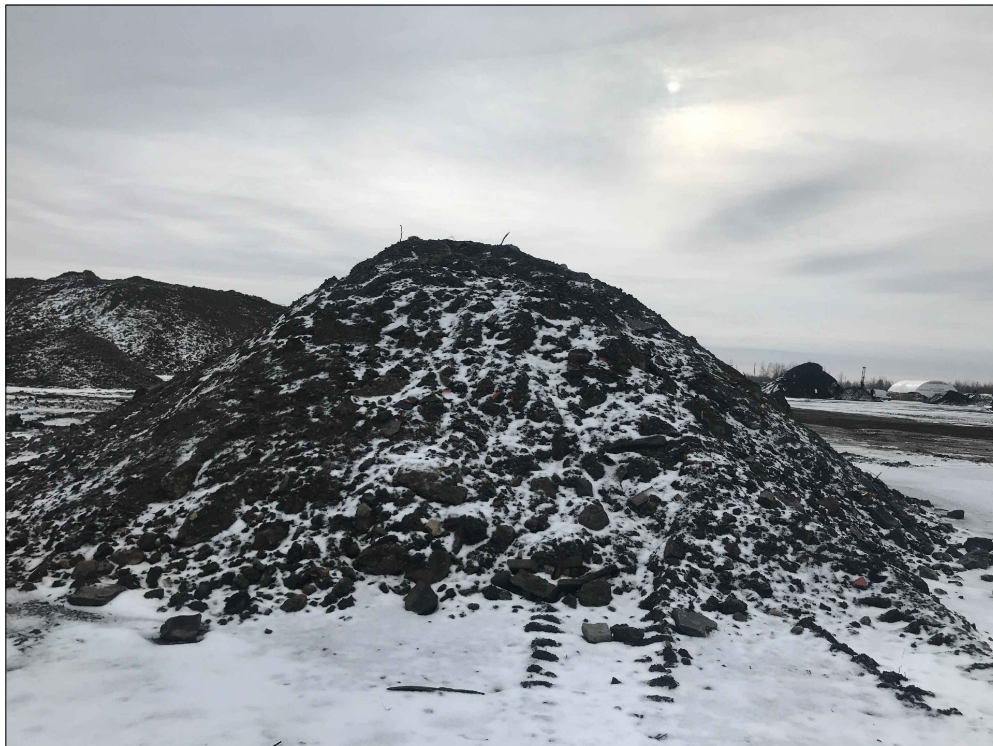
FIGURE I.7

FILL MATERIAL IDENTIFIED ON THE SUBJECT PROPERTY DURING THE SITE RECONNAISSANCE. SOME DELETERIOUS MATERIAL INCLUDING RED BROCK, CONCRETE, AND WOOD WAS IDENTIFIED IN THE FILL MATERIAL.

A Phase Two ESA is recommended to be completed for the subject property, to investigate soil and groundwater quality with respect to the COPCs in the vicinity of the identified APECs and assist in the preparation of a remedial or risk management strategy for the development of the subject property, if required.

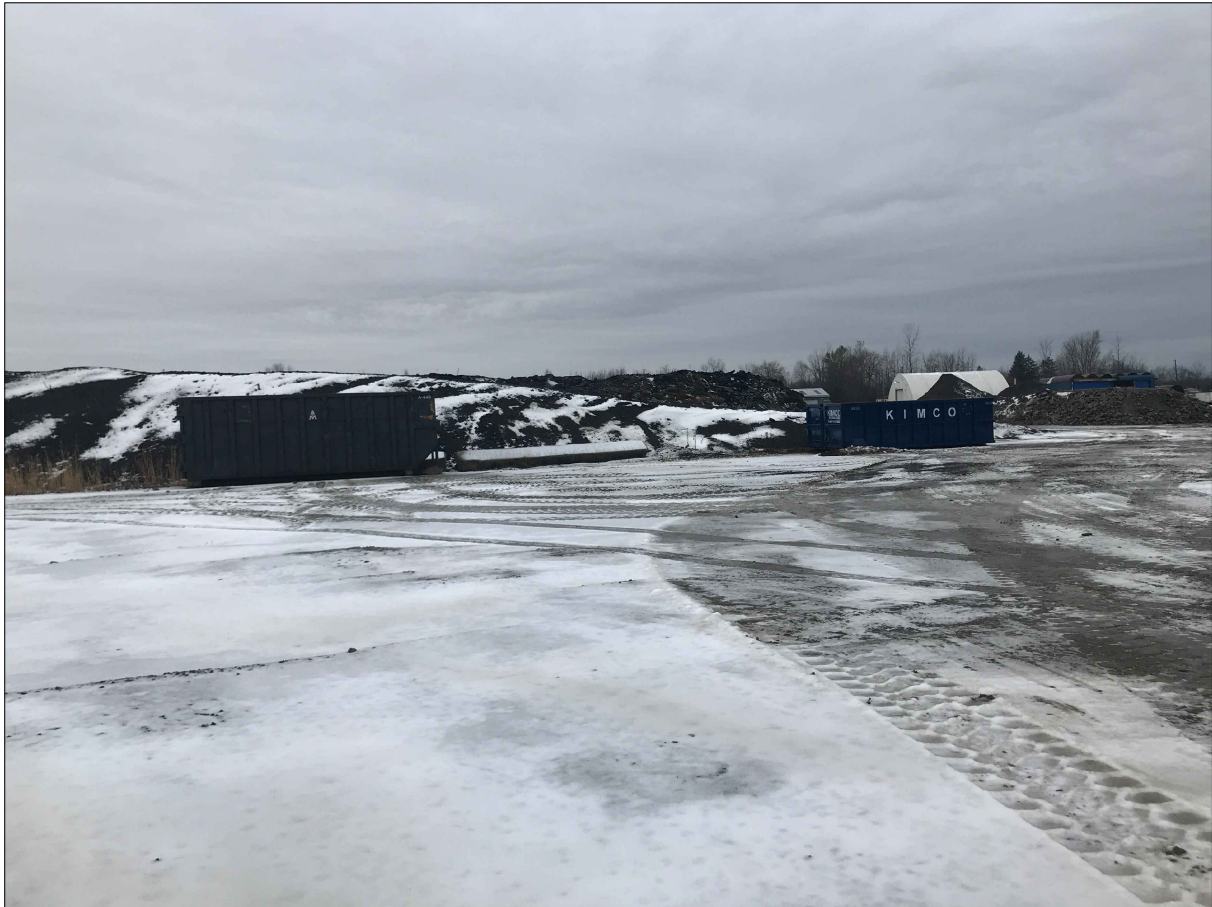
FIGURE I.8

TWO GARBAGE DUMPSTERS IDENTIFIED ON THE SUBJECT PROPERTY
AT THE TIME OF SITE VISIT.

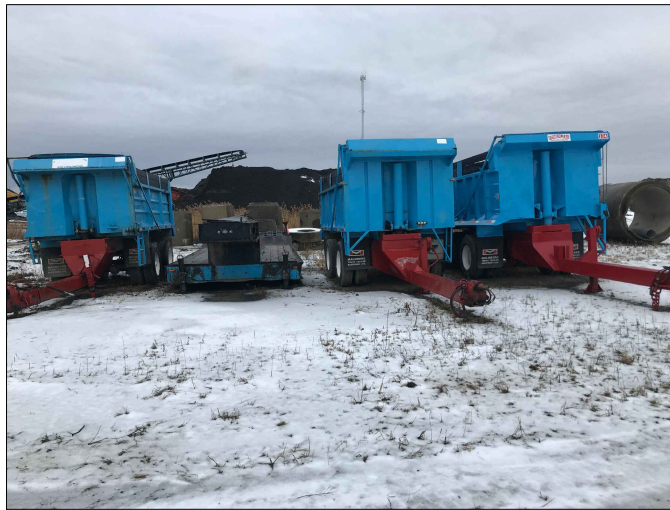
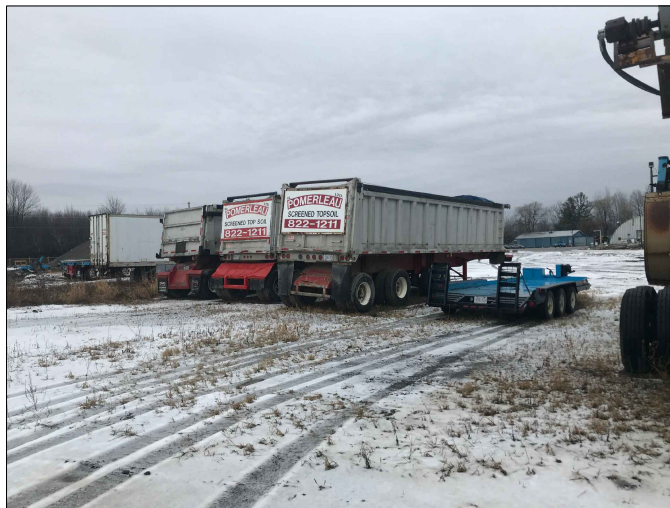
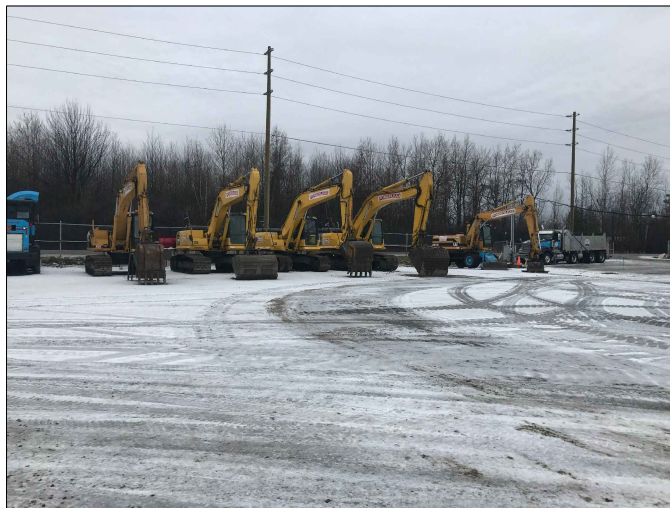
FIGURE I.10

EQUIPMENT PRESENT ON THE SUBJECT PROPERTY AT THE TIME OF SITE RECONNAISSANCE.

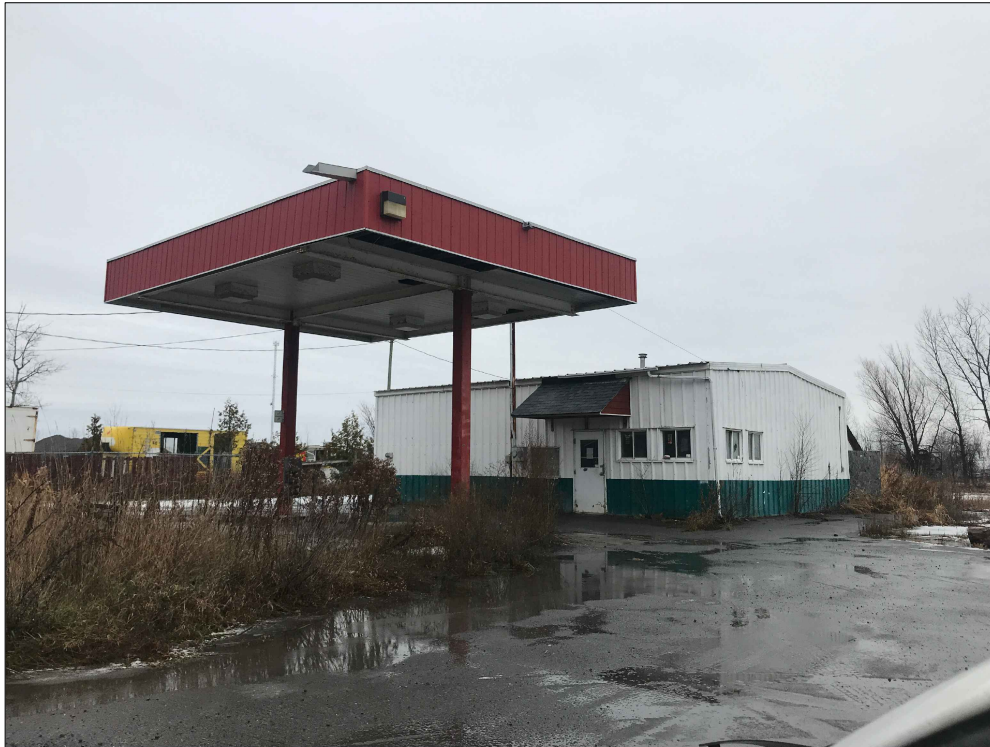
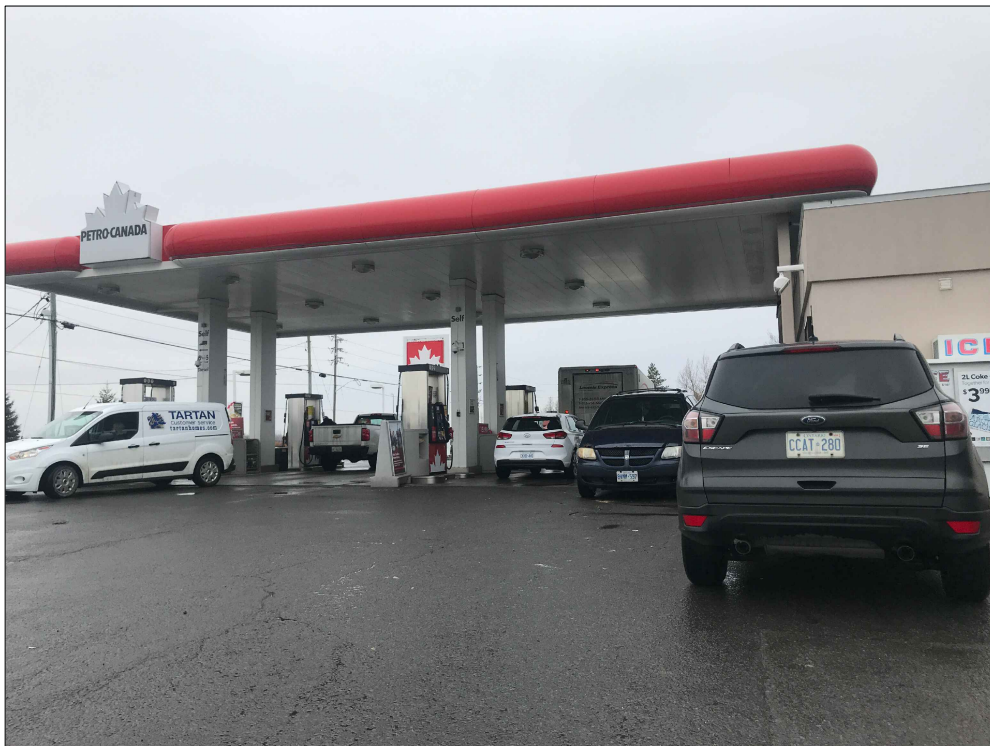
FIGURE I.11

ADJACENT GAS STATIONS IDENTIFIED WITHIN THE STUDY AREA

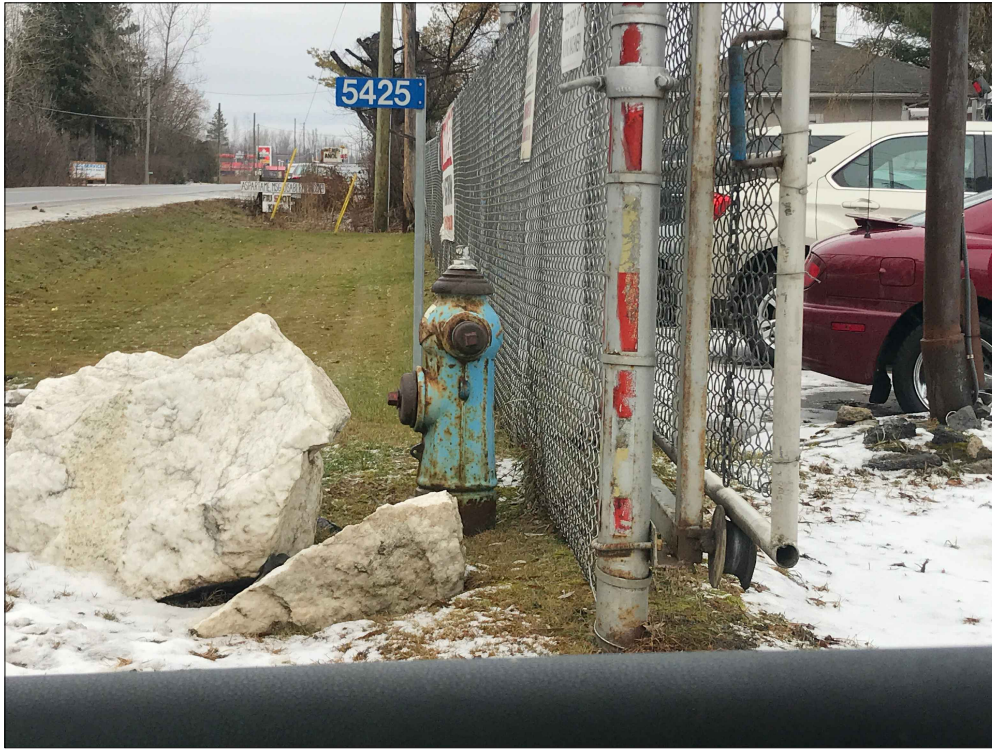
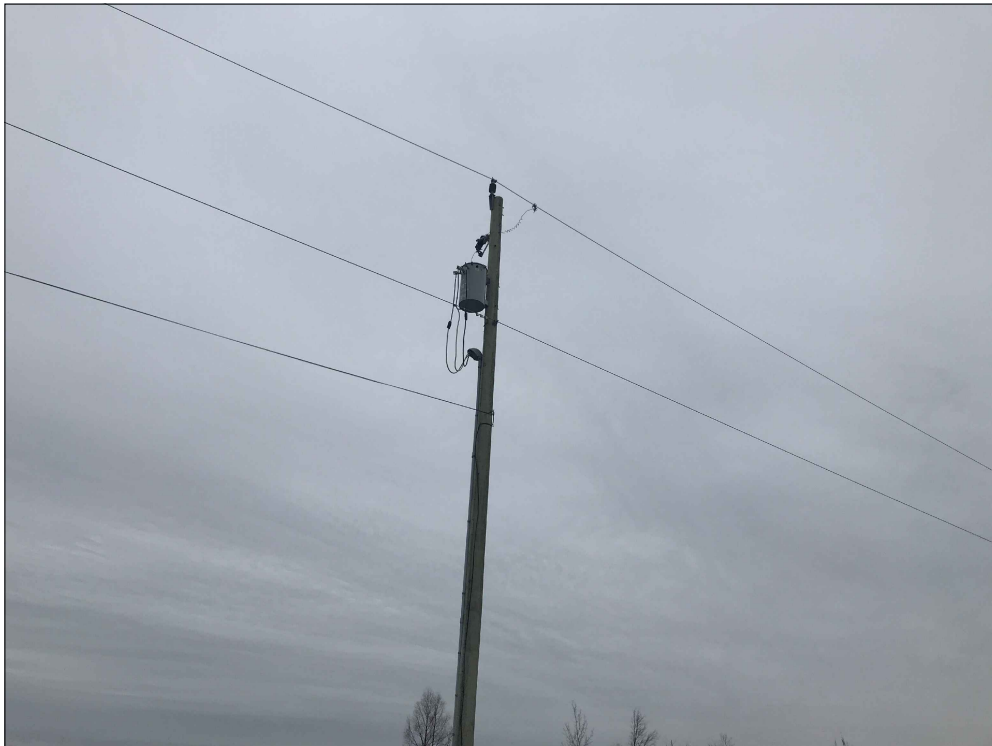
FIGURE I.12

Pole mounted transformers were identified in the study area where aboveground electricity was identified. The transformers appeared to be in good condition with no evidence of leaking.

SERVICES IDENTIFIED IN THE STUDY AREA
