**Hydrogeological Investigation,
Terrain Analysis & Impact
Assessment
Proposed Truck Repair Facility,
Badger Daylighting
3025 Carp Road
Ottawa, Ontario**

July 23, 2020 – Rev 1
Project: 61730.61

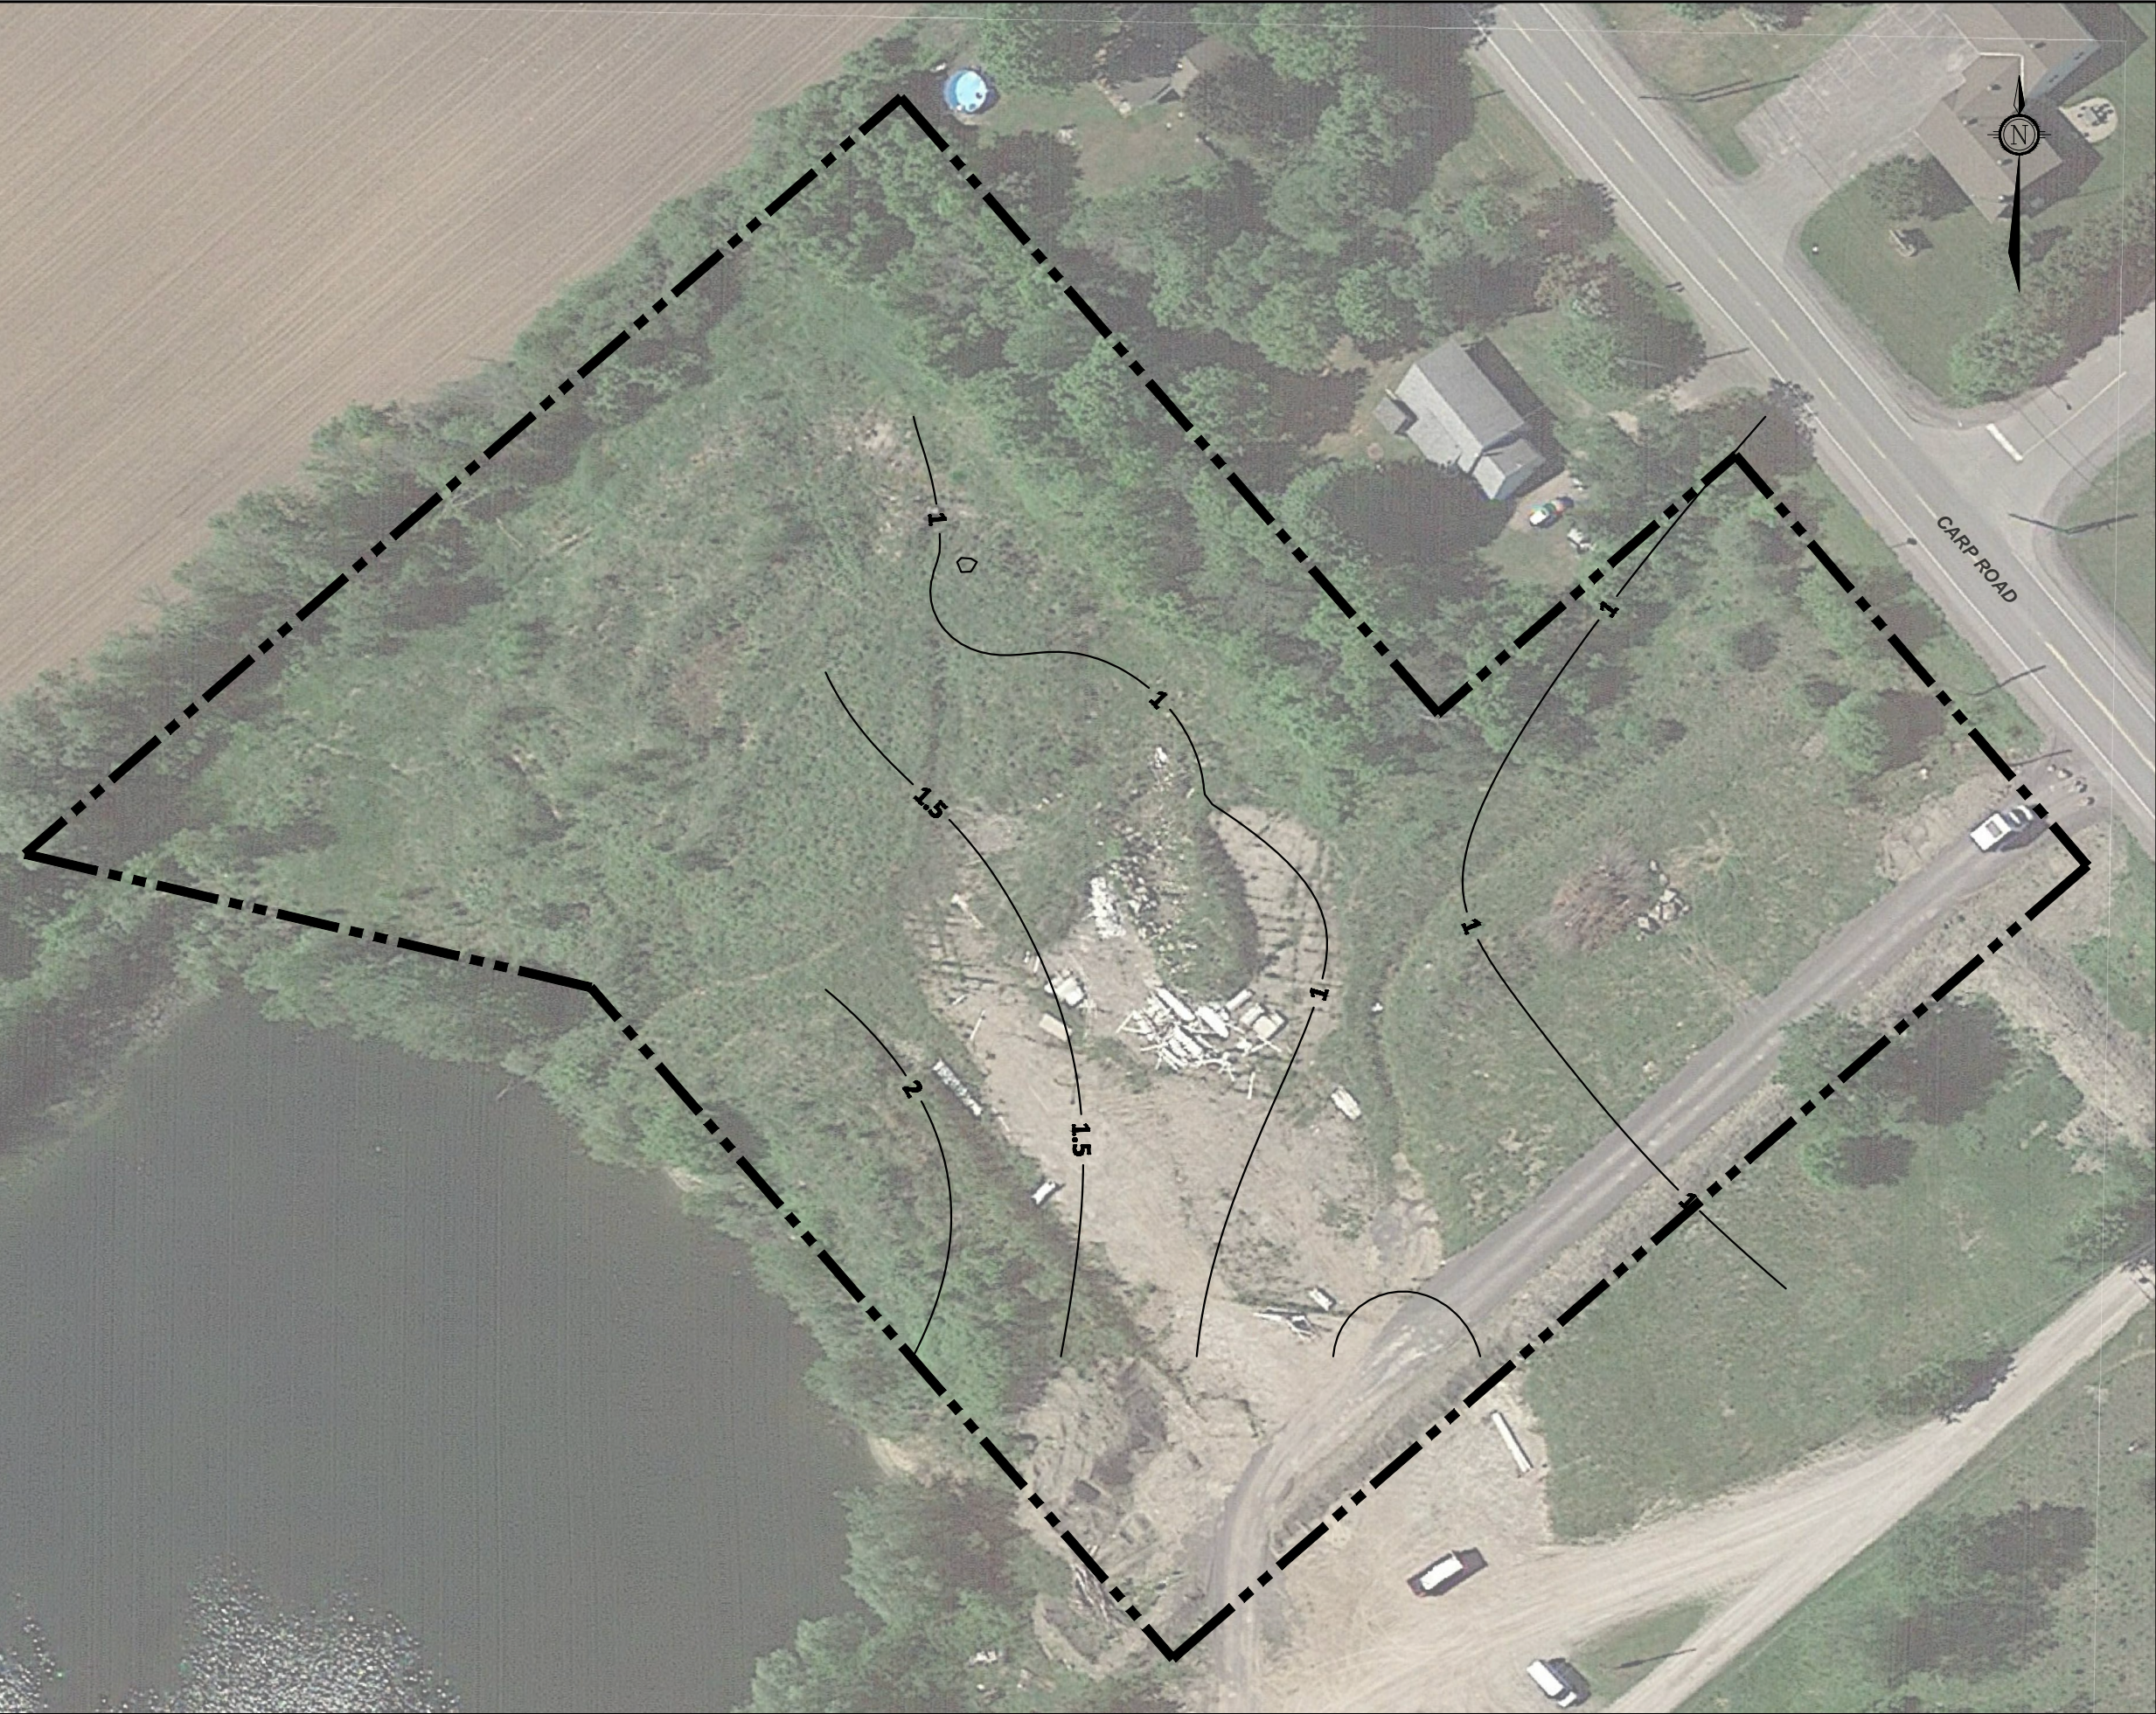
FIGURE 3

1.5 OVERBURDEN THICKNESS CONTOURS
(0.5 METRE INTERVALS)

The subsurface conditions at the subject site are described in the geotechnical investigation completed by GEMTEC. The field work for the geotechnical investigation was carried out on September 6 and 12, 2019. Seven boreholes, numbered 19-1, 19-2, 19-3a, 19-3b, 19-4, 19-5, and 19-6 were advanced across the subject site; practical auger refusal was encountered at depths between about 0.3 and 3.3 metres below ground surface level. In addition, five test pits, numbered 19-1a, 19-1b, 19-2 to 19-5, inclusive, were advanced to practical excavation refusal at depths between about 1.0 and 2.4 metres below ground surface level. The results of the boreholes and test pits are provided on the Record of Borehole and Test Pit sheets in Appendix B. The locations of the test holes are shown on the Detailed Site Plan, Figure 2. The overburden thickness map is shown on Figure 3.

- It is noted that the overburden soils are approximately equal to or greater than 1.0 metres in thickness in the location of urban lawns (Figure 3) and the Thornthwaite and Mather water surplus calculations are considered to be applicable. Areas of thin overburden (less than 1 metre) are generally within the building footprint and gravel parking area.

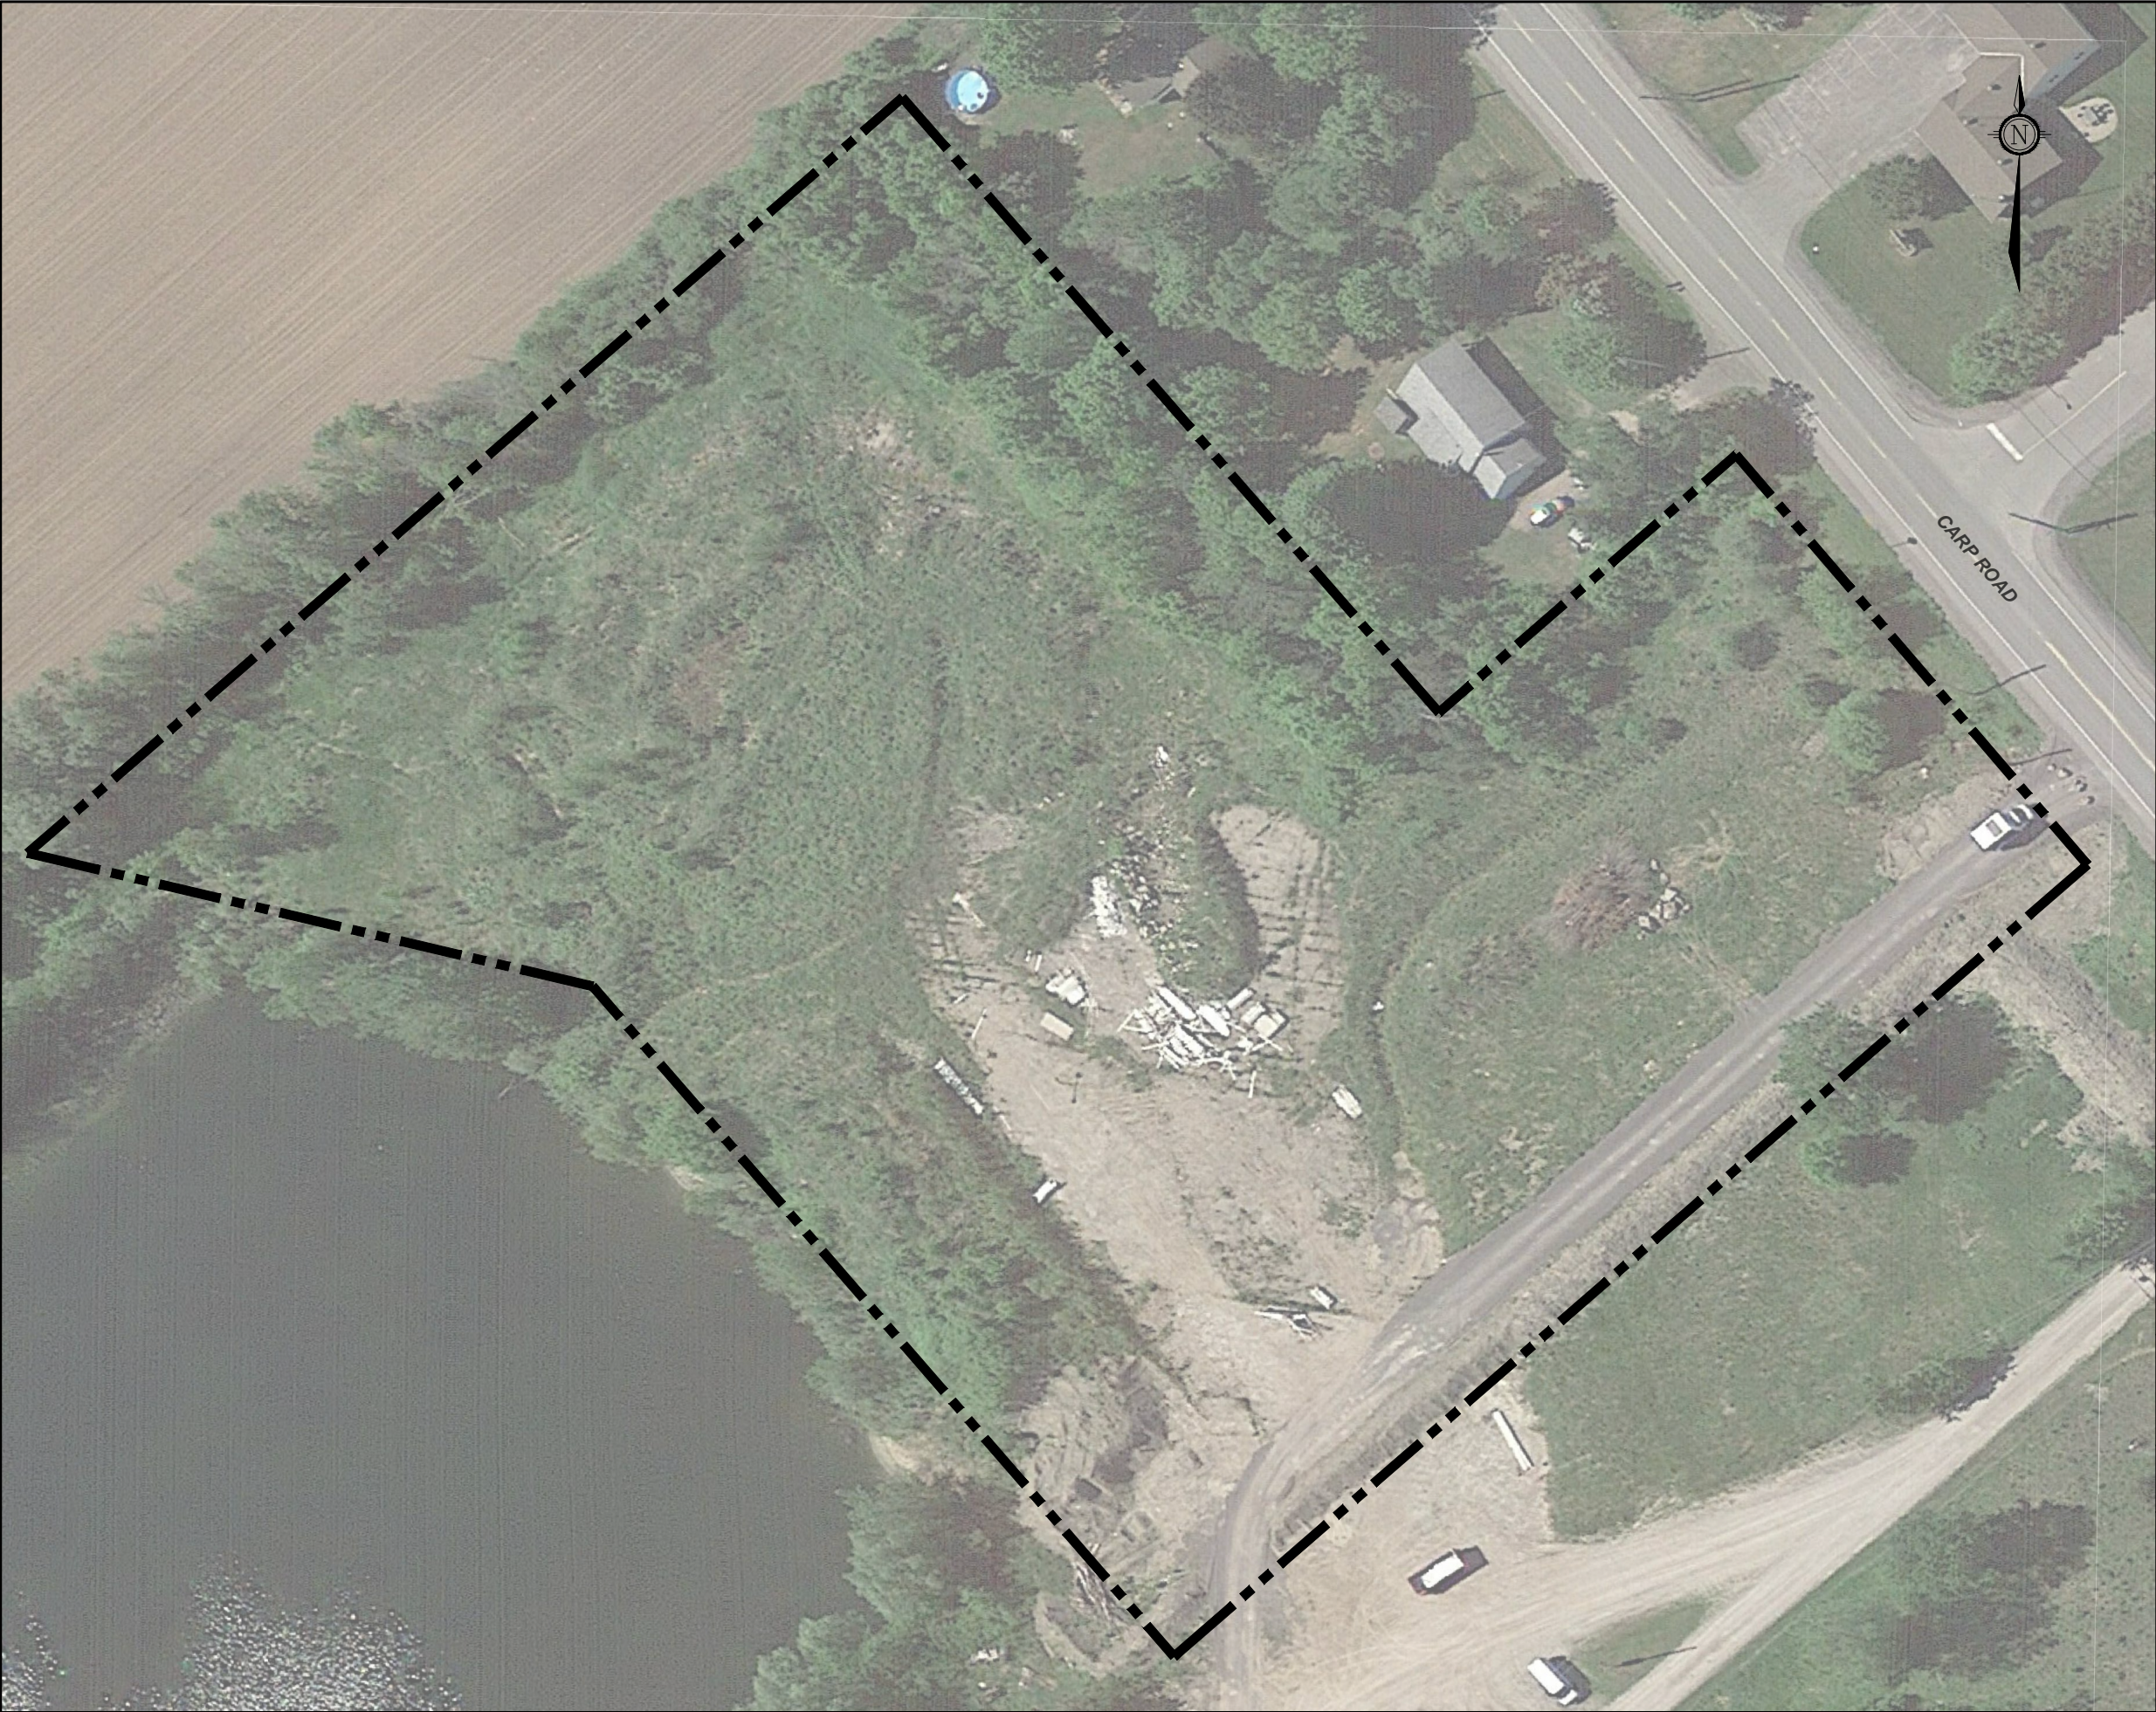
Date JULY 2020	Rev. 1	FIGURE 4
-------------------	-----------	-----------------

Drawing
PRE-DEVELOPMENT CONDITIONS

The subject site is currently vacant, with no structures and soil conditions consist of silty sand to sand and gravel fill material from the previous sand and gravel extraction. The site is vegetated with grasses and shrubs, along with trees lining the northern portion of the site. The subject site is generally flat, with a steep slope in the immediate vicinity of the pond located immediately west of the site. Based on the site characteristics, the infiltration factor is estimated to be 0.70, based on the following:

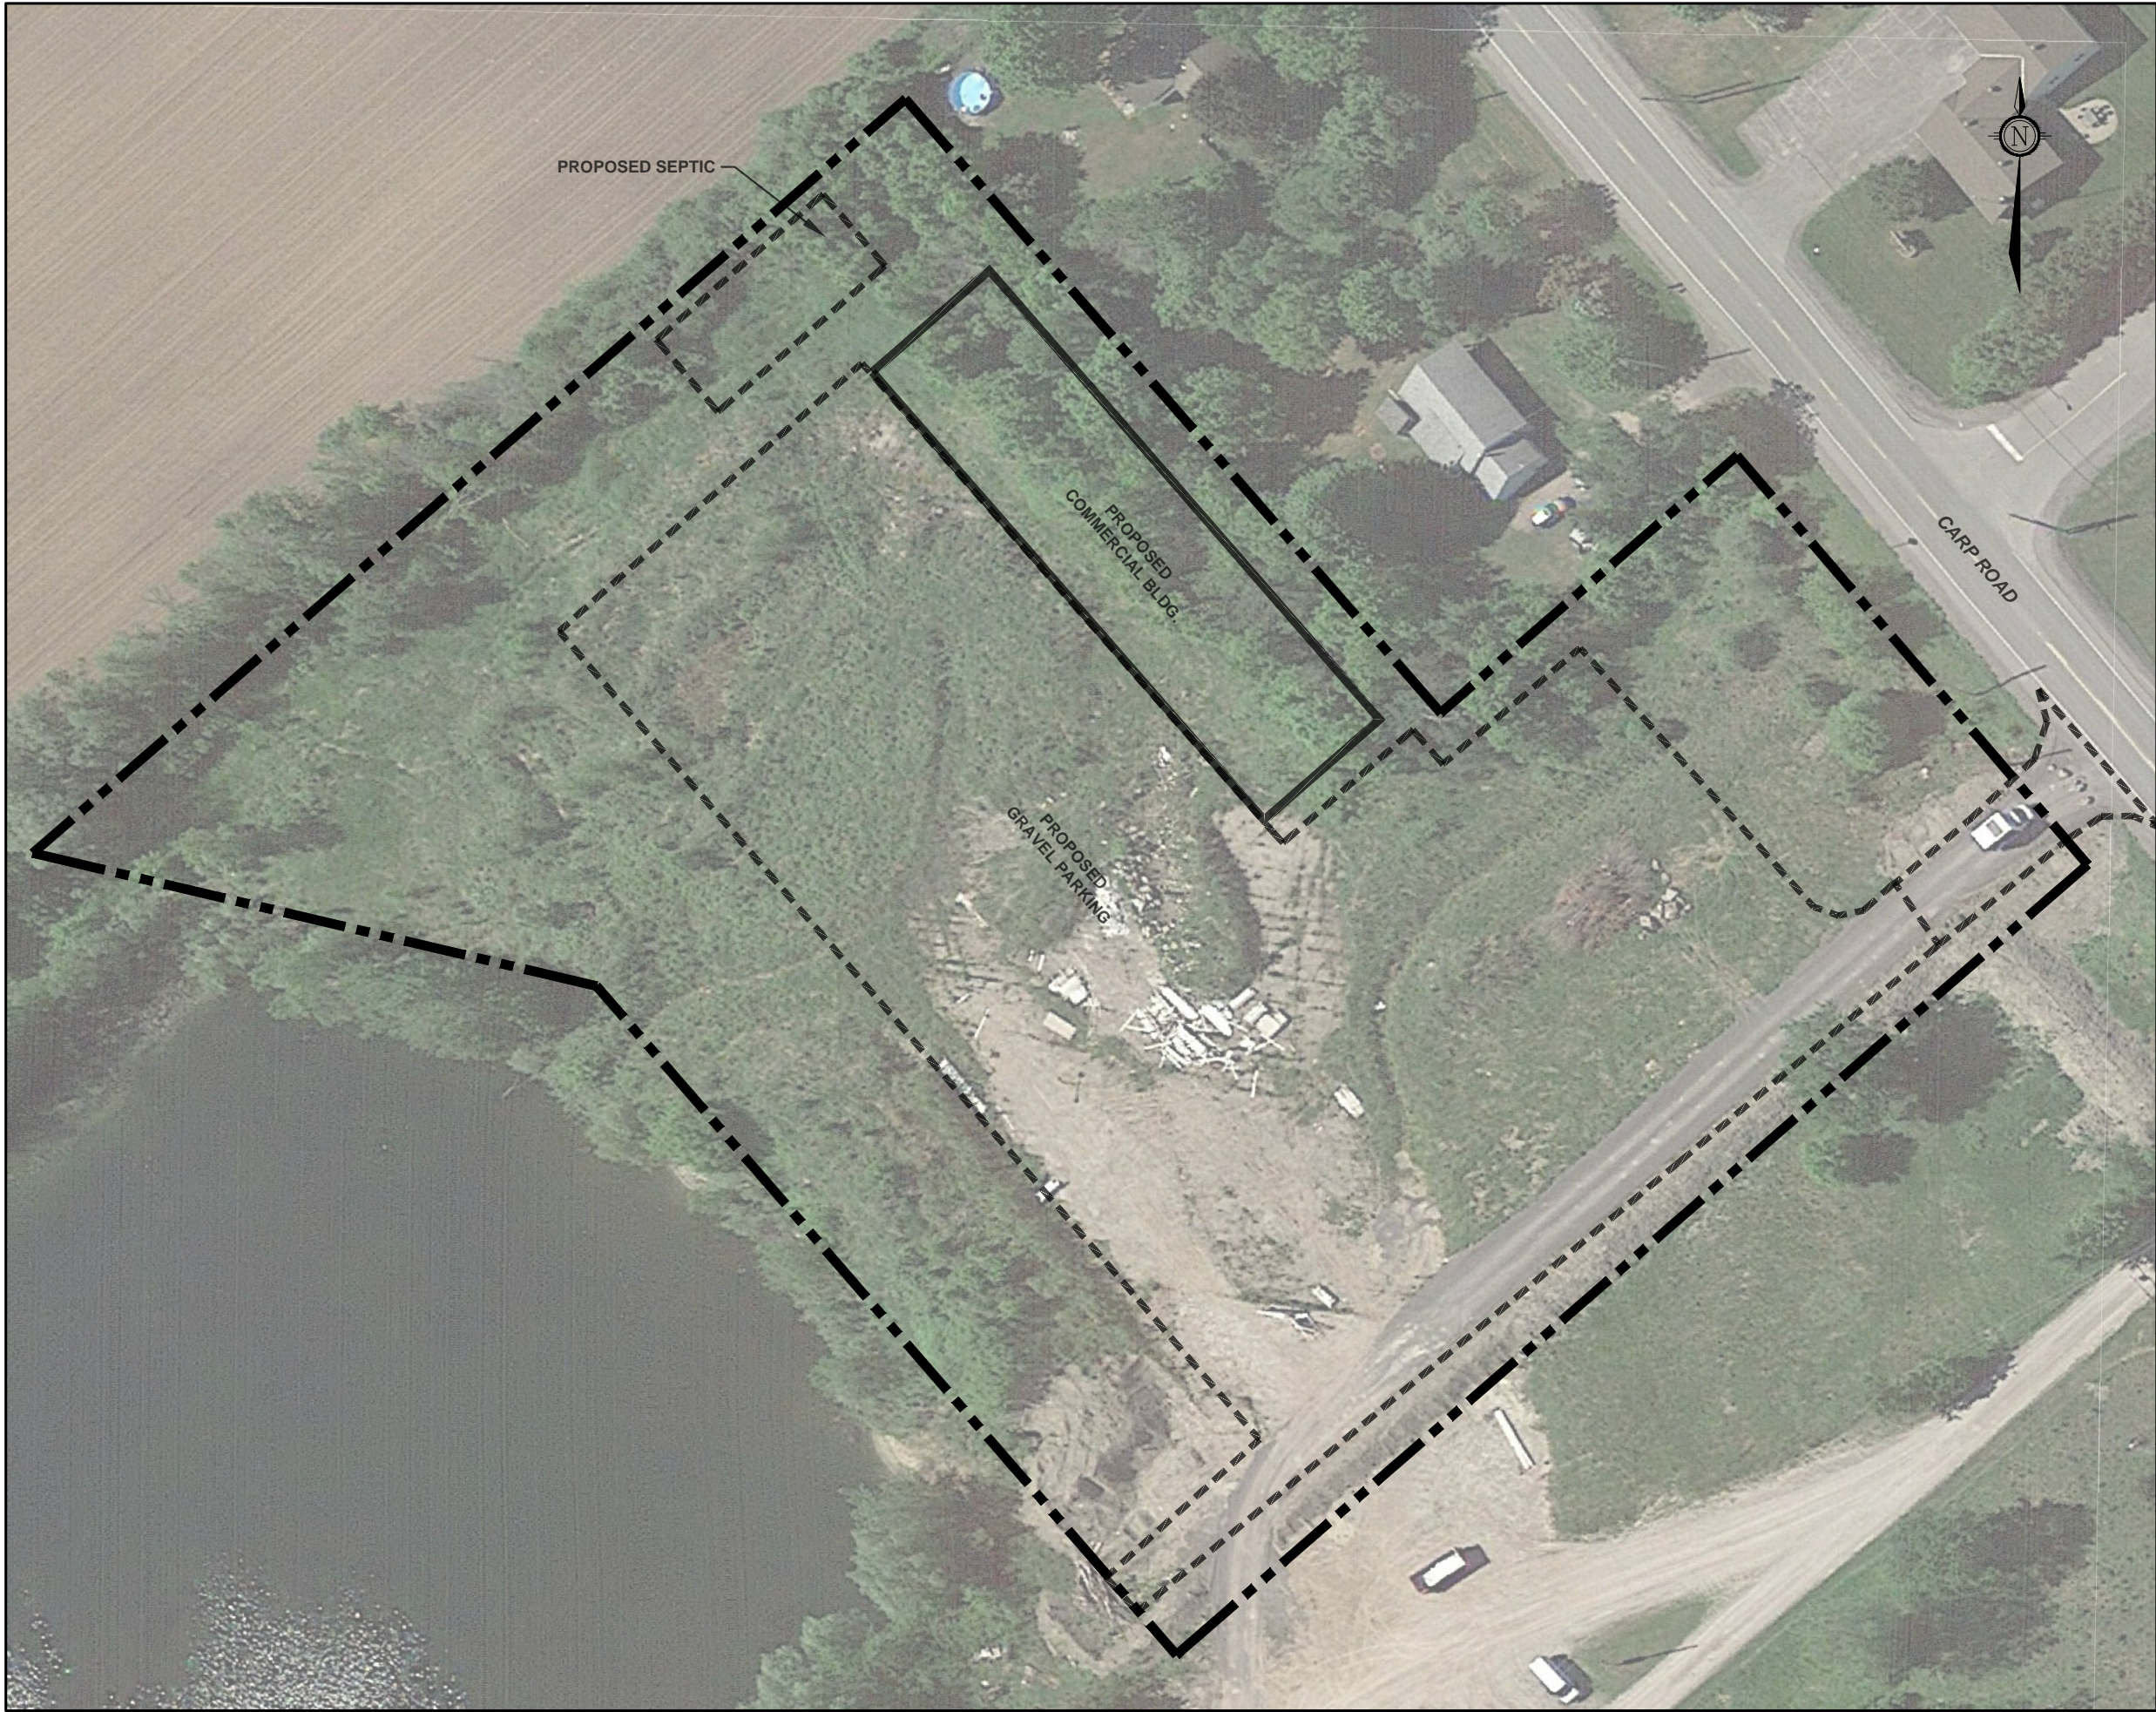
Drawing
POST-DEVELOPMENT CONDITIONS

The post-development conditions at the subject site will consist of 599.76 and 279.48 m² buildings, an approximate gravel parking area of 8,437 m² and the remaining vegetated areas are anticipated to be landscaped (refer to Site and Landscaping Plan, Appendix A). Based on the anticipated post-development site characteristics, there are no changes to the estimated infiltration factor for vegetated areas, which remains to be 0.70. The infiltration for the proposed building and gravel parking area (51% coverage) is considered to be impervious and the infiltration factor is 0. Landscaping of the existing soils may change the water holding capacity and the post-development water holding capacity is expected to be 75 mm, selected from Table 3.1 of the MOE Stormwater Management Planning and Design Manual (MOE, 2003). The post-development site vegetation will be classified as urban lawn underlain by fine sand.

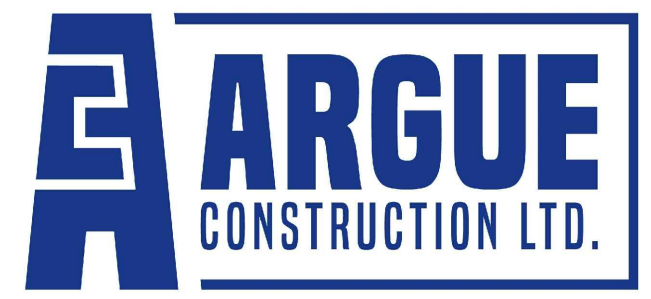
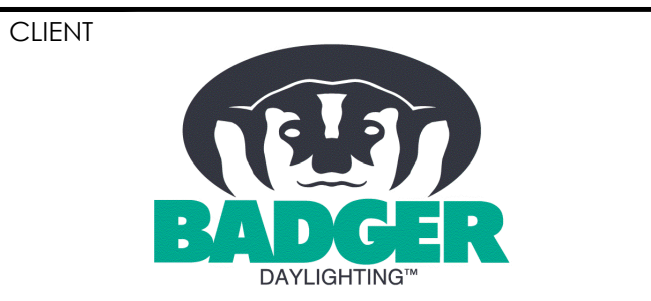
DRAWING TITLE		
SITE & LANDSCAPE PLAN		
DRAWN BY	A.A.	DRAWING NO.
REVIEWED BY	A.A.	A1.0
START DATE	2019/08/06	
PROJECT NO.	19011	REVISION NO.
		00

FRONT YARD SET BACK	10M (min.)	50.3M	REPAIR GARAGE	1	24 SPACES
	REAR YARD SET BACK	10M (min.)	70.1M	(739.59 Sq.M.)		
	INTERIOR SIDE YARD SET BACK	6M ABUTTING RESIDENTIAL/3M OTHERS (min.)	6M	OFFICE (277.96 Sq.M.)	0	0
	PRINCIPAL BUILDING HEIGHT	11M (max.)	8.5M±	ACCESSIBLE PARKING STALL PROVISIONS		
	LOT COVERAGE	25% (max.)	4.81%	REQUIRED	PROVIDED	
	PARKING REQUIREMENTS	Repair Garage: (Table 101 - Row N41) 0.75/100 Sq.M. GFA (739.59 Sq.M./100) X 0.75 = 5.6 parking spaces		2.4M WIDE + 1.5M WIDE ACCESS AISLE (min.)	3.7M (W) + 3M (W) ACCESS AISLE	
		Office: (Table 101 - Row N59) 2.4/100 Sq.M. GFA (277.96 Sq.M./100) X 2.4 = 6.7 parking spaces		AISLE AND DRIVEWAY PROVISIONS		
		Total: 5.6 + 6.4 = (12.3) 13 spaces		REQUIRED	PROVIDED

6.7M (min.) FOR DOUBLE TRAFFIC LANE	VARIES	
				SETBACK FROM WATERCOURSES PROVISIONS		
				REQUIRED	PROVIDED	
	DISABLED PARKING SPACES	1 Parking Space	58 Spaces	30M FROM HIGH WATER MARK/15M FROM T.O. BANK	30M SETBACK FROM T.O. BANK	
	BICYCLE PARKING SPACES	2 Parking Spaces	1 Space			
			2 Spaces

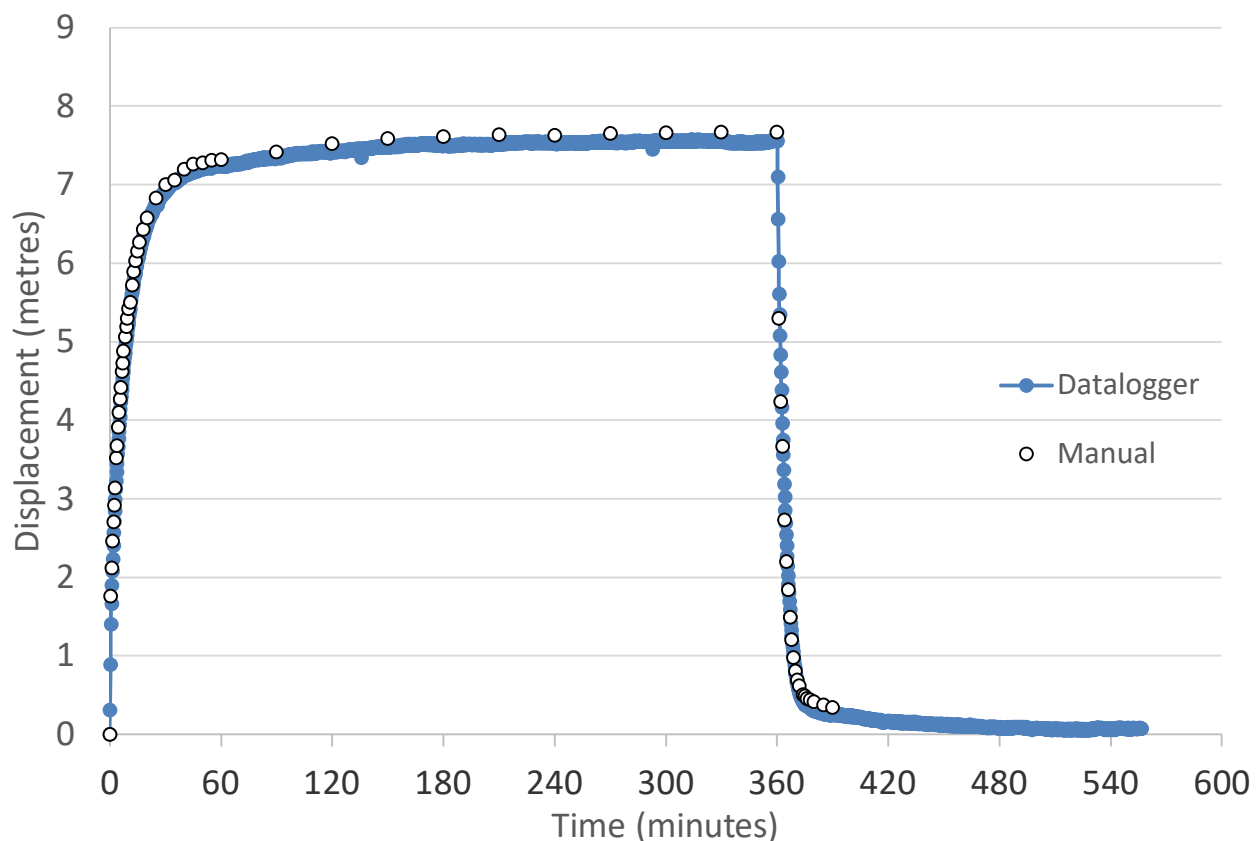
Pumping Test Data (TW19-1): Drawdown and Recovery

Water Levels TW19-1

Static : 4.41 m bgs

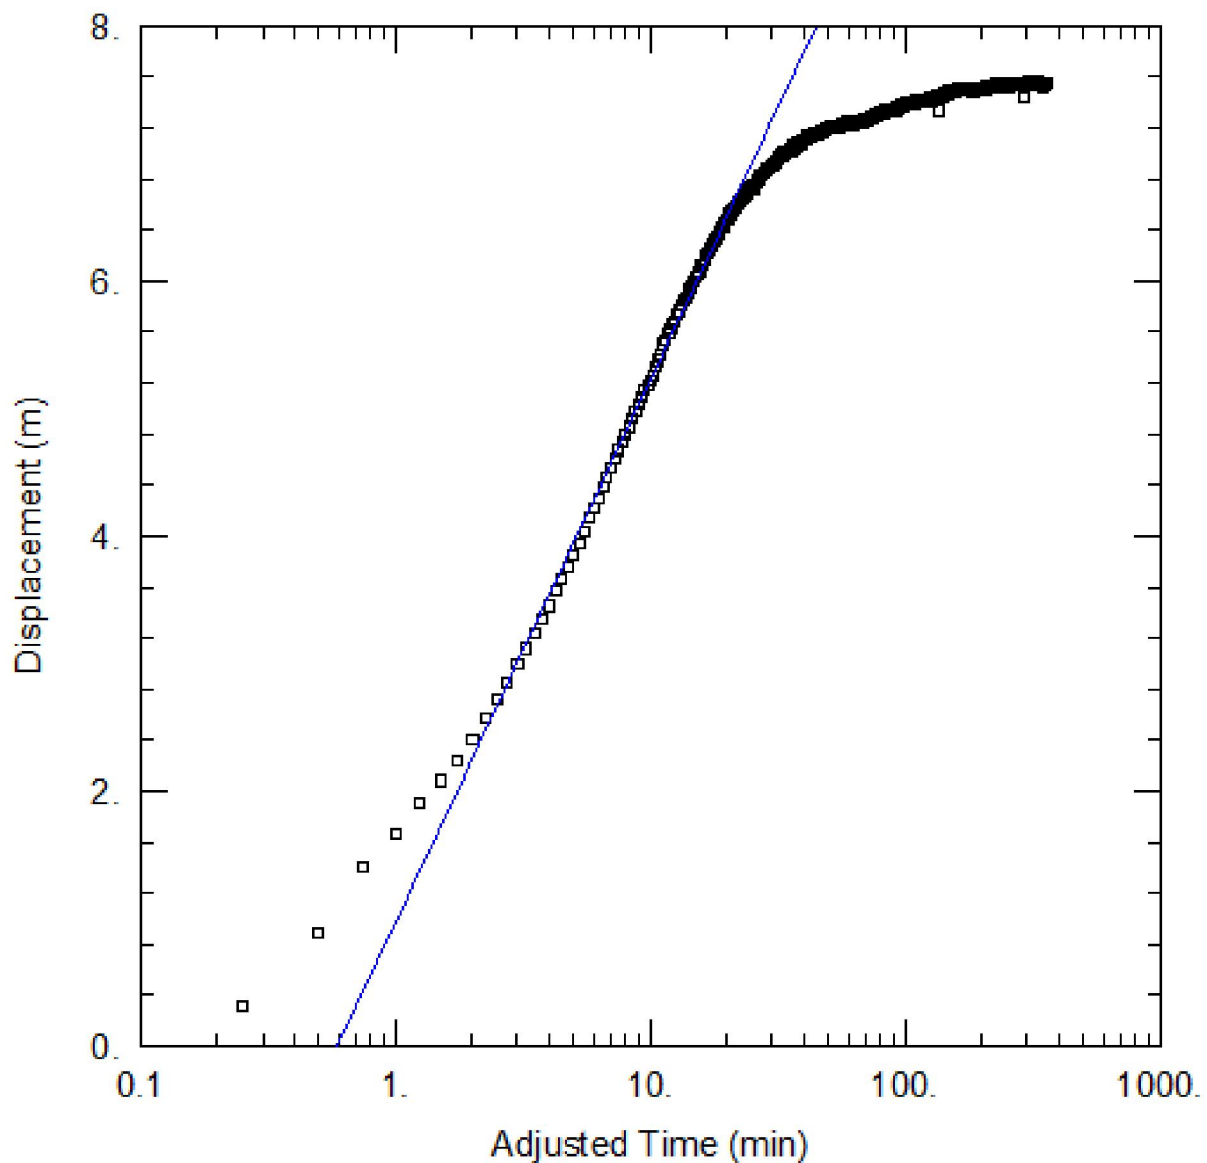
Pumping Test Analysis (TW19-1): Cooper-Jacob (Confined Aquifer)

Estimated Transmissivity: $1.6 \text{ m}^2/\text{day}$ or $2 \times 10^{-5} \text{ m}^2/\text{s}$

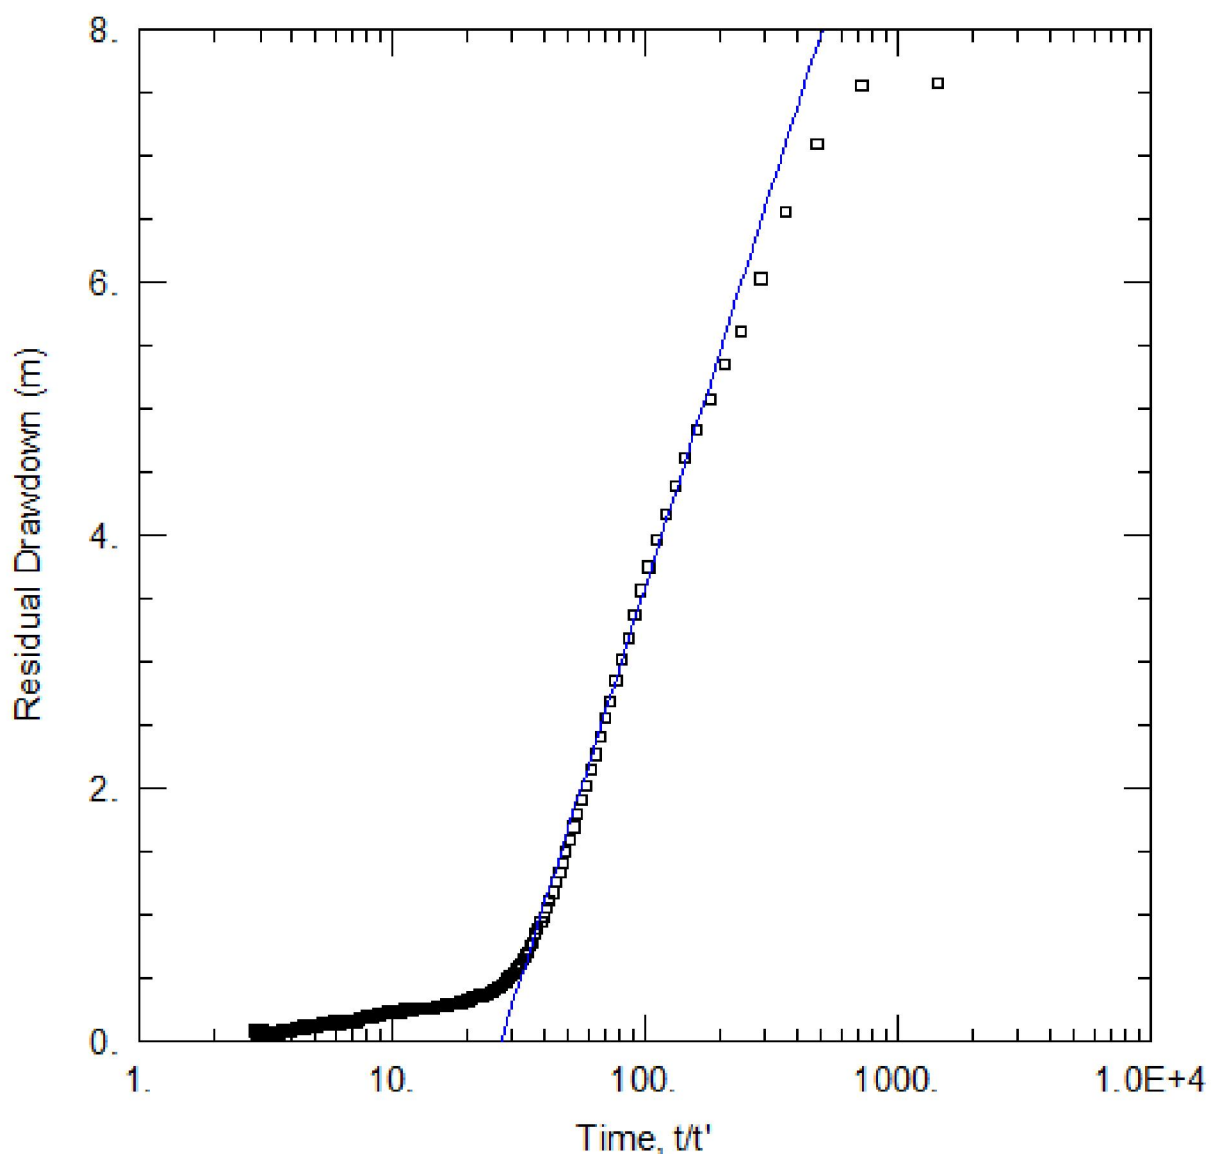
Pumping Test Analysis (TW19-1): Theis Recovery (Confined Aquifer)

Estimated Transmissivity: $1.1 \text{ m}^2/\text{day}$ or $1 \times 10^{-5} \text{ m}^2/\text{s}$
