Phase I-Environmental Site Assessment

200 Baribeau Street
Ottawa, Ontario

July 2, 2019

Report: PE4597-1

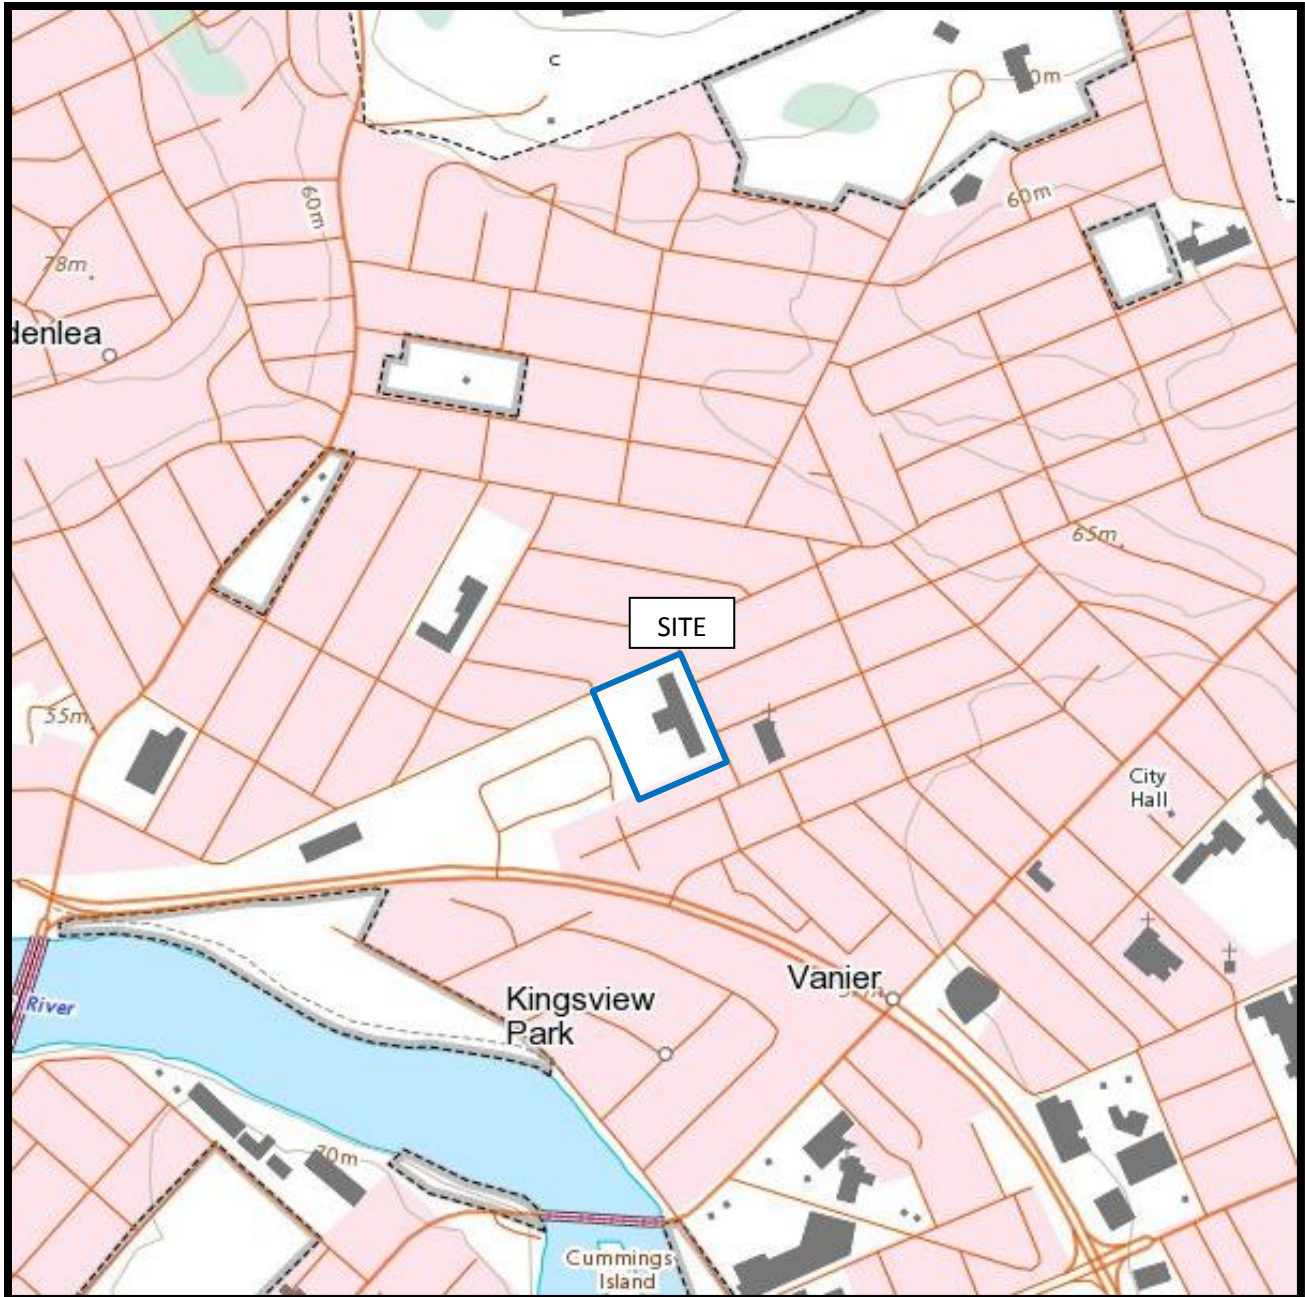
FIGURE 2
TOPOGRAPHIC MAP

A topographic map was obtained and reviewed from Natural Resources Canada – The Atlas of Canada website. The topographic maps indicate that the elevation of the Phase I Property is approximately 57m above sea level. The regional topography in the general area of the Phase I Property slopes downward to the southwest, towards the Rideau River. An illustration of the referenced topographic map is presented in Figure 2 – Topographic Map appended to this report.

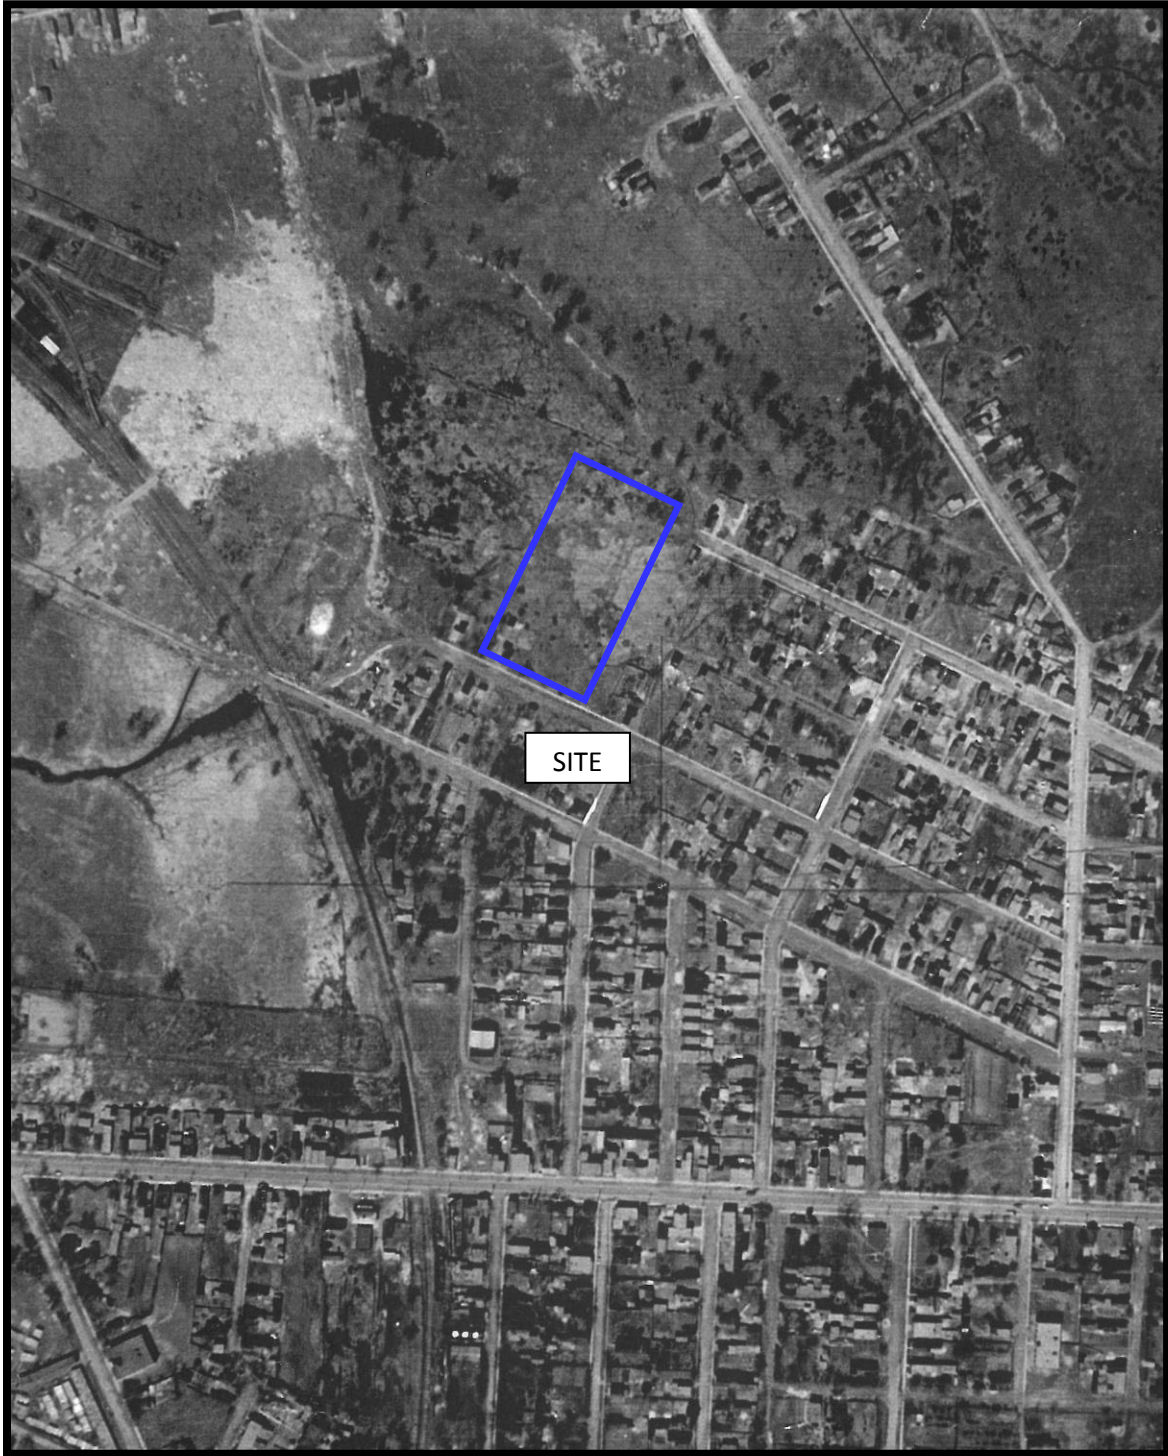
AERIAL PHOTOGRAPH
1928

| 1928 | The subject site appears to be low-lying undeveloped land, with possible fill placement occurring along the eastern limits of the property. The adjacent lands to the south and east are developed for residential use. The Dominion Bridge Company yard is visible to the west of the subject site along with the railway line. |

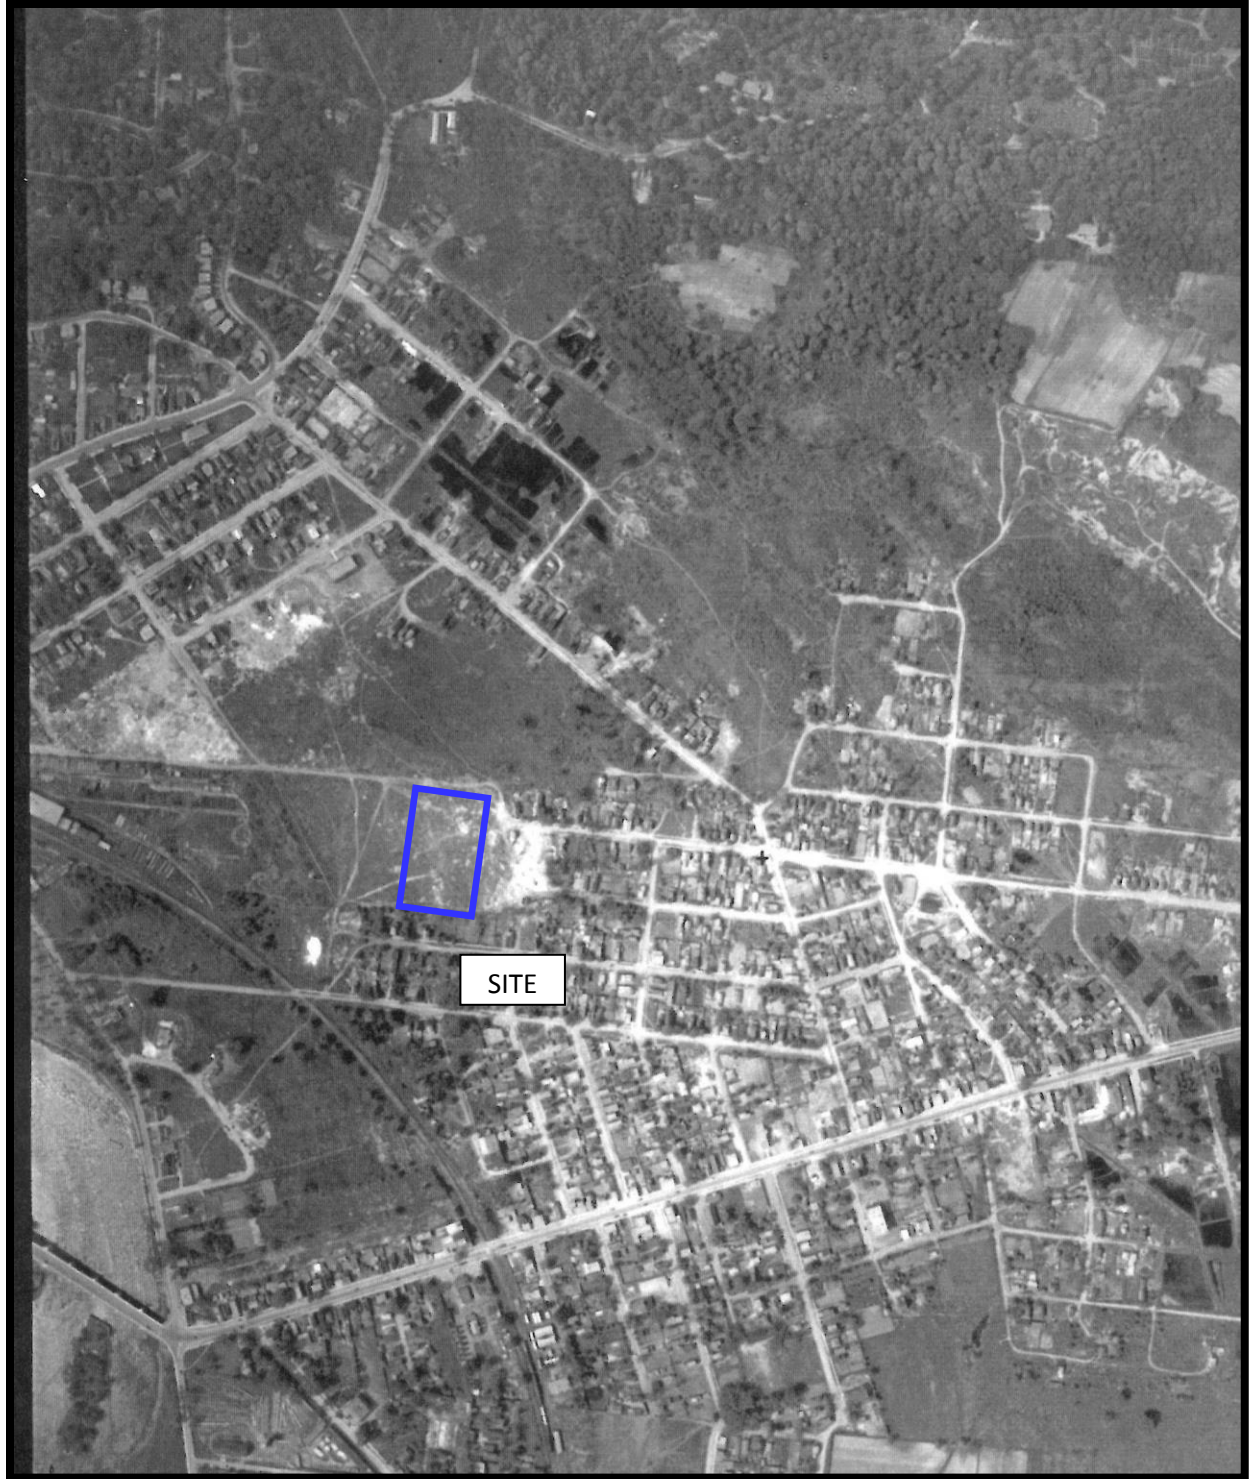
AERIAL PHOTOGRAPH
1937

| 1937 | The subject site appears have significant fill placement occurring with the low lying areas filled in. The surrounding properties remain unchanged from the previous photograph with the exception of the former steel fabrication yard to the west. The activities appear to be intensifying on the Dominion Bridge Company property. |

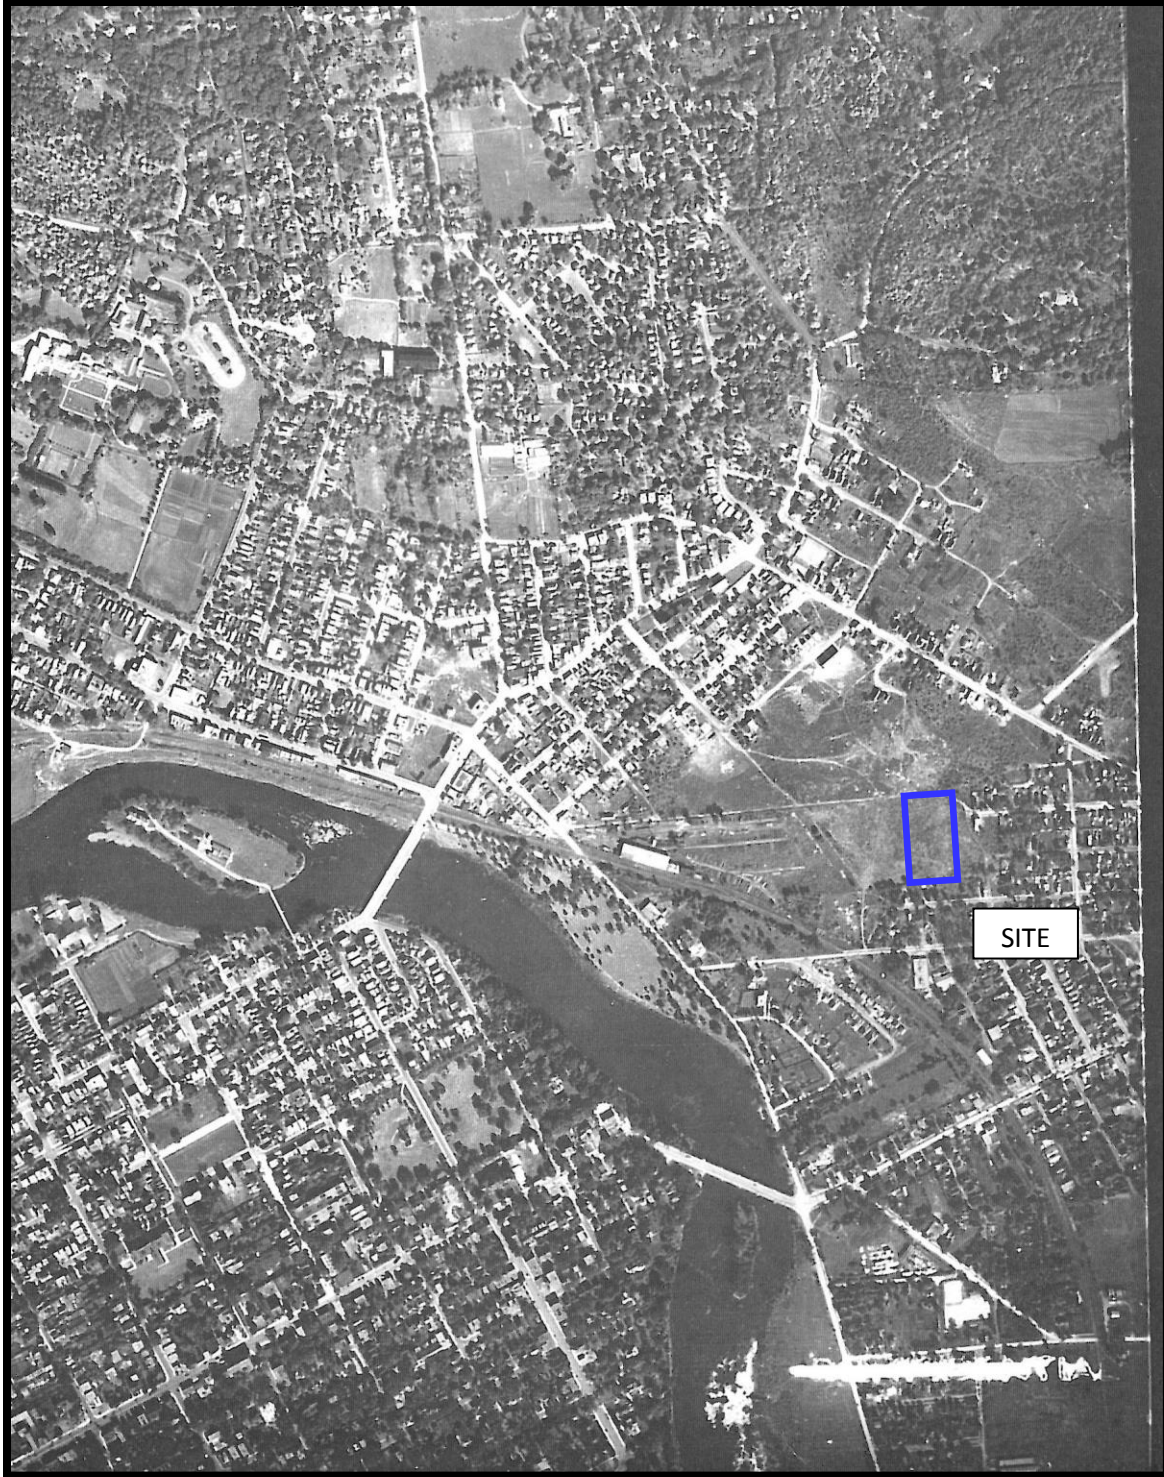
AERIAL PHOTOGRAPH
1944

| 1944 | No significant changes have been made to the subject site or surrounding properties. |

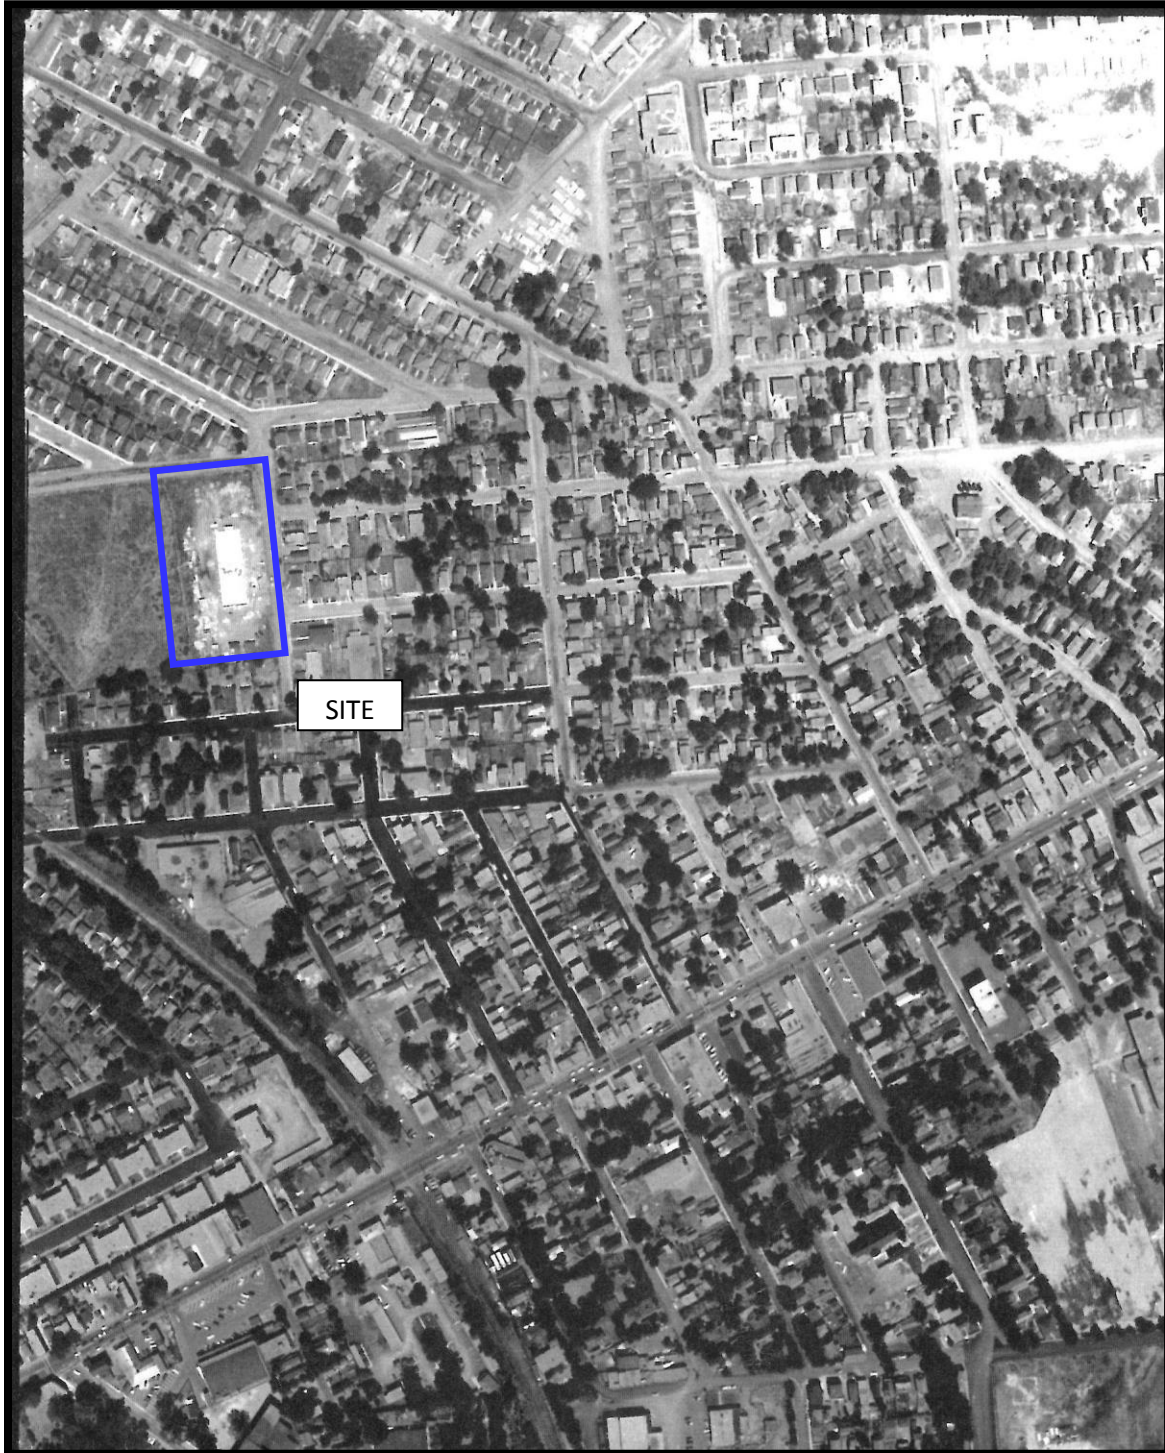
AERIAL PHOTOGRAPH
1955

| 1955 | The subject site is under development with a portion of the current building. No significant changes have been made to the subject site or surrounding properties. |

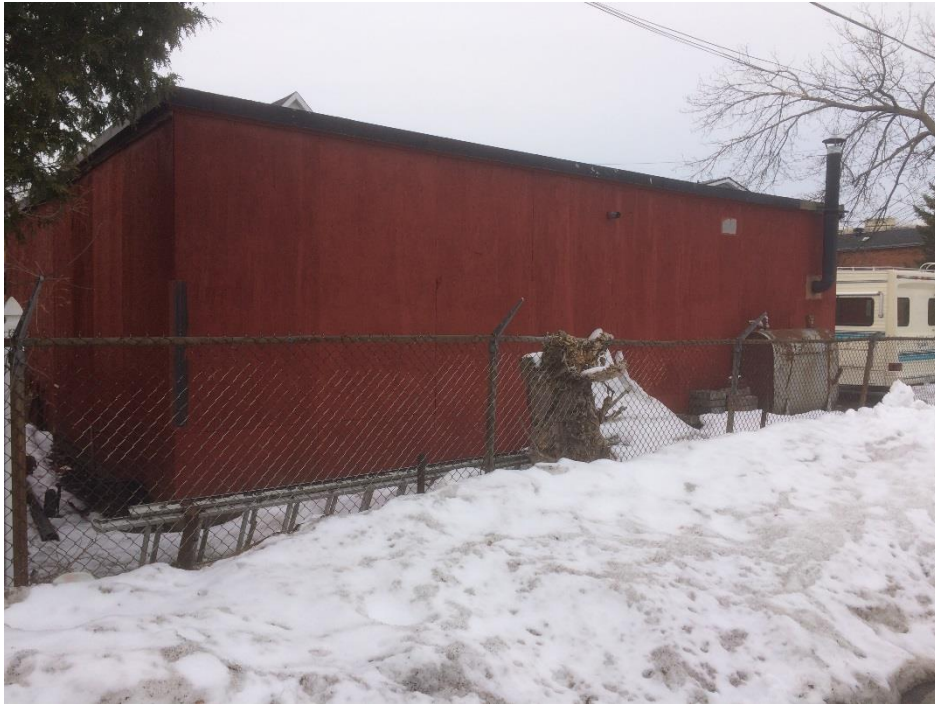
The presence of a private automotive service garage to the south of the subject site is considered to pose a potential environmental concern to the subject site.

Photograph 1: Adjacent private automotive service garage and exterior AST.

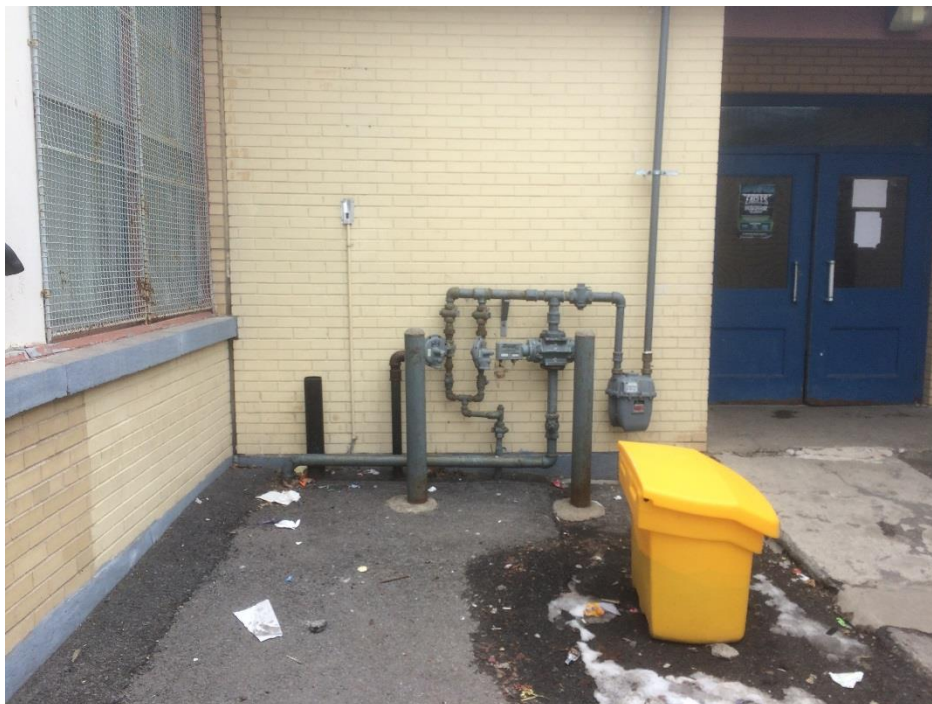
No signs of underground storage tanks (USTs) were observed on the Phase I Property at the time of the site visit. Evidence of an above ground storage tank (vent and fill pipes) was identified near the gas meter on the rear of the building.

Photograph 2: Natural gas connection for the subject site and vent and fill pipes.
