Phase I-Environmental Site Assessment

1155 Joseph Cyr Street and 1082 Cyrville Road
Ottawa, Ontario

TCU Development Corporation

Report: PE4967-1

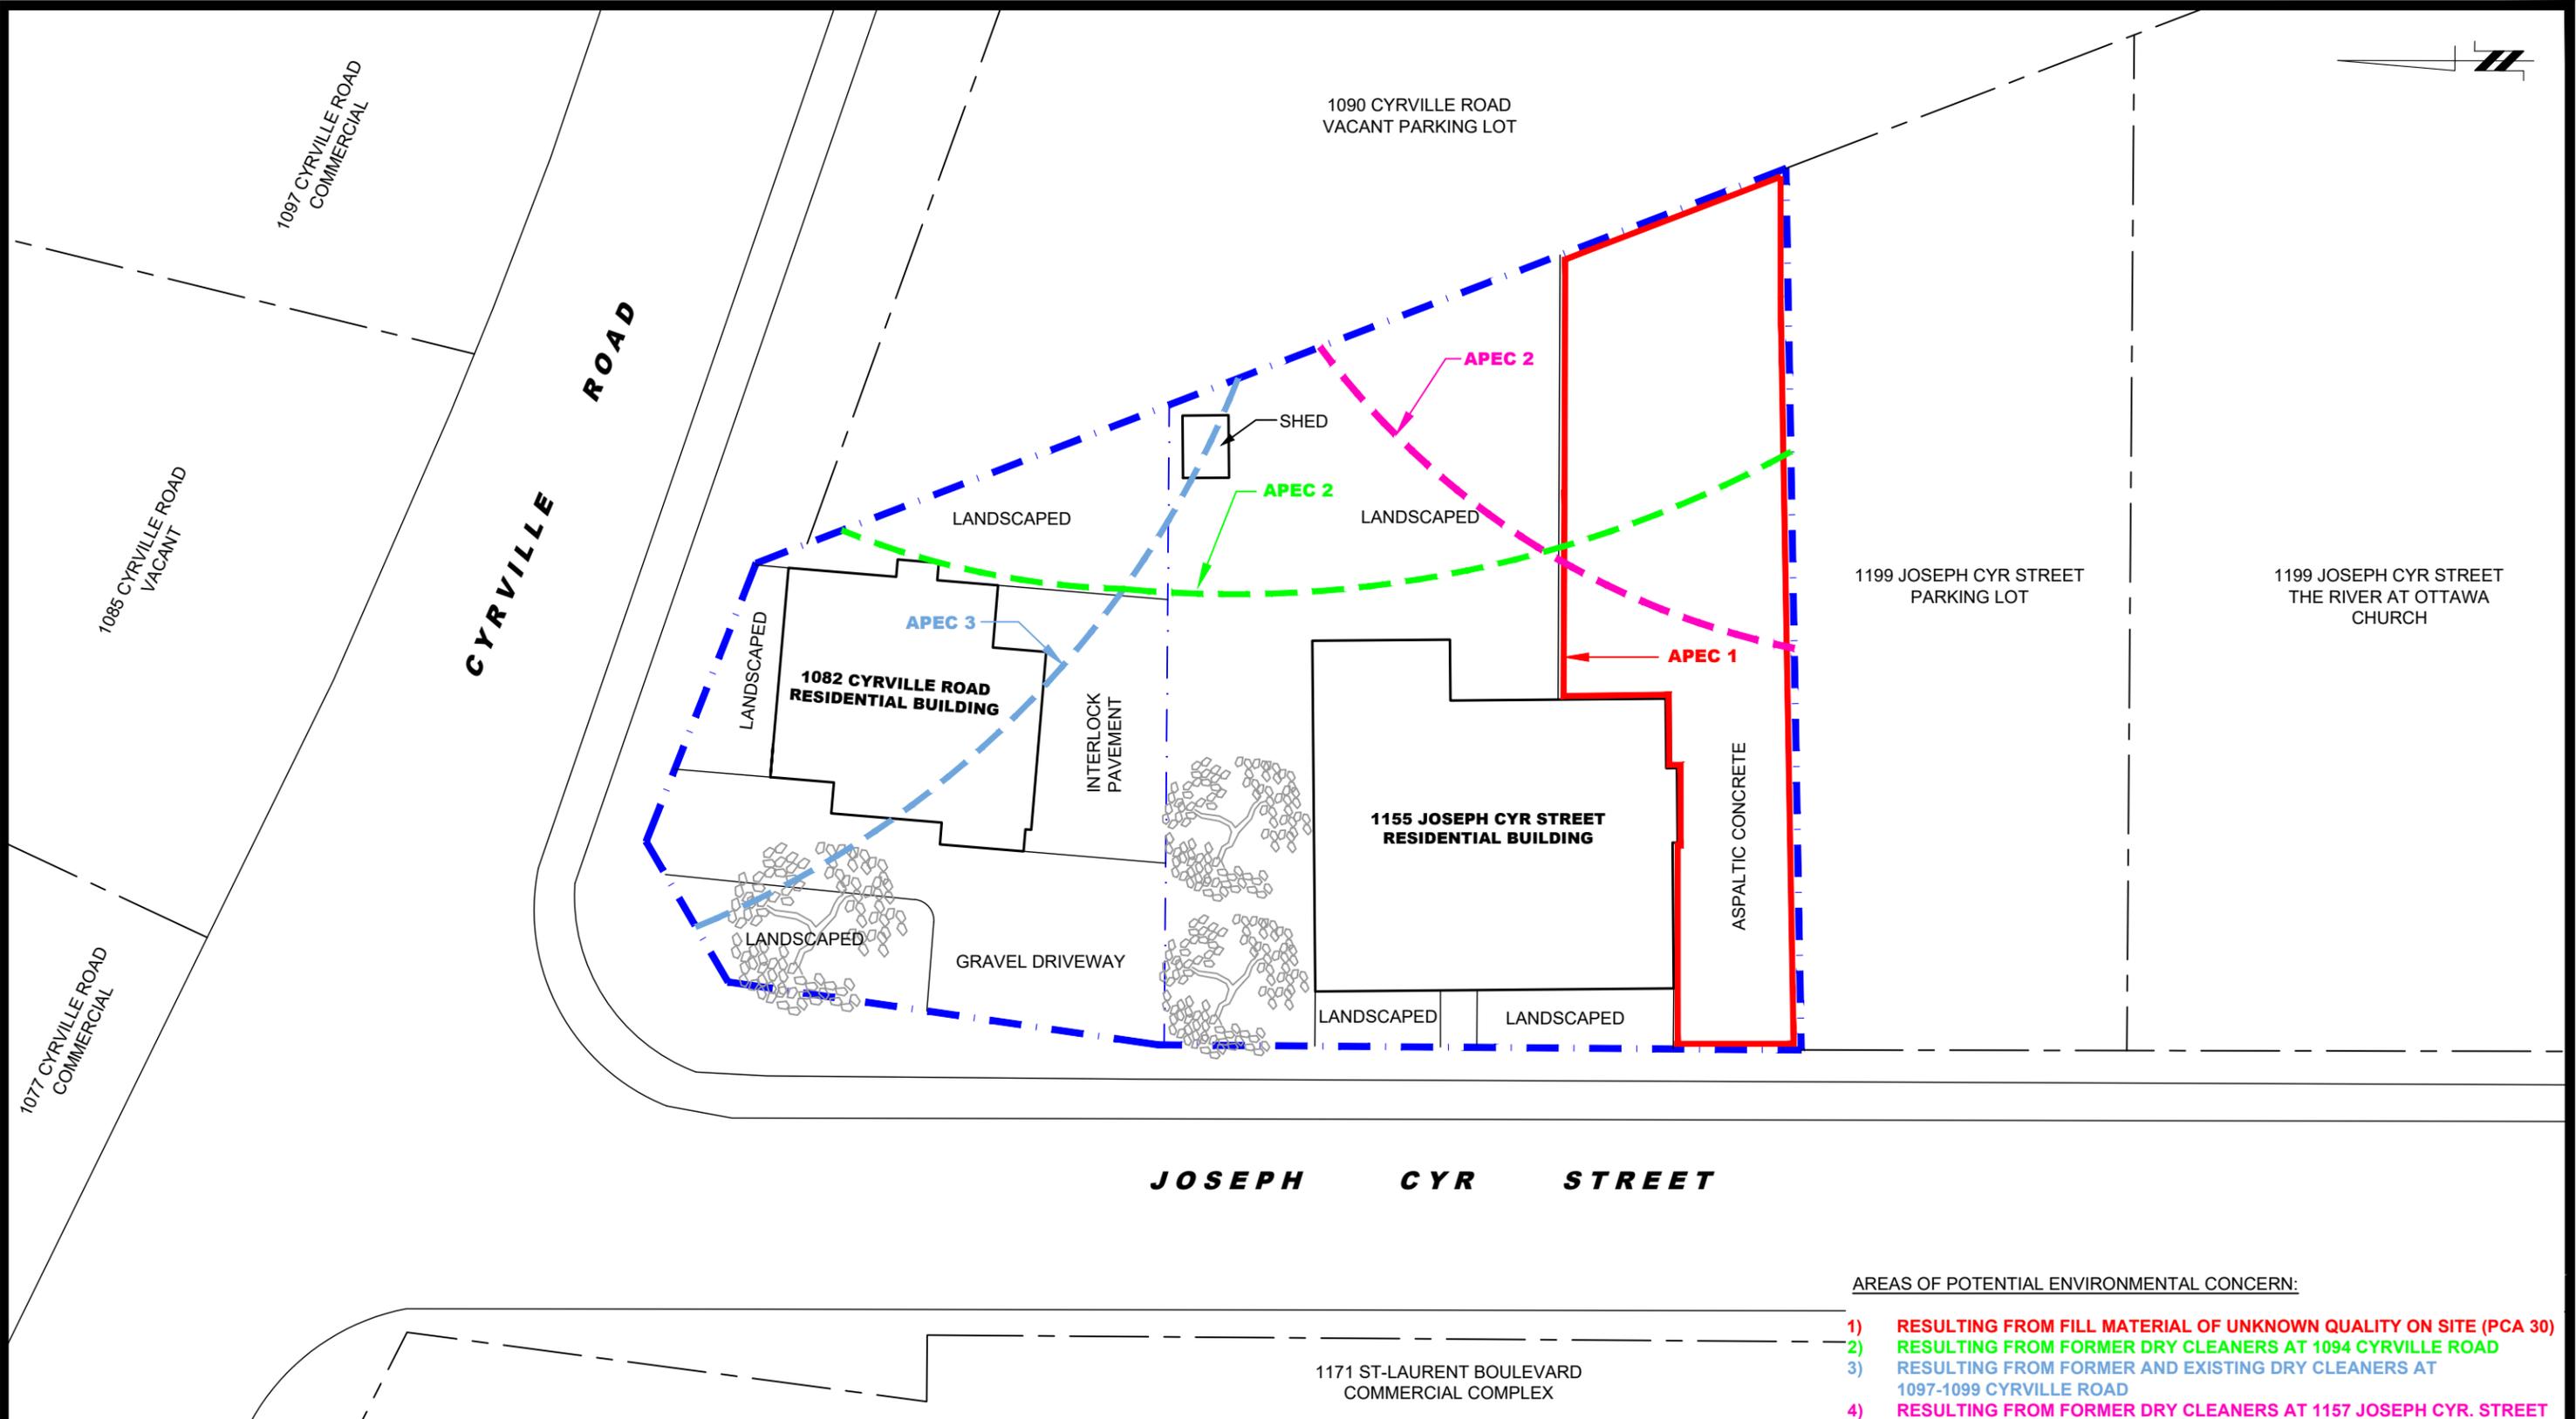
DRAWING PE4967-1 – SITE PLAN

- AREAS OF POTENTIAL ENVIRONMENTAL CONCERN:
- 1) RESULTING FROM FILL MATERIAL OF UNKNOWN QUALITY ON SITE (PCA 30)
 - 2) RESULTING FROM FORMER DRY CLEANERS AT 1094 CYRVILLE ROAD
 - 3) RESULTING FROM FORMER AND EXISTING DRY CLEANERS AT 1097-1099 CYRVILLE ROAD
 - 4) RESULTING FROM FORMER DRY CLEANERS AT 1157 JOSEPH CYR. STREET

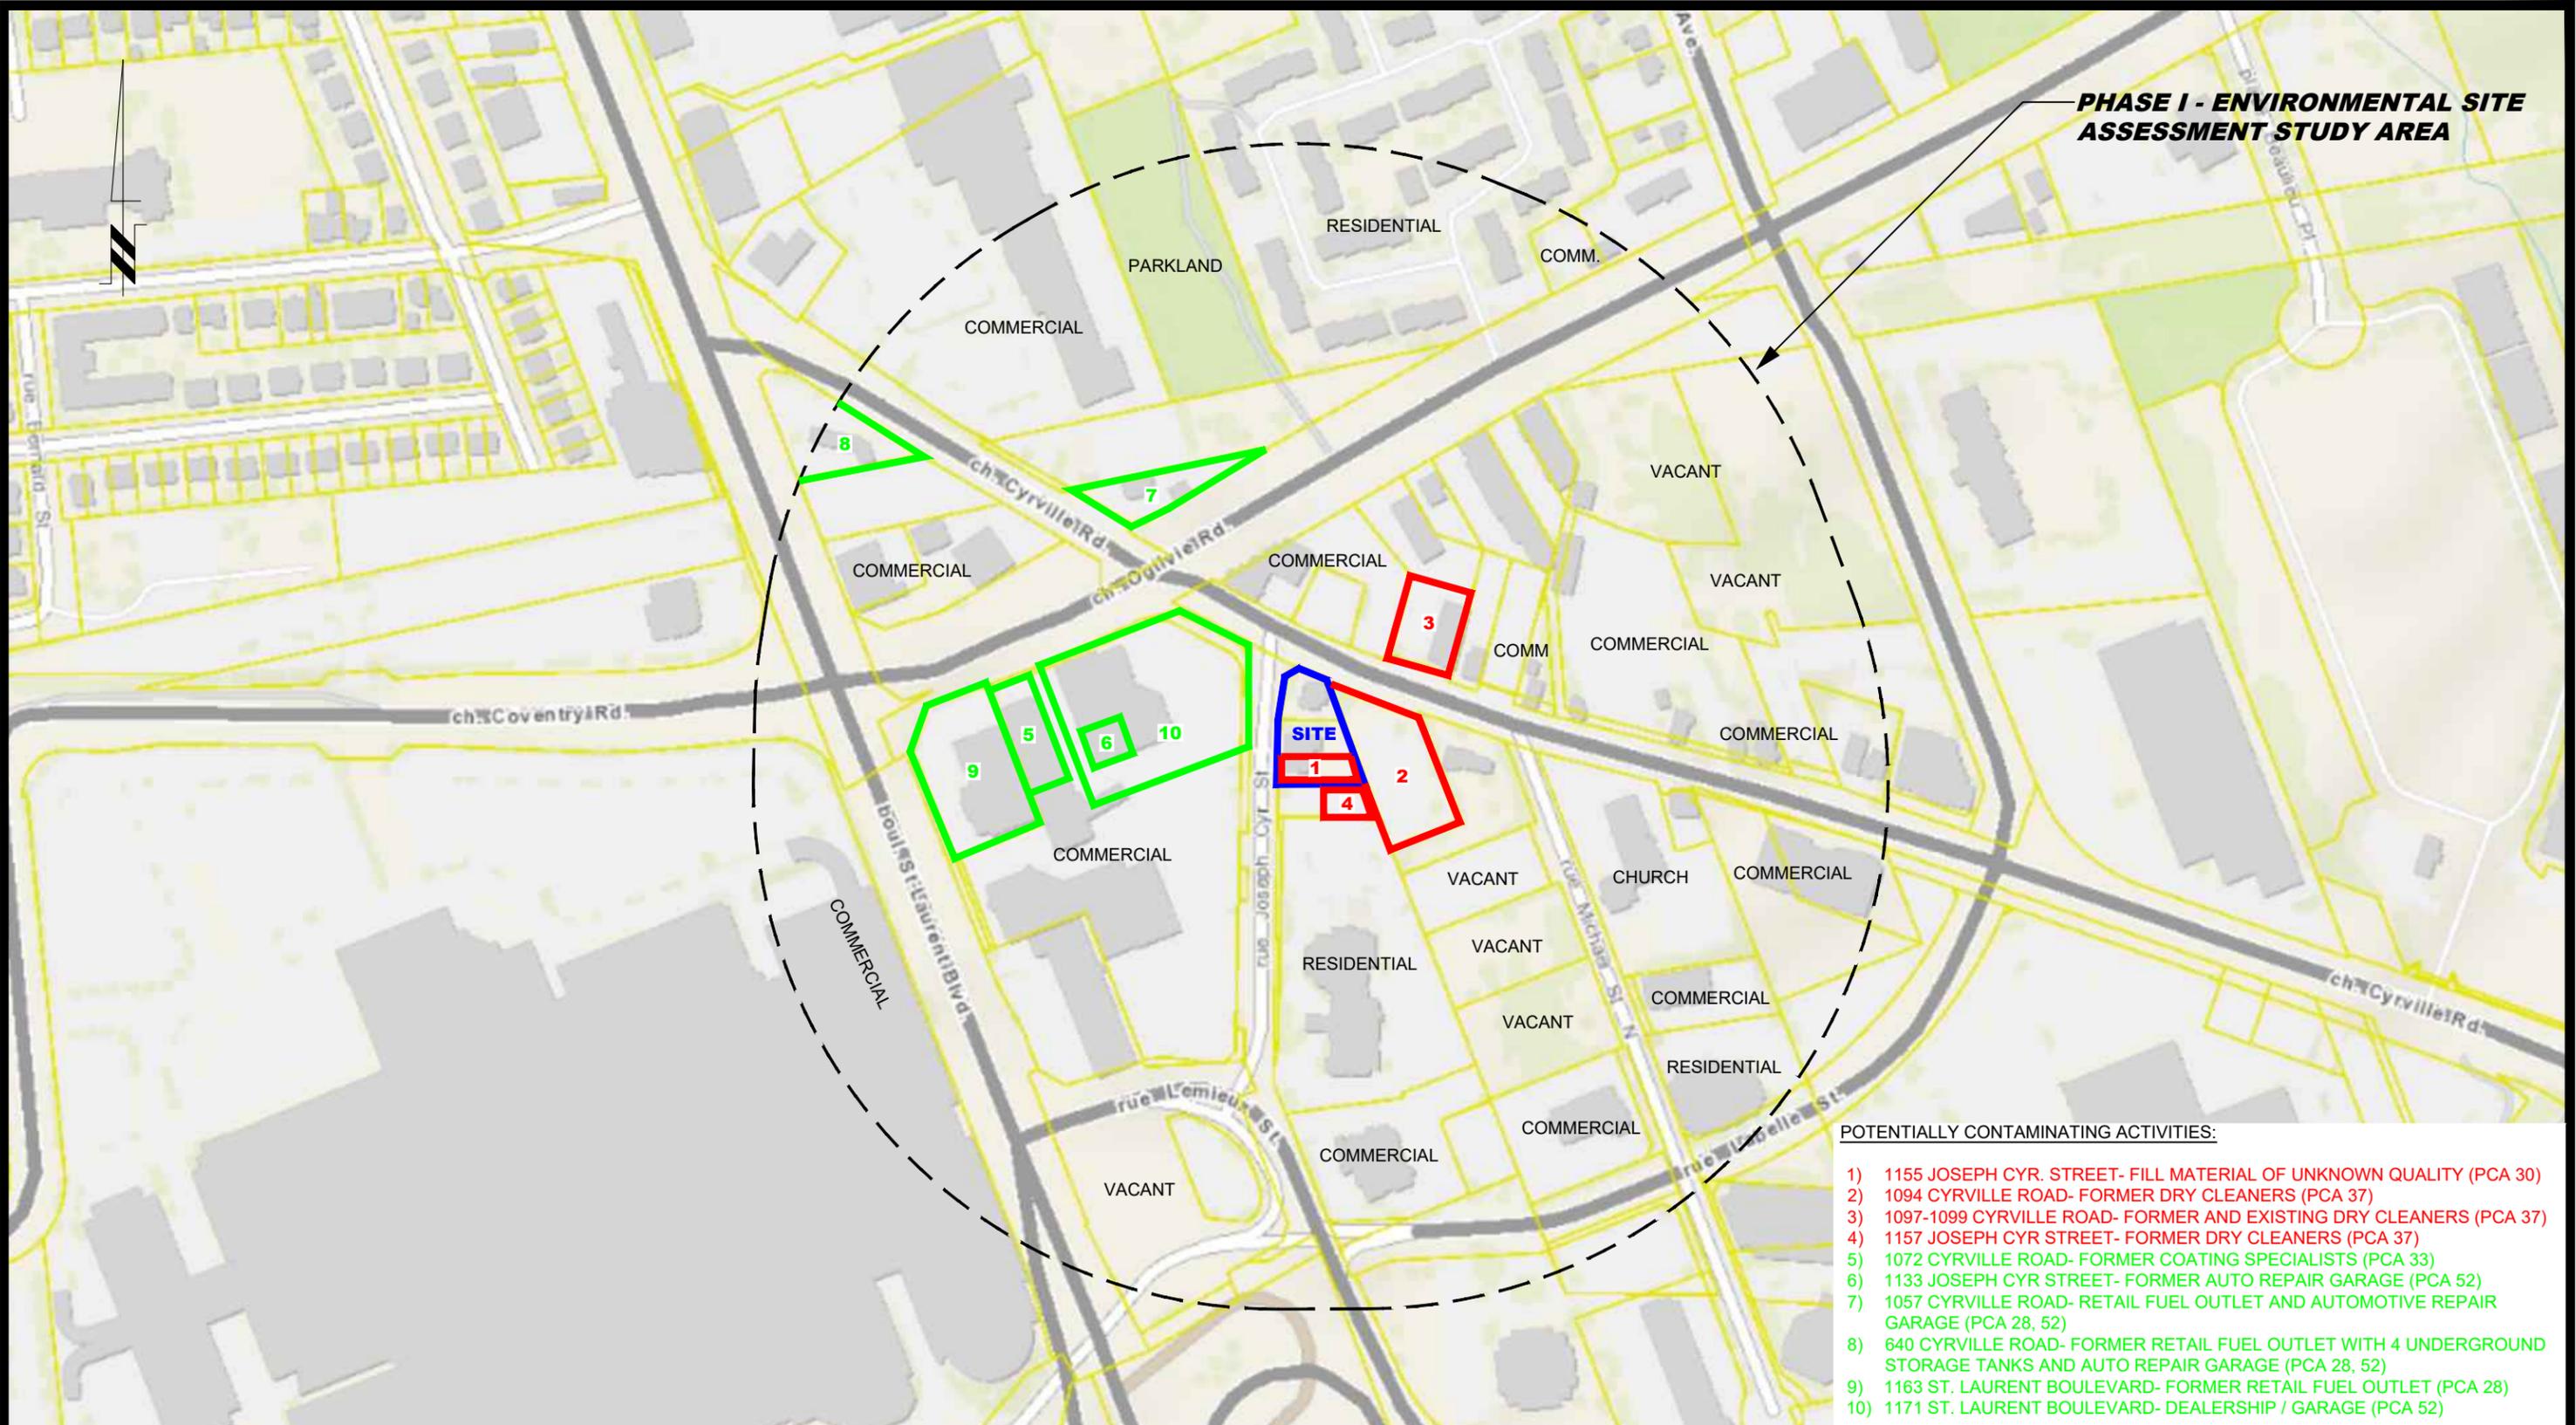
DRAWING PE4967-2 – SURROUNDING LAND USE PLAN

- POTENTIALLY CONTAMINATING ACTIVITIES:**
- 1) 1155 JOSEPH CYR. STREET- FILL MATERIAL OF UNKNOWN QUALITY (PCA 30)
 - 2) 1094 CYRVILLE ROAD- FORMER DRY CLEANERS (PCA 37)
 - 3) 1097-1099 CYRVILLE ROAD- FORMER AND EXISTING DRY CLEANERS (PCA 37)
 - 4) 1157 JOSEPH CYR STREET- FORMER DRY CLEANERS (PCA 37)
 - 5) 1072 CYRVILLE ROAD- FORMER COATING SPECIALISTS (PCA 33)
 - 6) 1133 JOSEPH CYR STREET- FORMER AUTO REPAIR GARAGE (PCA 52)
 - 7) 1057 CYRVILLE ROAD- RETAIL FUEL OUTLET AND AUTOMOTIVE REPAIR GARAGE (PCA 28, 52)
 - 8) 640 CYRVILLE ROAD- FORMER RETAIL FUEL OUTLET WITH 4 UNDERGROUND STORAGE TANKS AND AUTO REPAIR GARAGE (PCA 28, 52)
 - 9) 1163 ST. LAURENT BOULEVARD- FORMER RETAIL FUEL OUTLET (PCA 28)
 - 10) 1171 ST. LAURENT BOULEVARD- DEALERSHIP / GARAGE (PCA 52)

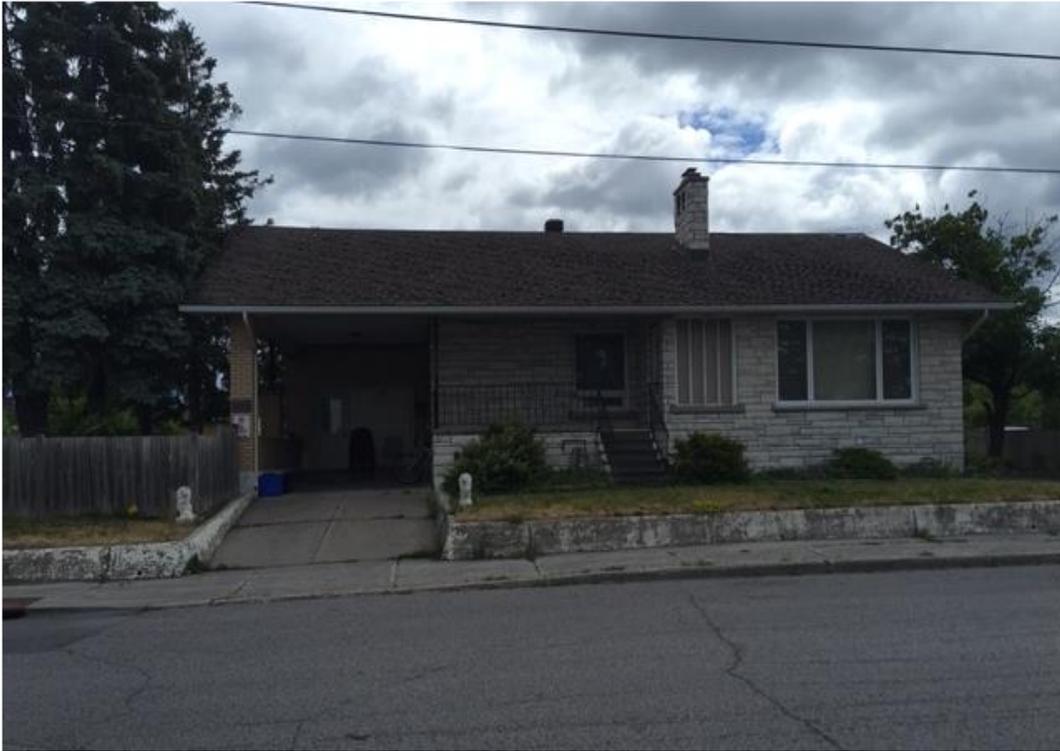
Photograph 1: Residential property addressed 1155 Joseph Cyr Street.

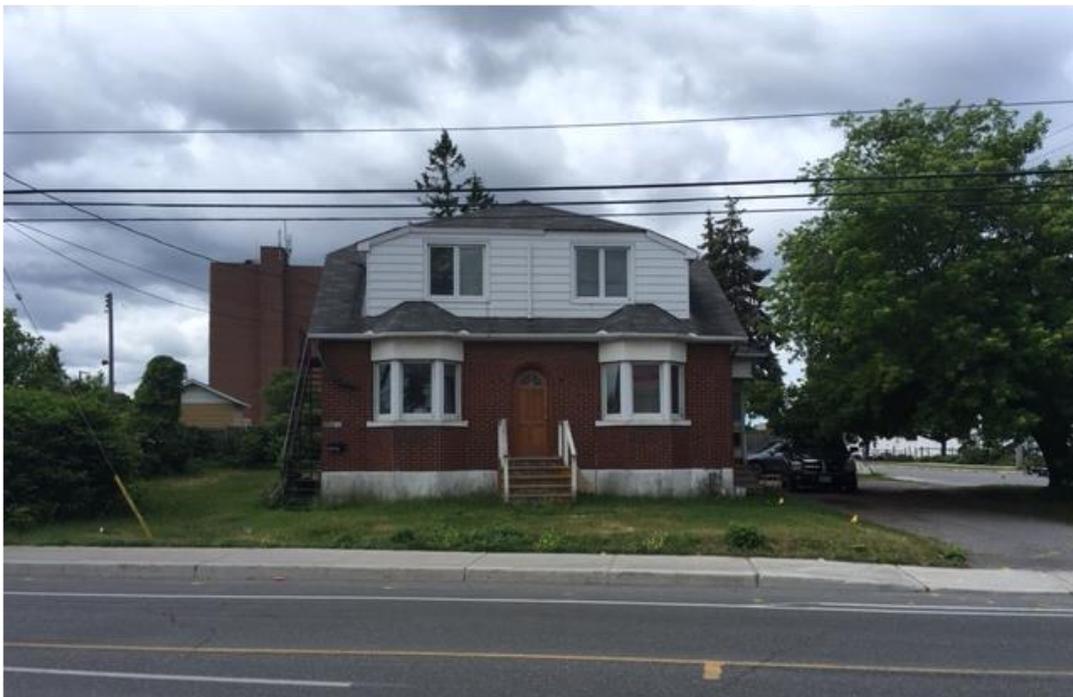
Photograph 2: Residential property addressed 1082 Cyrville Road.
