Phase I - Environmental Site Assessment

20 Mountain Crescent
Ottawa, Ontario

Surface Developments

Report: PE4988-1

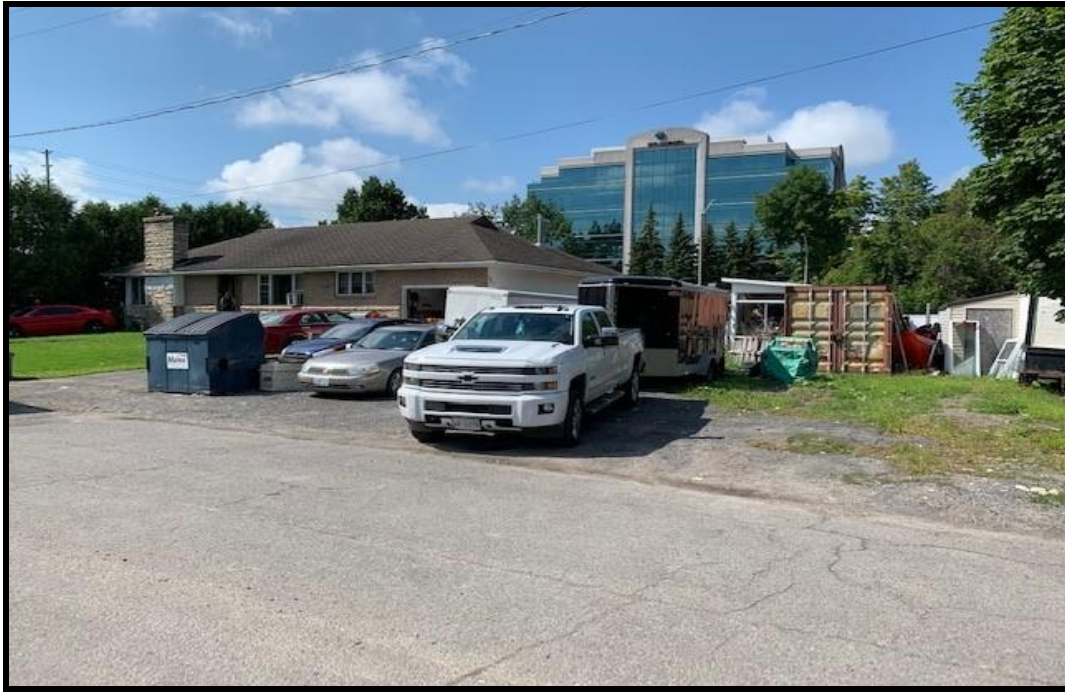
Photograph 1: View of the front of the subject site, facing west from Mountain Crescent.

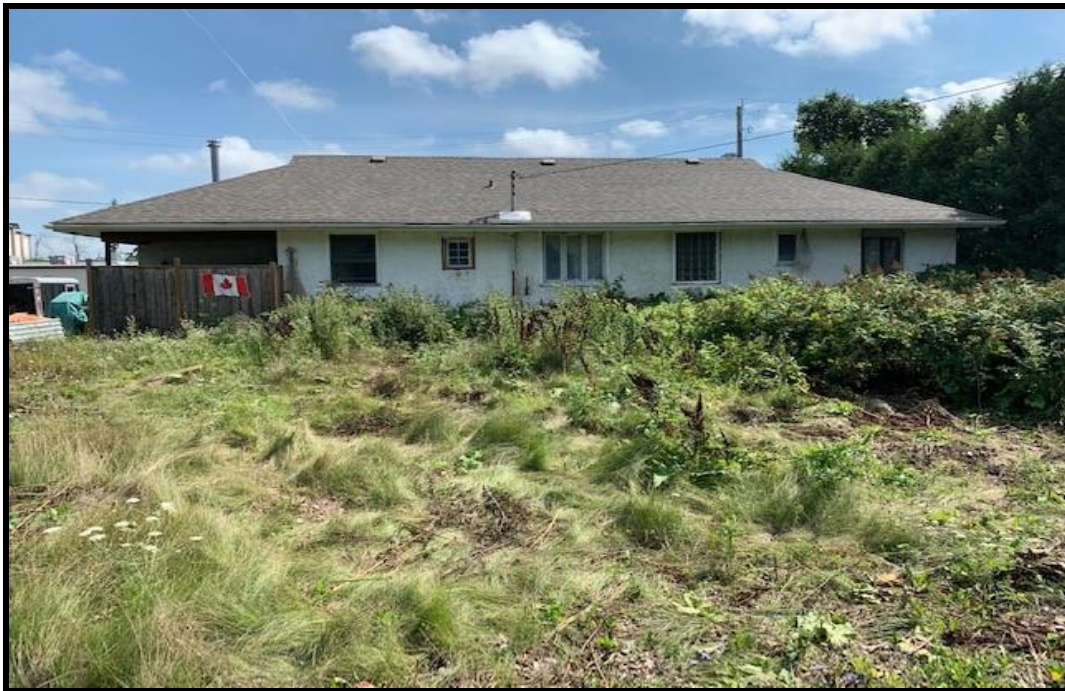
Photograph 2: View of the rear of the subject site, facing east from Dazé Street.

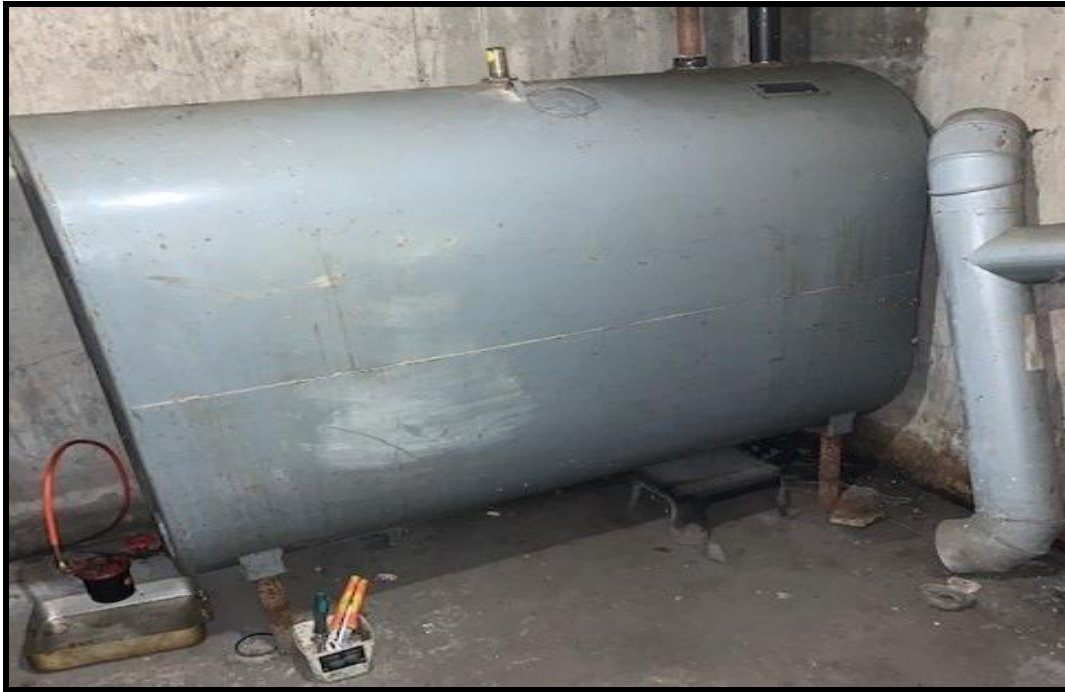
One (1) aboveground furnace oil tank was identified within the basement of the subject building. The tank, manufactured in 2002, was noted to be constructed with a single 2 mm thick steel wall and contained a capacity of 905 L of fuel oil. The tank was noted to be in good condition, with no signs of leaks or stains observed at the time of the site inspection. The underlying floor was observed to consist of poured concrete, which was also noted to be in good condition at the time of the site inspection, with no signs of cracks visible. The presence of this oil tank is not considered to pose an environmental concern to the subject site.

Photograph 3: View of an aboveground furnace oil storage tank, located in the basement of the subject building.

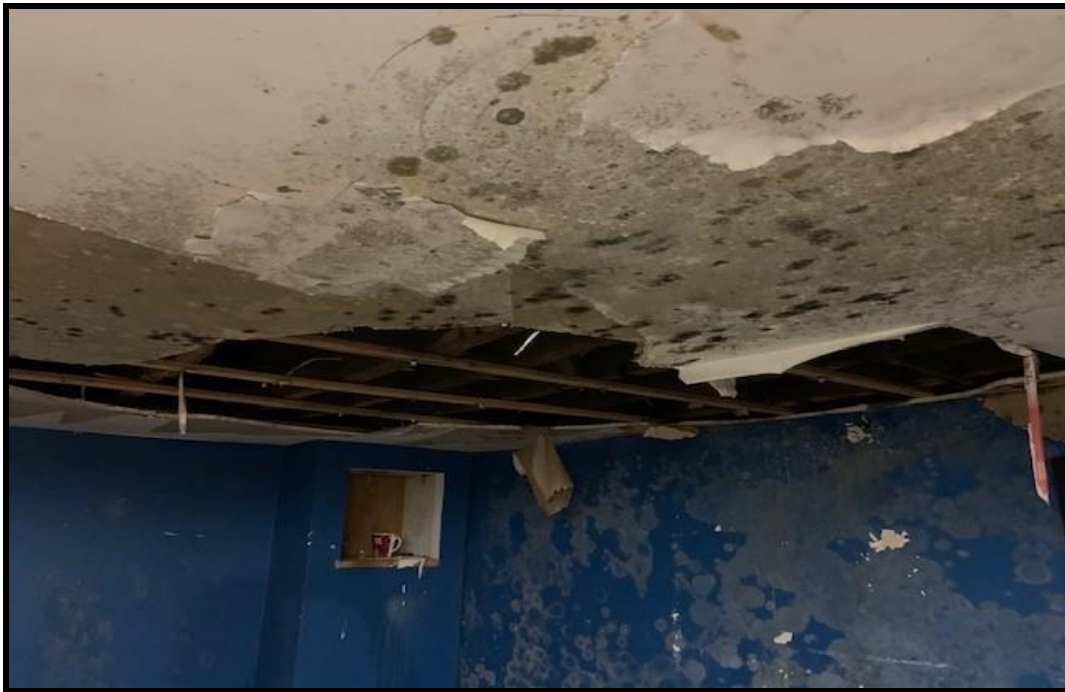
Due to extensive long-term water damage as a result of flooding, the entirety of the basement of the subject building was observed to contain a substantial amount of mould growth on the walls and ceilings, posing a potential health hazard to the occupants of the residence. A mould assessment and abatement program should be initiated immediately, including assessing the risk to the occupants of the residence. The basement should not be utilized without proper personal protective equipment.

Photograph 4: View of water damage and mould growth, located in the basement of the subject building.

Due to extensive long-term water damage as a result of flooding, the entirety of the basement of the subject building was observed to contain a substantial amount of mould growth on the walls and ceilings, posing a potential health hazard to the occupants of the residence. A mould assessment and abatement program should be initiated immediately, including assessing the risk to the occupants of the residence. The basement should not be utilized without proper personal protective equipment. Furthermore, efforts should be made to identify the source of the basement moisture and flooding issues, so that it can be rectified as soon as possible.
