TREE CONSERVATION REPORT

20 Mountain Crescent

Tree Conservation Report submitted as Partial
Requirements for a Site Plan Control Application,
November 23, 2020

Address: 20 Mountain Crescent
Date: November 23, 2020
Prepared by: Astrid Nielsen, RPF, ISA Certified Arborist ®
Prepared for: Jakub Ulak B.Arch, MRAIC, President, Surface Condos
Site Visit: November 13, 2020

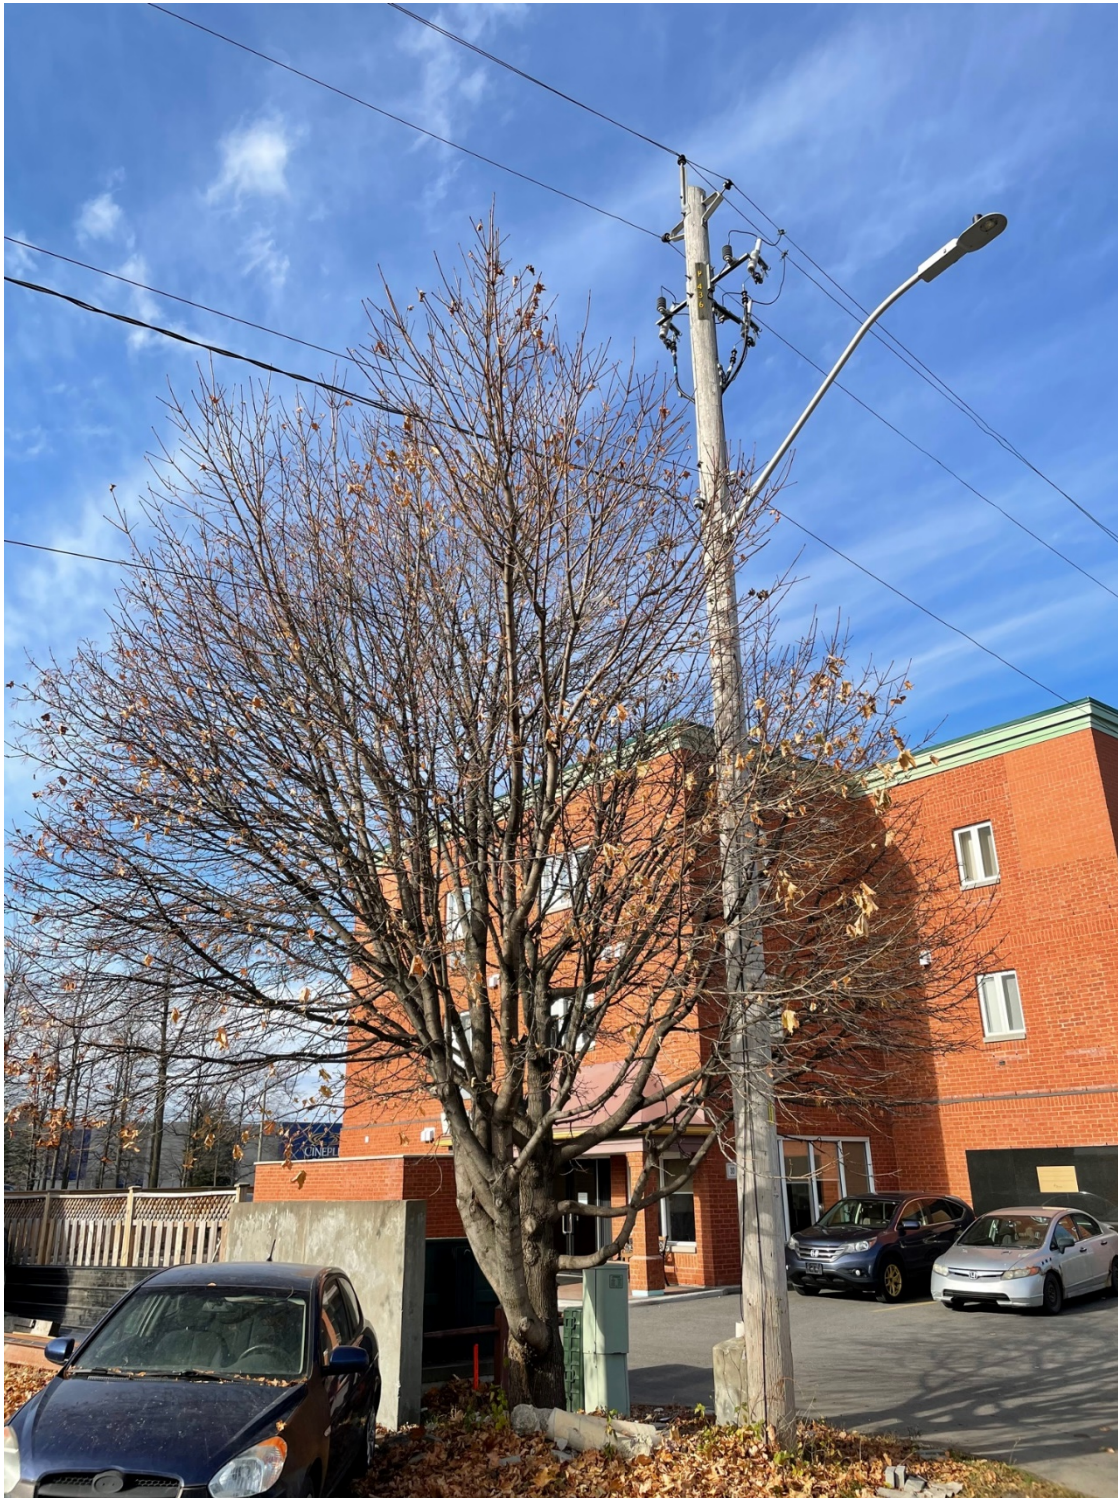
Tree 1 is a city-owned, multi-stemmed Norway maple that is on the edge of the proposed laneway for the parking area on the Mountain Crescent side of the building. This tree is in fair condition that has undergone successive hydro pruning. The roots will be severed along the south side of this tree which will impact the structural integrity of this tree, and removal is recommended. Because this tree is located on city property, permission from the city is required for removal.

Figure 1: Tree 1 - City-owned Norway maple along Mountain Crescent to be removed

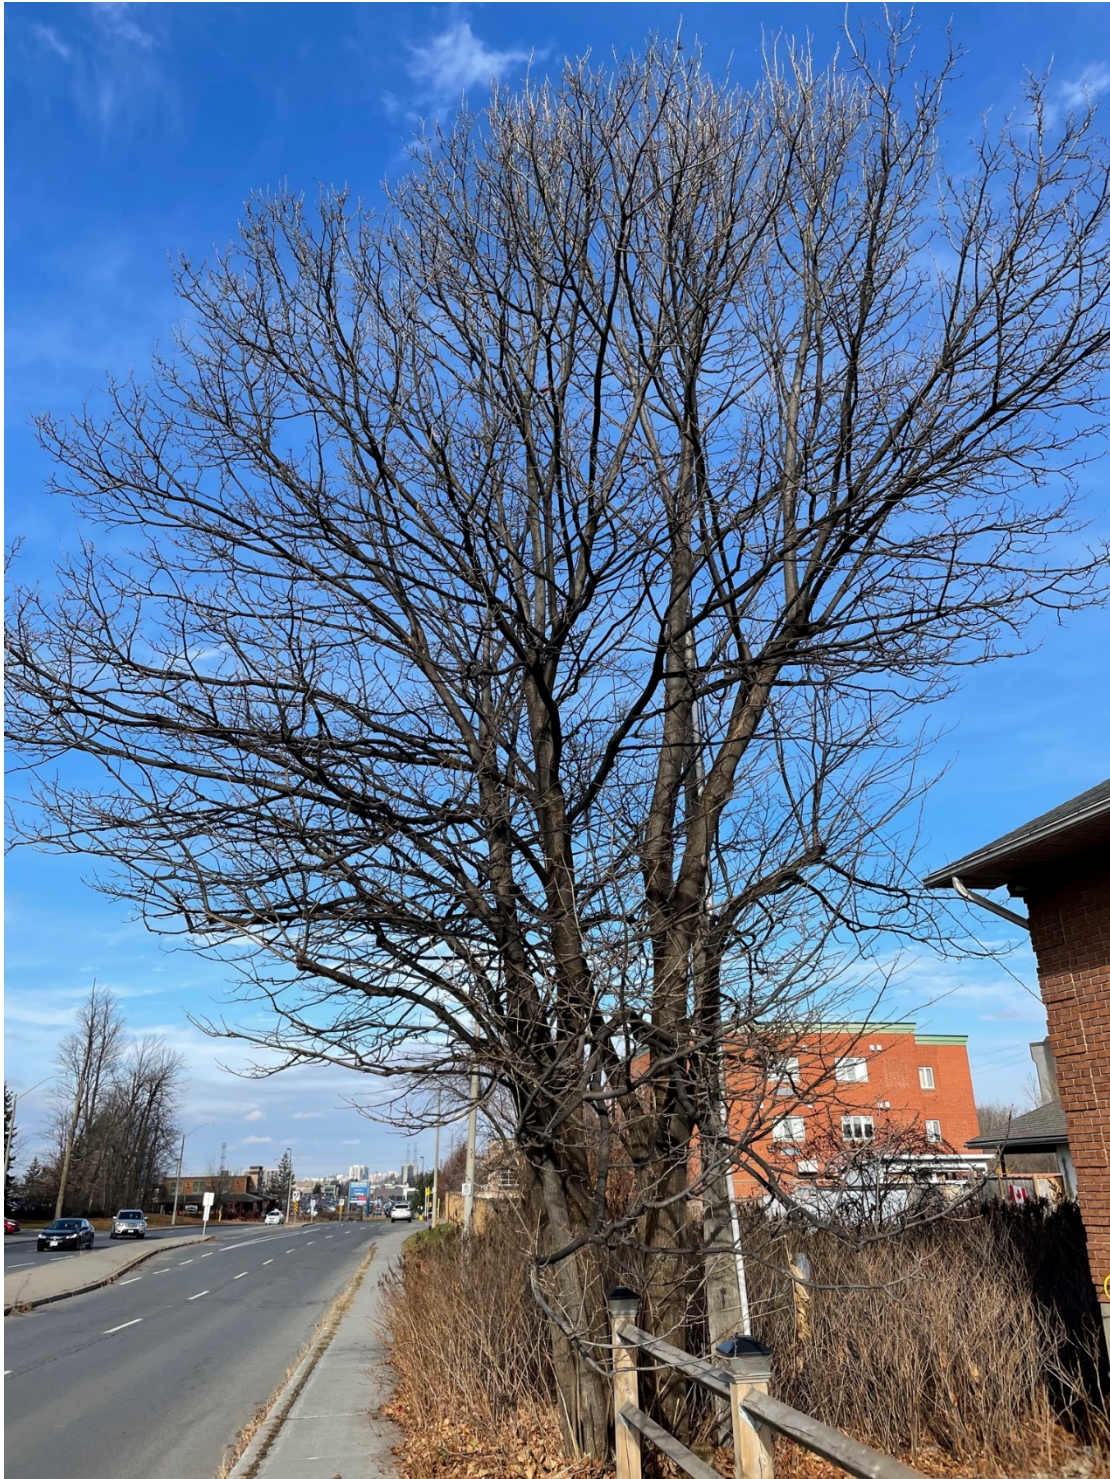
Tree 2 is a city-owned basswood tree in the right of way along Daze St, in front of the neighbouring property at 1 Mountain Crescent. This tree is in fair condition with many stems as it likely grew from sprouts which is a common growth characteristic for species. This tree will be impacted by the proposed construction with the installation of the interlocking pathway proposed within the critical root zone, approximately 3 m from the tree. When installing the pathway, the following mitigation measures are recommended to reduce the impact to the tree roots:

Figure 2: Tree 2 - city-owned basswood along Daze St to be retained

- Avoid tearing of the roots. If the roots do tear, they should be pruned with a clean cut to increase the likelihood of sealing properly and reduce the risk of pathogens from entering the tree.

-
- Roots should not be left exposed and be covered with soil as quickly as possible, or temporarily with a moist, organic material such as mulch and/or burlap
