**Tree Conservation Report
Proposed Commercial Development
1265 Teron Road
Ottawa (Kanata), Ontario**

December 8, 2020
Project: 64742.02 - V03

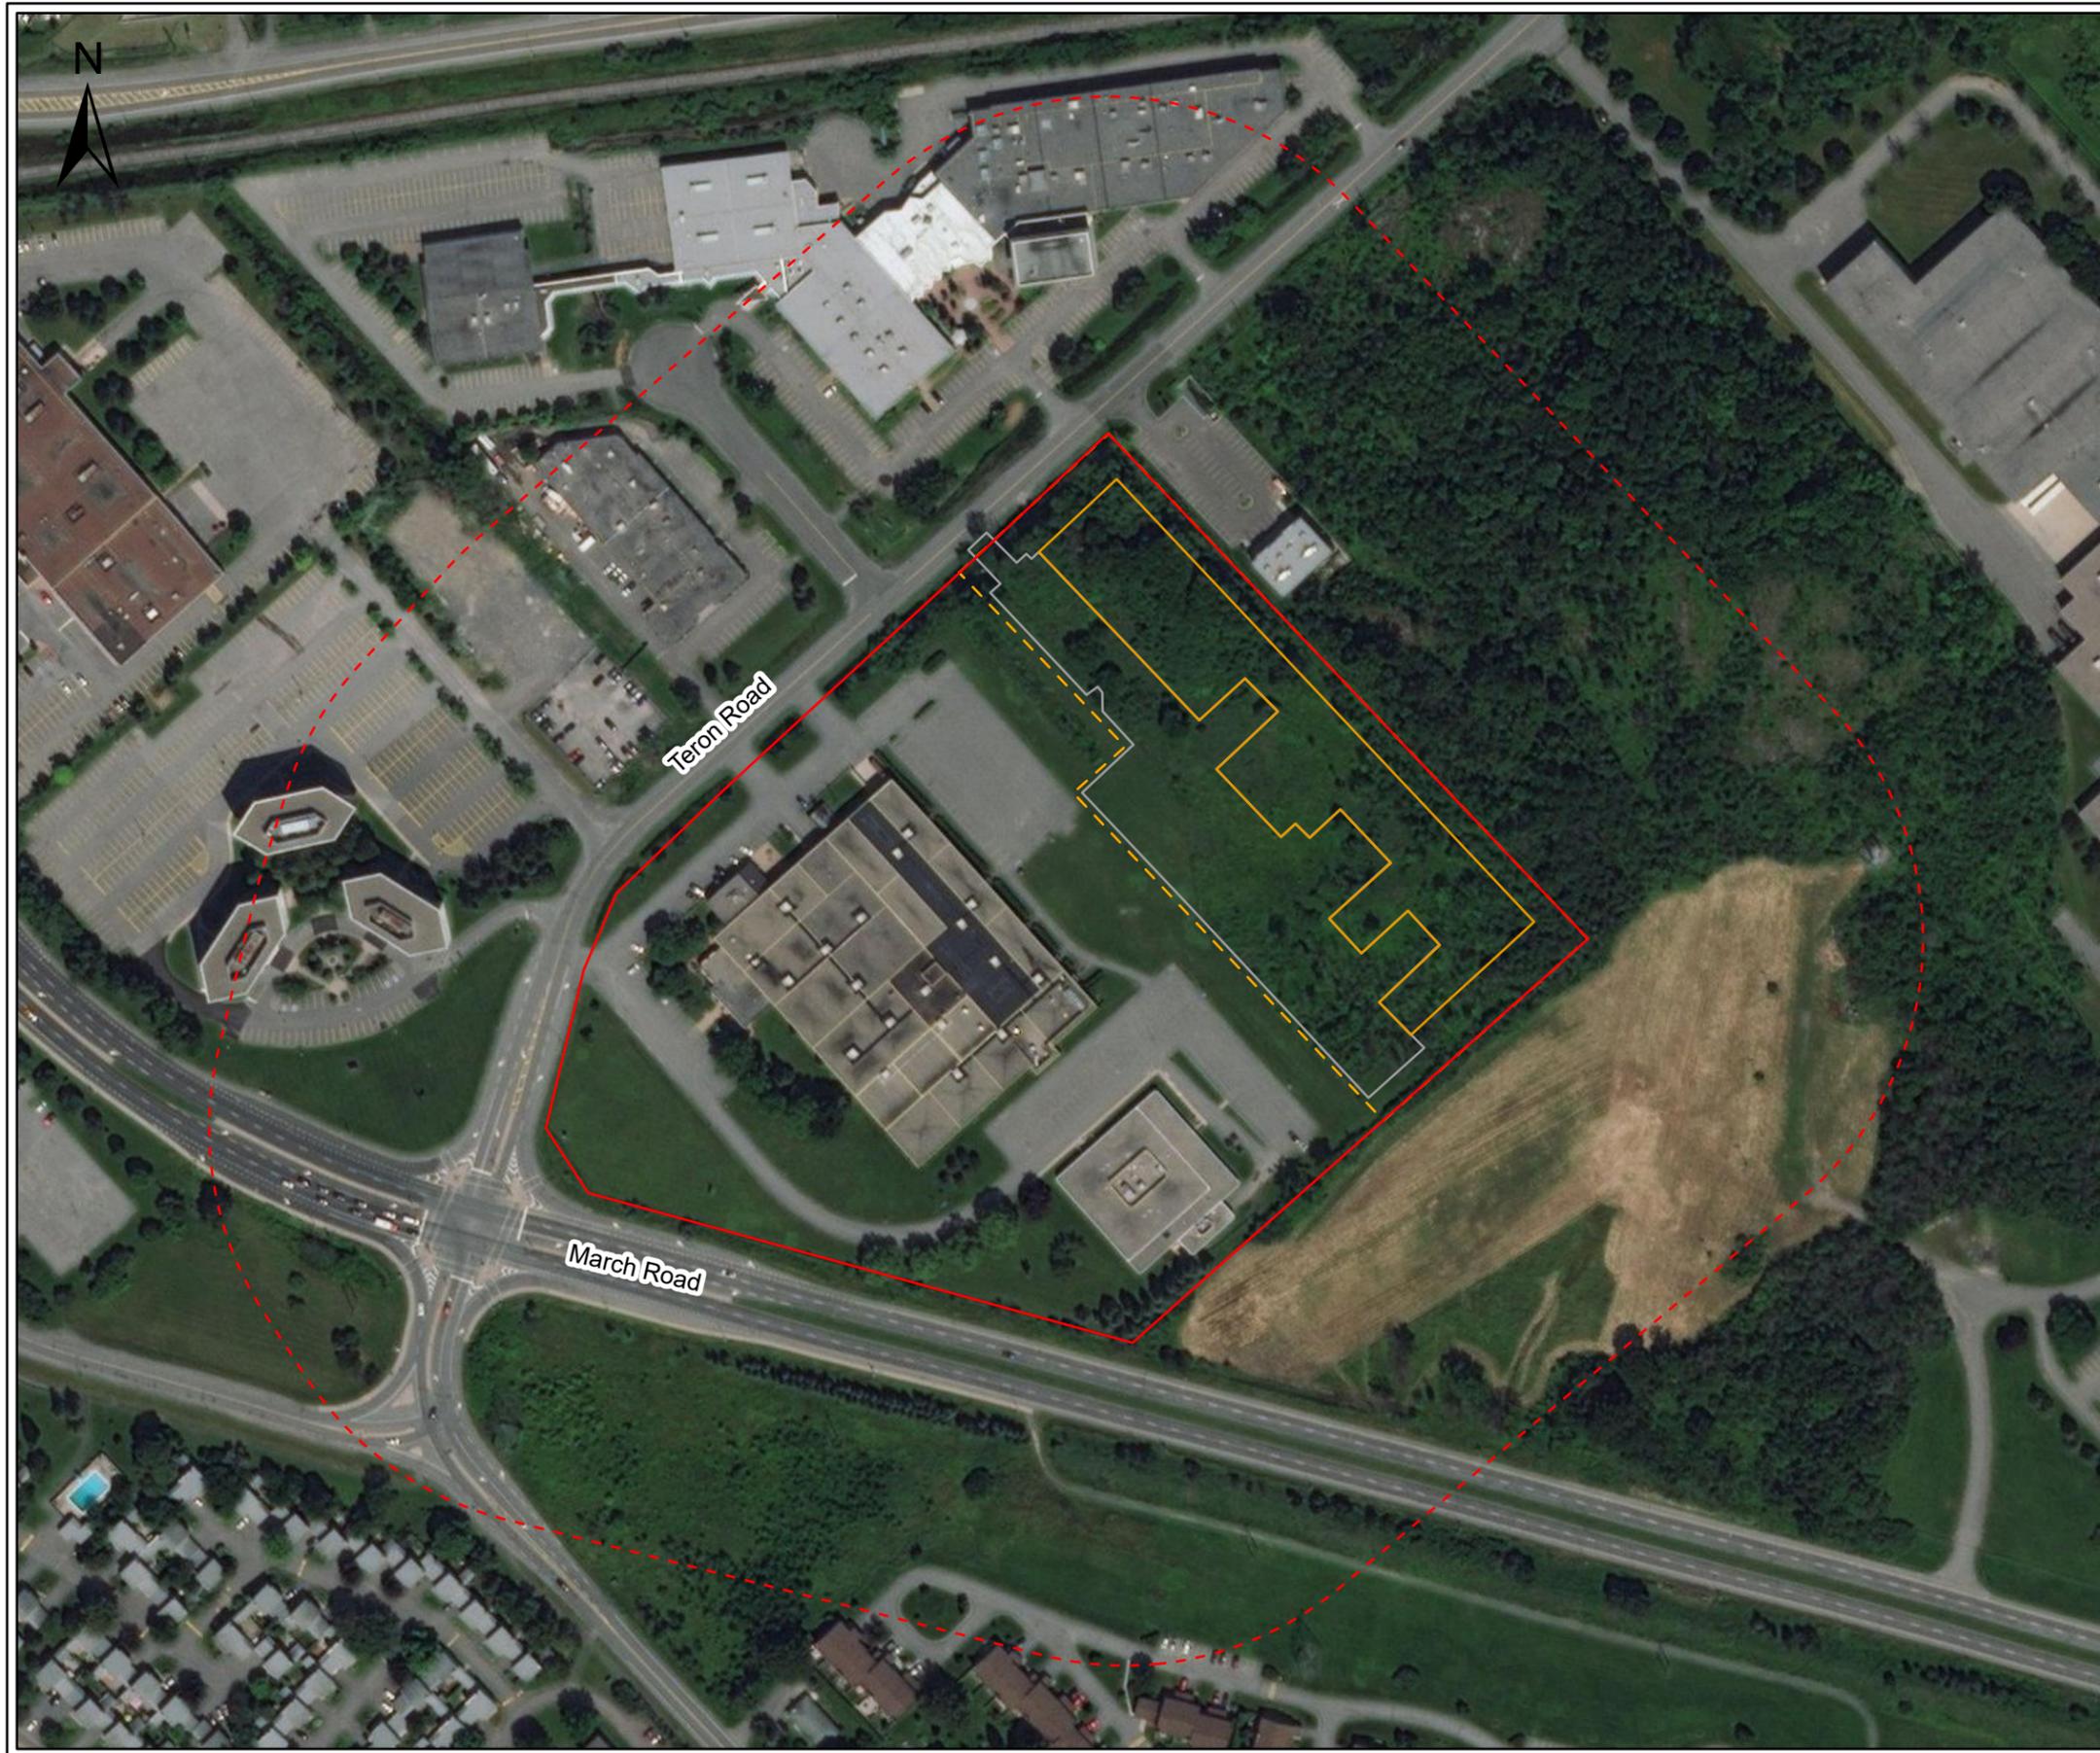
Date: September 2019	Rev. 0	Figure: A.2
© Queen's Printer for Ontario

- Study Area
- Property Boundary
- Proposed Development
- Proposed Severance
- Proposed Parking Lot

The proposed development concept includes the creation of an 9,281m² commercial building, with an 8,900 m² parking lot and associated landscaping. A stormwater management pond is proposed for the northeast corner of the property, as illustrated on the Site Servicing and Grading Plan from D. B. Gray Engineering Inc. The existing site layout and proposed development is provided in Figure A.2 in Appendix A.

Based on a review of the information summarized in Section 3.2, Table C.1 in Appendix C and the proposed development concept illustrated on Figure A.2, the following conclusions are provided:

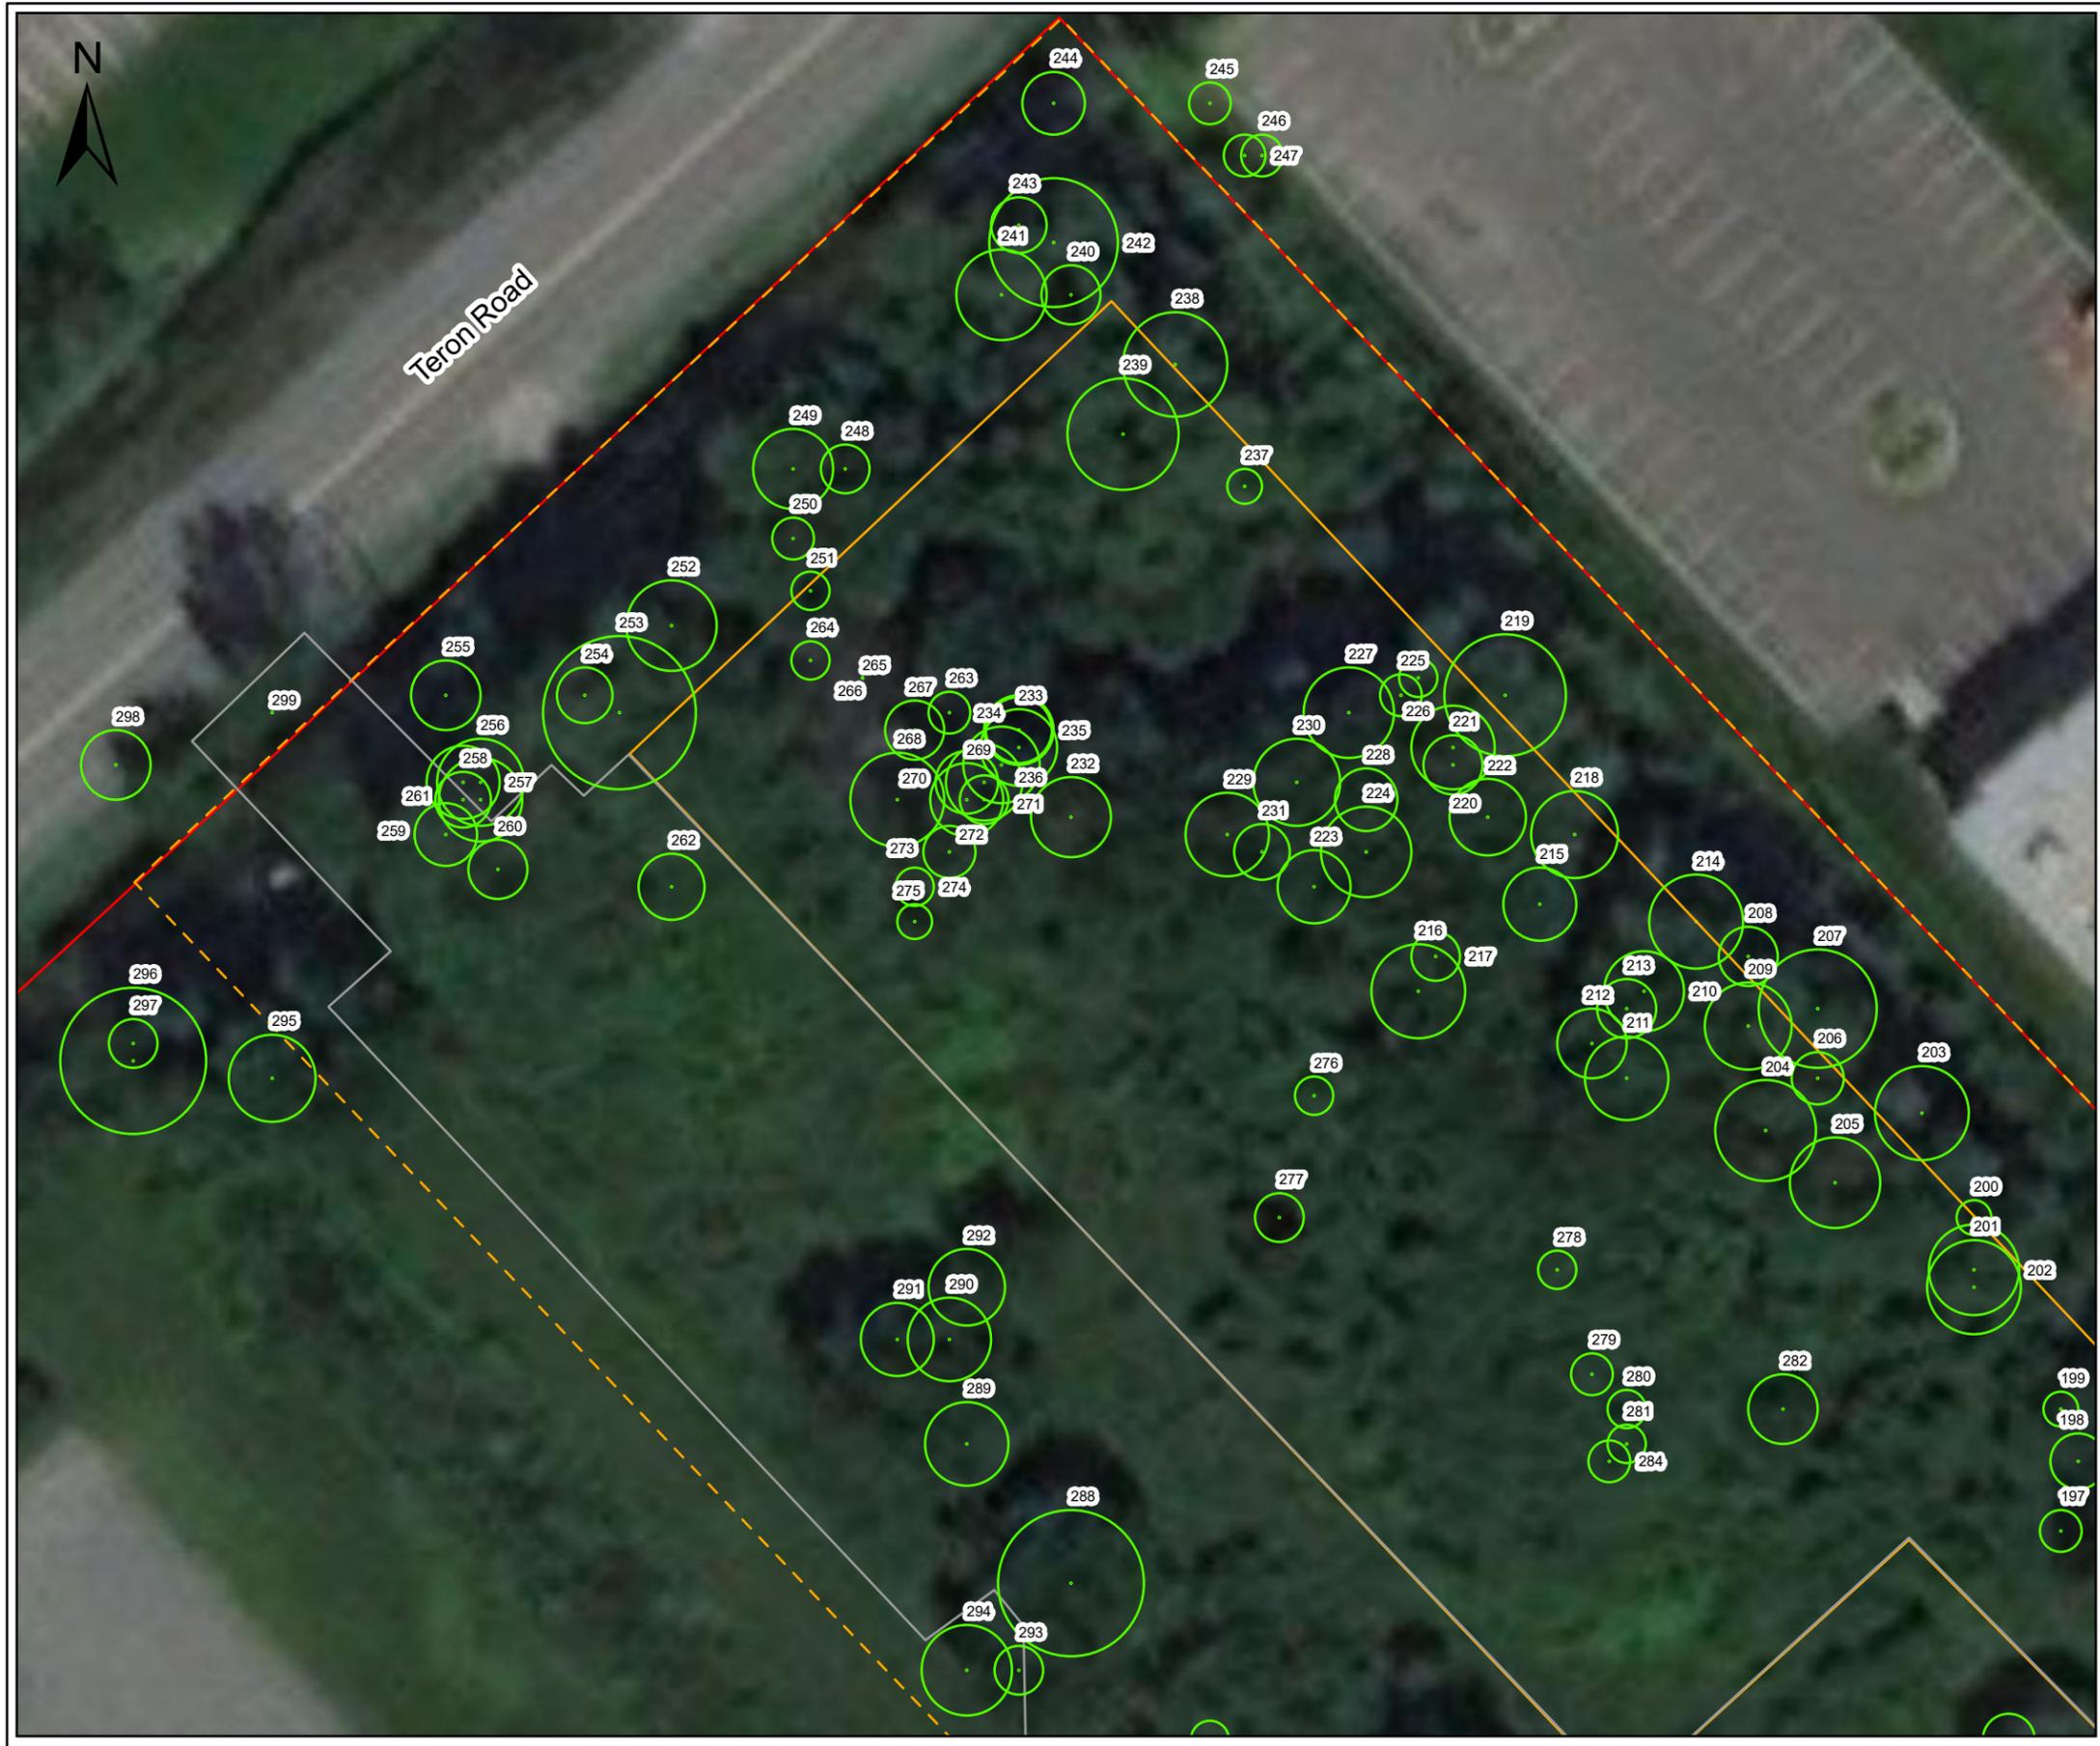
Date: September 2019	Rev.	Figure: A.4
© Queen's Printer for Ontario	0

Tree Number and Critical Root Zone

Note: Critical Root Zone values for all living trees are presented in Table C.1 in Appendix C.

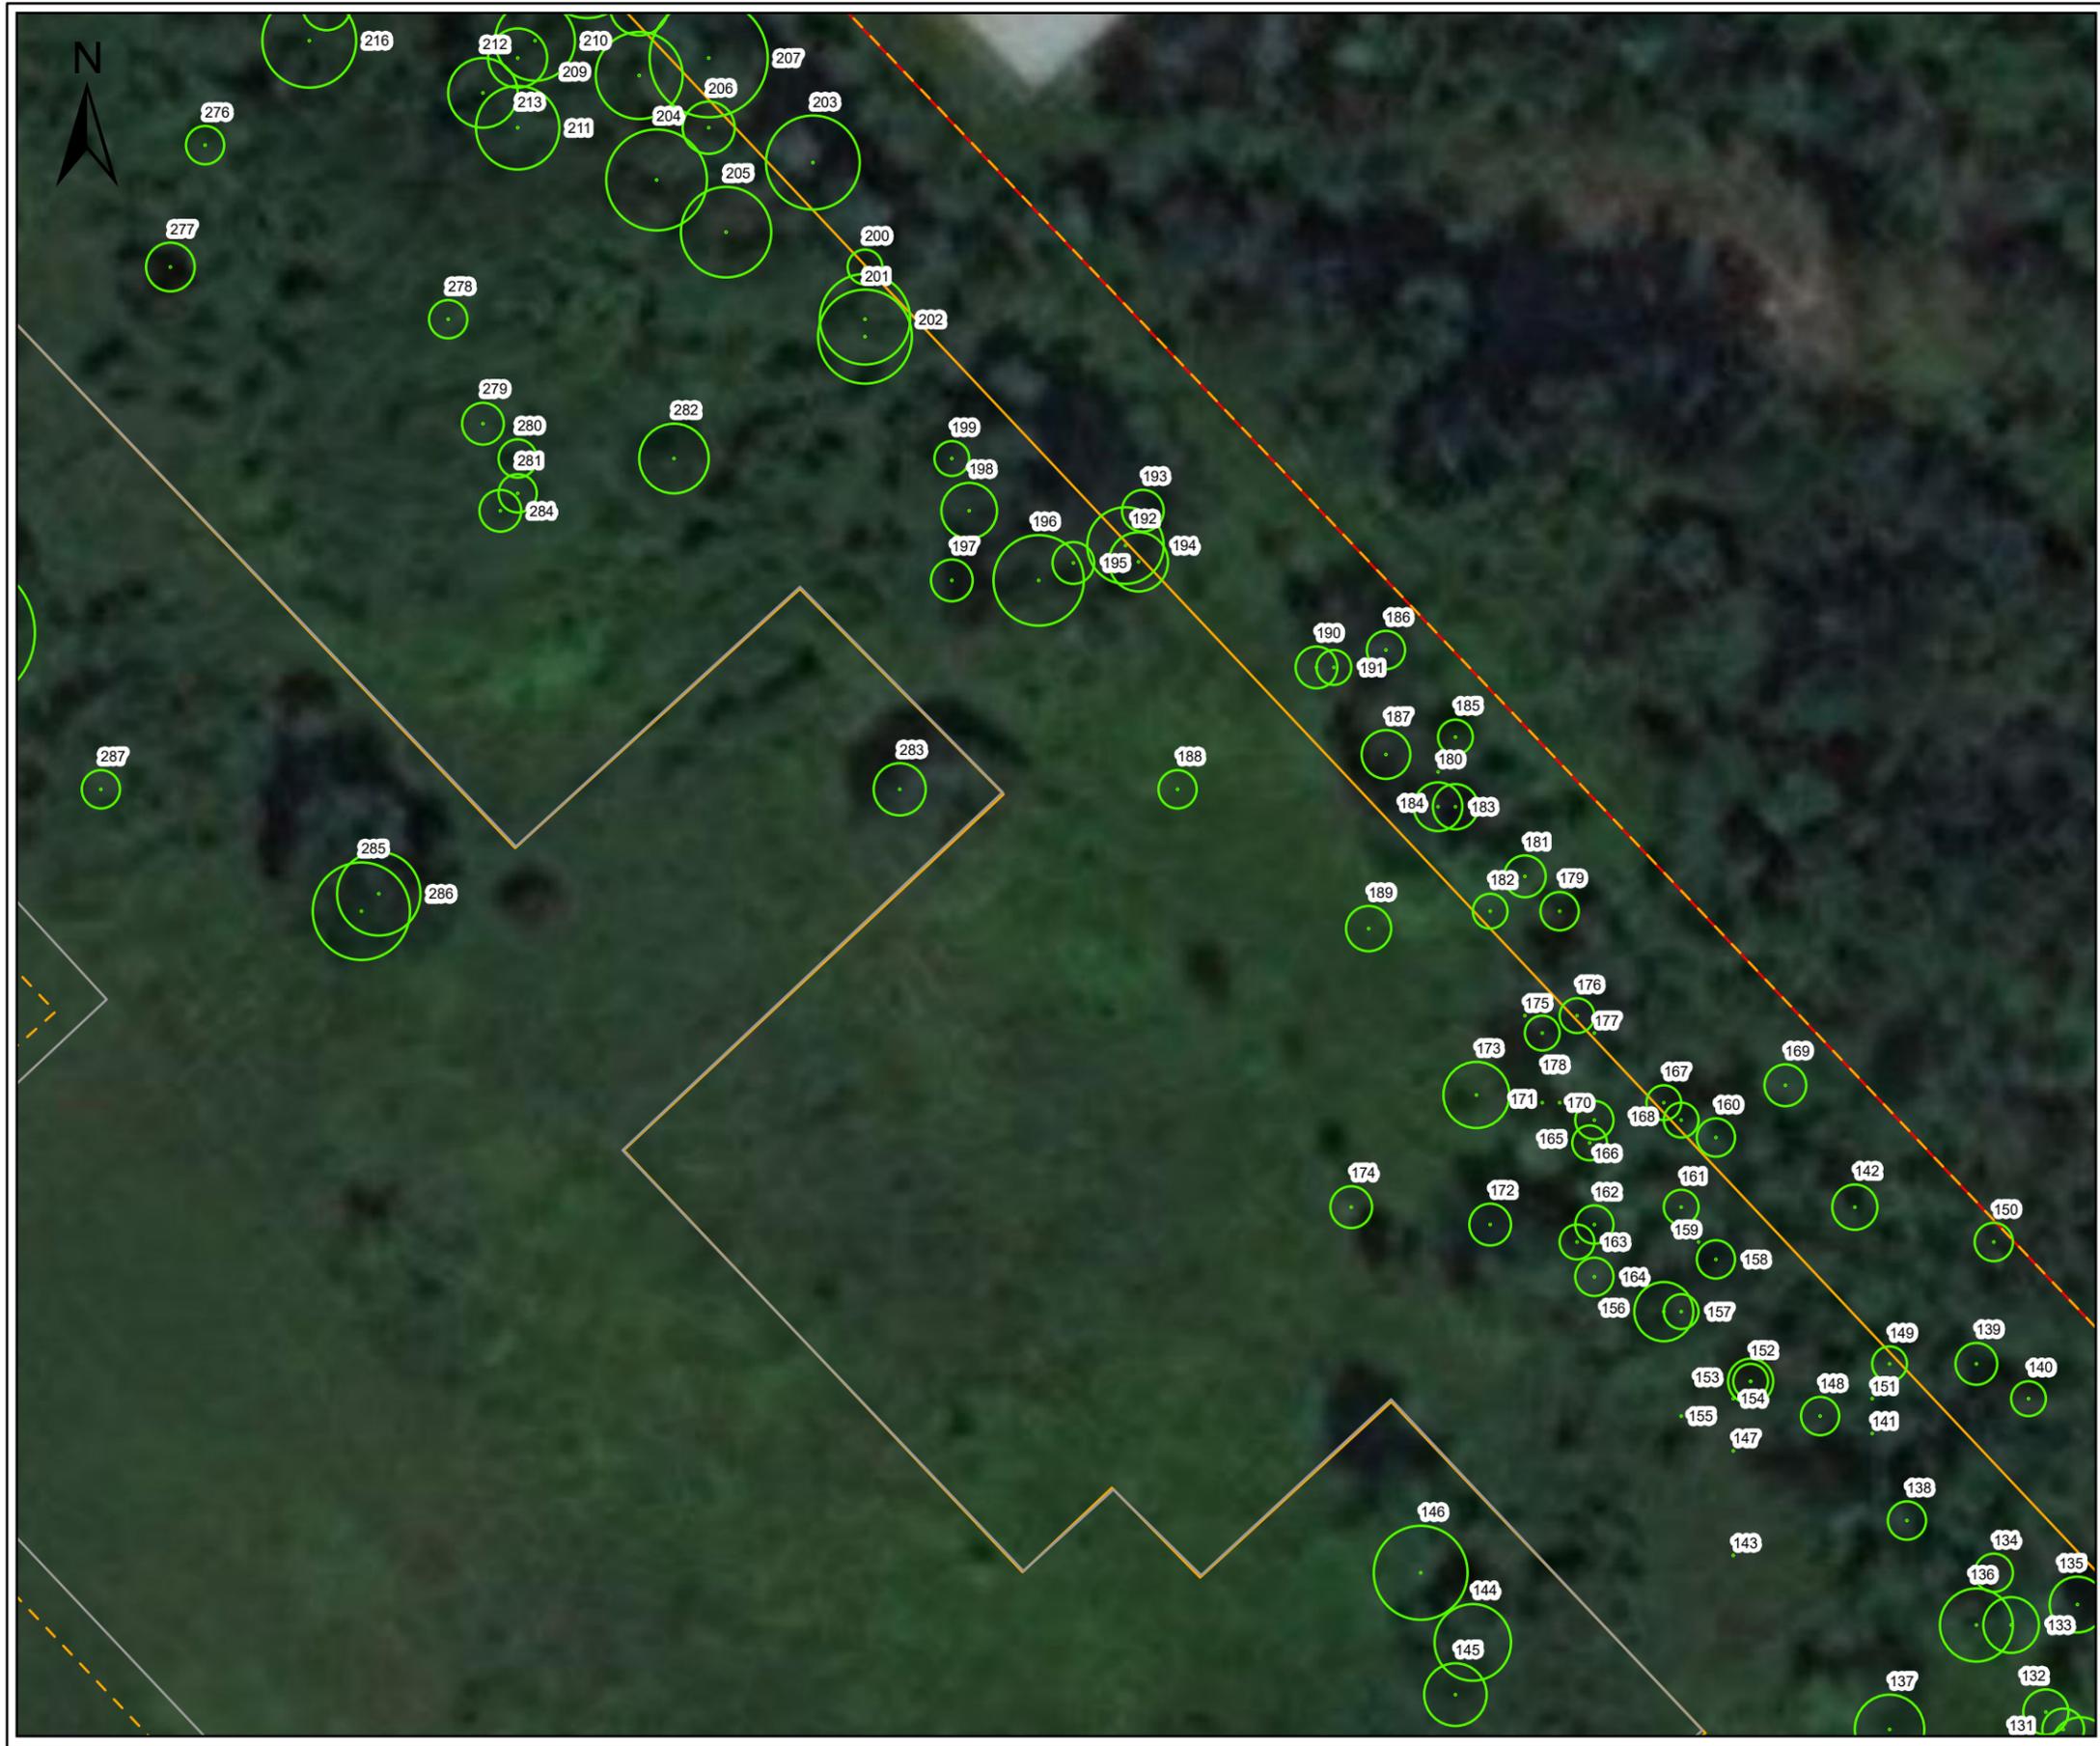
Date: September 2019	Rev. 0	Figure: A.5
© Queen's Printer for Ontario

Tree Number and Critical Root Zone

Note: Critical Root Zone values for all living trees are presented in Table C.1 in Appendix C.

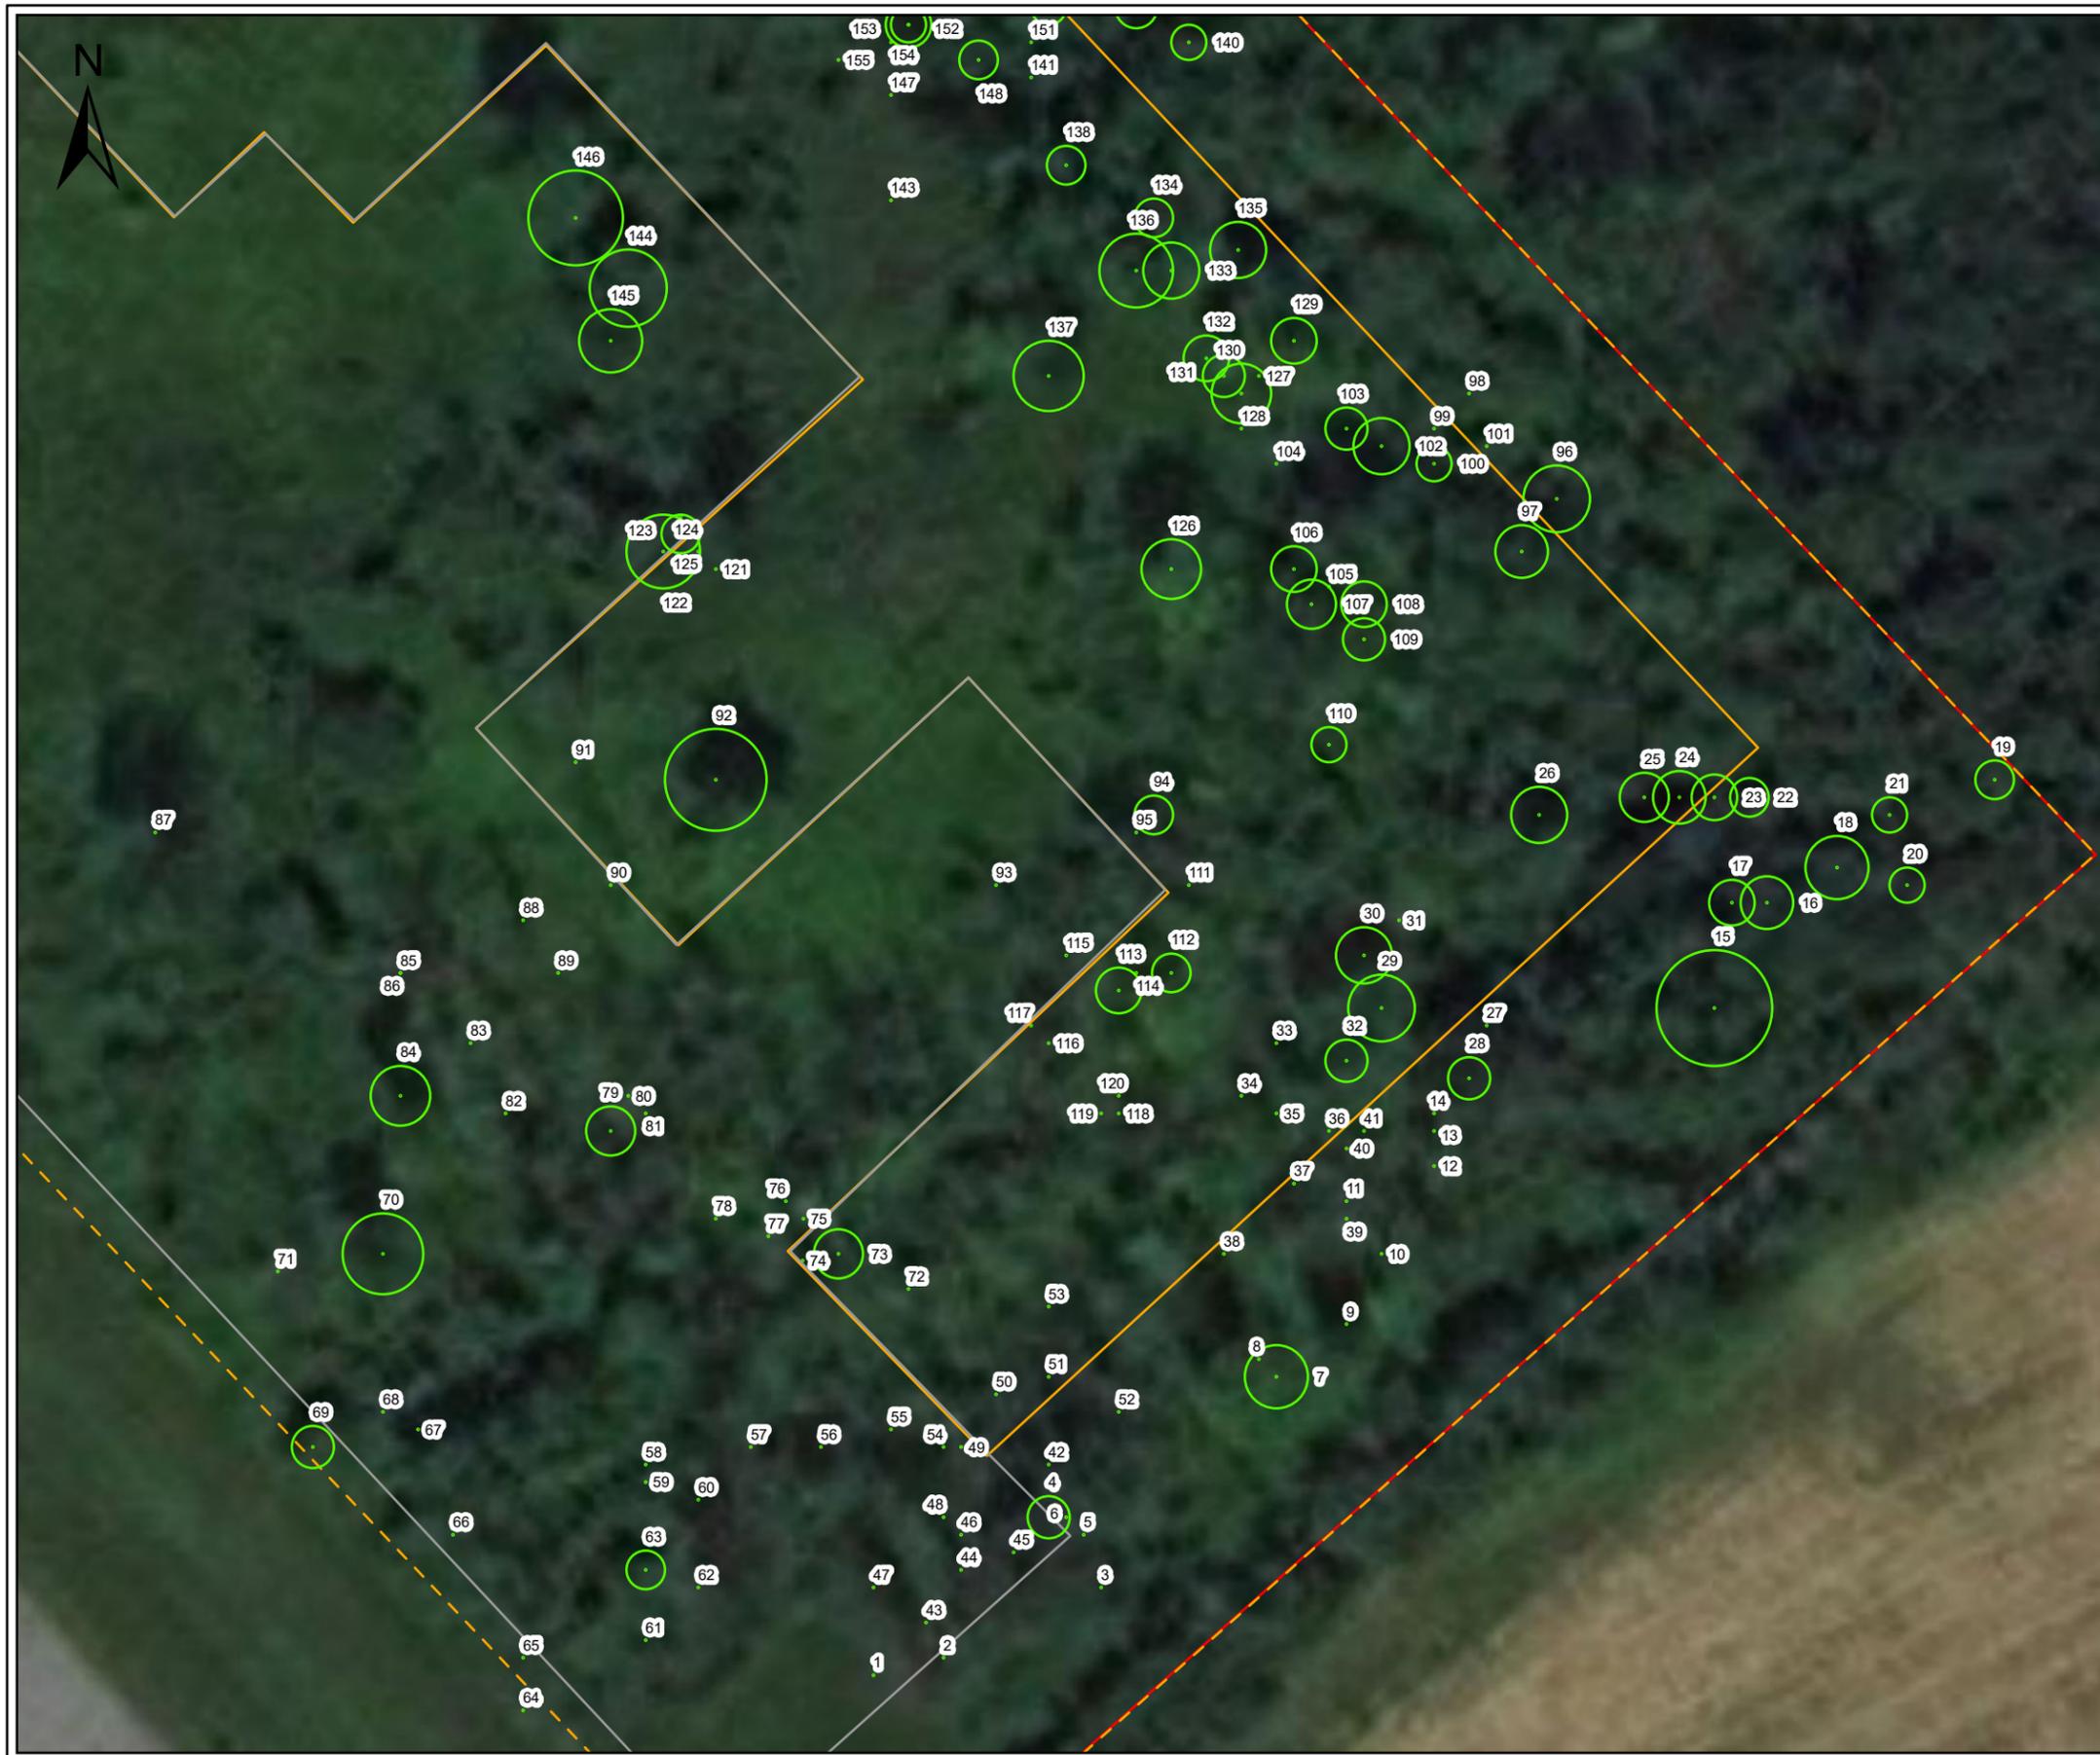
Date: September 2019	Rev. 0	Figure: A.6
----------------------	-----------	--------------------

- Property Boundary
- Proposed Development
- Proposed Severance
- Proposed Parking Lot
- Tree Number and Critical Root Zone

Note: Critical Root Zone values for all living trees are presented in Table C.1 in Appendix C.

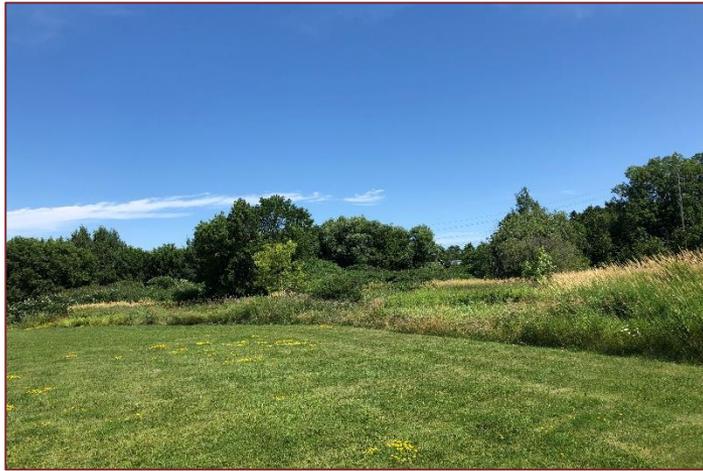
Site Photograph 1 – Cultural Meadow (CUM)

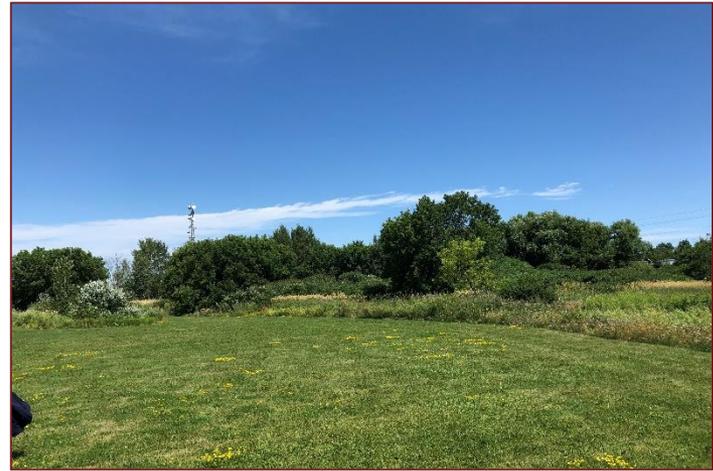
Site Photograph 2 – Cultural Meadow (CUM)

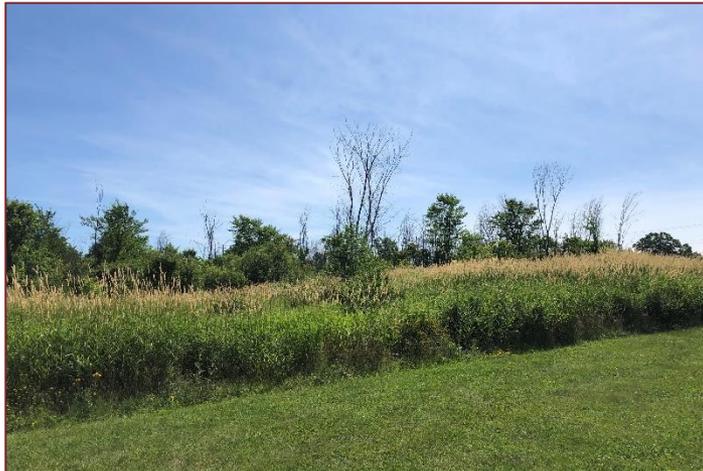
Site Photograph 3 – Cultural Meadow (CUM) with Cultural Woodland (CUW) in Background

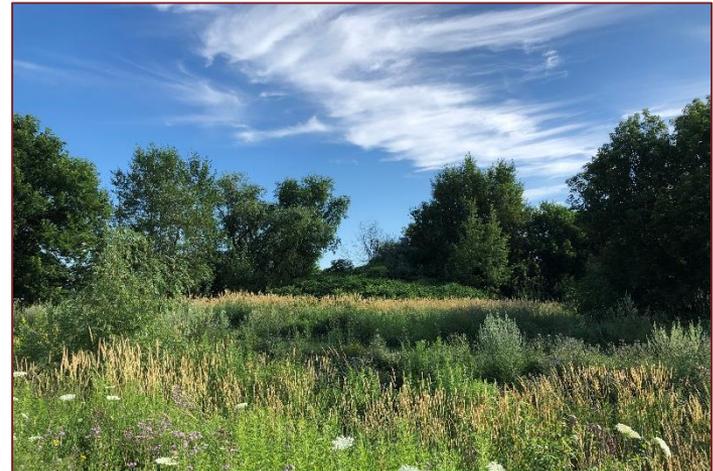
Site Photograph 4 – Cultural Meadow (CUM) with Sumac Cultural Thicket (CUT1-1) and Cultural Woodland (CUW) in Background

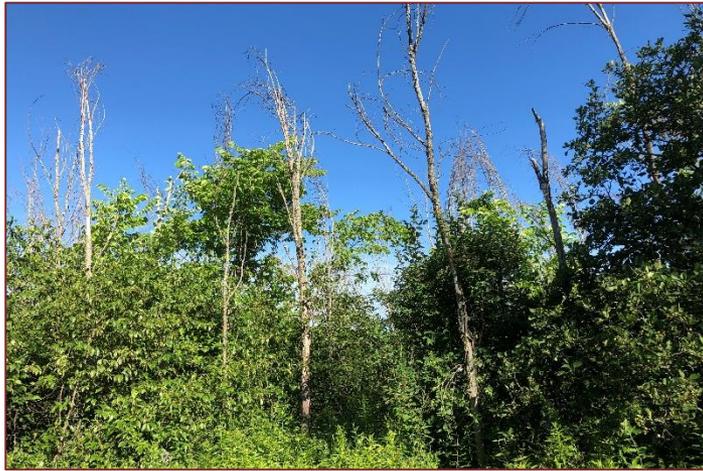
Site Photograph 5 – Cultural Woodland (CUW)
with Dead Ash Trees

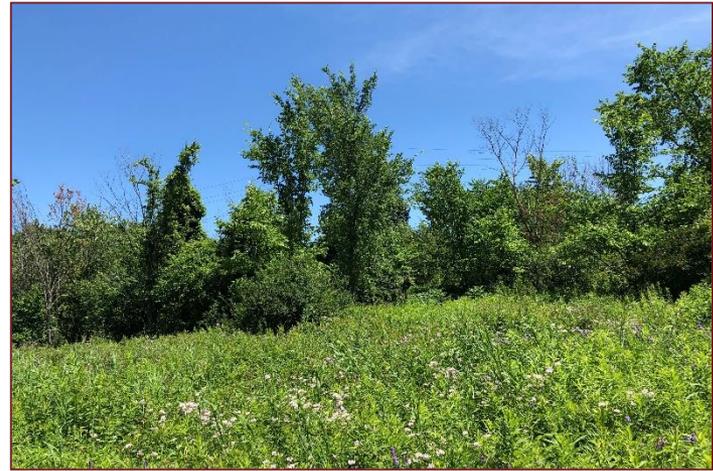
Site Photograph 6 – Cultural Woodland (CUW)

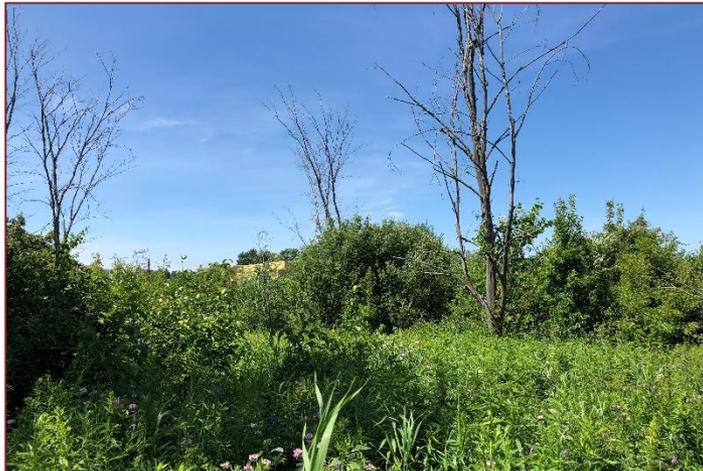
Site Photograph 7 – Cultural Woodland (CUW)

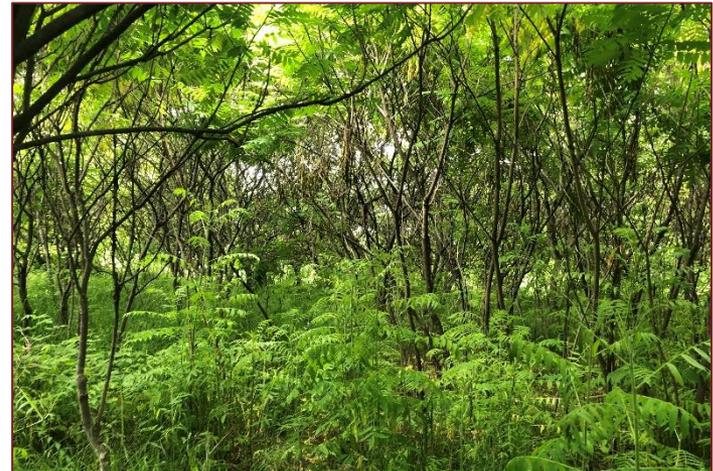
Site Photograph 8 – Sumac Cultural Thicket
(CUT1-1)
