ENVIRONMENTAL IMPACT STATEMENT

210 & 220 MAPLE CREEK COURT, CITY OF OTTAWA, ONTARIO

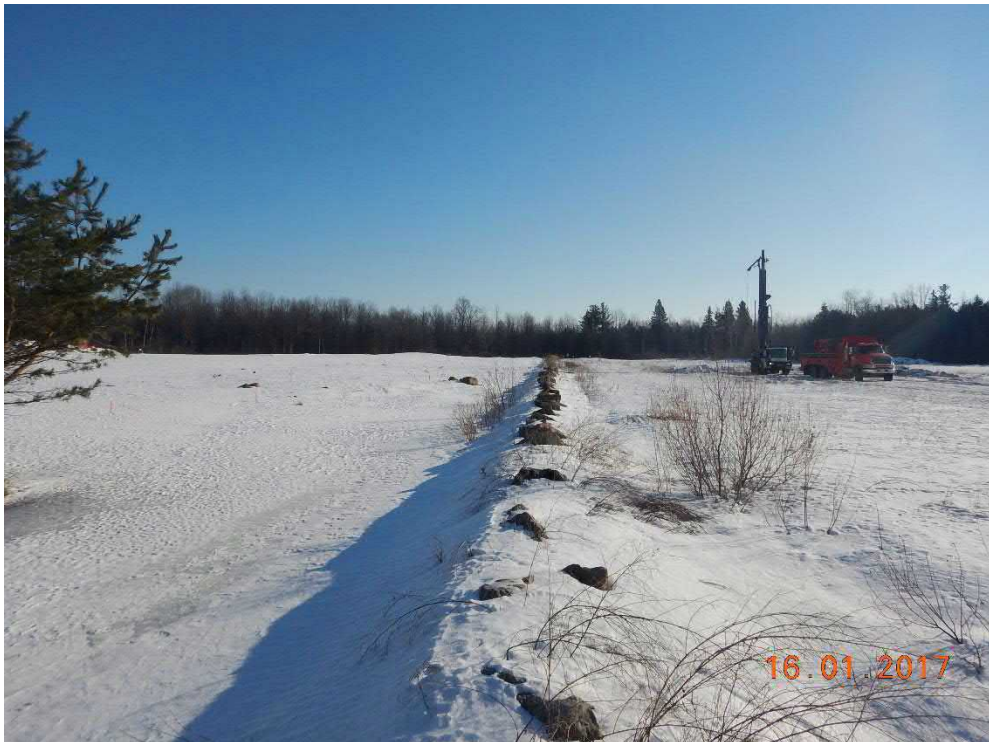
Photo 2: Subject properties at 210 and 220 Maple Creek Court in winter conditions, facing southeast. 16 January 2017.

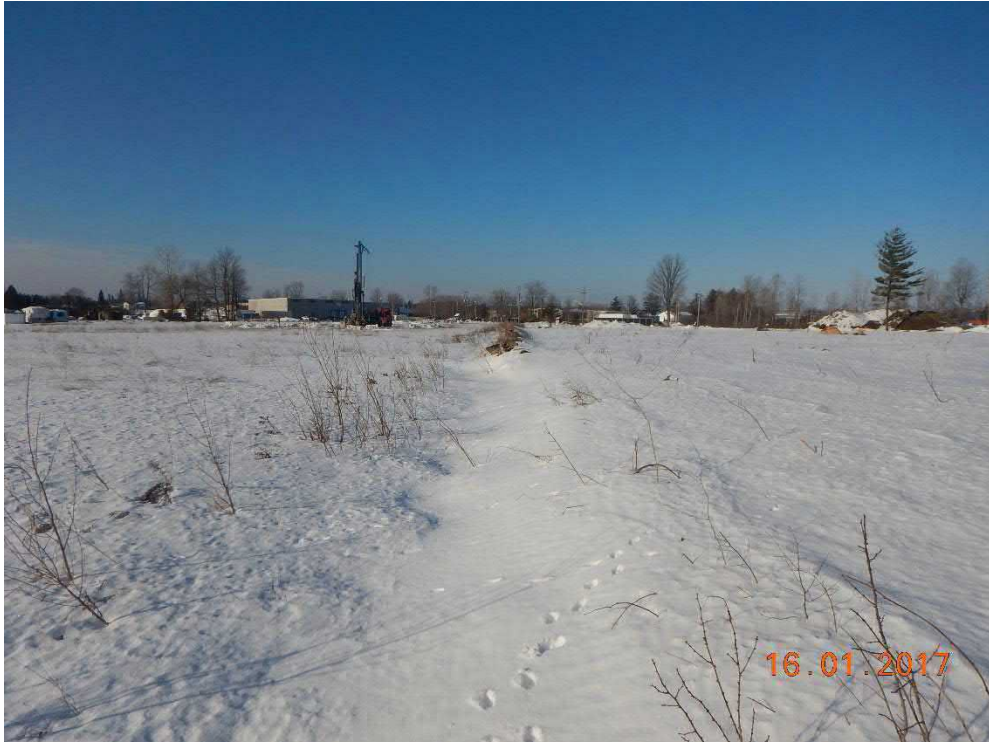
Photo 3: Subject properties at 210 and 220 Maple Creek Court in winter conditions, facing west towards Maple Creek Court. 16 January 2017.

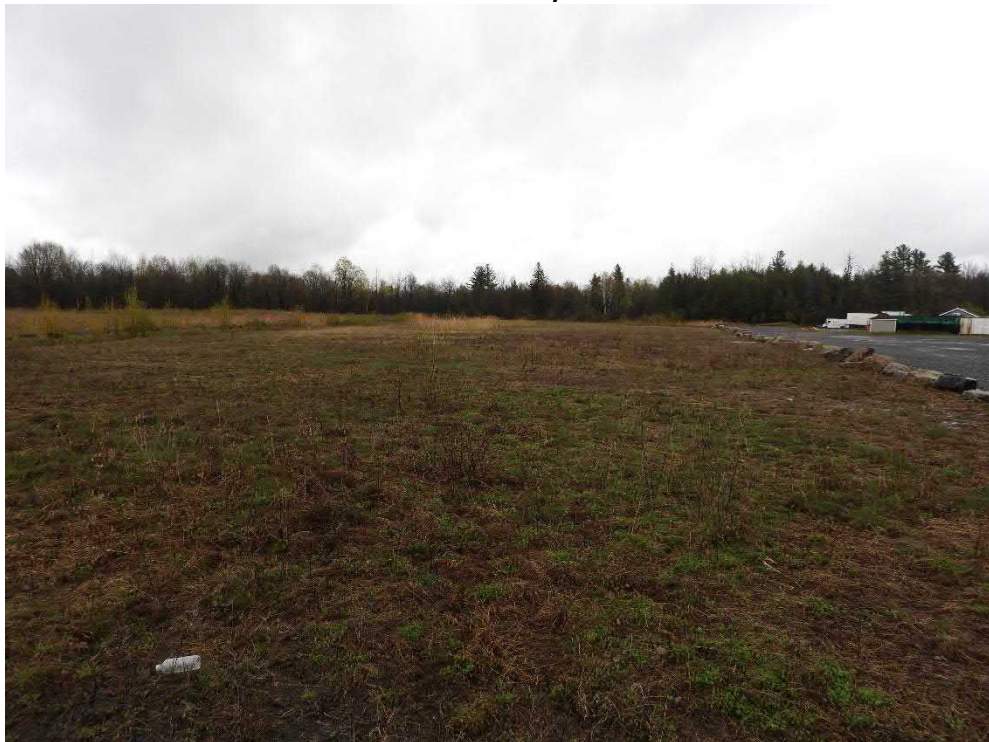
Photo 4: Subject property at 220 Maple Creek Court in spring conditions, facing east. 14 May 2019.

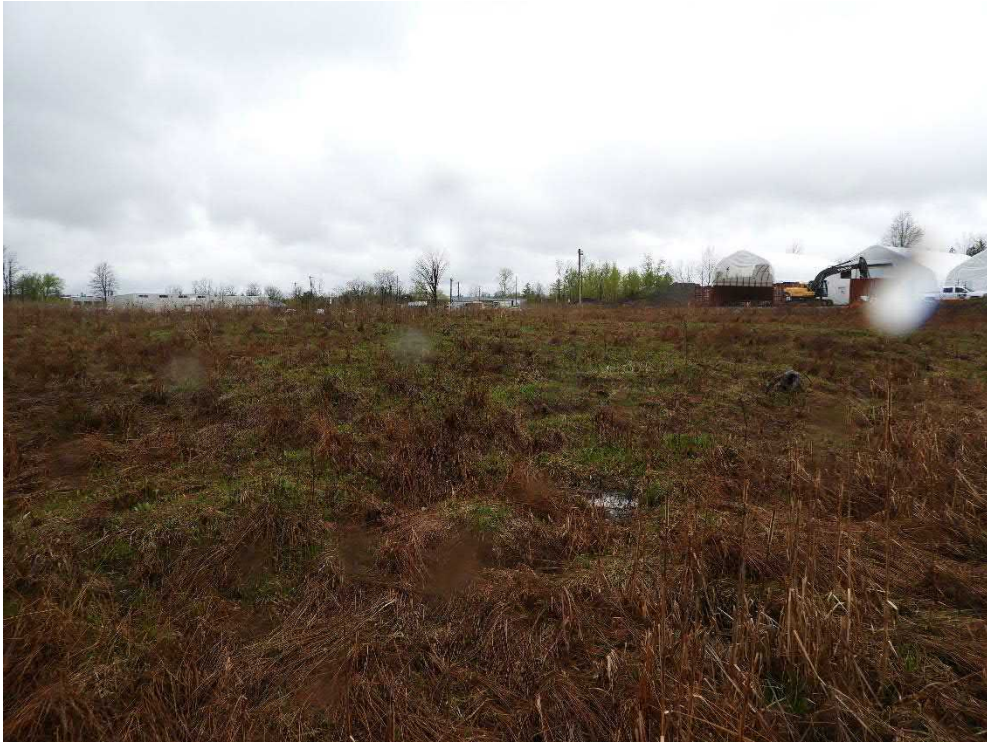
Photo 5: Subject property at 210 Maple Creek Court in spring conditions, facing west. 14 May 2019.

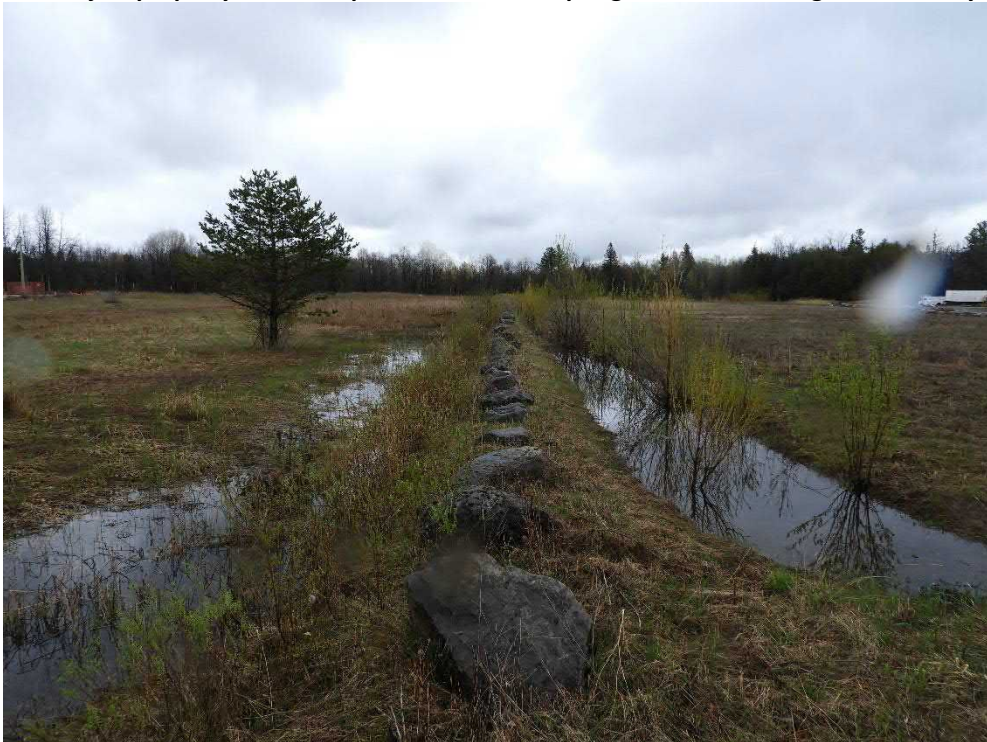
Photo 6: Subject property at 210 Maple Creek Court (left), subject property at 220 Maple Creek Court (right) and rock fence line (middle), facing east. 14 May 2019.

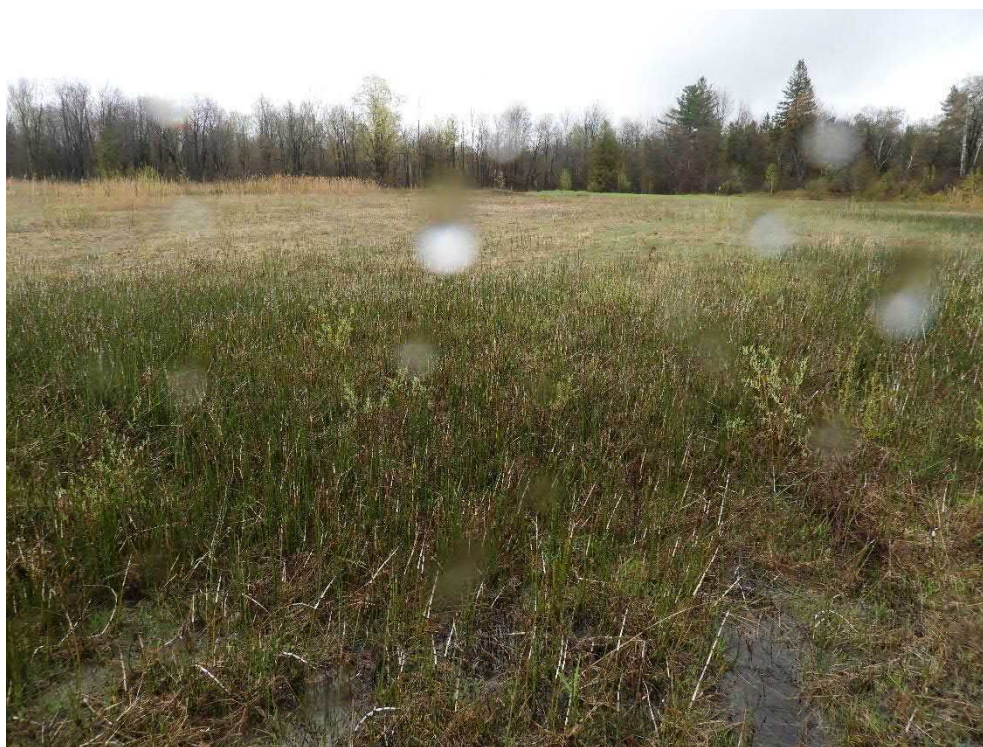
Photo 9: Wet horsetail area in southeast corner of study area, facing southeast. 14 May 2019.

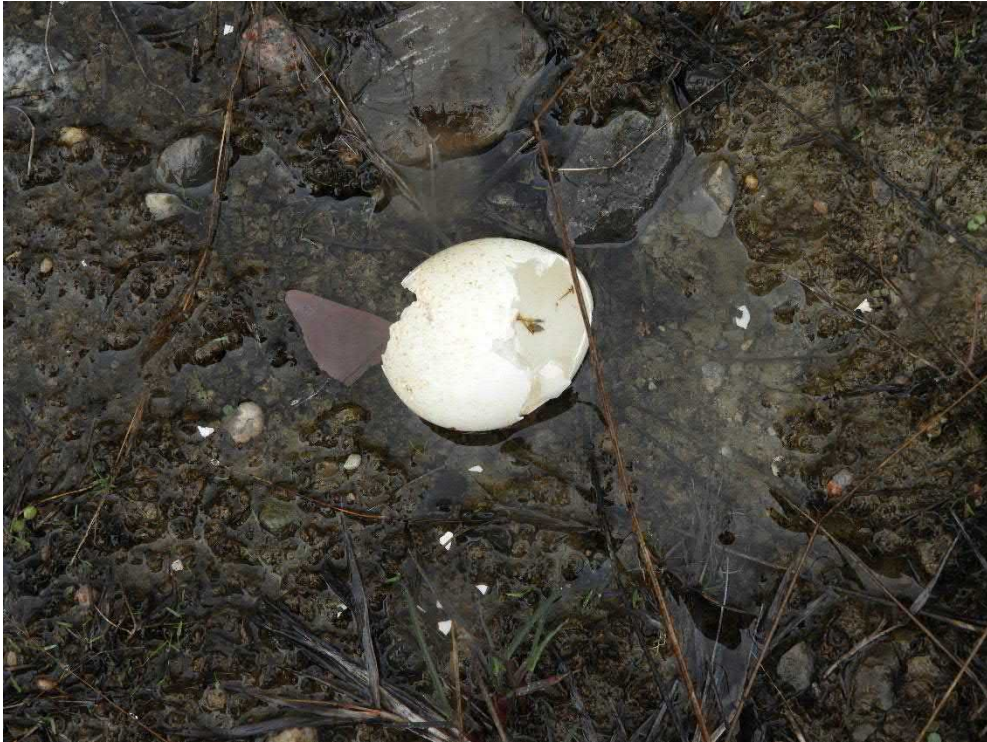
Photo 21: One of two Wild Turkey (*Meleagris gallopavo*) eggs found on the ground within the study area. 14 May 2019.

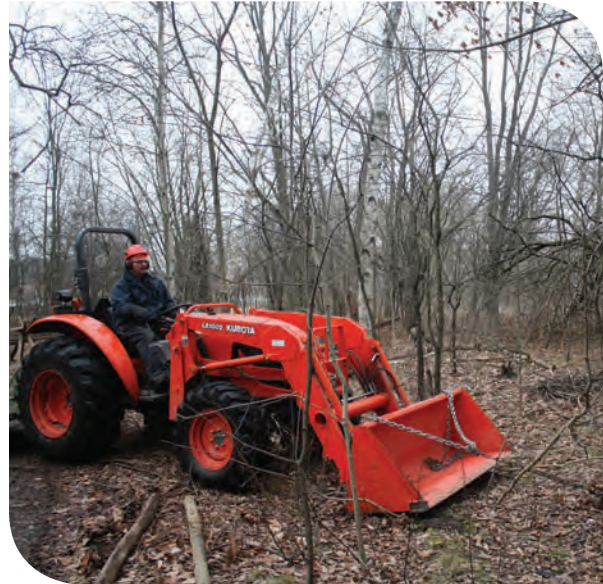
Buckthorn removal, Lynde Shores Conservation Area.
Photo by: Central Lake Ontario Conservation Authority

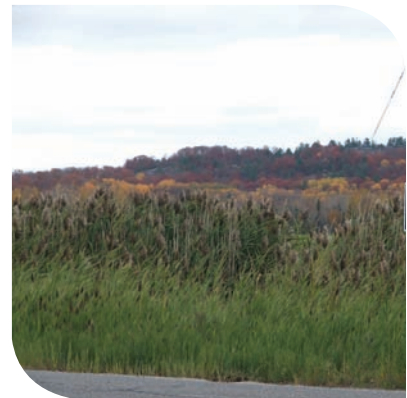
Phragmites
(*Phragmites australis* subsp. *Australis*)
Photo by: Michael Irvine

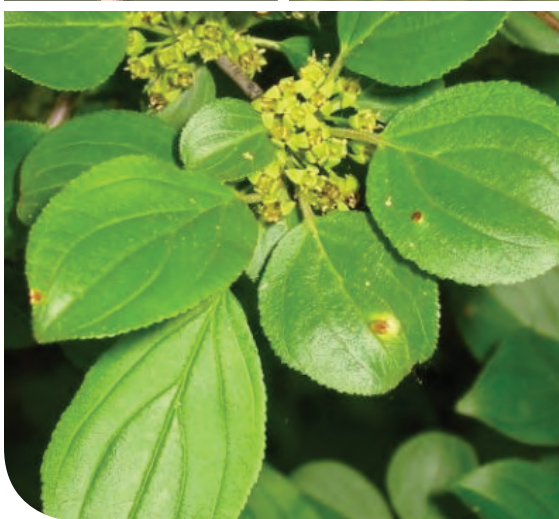
Similar native species: Native dogwoods, which lack the thorny “tip”. Native dogwoods are truly opposite in arrangement of twigs; only alternate leaved (pagoda) dogwood has alternate branching.
