**Phase One Environmental Site Assessment
Proposed Commercial Building
5506 Manotick Main Street
Manotick, Ontario**

September 2, 2020
Project: 65032.03 - V02

5.1 General Site Conditions

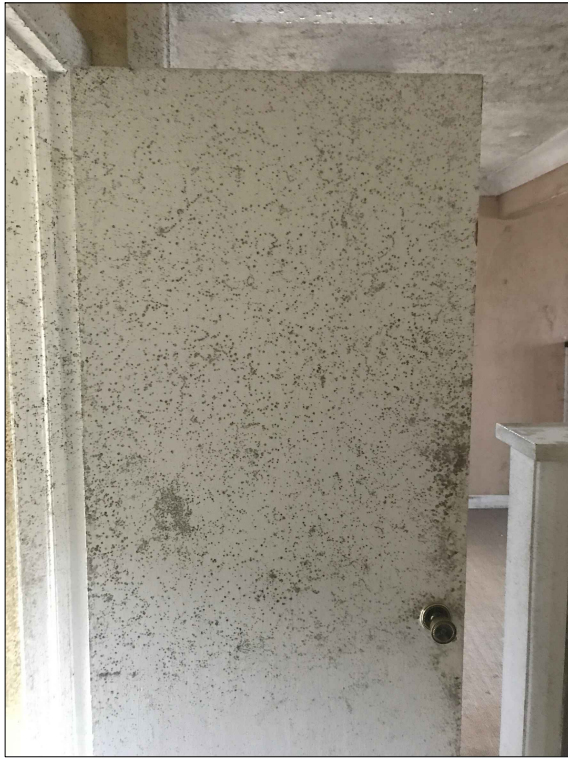
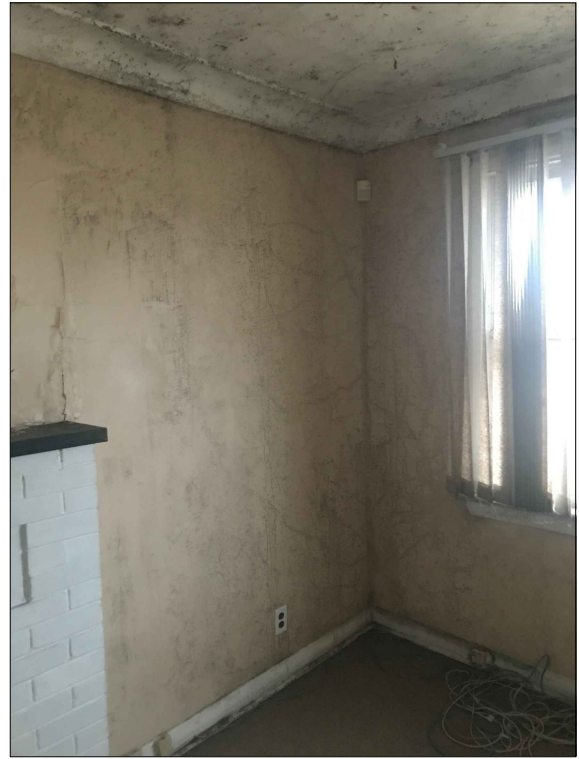
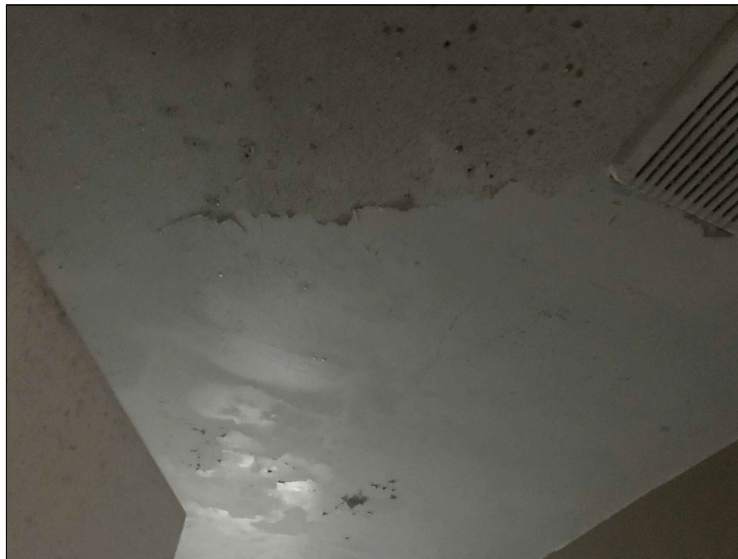
FIGURE I1

Plate Number	Compass Orientation	Description
I1	Northeast, and southwest	Mould was identified in all rooms/ areas of the structure on the subject site. Water damage was also identified on the ceiling in the bathroom
I2	Southeast	Flooded basement identified during the site reconnaissance.
I3	Southwest	Light ballasts possibly containing mercury were identified within the structure on the subject property.
I4	Northwest	Ditches along the roadways adjacent to the subject property and within the study area.
I5	Northwest	Pad mounted transformer identified on a property parcel east of the subject property.
I6	Southeast	A garage identified in the study area.

DOOR

ROOM

CEILING

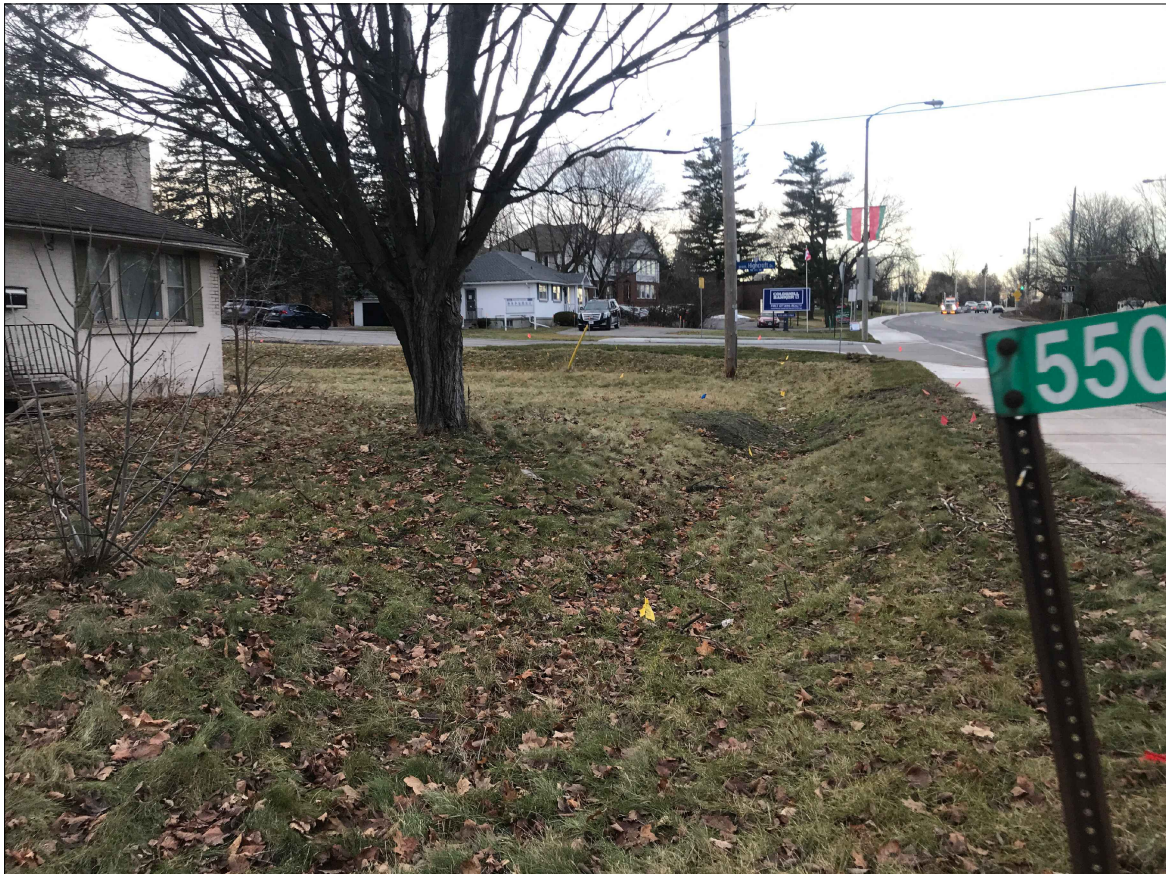
FIGURE I4

DITCHES ALONG THE ROADWAYS ADJACENT TO THE SUBJECT PROPERTY AND
WITHIN THE STUDY AREA (NORTHWEST)

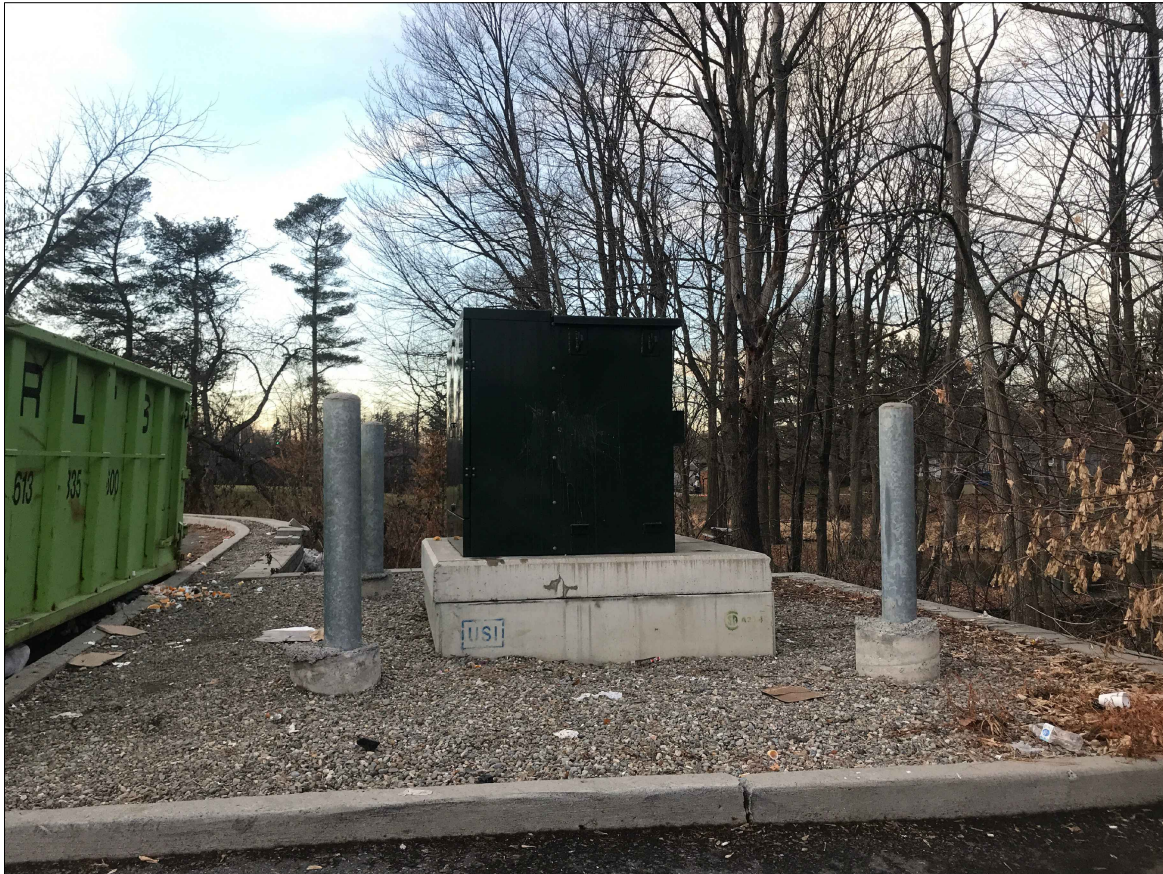
FIGURE I5

No transformers were identified on the subject property at the time of site reconnaissance. Pole and pad mounted transformers were identified in the study area. The transformers appeared to be in good condition with no evidence of leaking.

PAD MOUNTED TRANSFORMER IDENTIFIED ON A PROPERTY PARCEL
EAST OF THE SUBJECT PROPERTY (NORTHWEST)
