PROJECT NAME
CIRCLE K STORES INC.
R&R No. 52287
NEPEAN ONTARIO
1545 WOODROFFE AVENUE
NEPEAN, ON, CANADA
K2G 1W2

SHEET TITLE
TREE PRESERVATION AND PROTECTION EXISTING CONDITIONS PLAN

SHEET NUMBER
L1.0

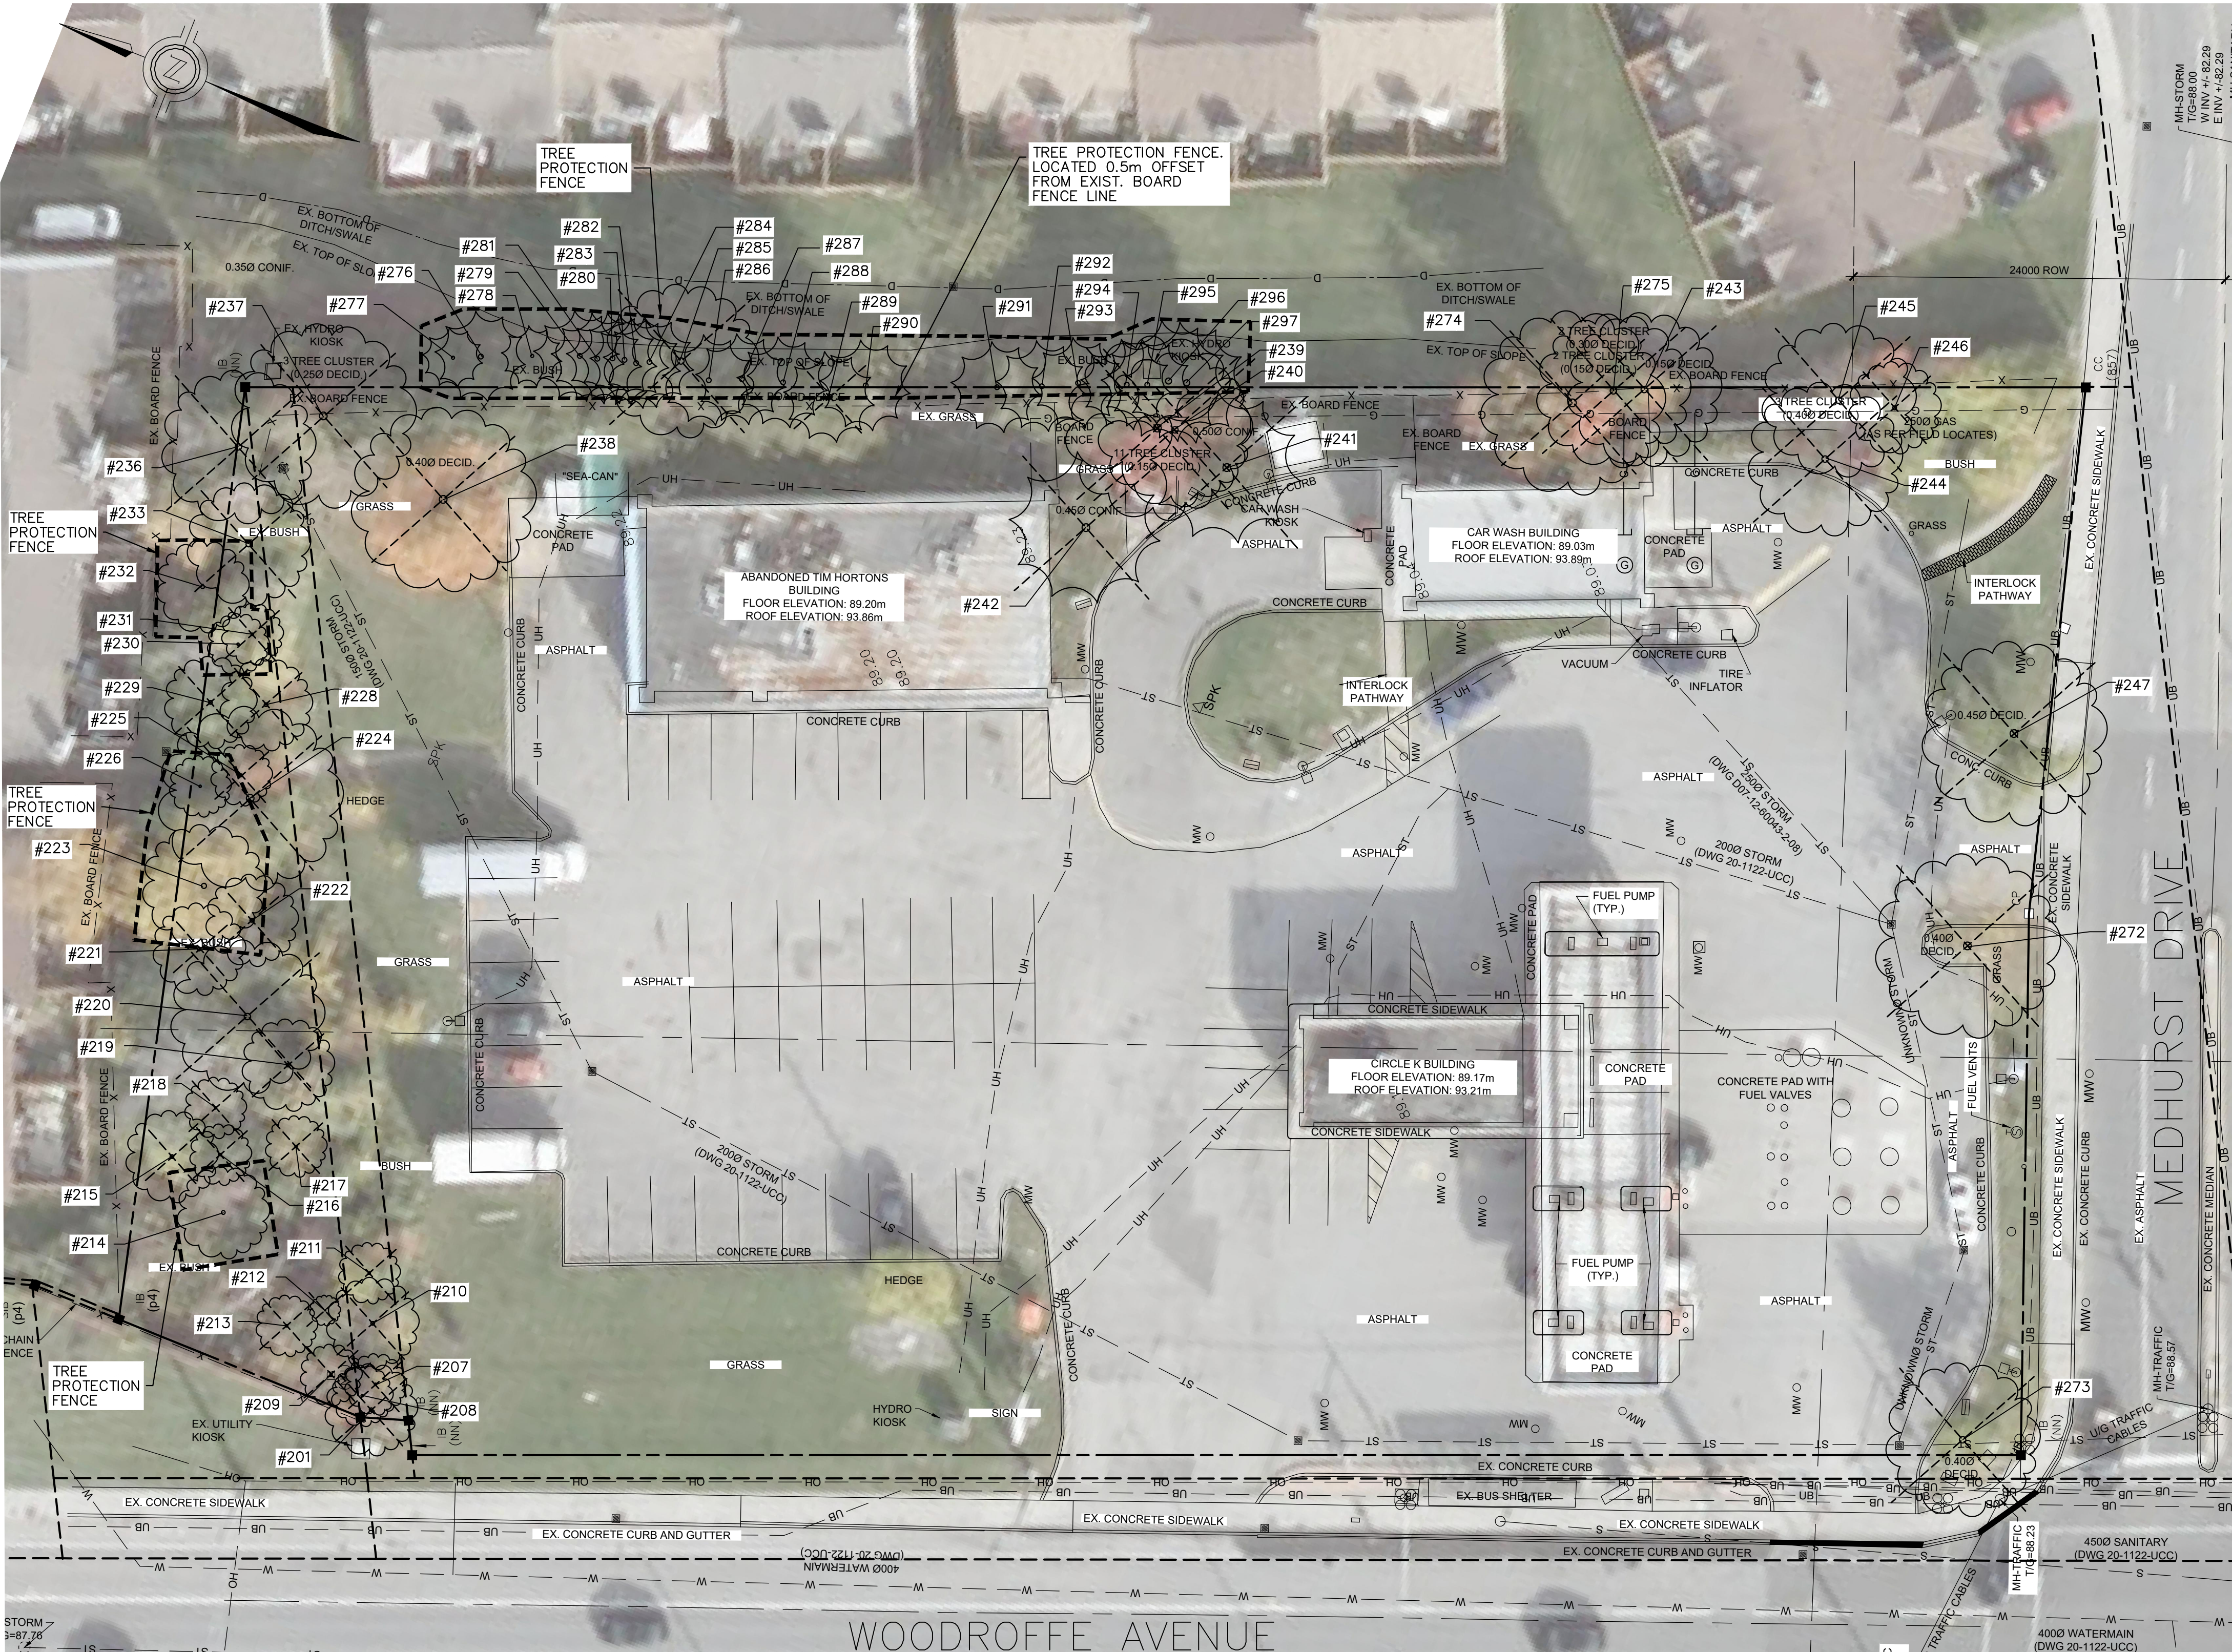
- DENOTES SURVEYED LOCATION OF EXISTING TREES, & # SPECIES / CALIPER / CONDITIONS /REMARKS ARE AS NOTED IN ARBORIST REPORT & TREE INVENTORY LIST
- TREE PRESERVATION FENCE, PER OTTAWA TREE PROTECTION SPECIFICATION DETAIL
- DENOTES EXISTING TREES TO BE REMOVED FOR DEVELOPMENT, AS NOTED, SEE ARBORIST REPORT
