# Phase Two Environmental Site Assessment

715 Mikinak Road  
Ottawa, Ontario

Prepared for:  
Ottawa Community  
Housing Corporation

July 15, 2020

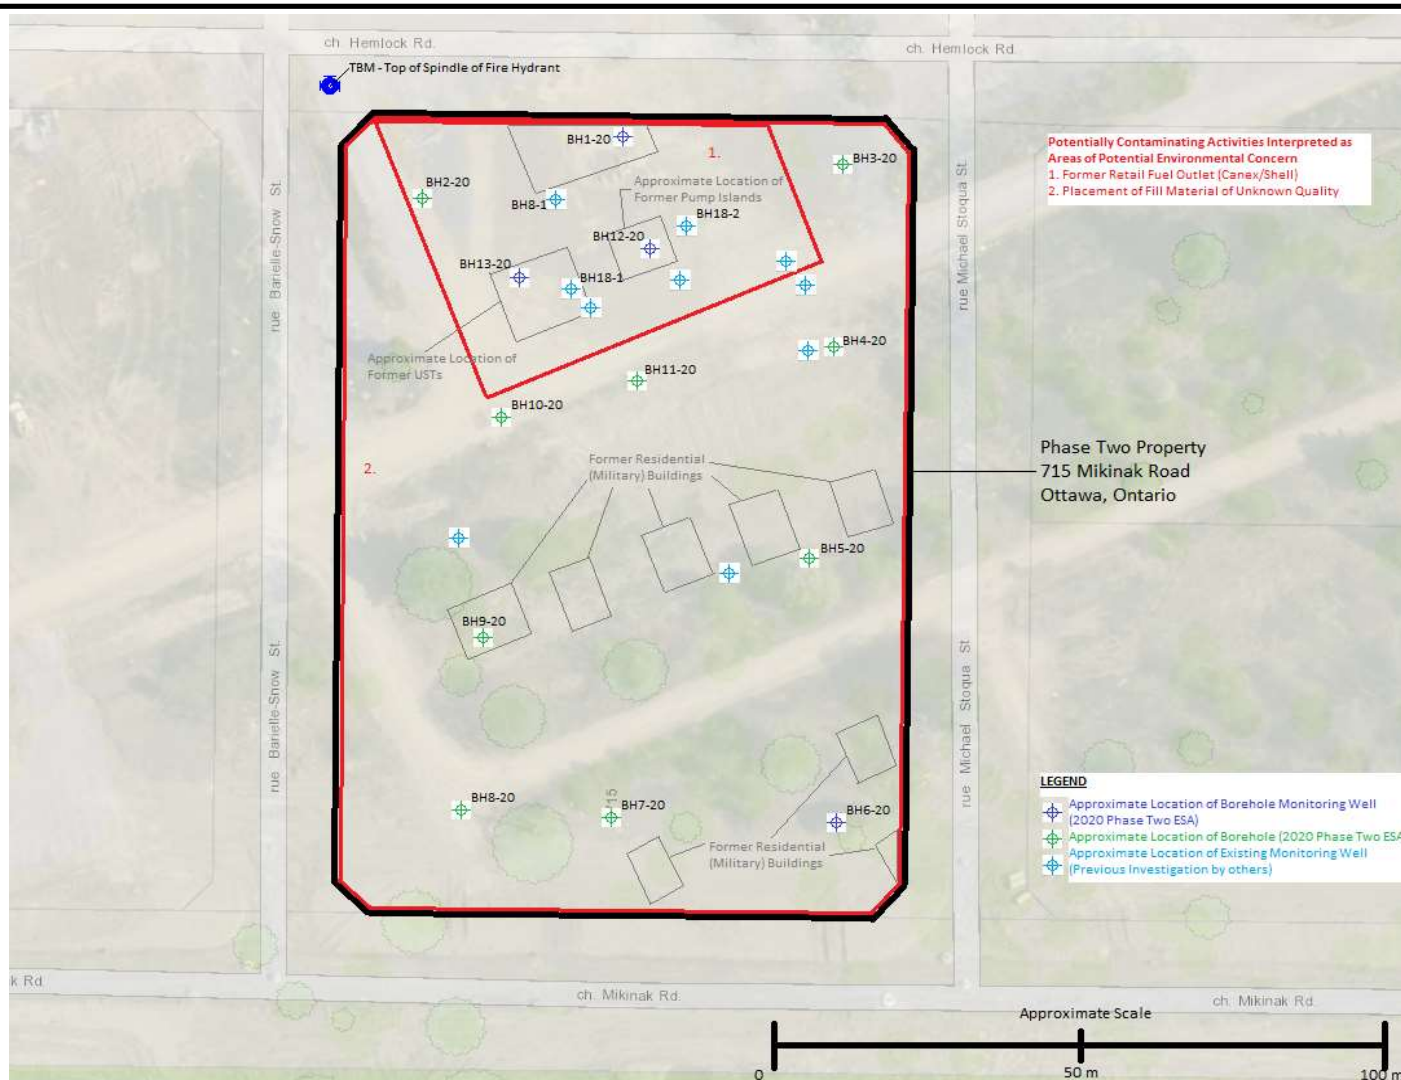
**Figure 2: Site Plan**  
Phase Two Environmental Site Assessment  
715 Mikinak Road, Ottawa, Ontario  
Ottawa Community Housing Corporation

On June 15 and 16, 2020, a total of 13 boreholes (BH1-20 through BH13-20) were drilled at the Phase Two Property. The boreholes were drilled using a track mounted CME 55 drill rig. Soil samples were collected from auger cuttings (near ground surface) and using stainless steel split spoons for samples at deeper depths. Soil samples recovered during the sampling program were screened in the field for volatile vapour concentrations, as well as visual and olfactory observations.
