RE: 1164/1166 Highcroft Drive, Manotick
Tree Conservation Report and Environmental Impact Statement - Updated

This Environmental Impact Statement (EIS) and Tree Conservation Report (TCR) assesses an urban residential development for an approximately 0.37 hectare site in the central portion of Manotick. The municipal addresses are 1164 and 1166 Highcroft Drive and the site begins about 50 metres west of Manotick Main Street, northwest of the intersection of Main Street and Bridge Street/Maple Avenue (Map 1). For the purposes of this report Highcroft Drive is considered to be in an east-west orientation.

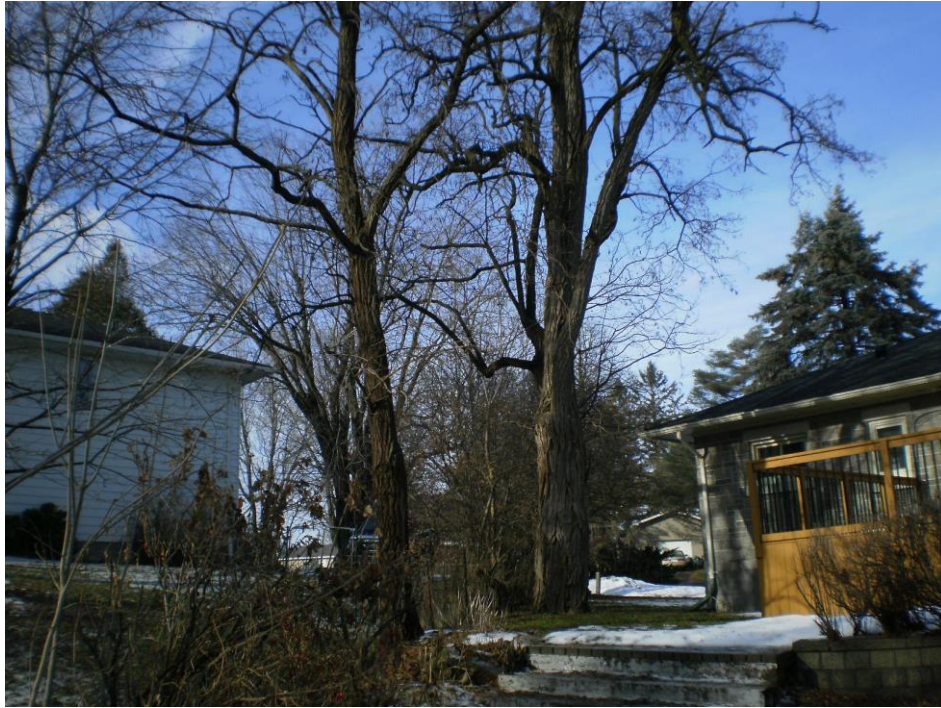
Photo 3 – Mature locust in the west portion of 1166 Highcroft Drive, with smaller locust along the west property line to the left. View looking northwest

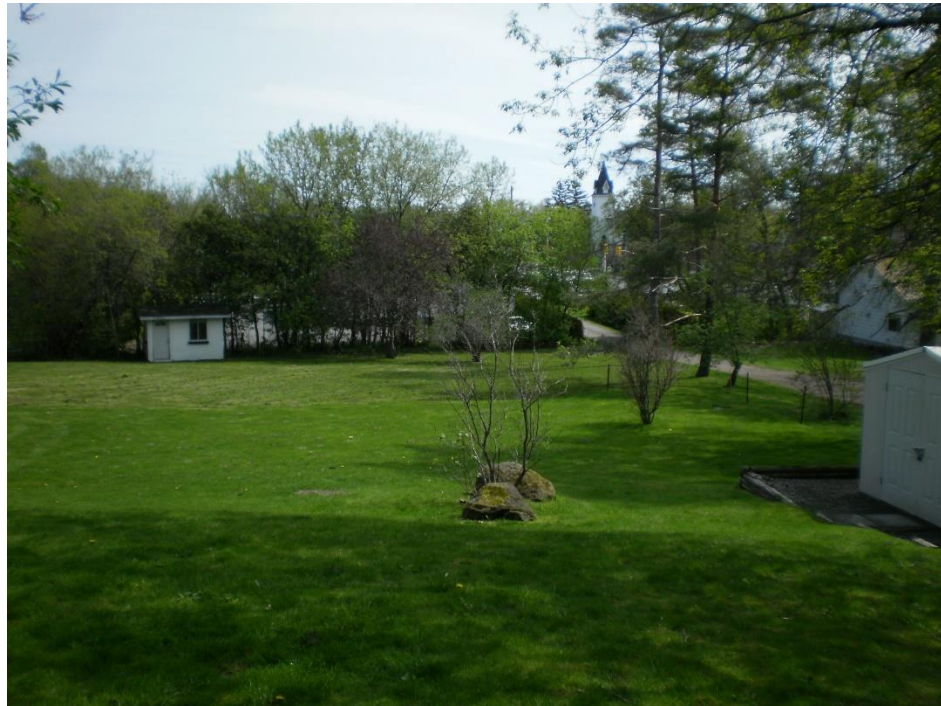
The site is dominated by two existing residences and associated large manicured grassed lands (Photos 4 and 5) to the north and south of the residences. In addition to the dominant bluegrass, common dandelion, ground ivy, common burdock, and goldenrod were observed.

Photo 4 –South portion of the site. View looking east from west site edge

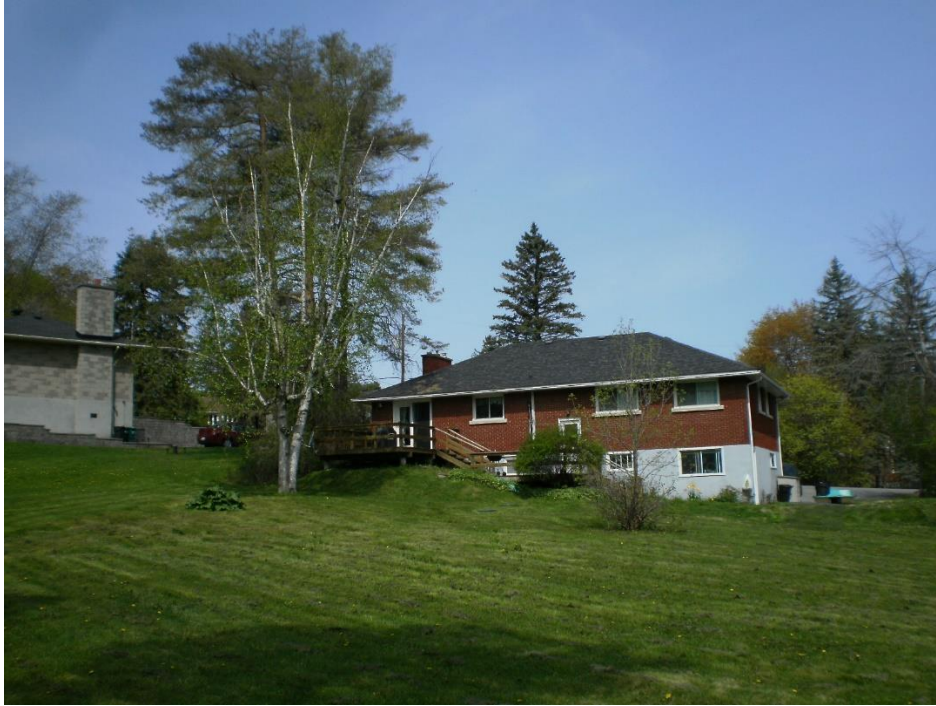
*Photo 5 – South portion of 1164 Highcroft Drive.
From southeast corner of the site view looking north to residence to be removed*

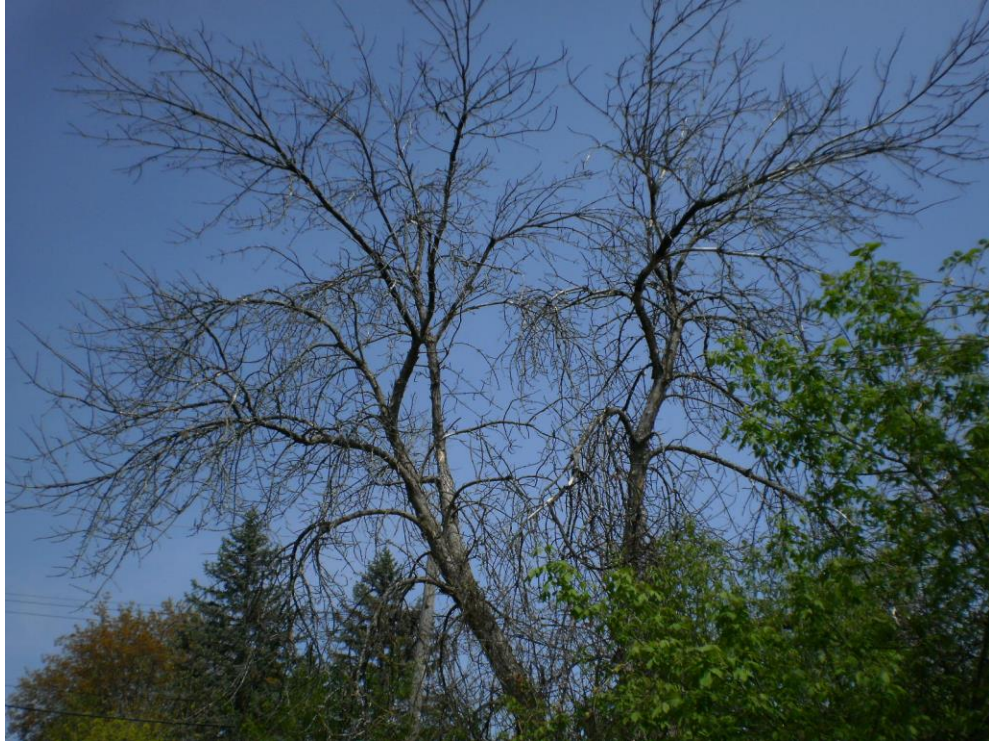
Along the east site boundary, a 44cm dbh white ash is about one metre to the east of the property line approximately 20 metres south of Highcroft Drive (Photo 7). Vine growth was extensive on the ash and very few live buds were observed. Many regenerating Manitoba maple and white elm stems up to 15cm dbh are also along the property line in this area. Further south, a hedgerow of white cedars up to 12cm dbh are along the property line and west of a commercial parking lot. Several of the smaller cedar stems appeared dead. Manitoba maples up to 30cm dbh and common lilac shrubs were among the cedars. Many of the Manitoba maples had badly bent trunks.

Photo 7 – White ash with no live buds of note, smaller Manitoba maple, and vines along the east property line south of Highcroft Drive. View looking north to Highcroft

The Grading Plan also shows retaining walls along much of the site periphery not fronting onto Highcroft Drive. This will preclude retention of trees along most of the site peripheries. The Scot's pine just to the south of the site would also likely have required removal and as noted above the pines have been removed by the adjacent landowner. Discussions have been completed with the adjacent landowners. The landowners to the west at 1172 Highcroft Drive have provided in writing that they have no concerns with removal of any co-owned trees (see Appendix A). The white ash and Manitoba maple that are in poor condition in the south portion of the west property line will be removed, along with the 30cm dbh black locust along the property line to the west of Lot 10. The landowners to the east have both confirmed that they have no concerns with removal of the ash, Manitoba maple and other trees in poor condition along the east property line.

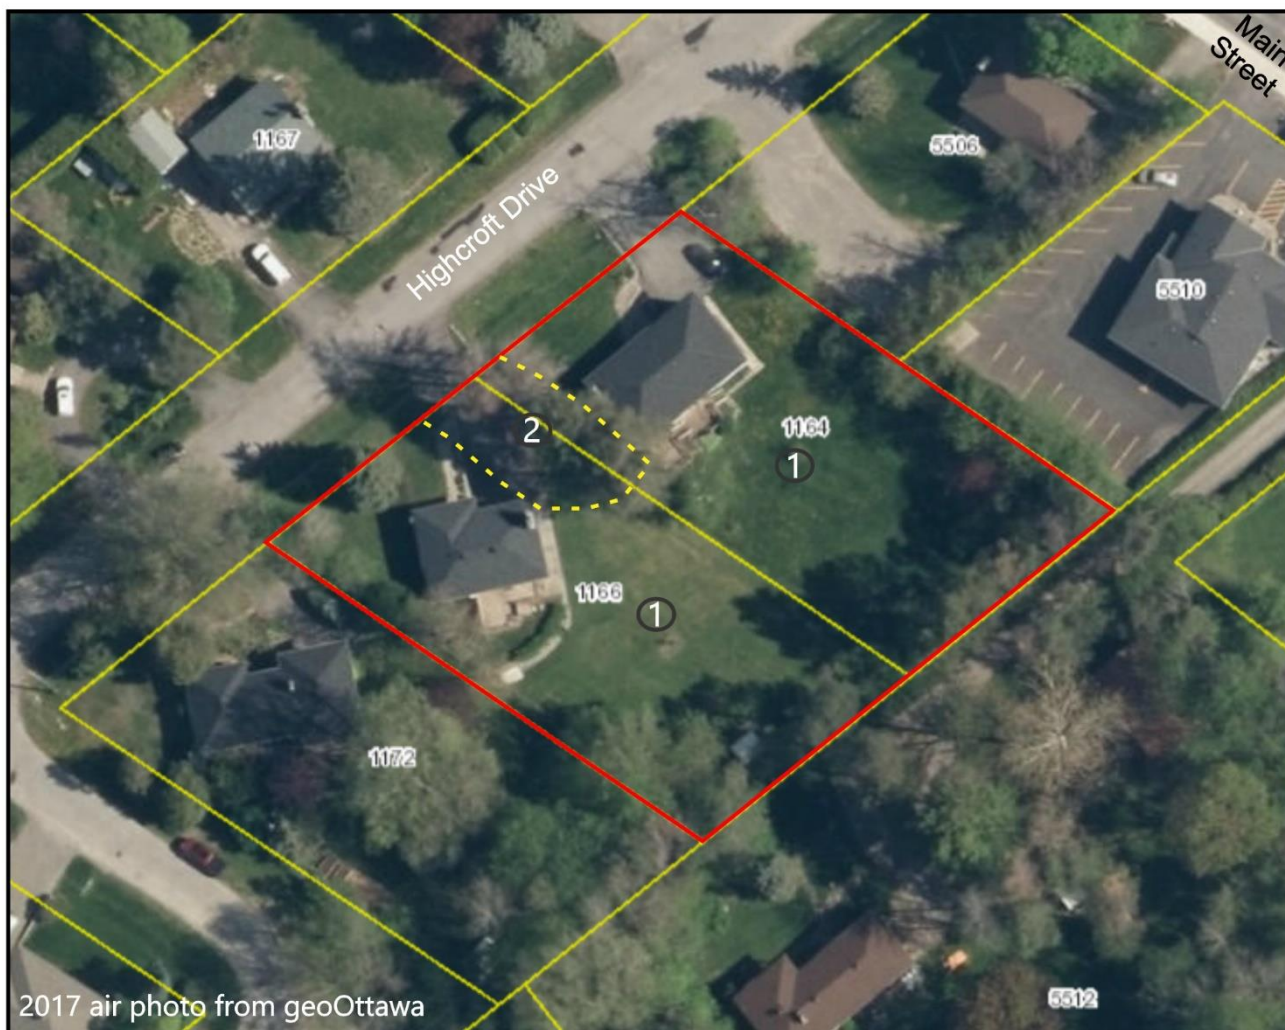
Map 1

- ① Cultural Meadow
- ② Coniferous hedgerow

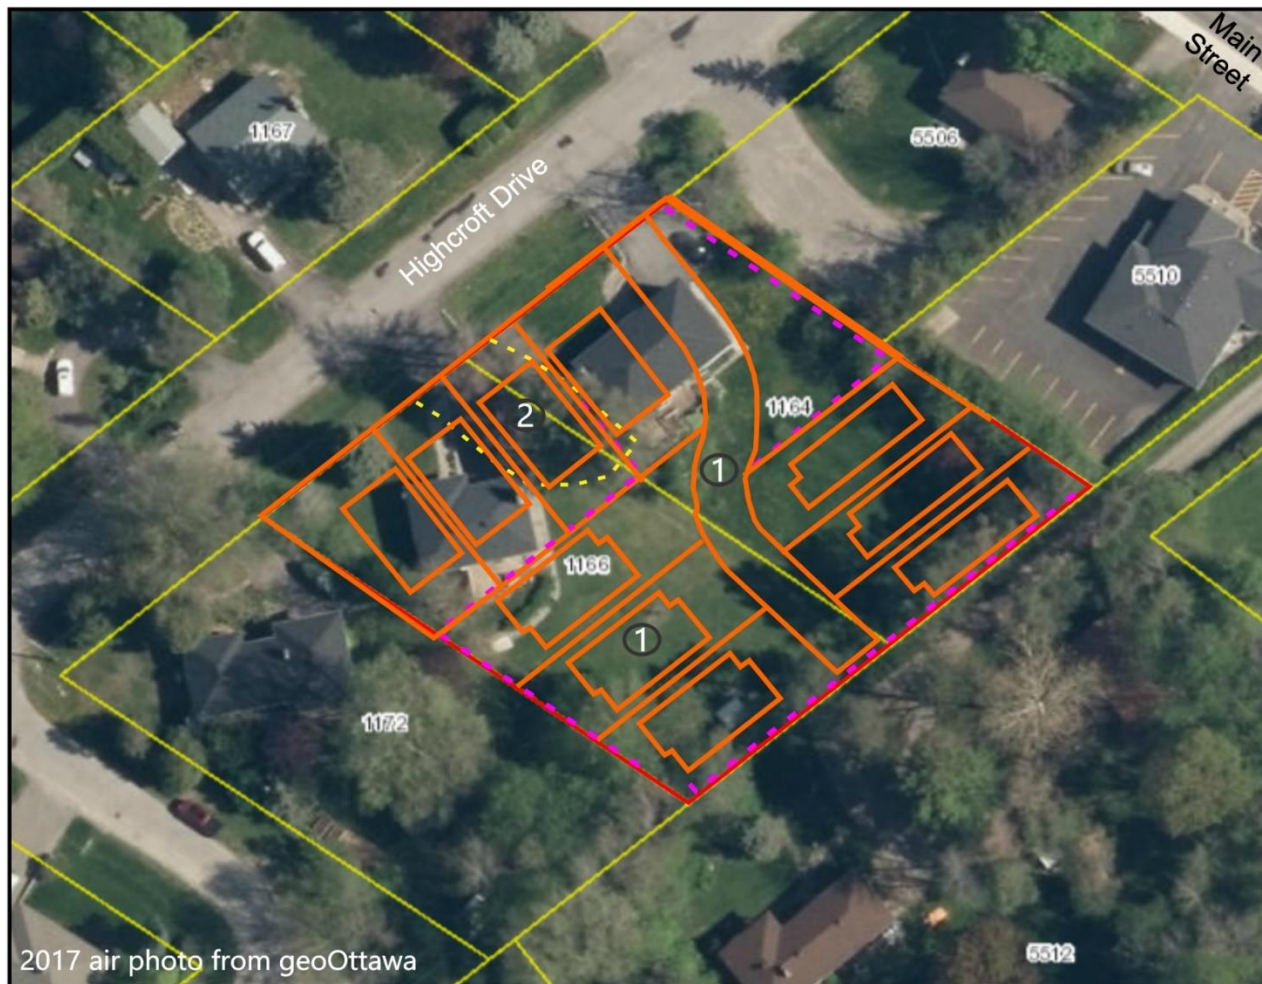
Map 2

Note - Due to locations, grading requirements and tree condition no trees are proposed for retention

PROPOSED CONSERVED VEGETATION TREE CONSERVATION REPORT
