**200 BARIBEAU STREET**  
**RESIDENTIAL DEVELOPMENT**

200 BARIBEAU STREET  
 OTTAWA, ONTARIO

**TREE CONSERVATION**  
**REPORT**

| Project Number: | 2053-01 | Sheet Number: | TCR 01 |

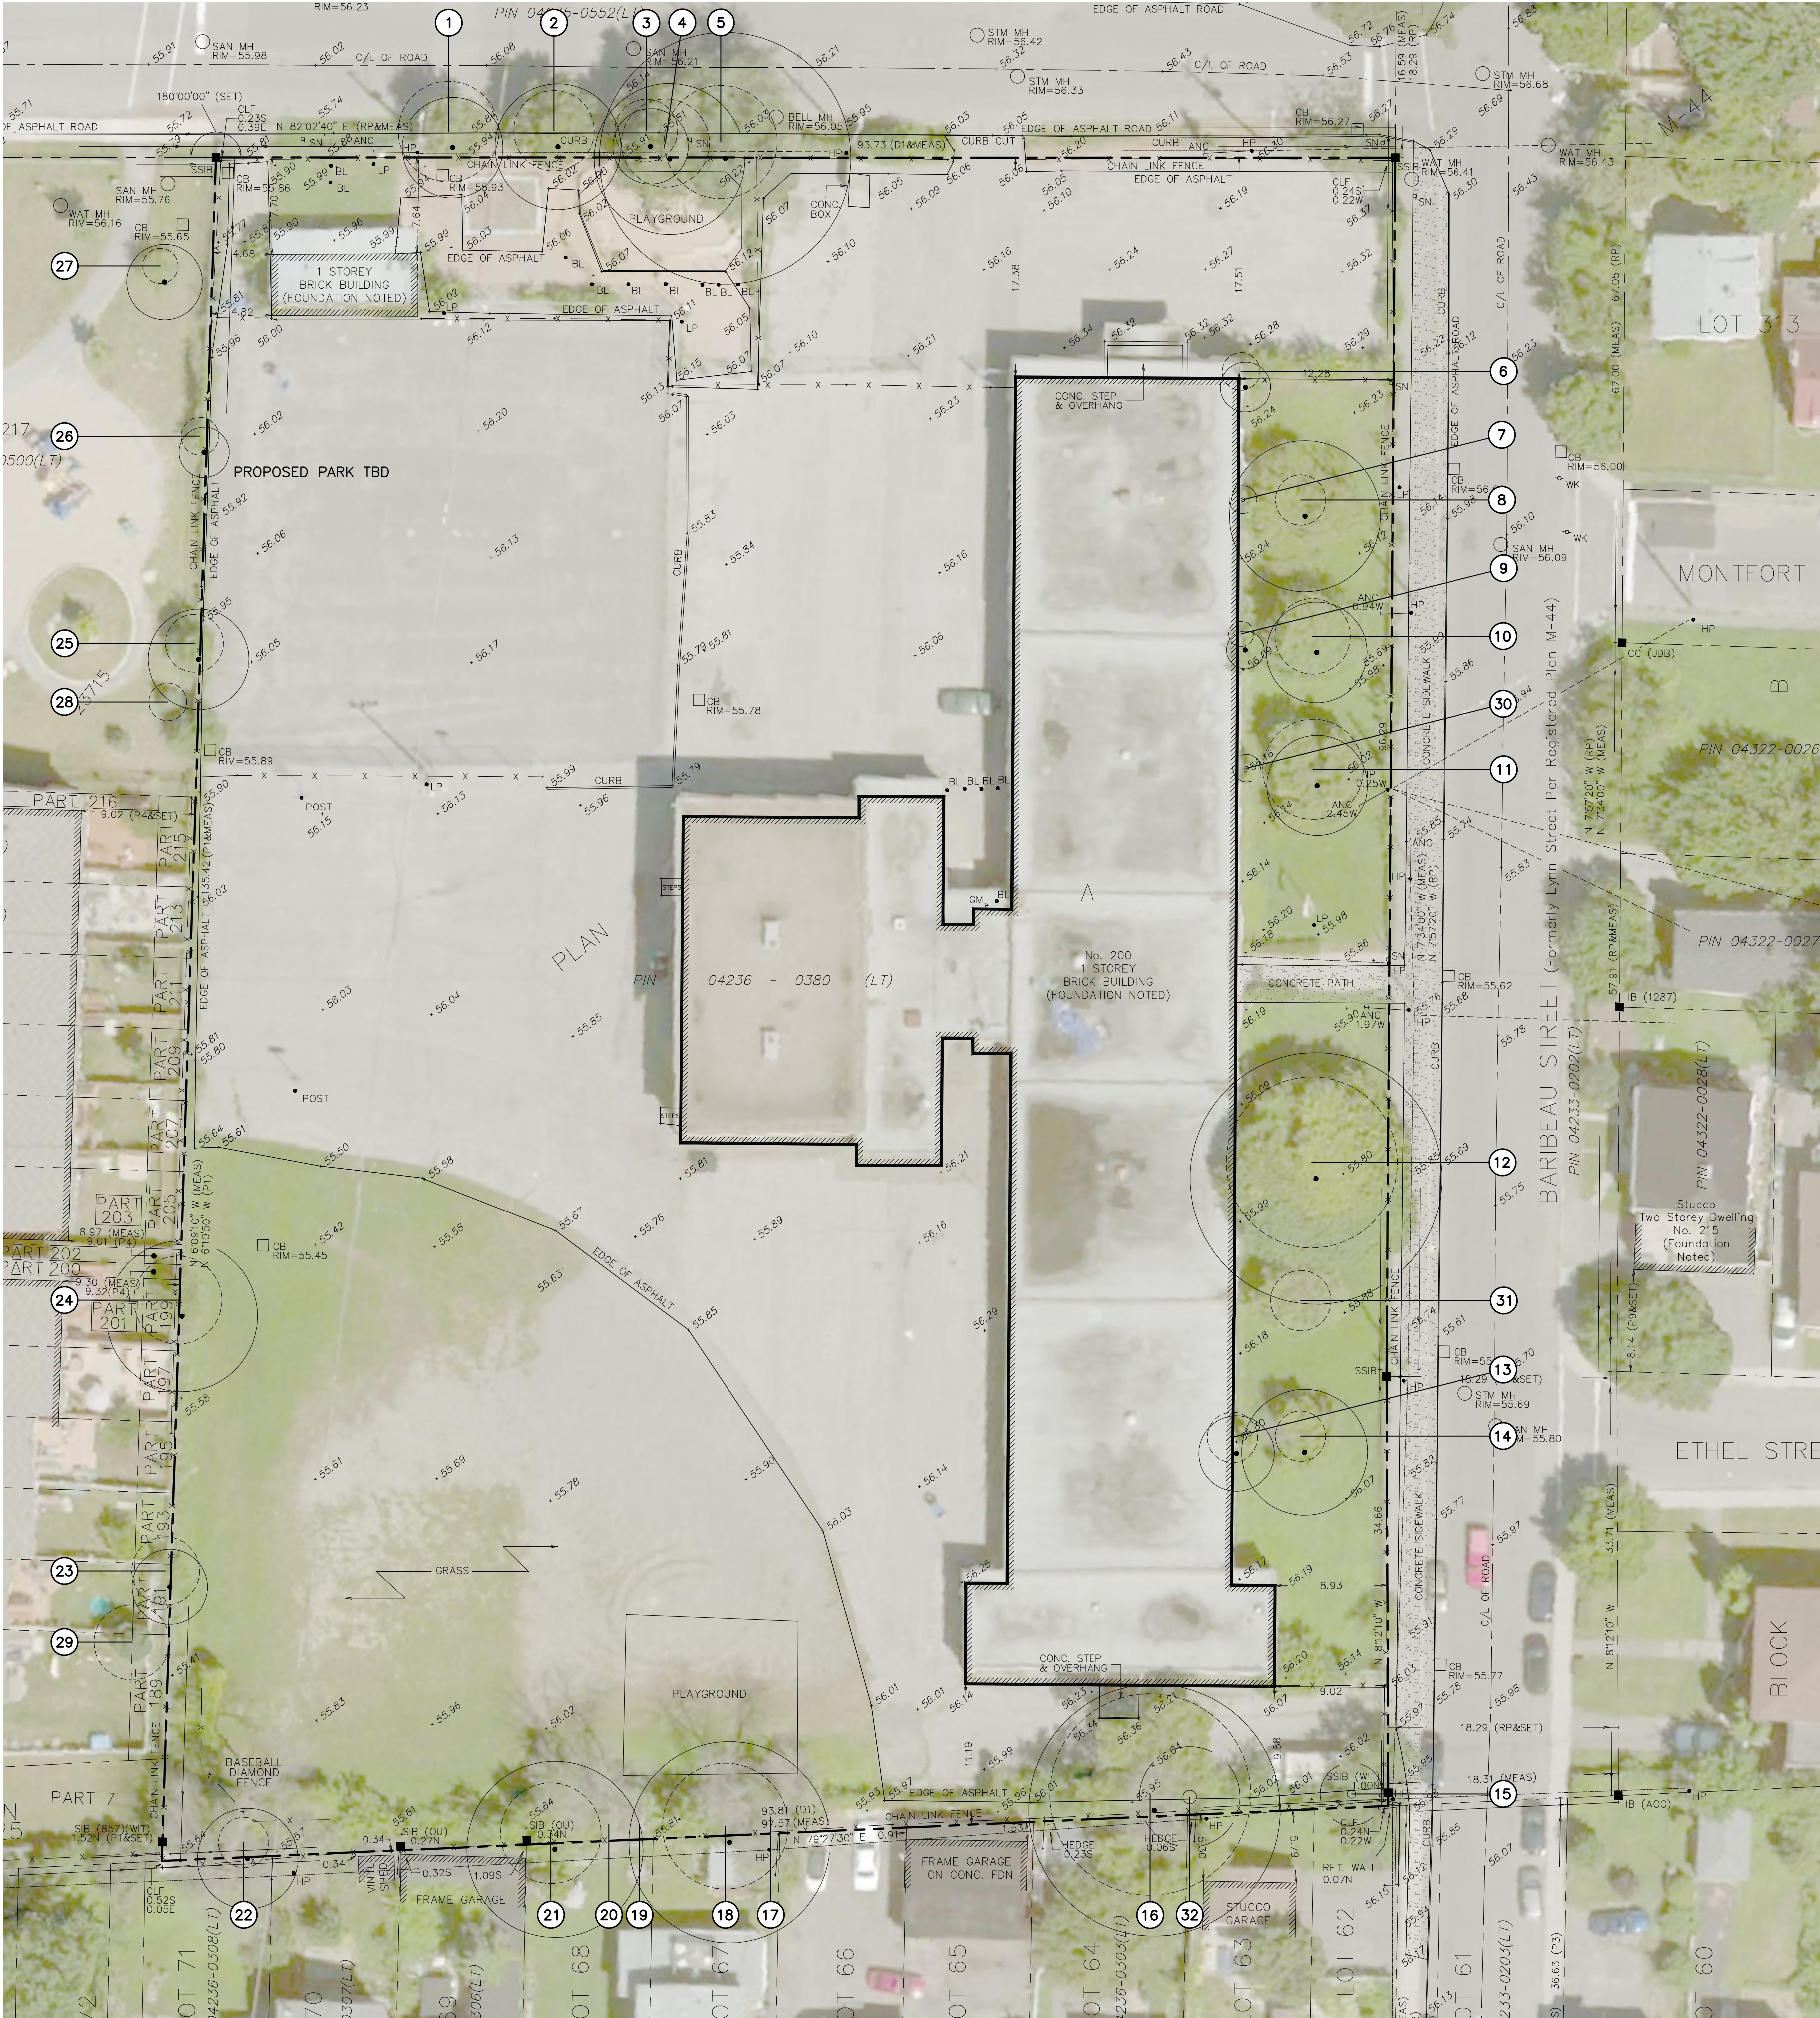
1 EXISTING VEGETATION

| Tree # | Botanical Name | Common Name | Caliper (cm) | Condition | High Quality Tree | Rare Tree | Comments | Disposition |
|---|---|---|---|---|---|---|---|---|
| 1 | Tilia cordata | Littleleaf Linden | 40 | Moderate | No | No | City owned, Symmetrical canopy, Pruned @ OH Utilities, Single stem, Co-dominant leaders: 2 @ ~2m above grade, Included bark, Suckering @ base | Remove |
| 2 | Tilia cordata | Littleleaf Linden | 32 | Good | No | No | City owned, Symmetrical canopy, Co-dominant leaders: 2 @ ~2m above grade, Included bark | Remove |
| 3 | Tilia cordata | Littleleaf Linden | 24 | Moderate | No | No | City owned, Asymmetrical canopy, Die back ~10% @ branches, Single stem, Included bark | Remove |
| 4 | Ulmus pumila | Siberian Elm | 35 | Moderate | No | No | Privately owned, Asymmetrical canopy, Pruned @ OH Utilities, Poor branch angle, Single stem, Co-dominant leaders: 2 @ ~2.5m above grade | Remove |
| 5 | Ulmus pumila | Siberian Elm | 45 | Moderate | No | No | Privately owned, Asymmetrical canopy, Broken limbs, Pruned @ OH Utilities, Single stem, Co-dominant leaders: 3 @ ~2m above grade, Bark rot @ limbs | Remove |
| 6 | Thuja nigra | Black Cedar | 15, 17 | Good | No | No | Privately owned, Asymmetrical canopy, Multi stem: 2 | Remove |
| 8 | Acer ginnala | Amur Maple | 23, 25, 20 | Moderate | No | No | Privately owned, Asymmetrical canopy, Pruned leader branches, Multi stem: 3, Heart rot @ trunk, Broken leader | Remove |
| 9 | Thuja nigra | Black Cedar | 15 | Poor | No | No | Privately owned, Die back: ~40% @ canopy, Single stem, Co-dominant leaders: 3 @ ~0.5m above grade, Bark damage | Remove |
| 10 | Acer saccharum | Sugar Maple | 32 | Good | No | No | Privately owned, Symmetrical canopy, Broken limbs, Single stem, Bark rot @ crotches, Included bark | Remove |
| 11 | Acer ginnala | Amur Maple | 18, 24, 15, 12 | Moderate | No | No | Privately owned, Symmetrical canopy, Pruned leader, Multi stem: 4, Bark rot @ limbs, Existing feature: Bird house | Remove |
| 12 | Acer rubrum | Red Maple | 68 | Moderate | No | No | Privately owned, Broken limbs, Pruned, Heart & Bark rot @ limbs, large split in limb. | Remove |
| 13 | Thuja nigra | Black Cedar | 18 | Moderate | No | No | Privately owned, Asymmetrical canopy, Single stem, Co-dominant leaders: 2 @ ~1.5m above grade, Leaning | Remove |
| 16 | Acer saccharum | Sugar Maple | 72 | Poor | No | No | Privately owned, Asymmetrical canopy, Pruned @ OH Utilities, Poor branch angle, Single stem, Co-dominant leaders: 2 @ 2.5m above grade, Bark rot @ trunk & crotches | Remove |
| 18 | Acer negundo | Manitoba Maple | 50 | Poor | No | No | Privately owned by adjacent homeowner, Pruned @ OH Utilities, Poor branch angle, Multi stem: 5, Bark rot @ trunk, Included bark | Retain |
| 21 | Acer negundo | Manitoba Maple | 40, 20 | Moderate | No | No | Privately owned by adjacent homeowner, Asymmetrical canopy, Broken limbs, Poor branch angle, Multi stem: 2, Bark rot @ limbs, Included bark | Retain |
| 23 | Populus balsamifera | Balsam Poplar | 27, 23 | Moderate | No | No | Privately owned, Symmetrical canopy, Single stem, Co-dominant leaders: 2 @ ~1.5m above grade, grown into chain link fence | Retain |
| 24 | Populus balsamifera | Balsam Poplar | 35 | Good | No | No | Privately owned, Symmetrical canopy, Single stem, Included bark | Remove |
| 25 | Ulmus pumila | Siberian Elm | 23 | Moderate | No | No | City owned: Park property, Symmetrical canopy, Pruned @ lower limbs, Single stem, Bark rot @ crotches, Grown into chain link fence | Retain |
| 26 | Ulmus pumila | Siberian Elm | >10 (4) | Poor | No | No | City owned: Park property, Symmetrical canopy, Pruned @ main leader, Single stem, Co-dominant leaders: 4 @ ~0.5m above grade, Grown into chain link fence | Retain |
| 27 | Gleditsia triacanthos var. inermis | Thornless Honey Locust | 14 | Good | No | No | City owned: Park property, Symmetrical canopy, Single stem, Co-dominant leaders: 2 @ ~1.5m above grade, Bark rot @ crotches | Retain |
| 31 | Acer Saccharum | Sugar Maple | 24 | Good | No | No | Privately owned, Symmetrical canopy, Single stem, Bark rot @ limbs, Included bark | Remove |

- THE EXISTING SITE CONTAINS TWO SINGLE-STORY BRICK BUILDINGS, A LARGE ASPHALT-PAVED AREA, AN OPEN GRASS FIELD, AND A SAND-PLAY AREA.
  - APPROXIMATELY 85m<sup>2</sup> IS OCCUPIED BY BUILDING FOOTPRINTS.
  - APPROXIMATELY 5685m<sup>2</sup> IS HARD SURFACES.
- THERE ARE A TOTAL OF THIRTY-TWO TREES INCLUDED IN THE TREE CONSERVATION REPORT, IN VARYING CONDITIONS. TREES ARE LOCATED WITHIN THE SITE BOUNDARY, WITHIN THE CITY RIGHT-OF-WAY, WITHIN AN ADJACENT CITY PARK, AND ON ADJACENT HOMEOWNER PROPERTY.
- THE EXISTING ON-SITE GREENSPACE IS MAINLY COMPRISED OF TURFGRASS.
- THE DEVELOPMENT SITE IS NOT CONSIDERED OF PRIMARY OR SUPPORTING SIGNIFICANCE AS NATURAL LANDS IN THE GREENSPACE MASTER PLAN.
