Phase Two Environmental Site Assessment

729 Ridgewood
Avenue
Ottawa, Ontario

Prepared for:
11684663 Canada
Inc.

August 14, 2020

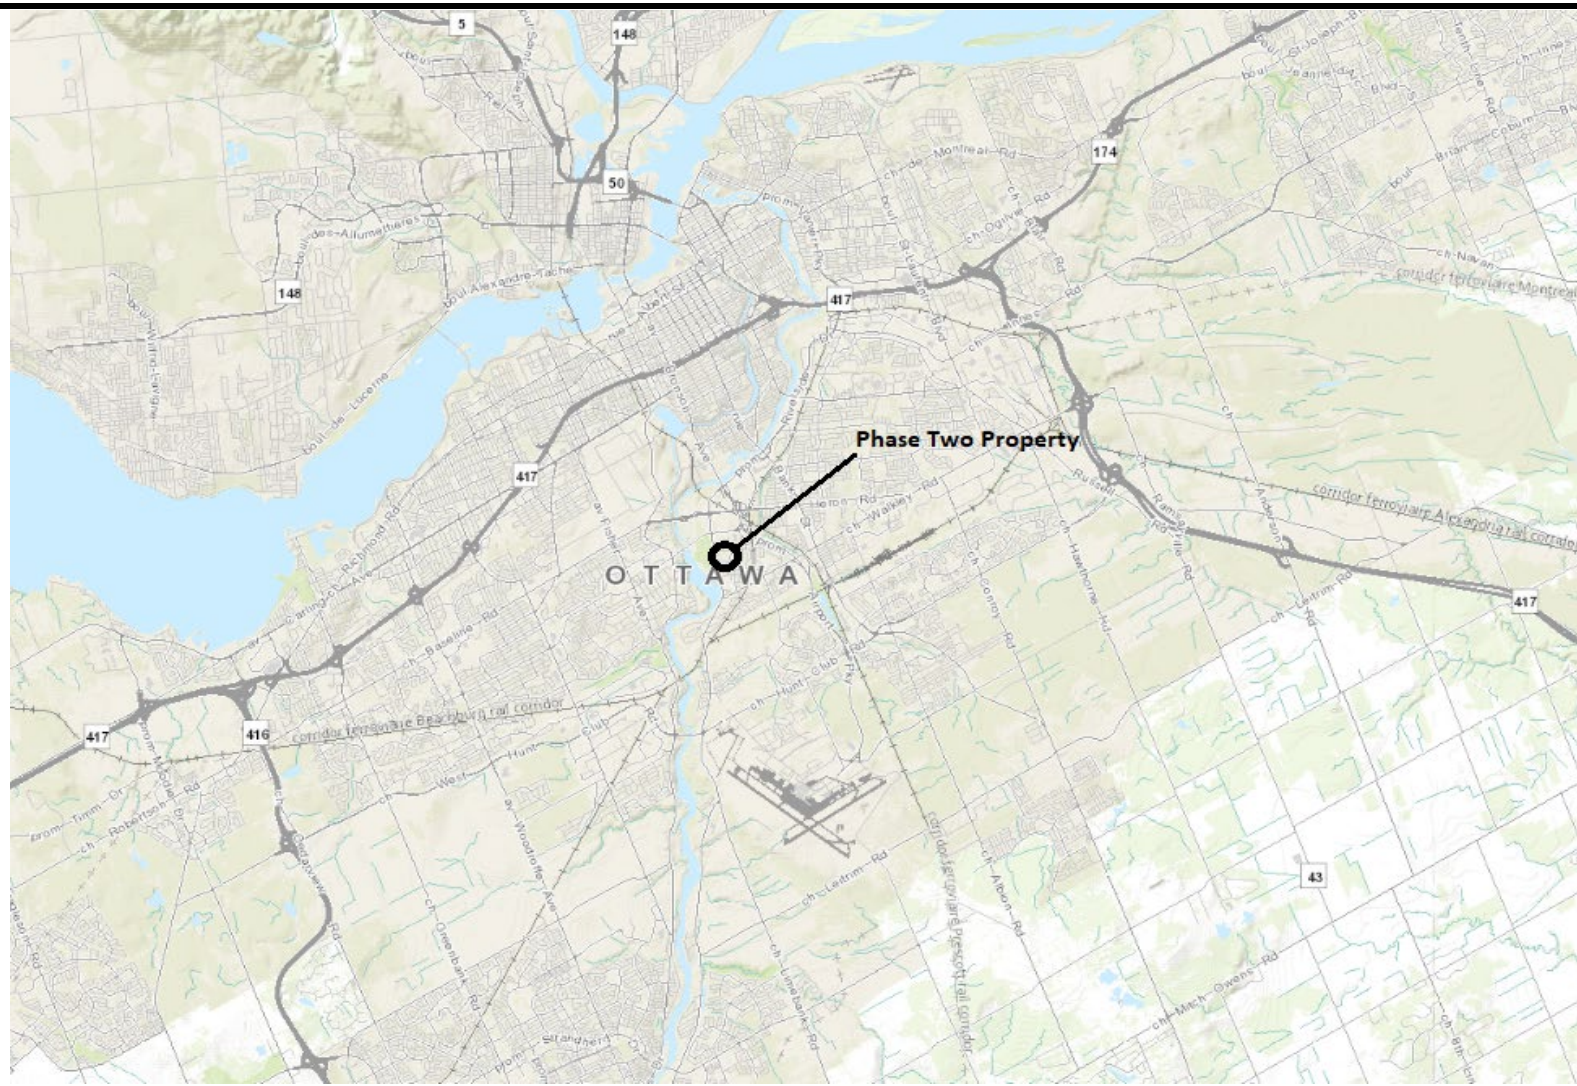
Figure 1: Key Plan
 Phase Two Environmental Site Assessment
 729 Ridgewood Avenue, Ottawa, Ontario
 11684663 Canada Inc.

Project Reference No: LOP20-002B
 Drawing No.: LOP20-002B-1
 Date: July 24, 2020
 Author: L. Lopers
 Source: geoOttawa, Base Mapping
