Phase I Environmental Site Assessment

1435-1455 Morisset Avenue
Ottawa, Ontario

EXECUTIVE SUMMARY

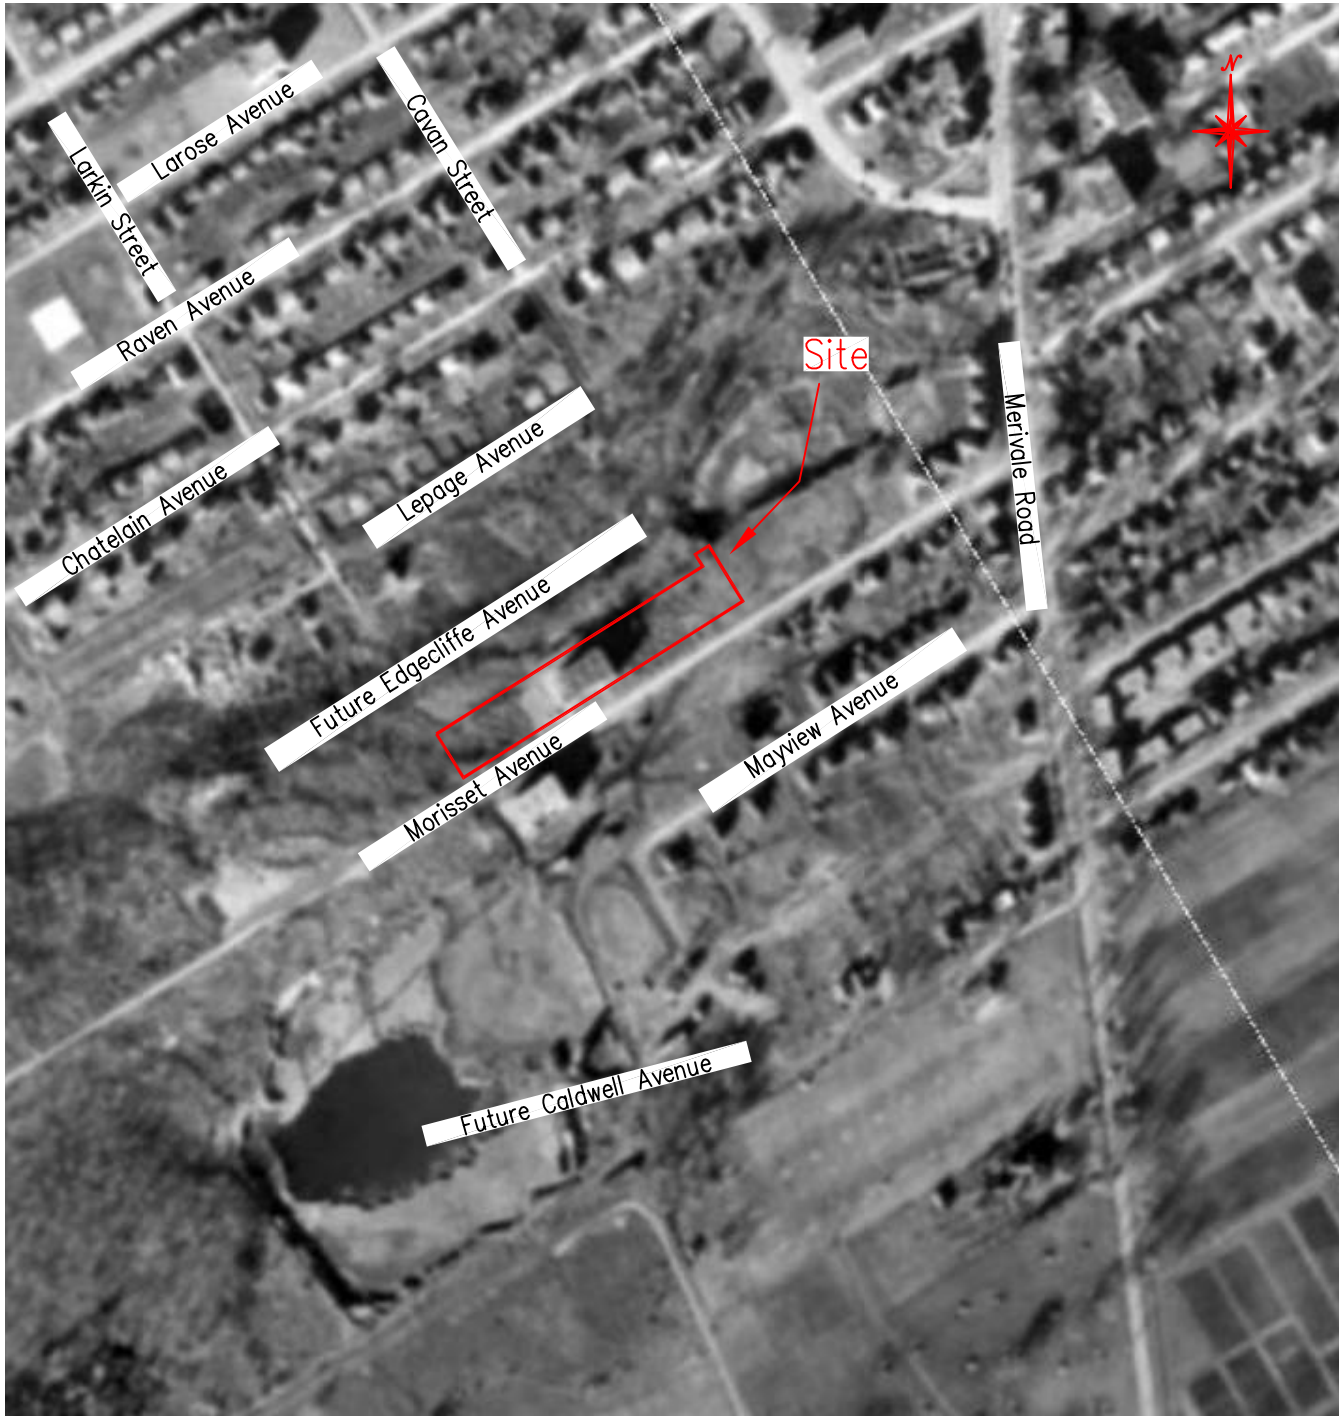
AP1958

- In 1958 (AP1958), the eastern and western portions of the Site are vacant. The building identified as 1455 Morisset Avenue is present in the central portion of the Site. Adjacent properties to the east, north and west are not developed. One property to the south is developed, and the development of a subdivision is occurring to the southeast. A pond is present approximately 150 m southwest and appears to have been created during construction activities.

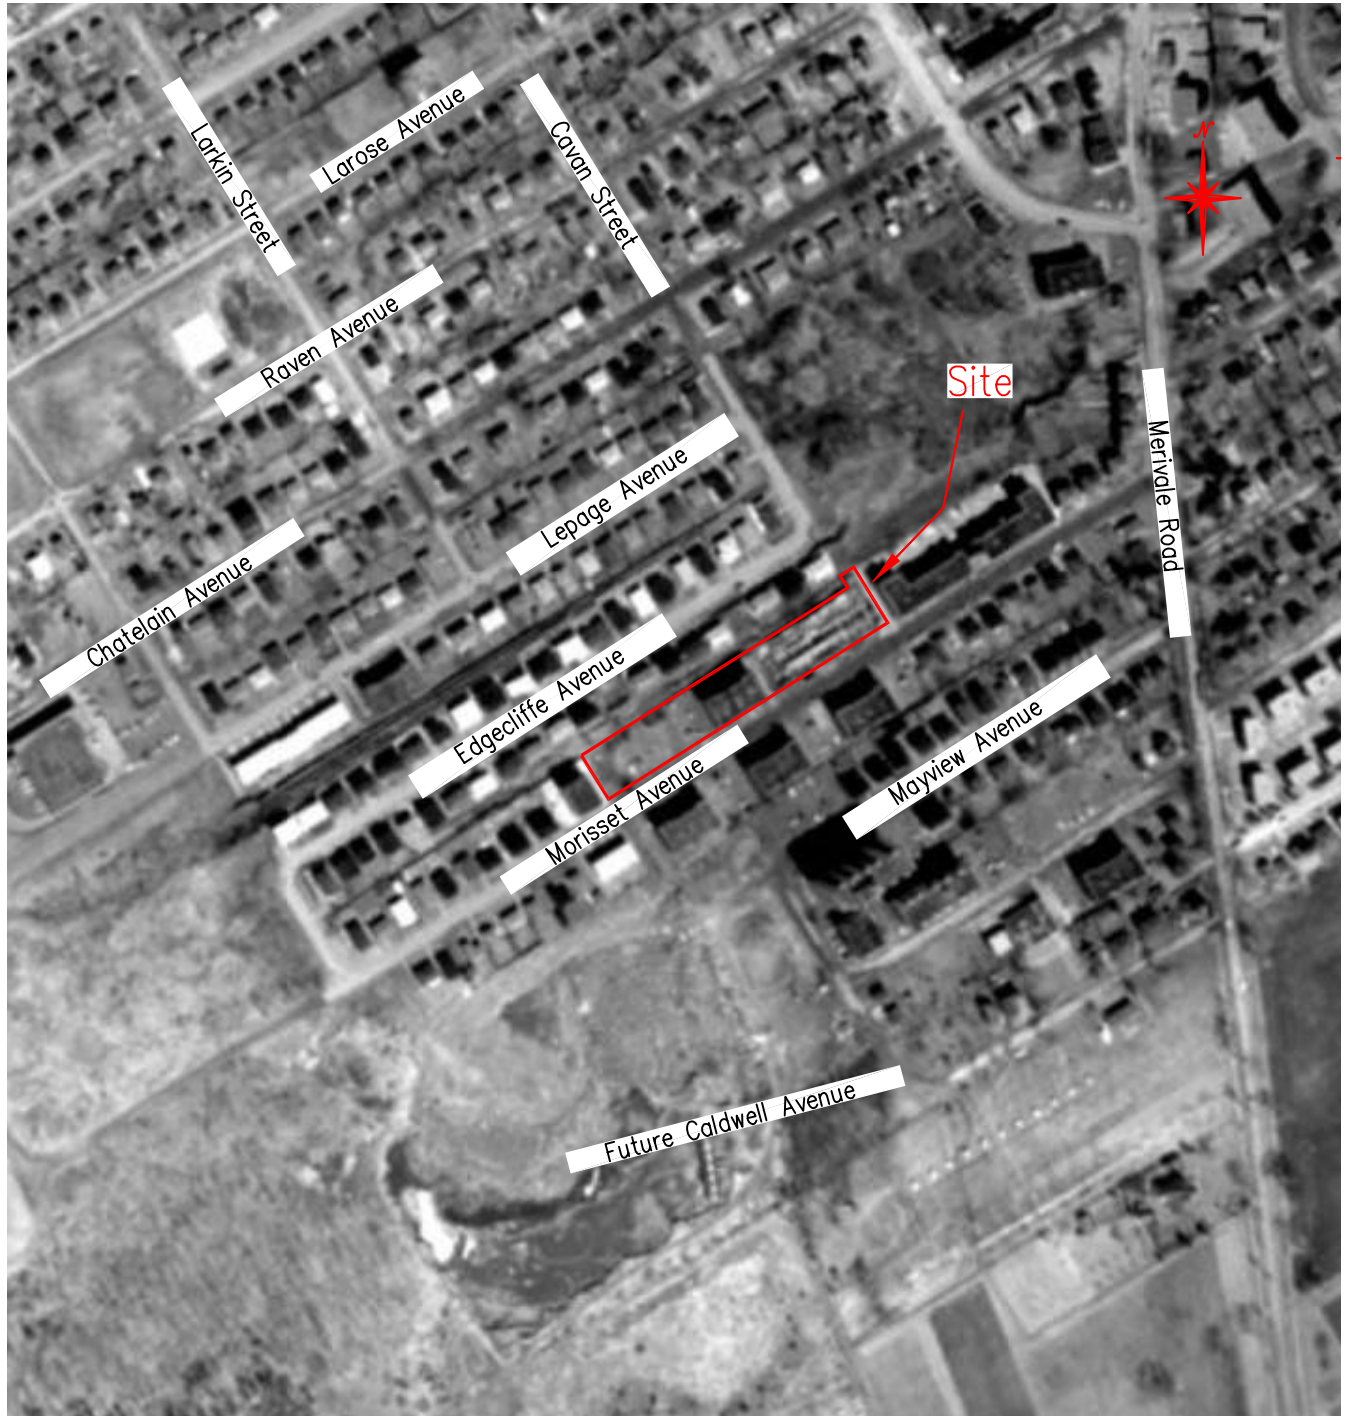
AP1965

- In 1965 (AP1965), the pond to the southwest is no longer present. The second building on-Site, identified as 1435 Morisset Avenue in the east portion, is under development. Adjacent properties to the north are developed with apparent residences, and the adjacent properties west, south, and east are developed with larger residential apartment buildings.

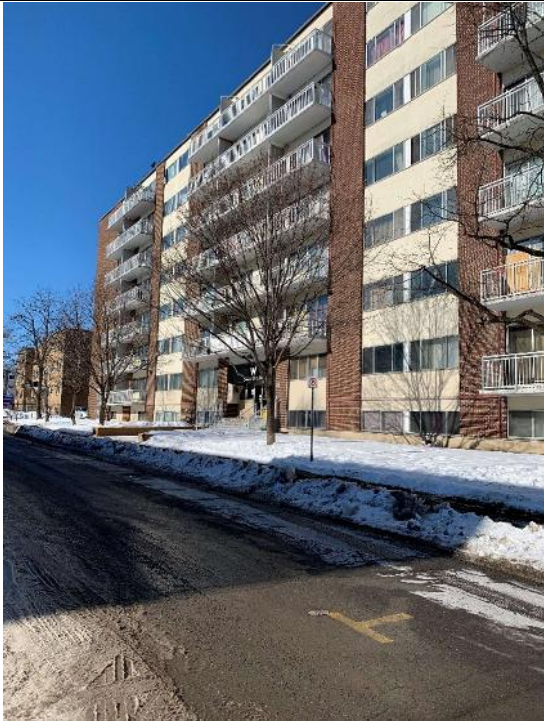
Photograph No. 1

Date: 11/02/2021	
Description Facing northwest. 1435 Morisset Avenue is in the foreground and 1455 Morisset avenue is visible in the background.

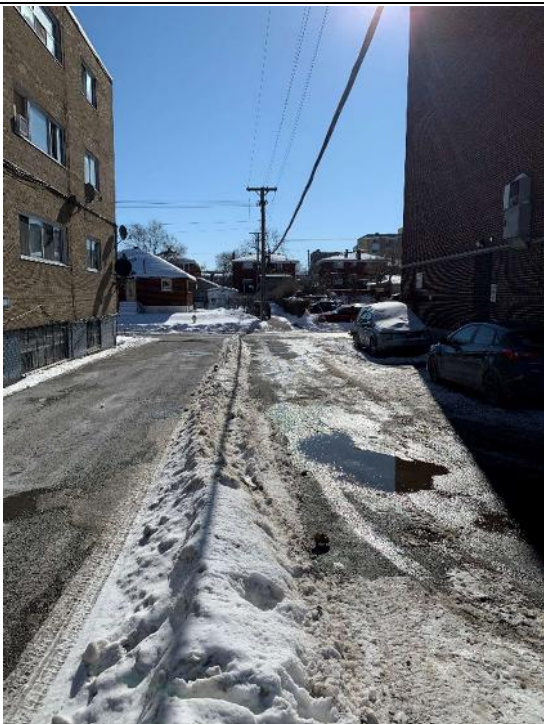
Photograph No. 2

Date: 11/02/2021	
Description Facing south along the eastern extent of the Site.

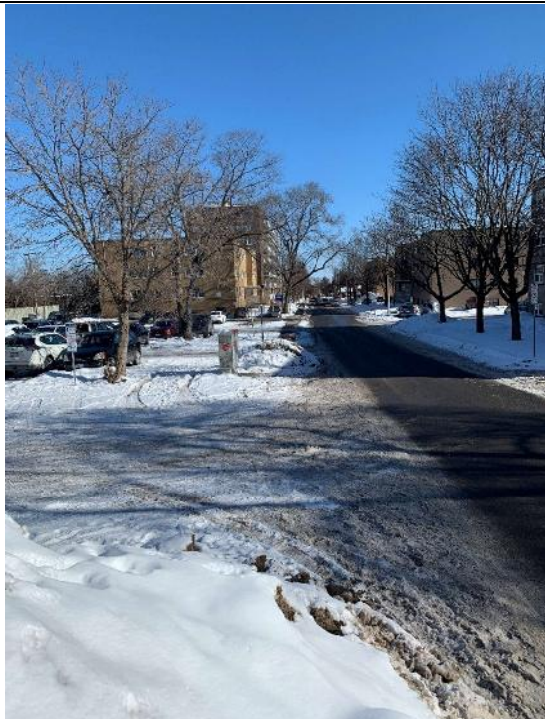
Photograph No. 4

Facing east along the southern extent of the Site. The Site parking lot present on the left, and Morisset Avenue is present on the right.

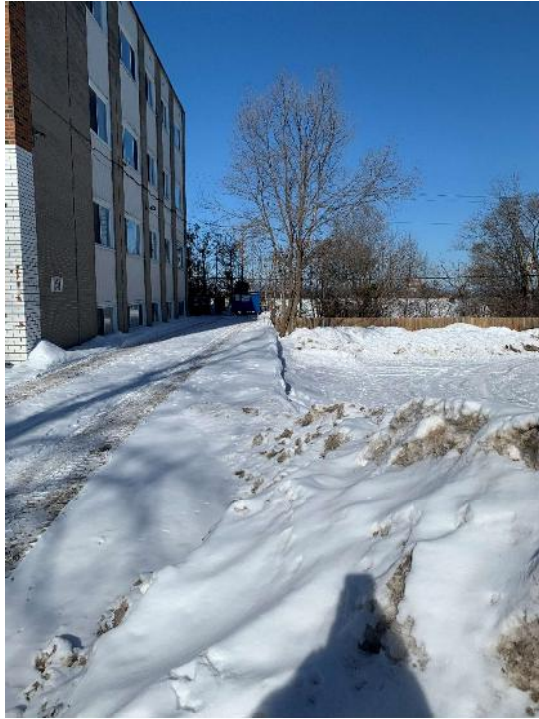
Photograph No. 5

Date: 11/02/2021		
<p>Description</p> <p>Facing north along the west extent of the Site. A retaining wall is present between the Site and the adjacent property to the west.</p>

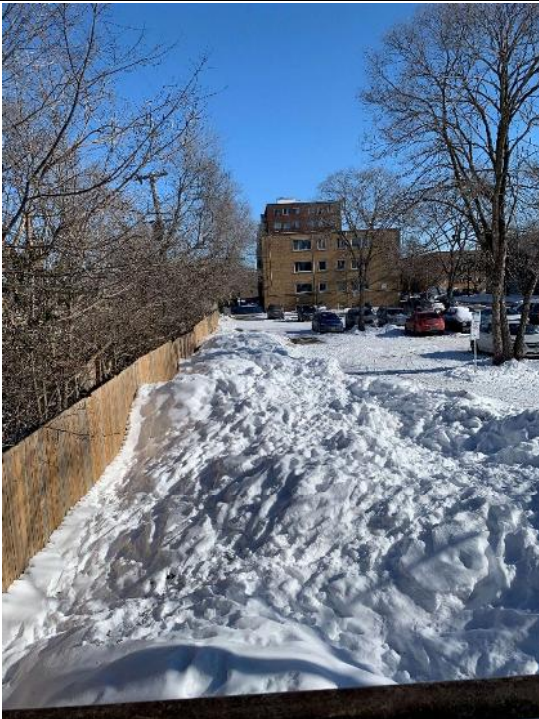
Photograph No. 6

Date: 11/02/2021		
<p>Description</p> <p>Facing east along the northern extent of the Site.</p>

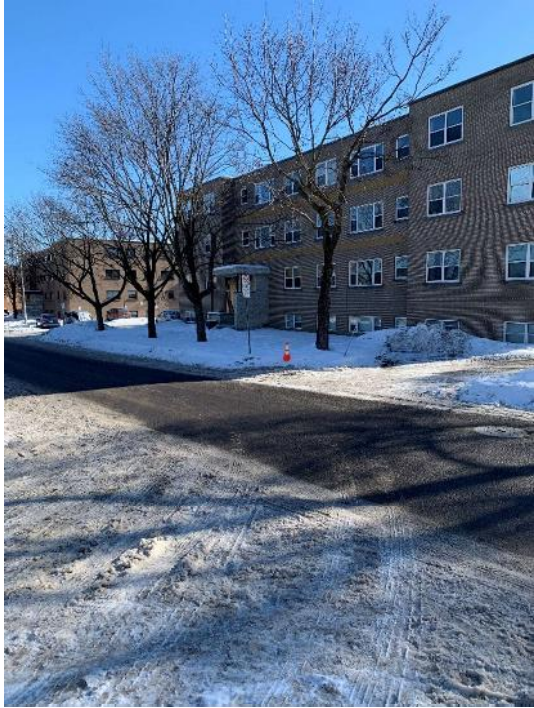
Photograph No. 7

Date: 11/02/2021		
Description Facing southeast. Adjacent properties to the south: Morisset Avenue followed by multi-tenant residential.

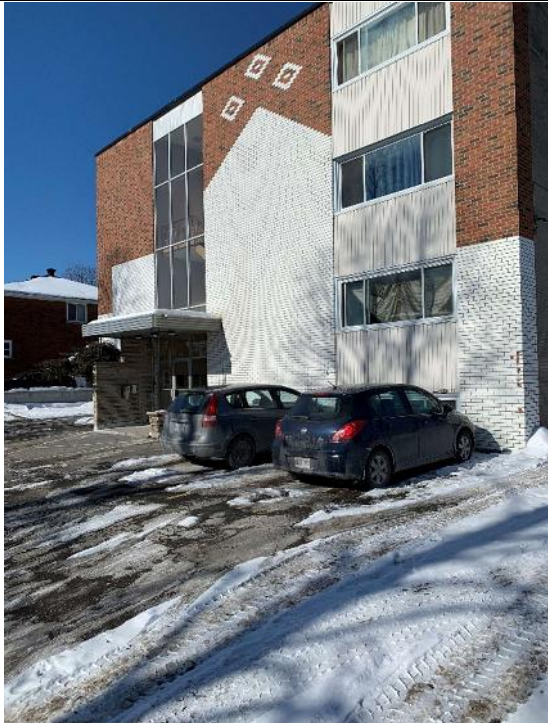
Photograph No. 8

Date: 11/02/2021		
Description Facing northwest. Adjacent property to the west: multi-tenant residential.

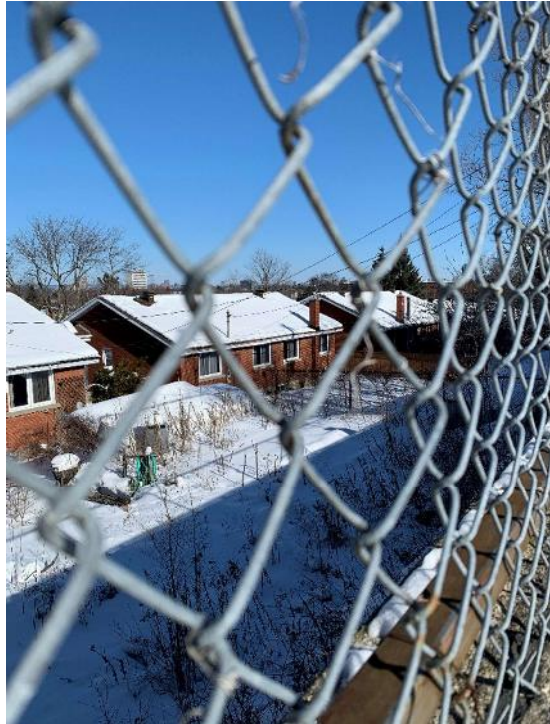
Photograph No. 9

Date: 11/02/2021		
Description Facing northeast. Adjacent properties to the north: residential. Significant drop in elevation to the north with retaining wall visible in the foreground.

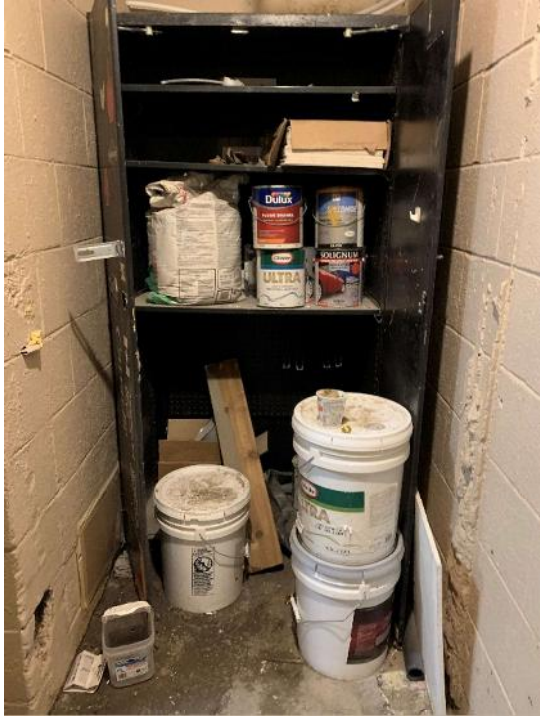
Photograph No. 11

Date: 11/02/2021	
Description Chemical storage in 1435 Morisset Avenue.

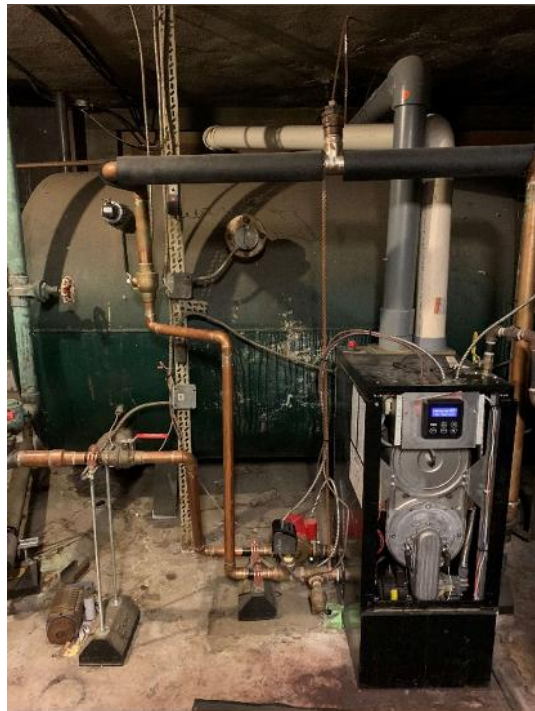
Photograph No. 12

Date: 11/02/2021	
Description Boiler room in in 1435 Morisset Avenue.

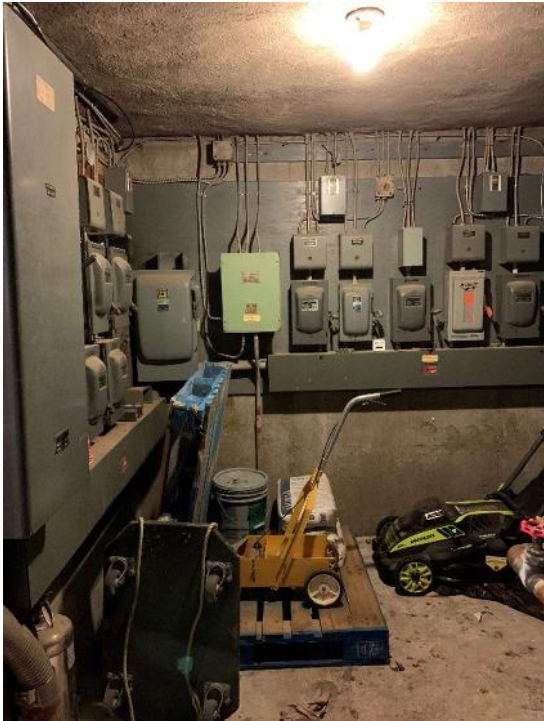
Photograph No. 13

Date: 11/02/2021		
Description Electrical room in 1435 Morisset Avenue.

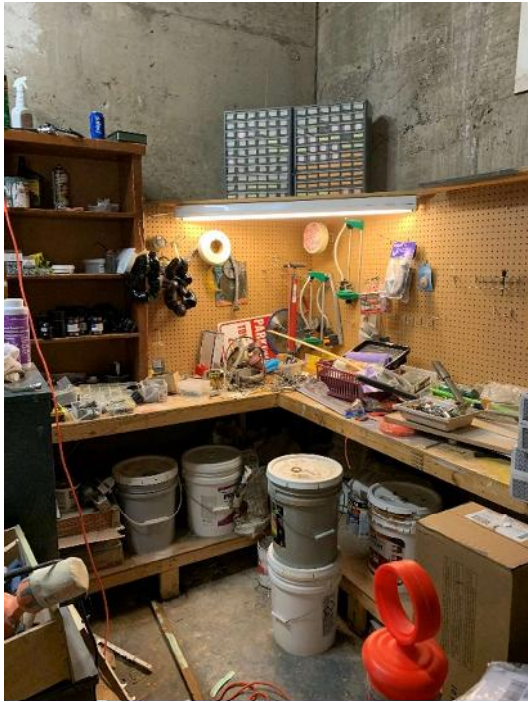
Photograph No. 14

Date: 11/02/2021		
Description Workshop and chemical storage in 1435 Morisset Avenue.

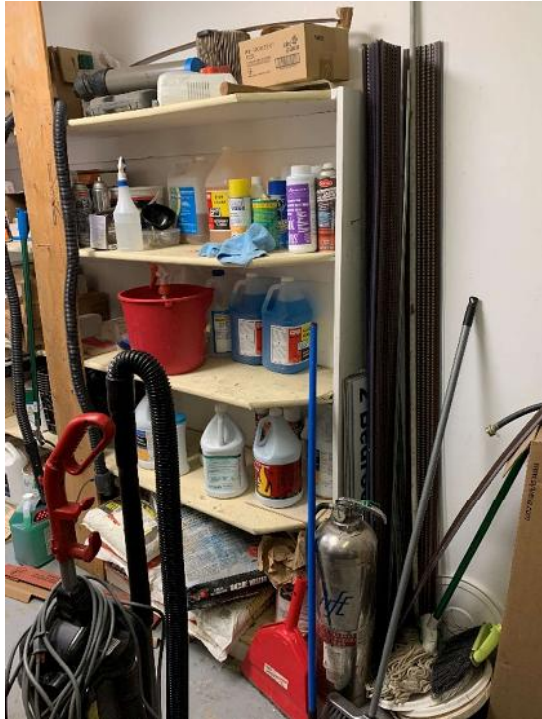
Photograph No. 15

Date: 11/02/2021		
Description Chemical storage in 1435 Morisset Avenue.

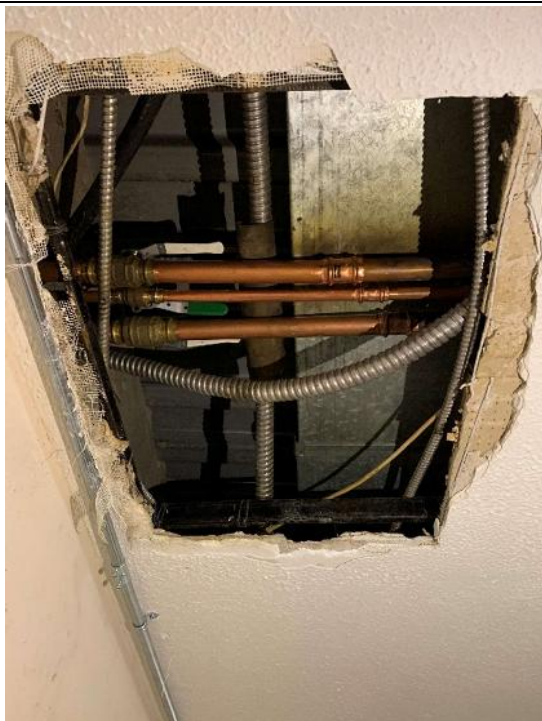
Photograph No. 16

Date: 11/02/2021		
Description Material removed from the hallway ceiling in 1435 Morisset Avenue due to water damage.

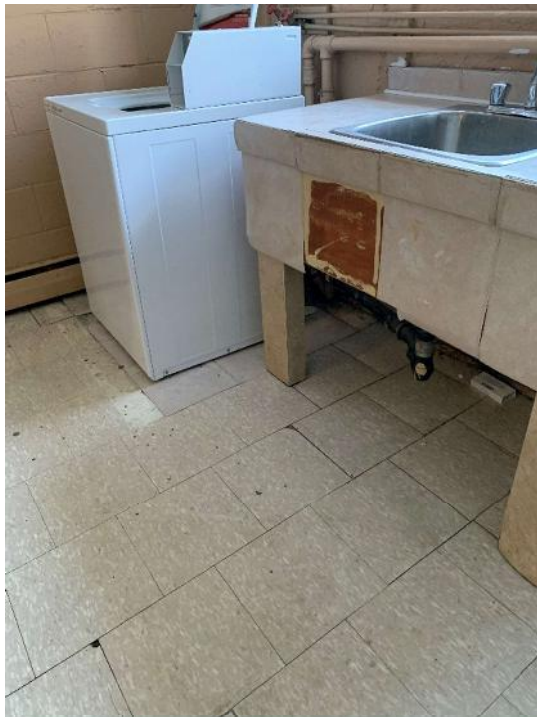
Photograph No. 20

Date: 11/02/2021	
Description Water damage noted on floor of laundry room in 1455 Morisset Avenue.

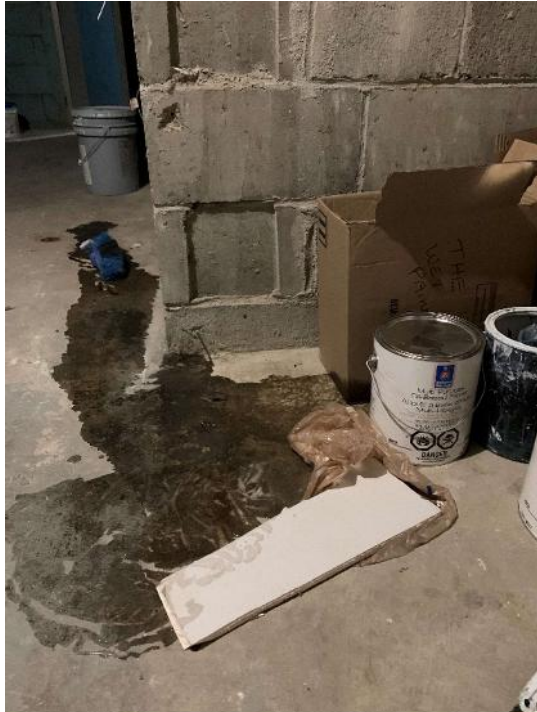
Photograph No. 21

property sealed and labelled, however, evidence of minor spills were observed in the basements of 1435 and 1455 Morisset Avenue. Some containers were not properly sealed labelled or stored.
--	-----------------------------------------------------------------------------------------------------------------------------------------------------------------------------------------------

Date: 11/02/2021	
Description Spill observed in electrical room of 1455 Morisset Avenue.

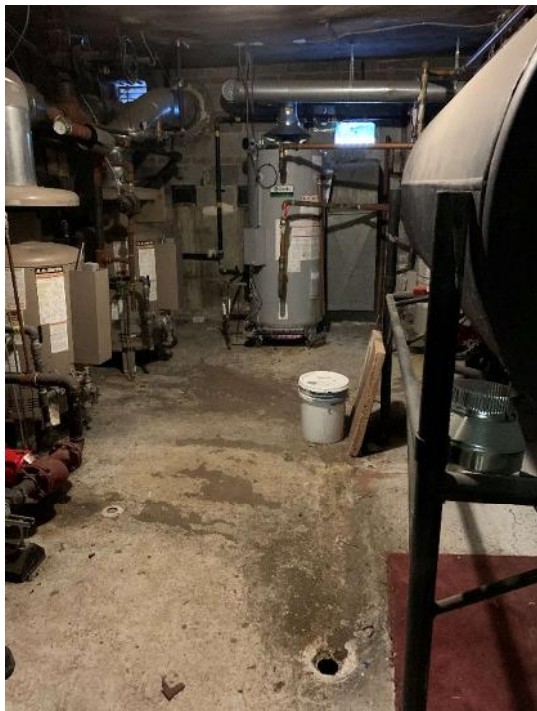
Photograph No. 22

Date: 11/02/2021	
Description Boiler room in 1455 Morisset Avenue.

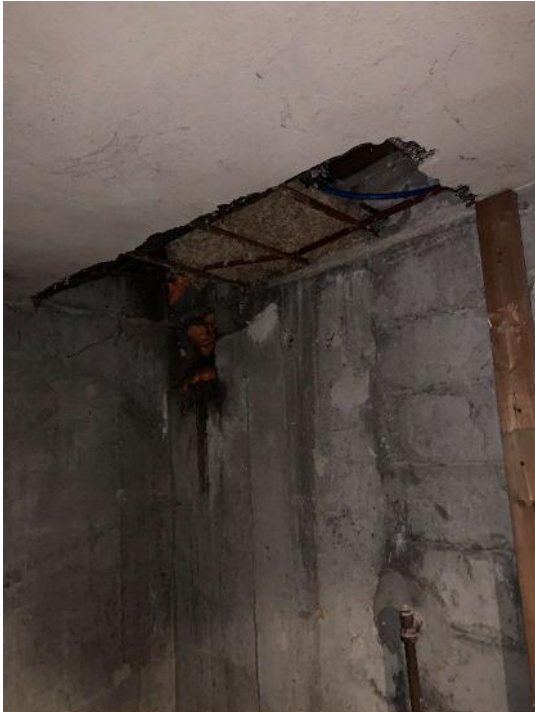
Photograph No. 23

Date: 11/02/2021	
Description Hole in ceiling of storage room in 1455 Morisset Avenue due to water damage.

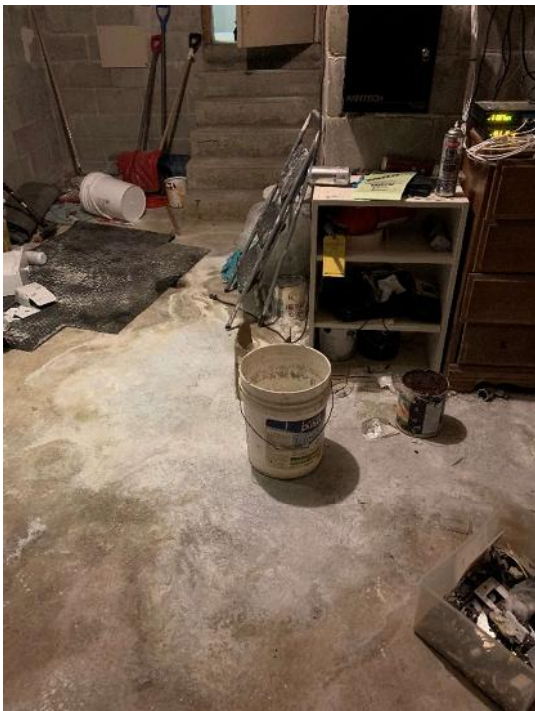
Photograph No. 24

Date: 11/02/2021	
Description Spill observed in storage room of 1455 Morisset Avenue leading to floor drain.
