# Phase One ESA Update

*RSC #3 - 175 Main Street, Ottawa ON*

**Golder Associates Ltd.**

July 2021

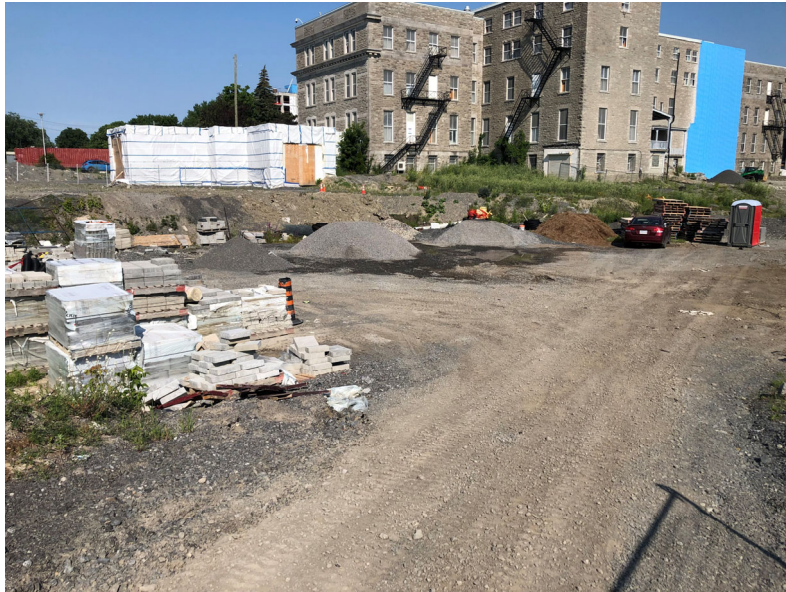
Photo 1 – Area being used for storage of construction and landscaping materials such as: bricks, patios stones, gravel and mulch.

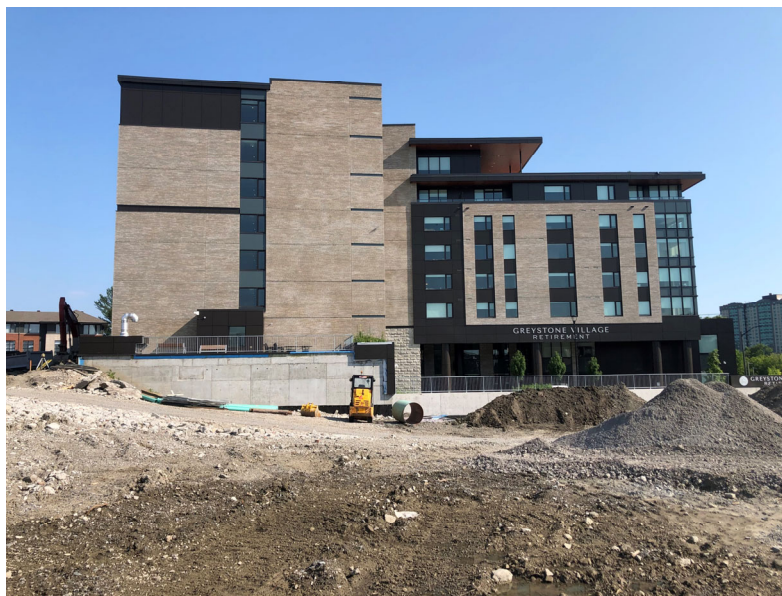
Photo 2 – View of residential building to the north of Site.

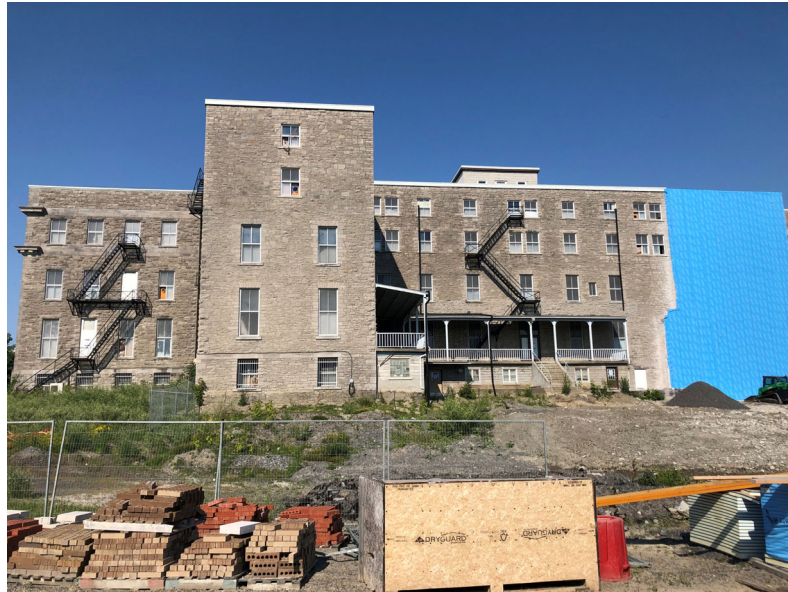
Photo 3 – View of Former Oblates residence to the west of site.

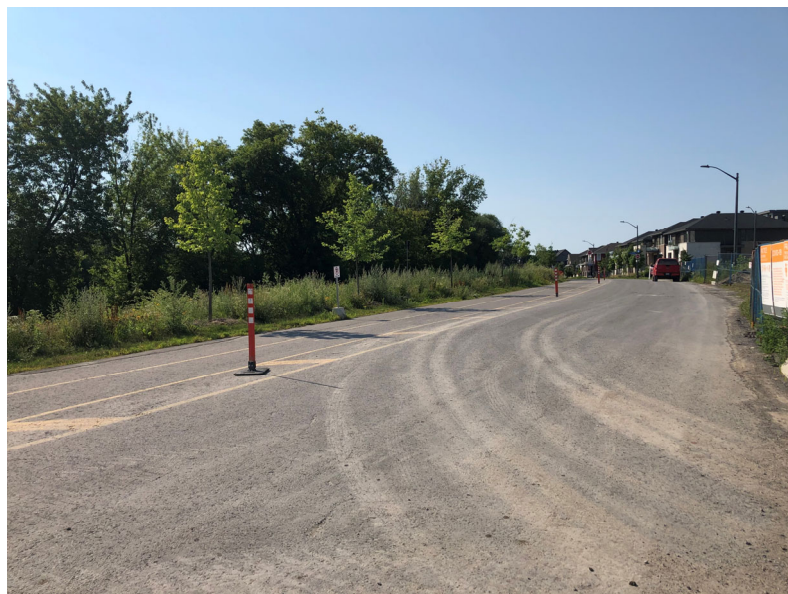
Photo 4 – View of Scholastic Drive (Paved residential street), followed by MUP and the Rideau River to the east of site.

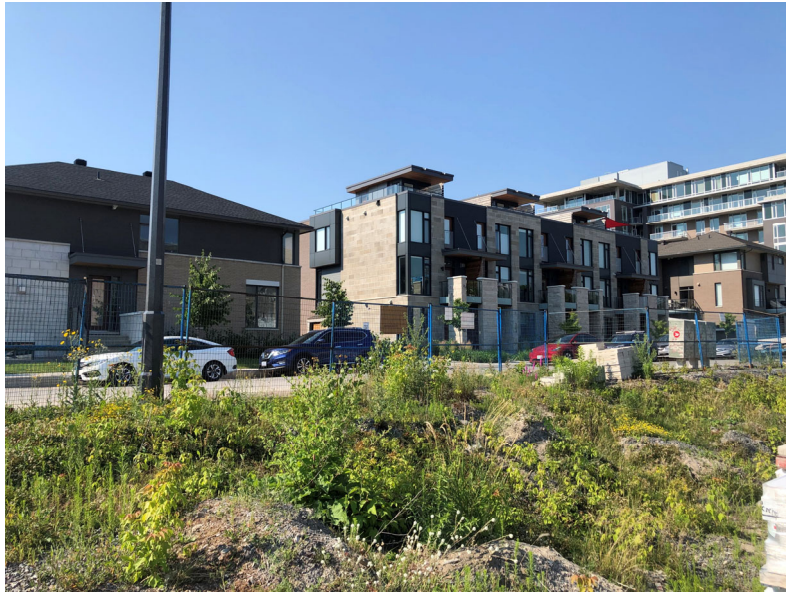
Photo 5 – View of Deschatelets Ave (Paved residential street), followed by condo buildings and houses to the south of site.
