Phase II - Environmental Site Assessment

70 Nicholas Street
Ottawa, Ontario

The Cadillac Fairview Corporation Limited

Report: PE5267-2

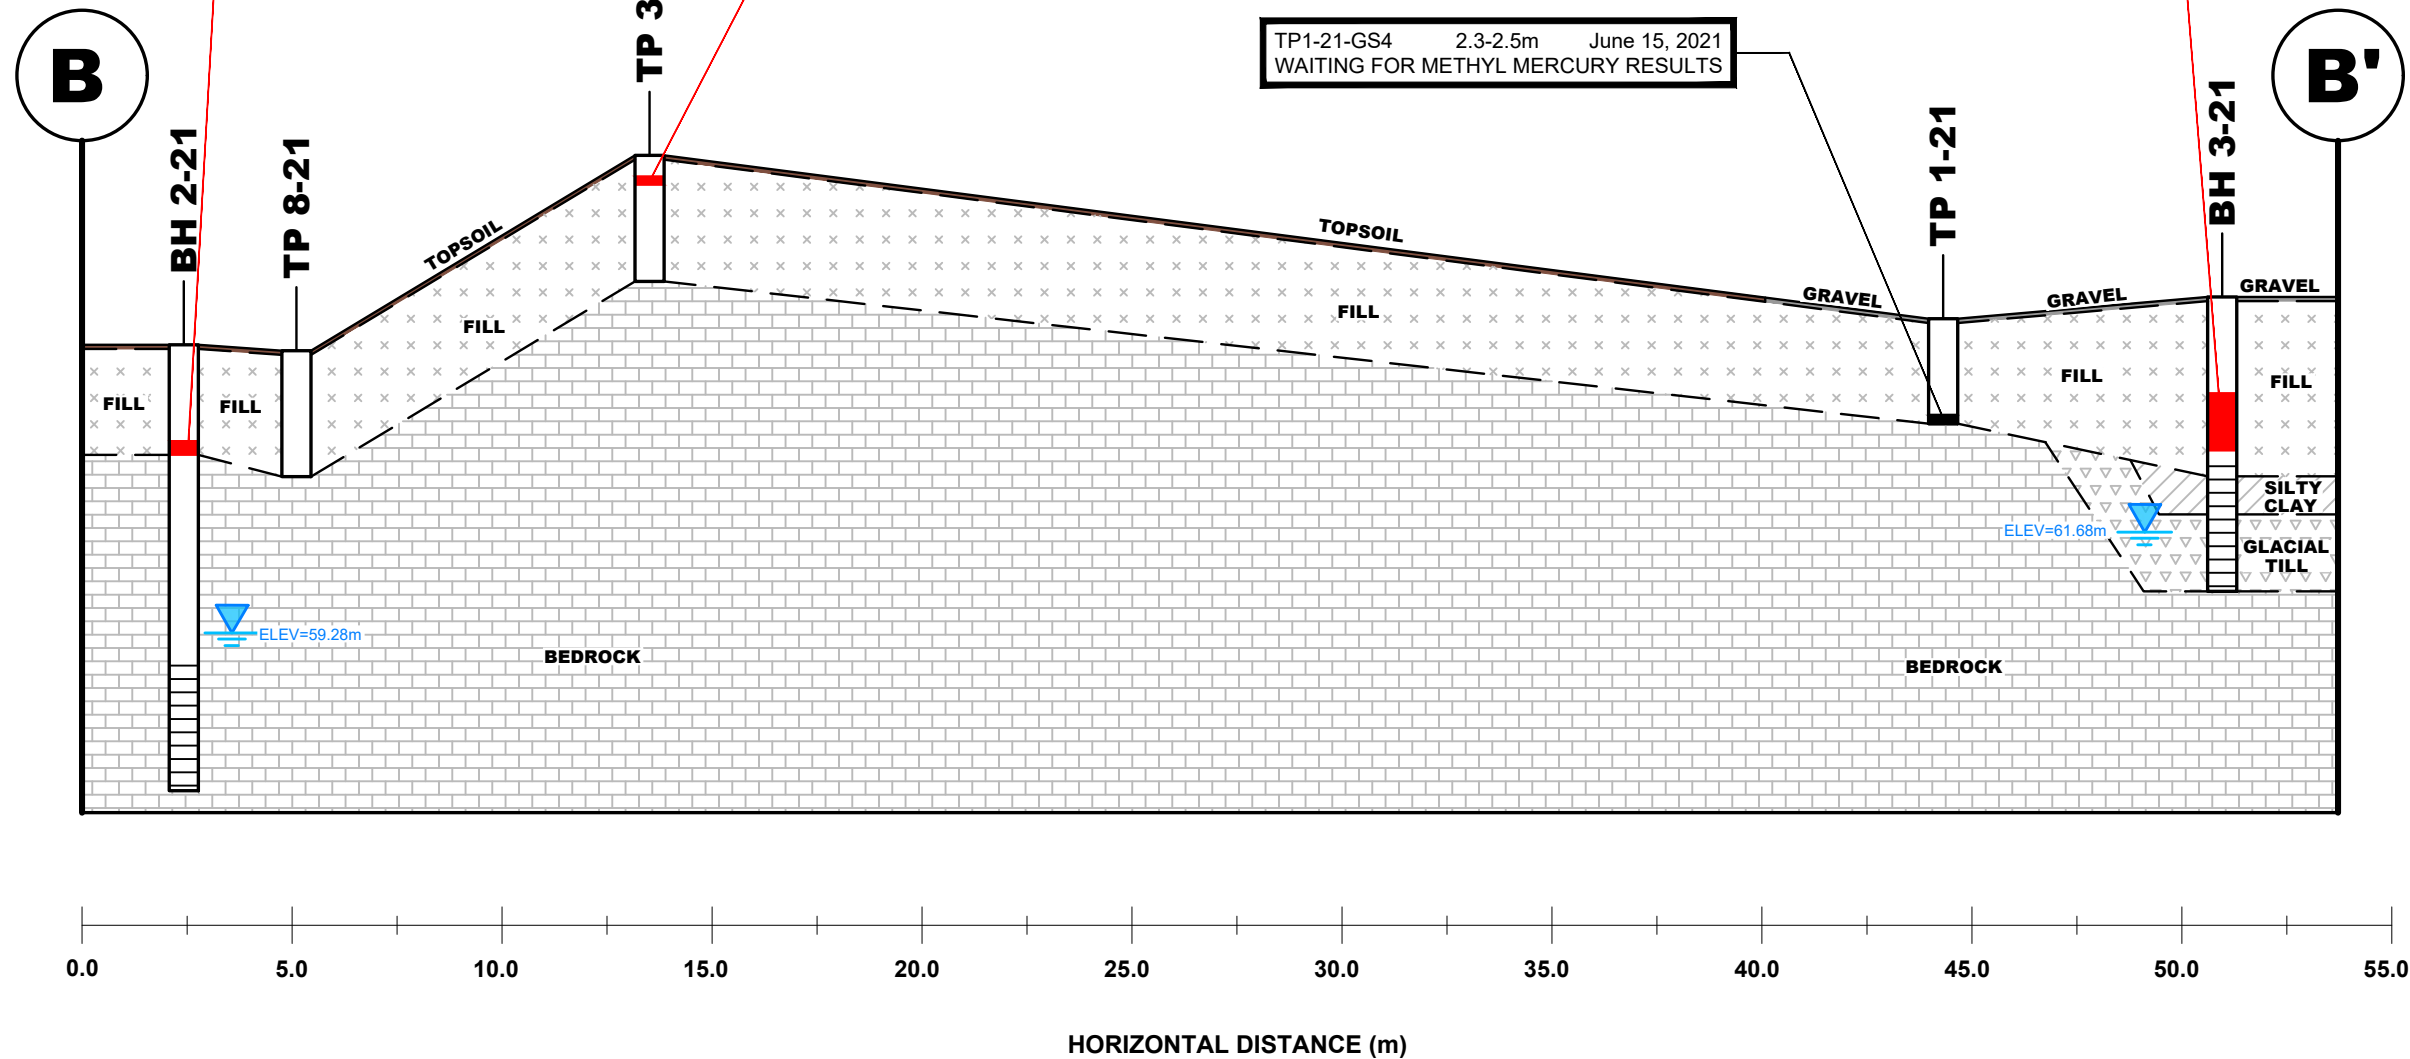
| Checked by: | JC | Dwg. No.: | PE5267-4B |

SOIL RESULT COMPLIES WITH MECP TABLE 3 STANDARDS

SOIL RESULT EXCEEDS MECP TABLE 3 STANDARDS

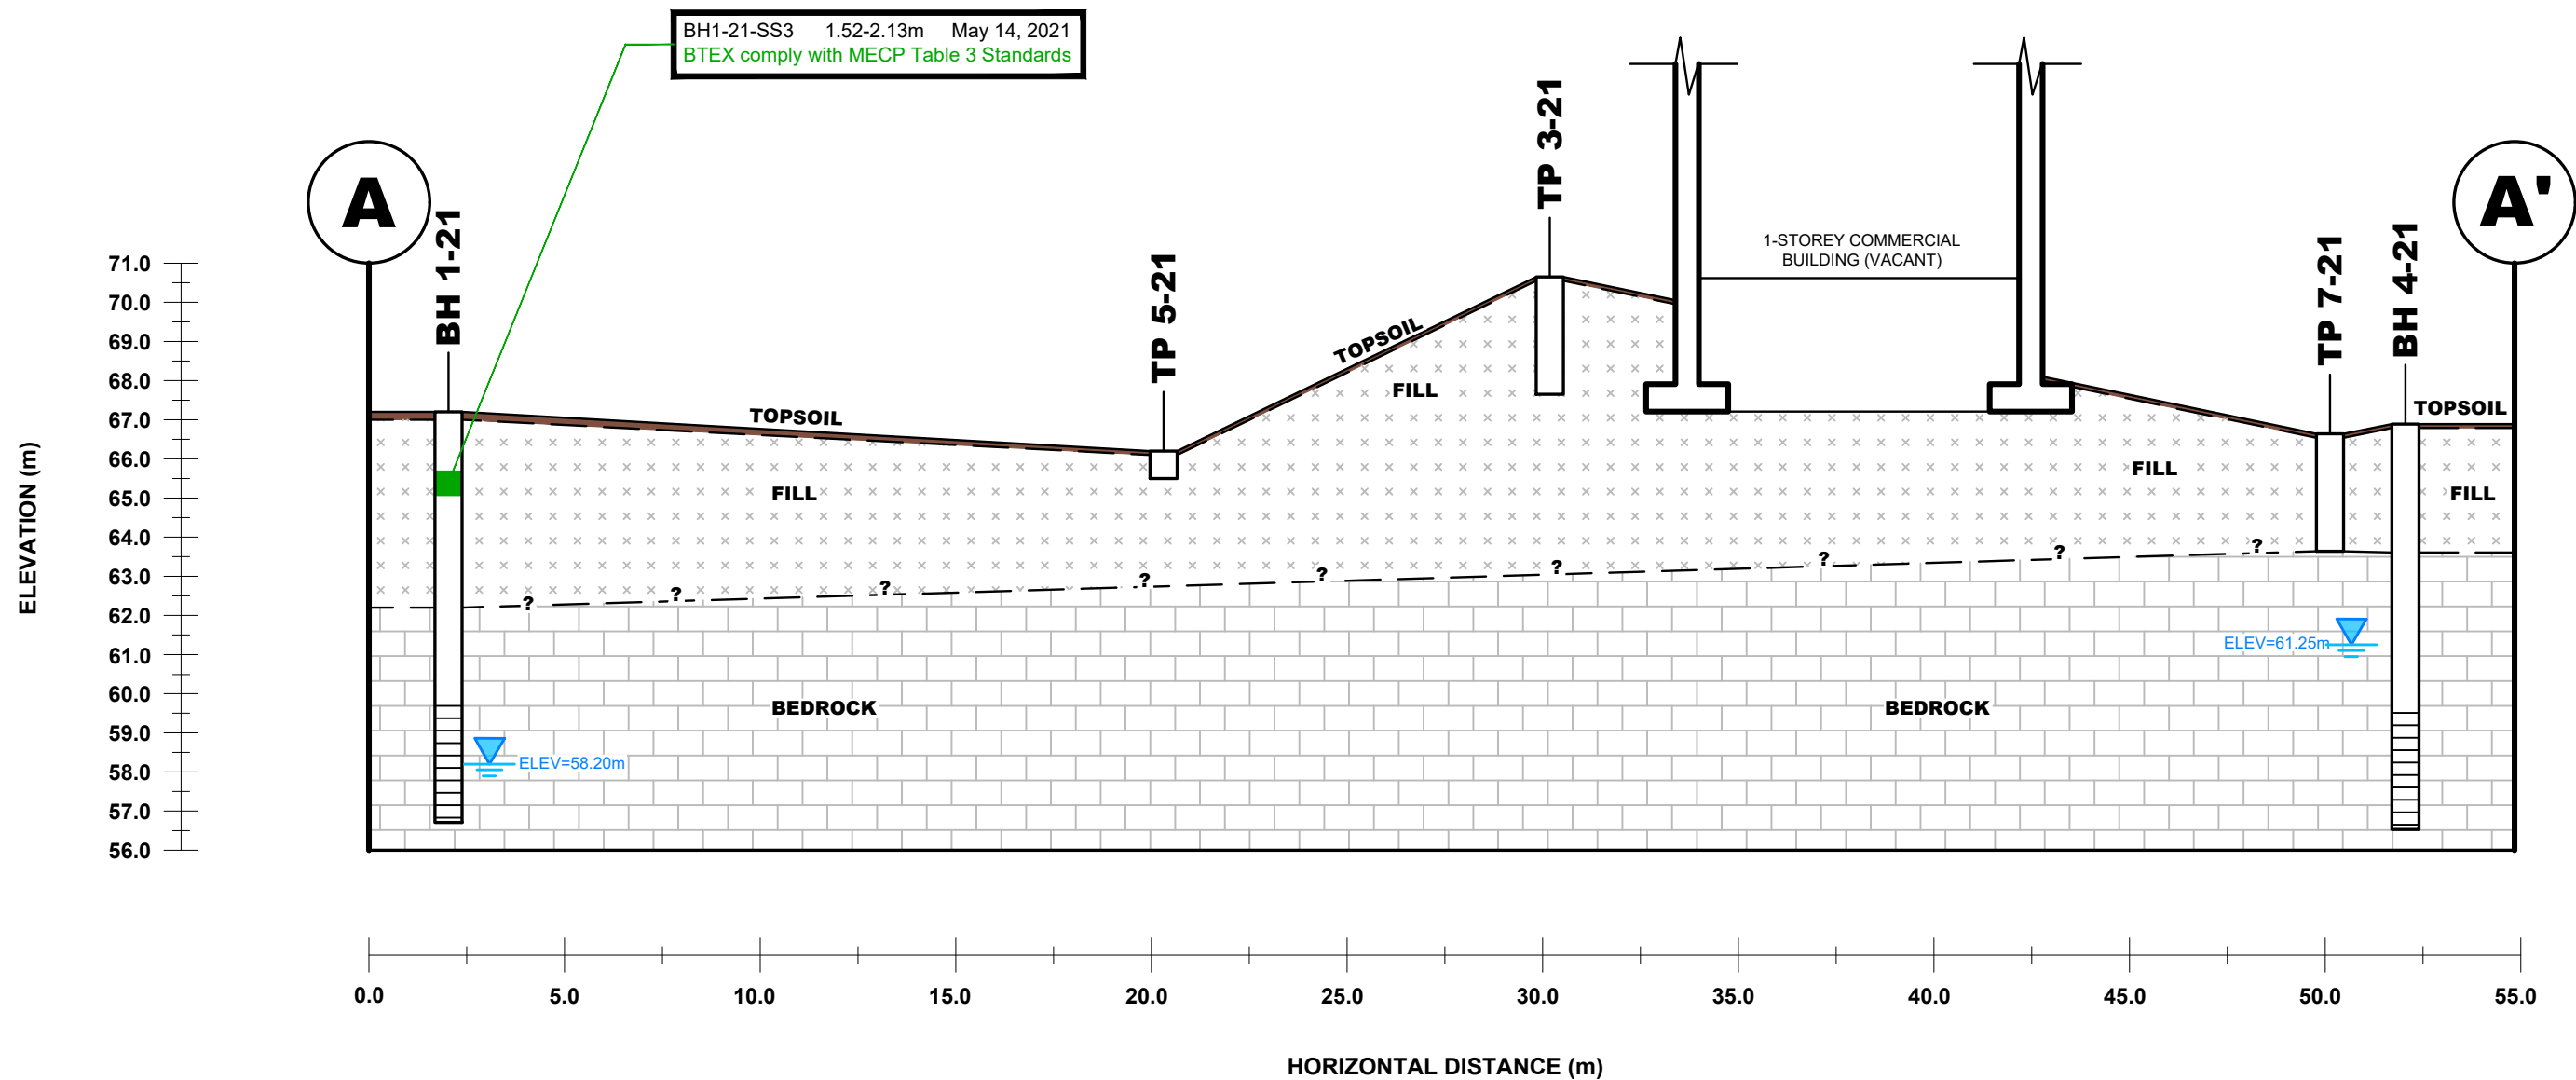
| Checked by: | JC | Dwg. No.: | PE5267-5A |

SOIL RESULT COMPLIES WITH MECP TABLE 3 STANDARDS

SOIL RESULT EXCEEDS MECP TABLE 3 STANDARDS

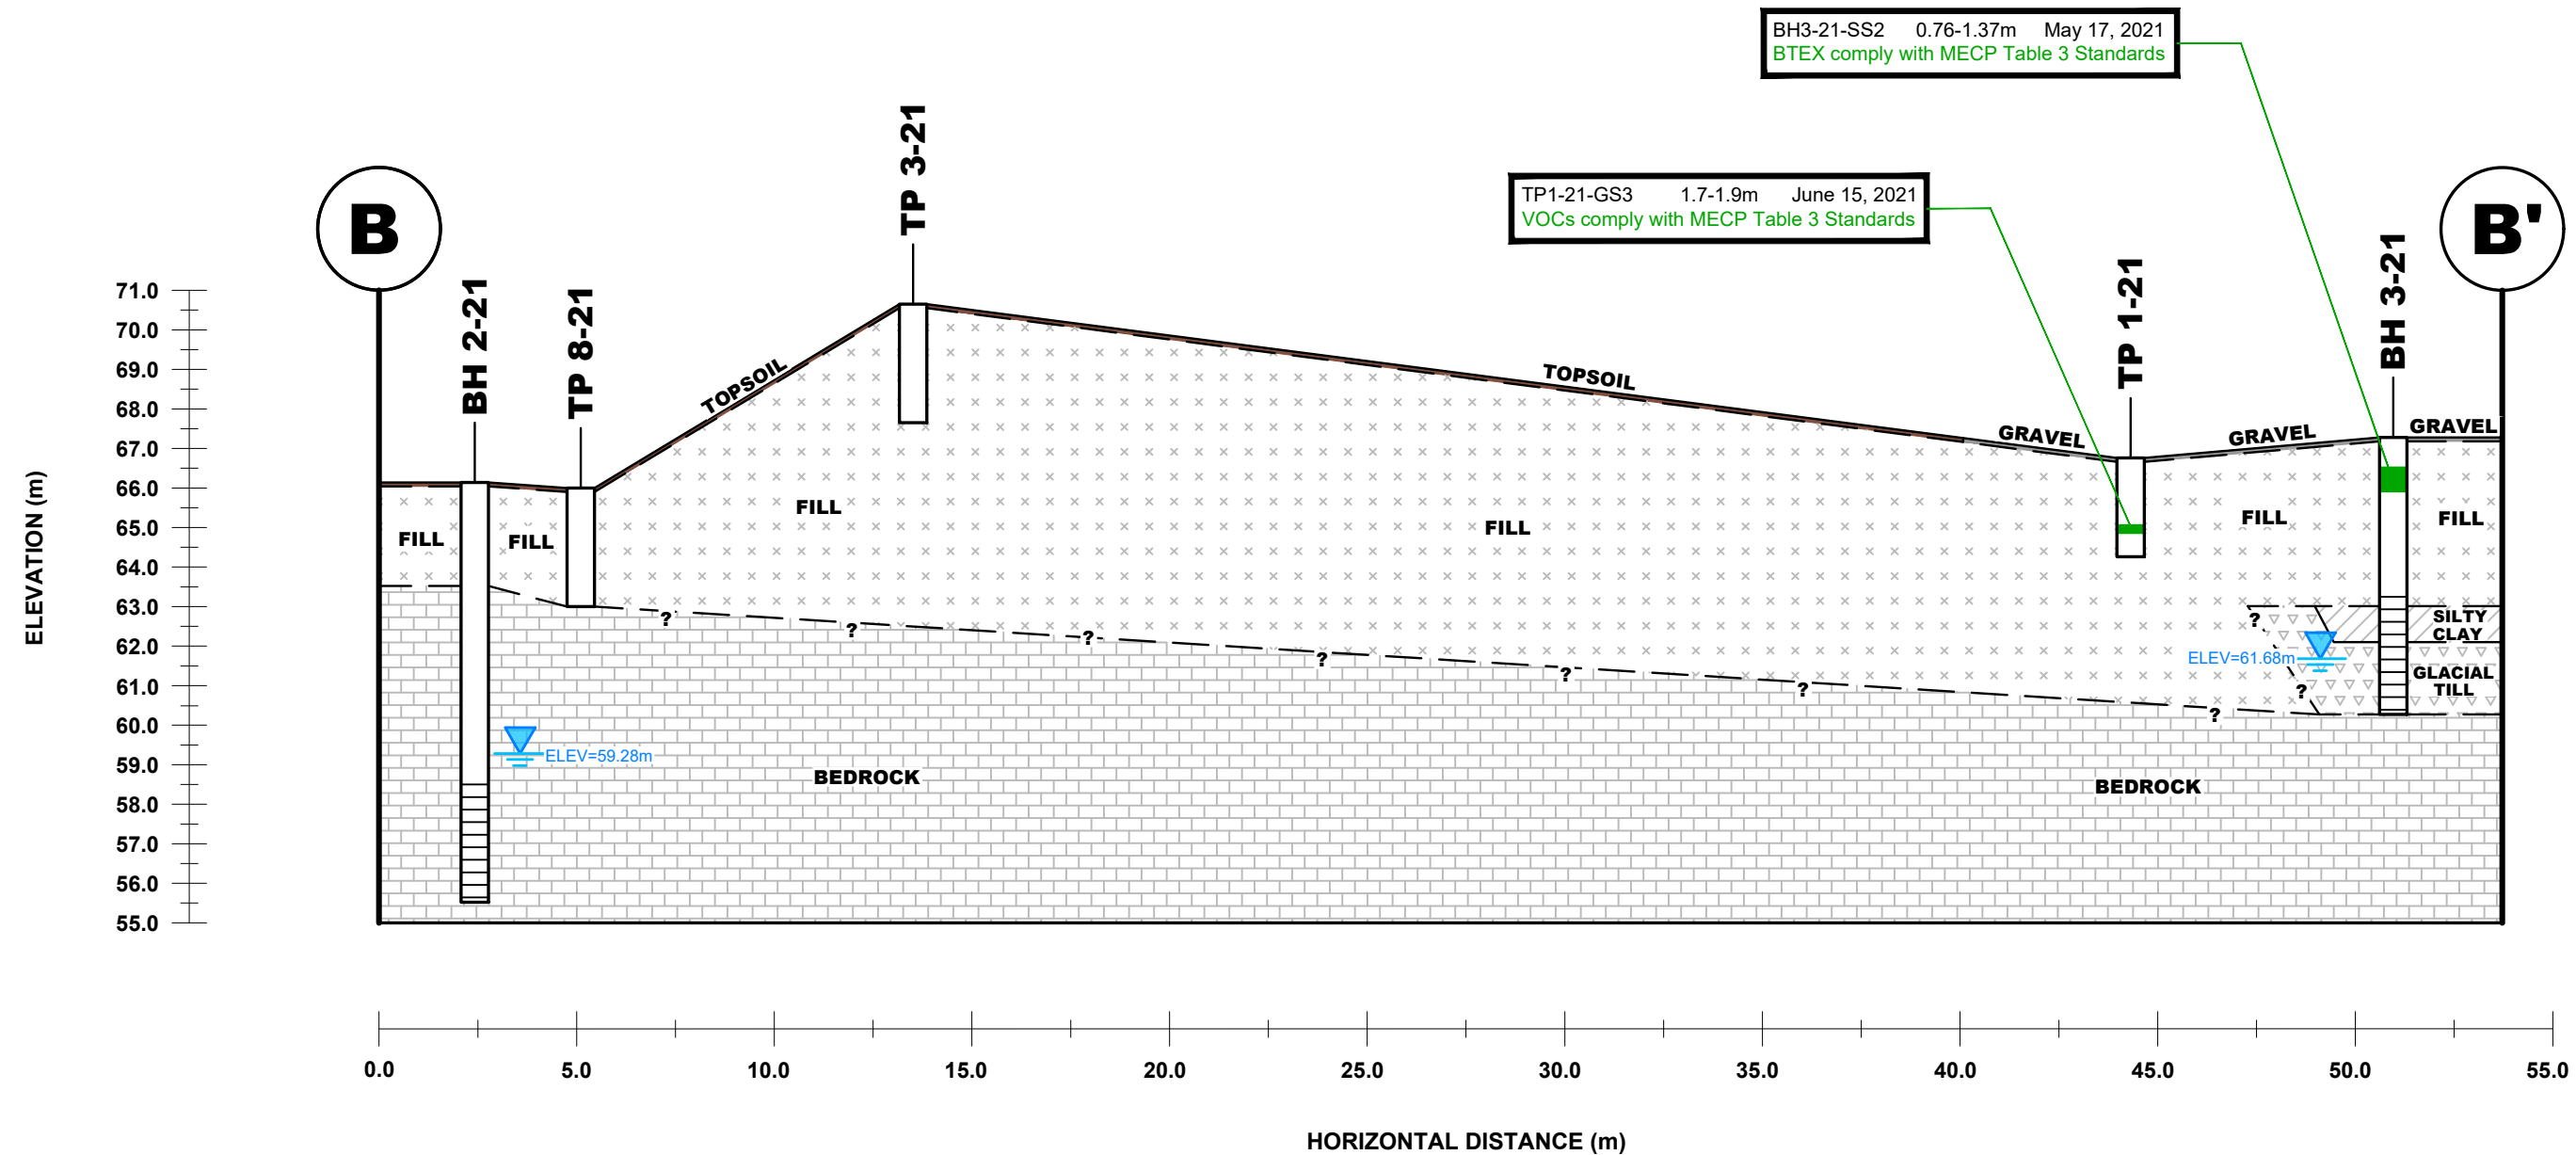
| Checked by: | JC | Dwg. No.: | PE5267-5B |

SOIL RESULT COMPLIES WITH MECP TABLE 3 STANDARDS

SOIL RESULT EXCEEDS MECP TABLE 3 STANDARDS
