**Environmental Impact Statement  
6150 Thunder Road, Ottawa**

**Updated Report**

**July 15, 2021**

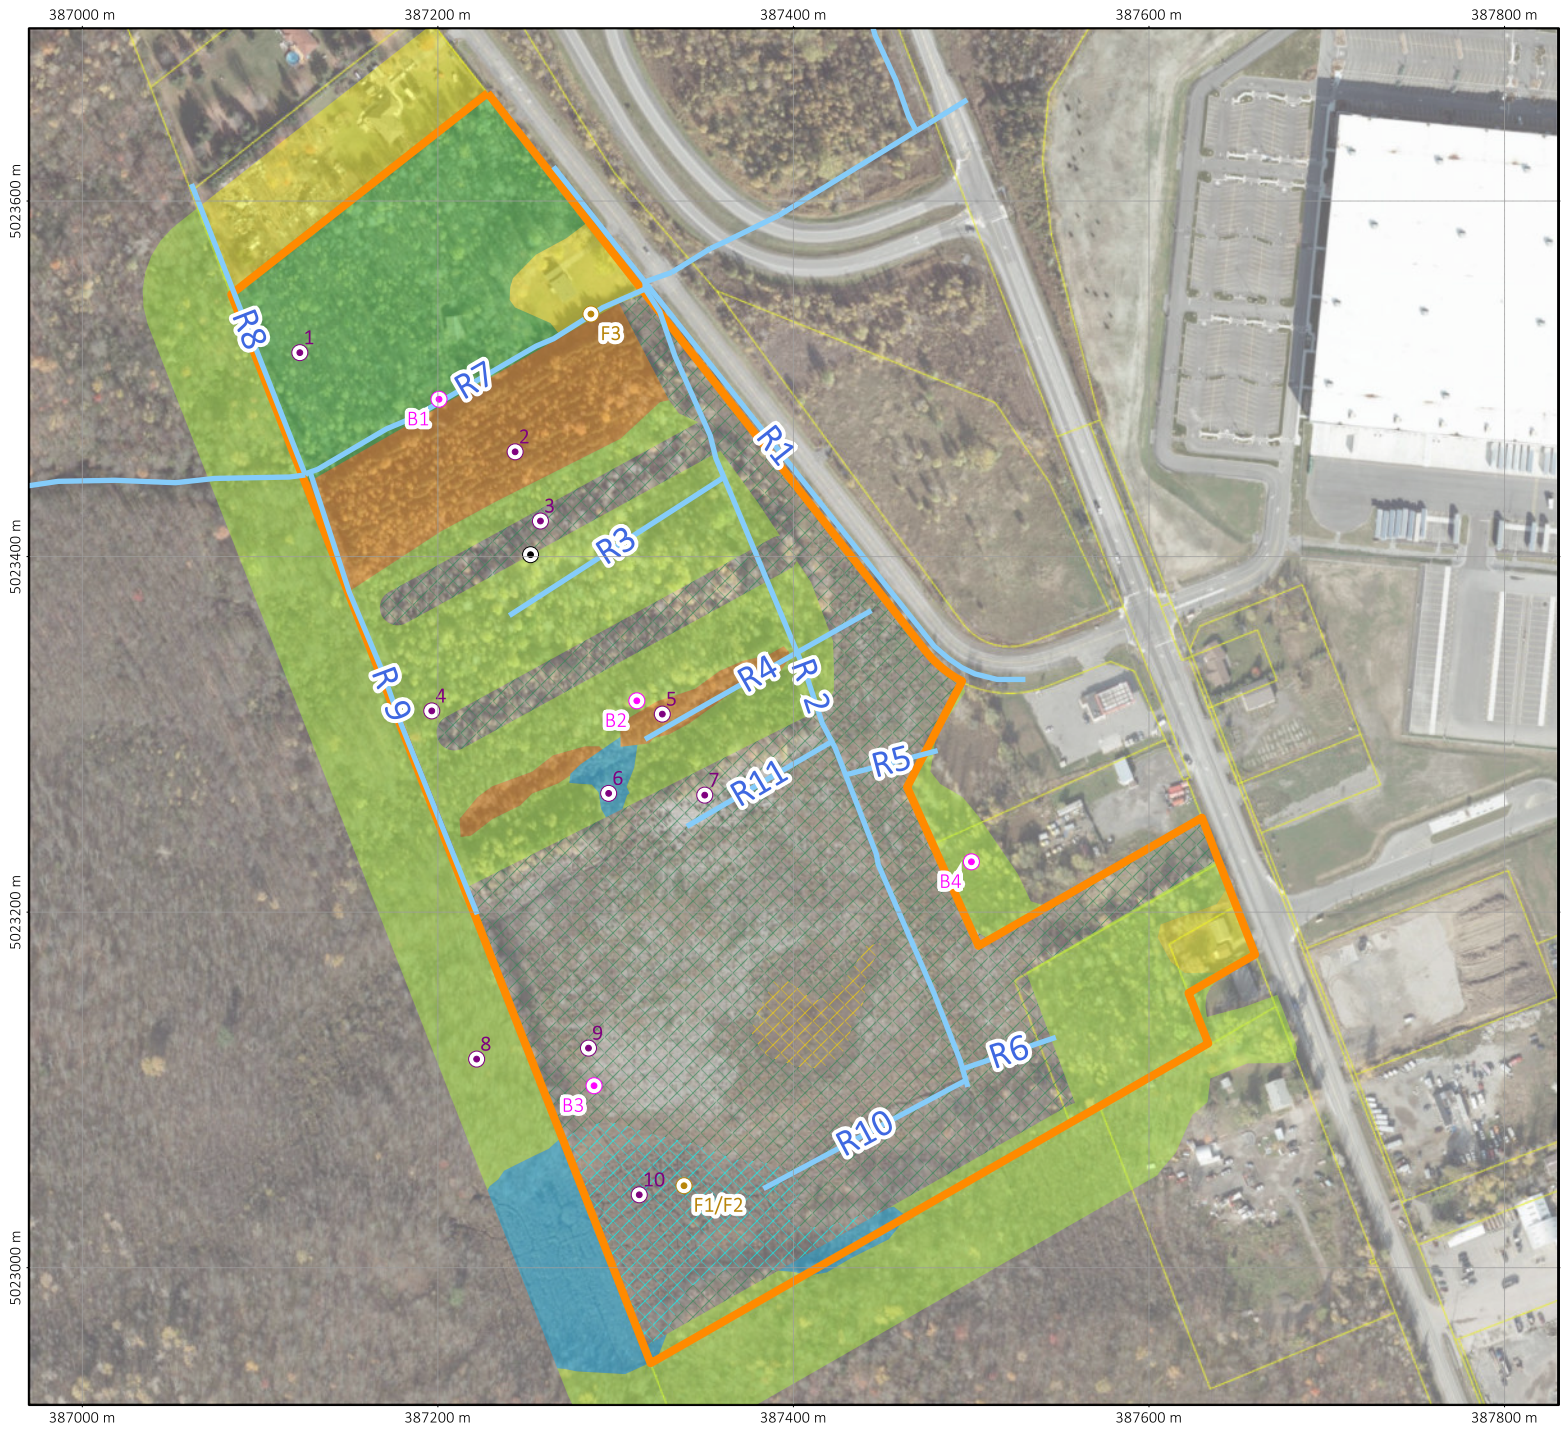
**Figure 2** Existing conditions

Channels R8 through R11 were either observed or created subsequent to the initial HDFA review (Appendix C).

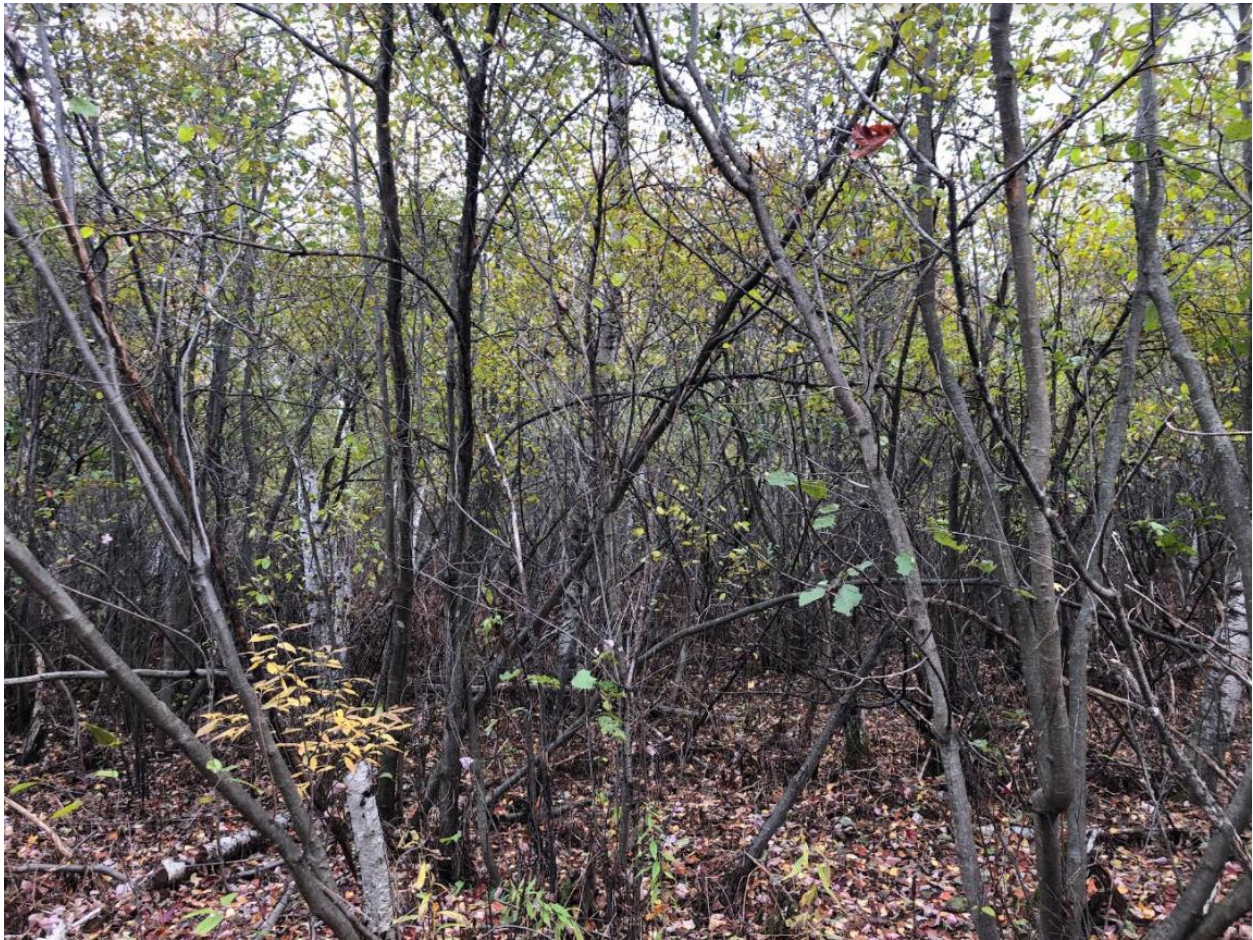
**FOD7 Ecosite**

The remainder of this original plantation area has grown over with species of trees common to the older forested areas south and west of the Site, with most of those areas now consisting of Fresh–Moist Lowland Deciduous Forest (FOD7). This ecosite consists of a mix of Red Maple and Green Ash, with subordinate species of Black Ash (*Fraxinus nigra*), American Elm (*Ulmus americana*), European Birch, Balsam Poplar, Largetooth Aspen (*Populus grandidentata*), Trembling Aspen, and Manitoba Maple (*Acer negundo*). A small number of the Red Maple, Trembling Aspen, and Balsam Poplar in the FOD7 ecosite are as large as 30 cm DBH, but most of the area is composed of smaller trees and saplings, representing a regenerating forest habitat that may be recovering from tree loss to due to occasional beaver-induced flooding. Common Buckthorn (*Rhamnus cathartica*) is also common in the understory. Within the re-naturalizing area of the FOD7 ecosite, some pockets have retained sufficient numbers of White Spruce and to suggest

up a Fresh – Moist White Spruce – Hardwood Mixed Forest (FOMM10-2) inclusions, though these pockets generally too small to delineate as separate ecosites.

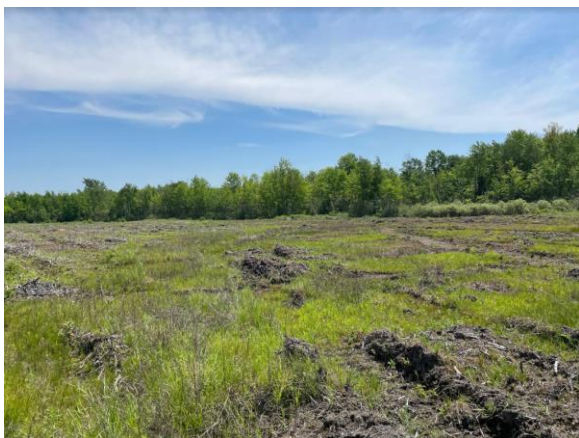
The southern portion of the Site was fully cleared of all vegetation in 2019. Vegetation cover here had previously consisted mostly of young, early-successional forest with the same FOD7 species mix apparent beyond the south and west site boundaries and present in the central portion of the Site. Trees here though had been the youngest on Site, with the forest cover only starting to develop in the late 1990s. A small pocket of SWT2 thicket swamp is located just off the southwest edge of the Site with the same species mix present the SWT2 pocket in the center of the site.

**Cleared area**

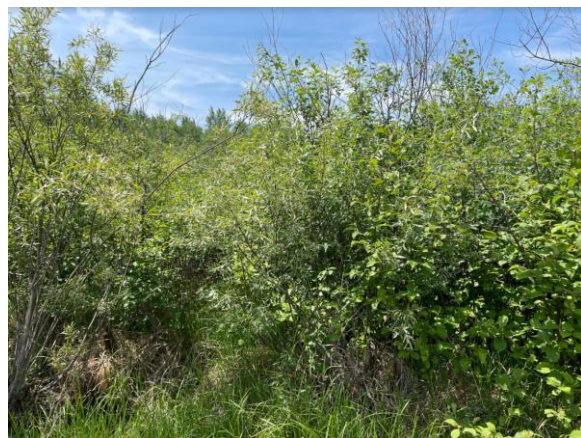
**Adjacent SWT2 ecosit off the SW corner of the Site**

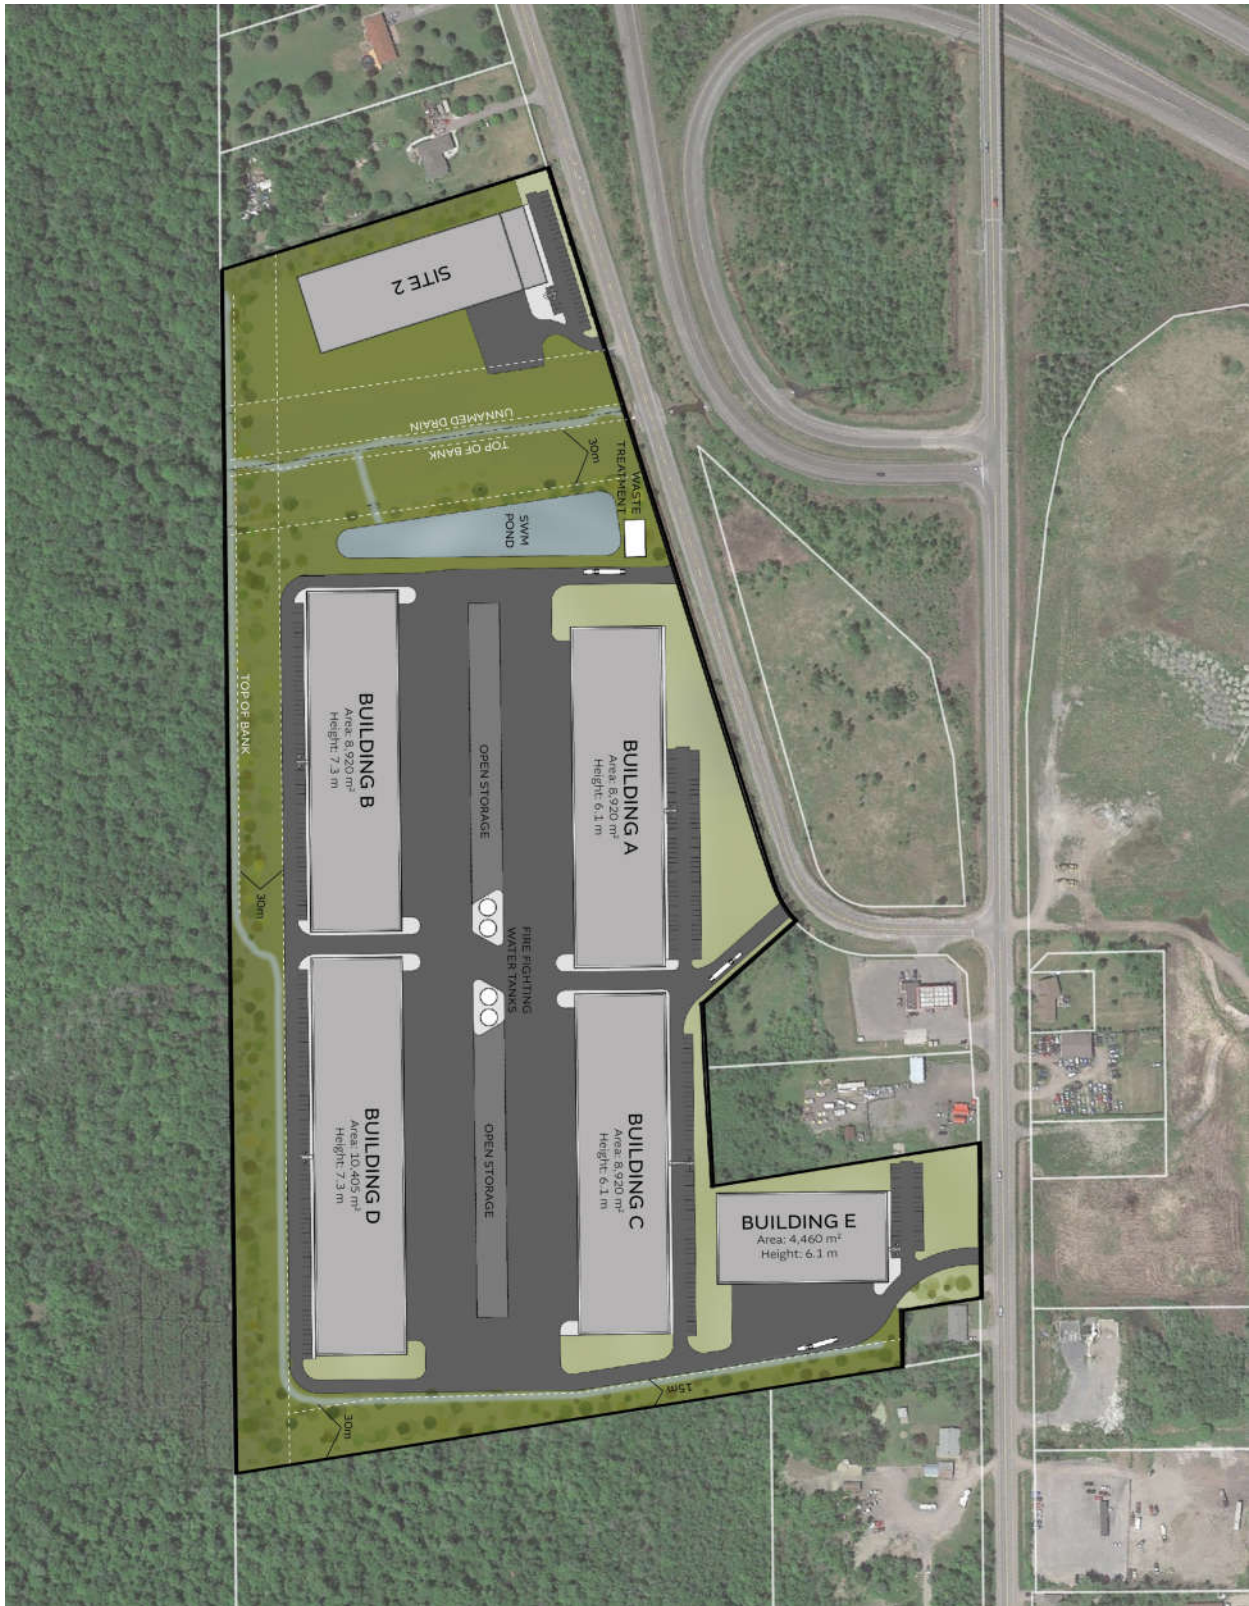
**Figure 3 Development concept**

This could be replaced with a 1-2 m wide vegetated swale around the perimeter of the developed area within Phase 1 (Figure 3). This new swale would not be intended as a naturalized watercourse, but rather would form a green infrastructure component of the Site SWM system. Swales at the north half of Phase 1 would lead to a SWM detention pond. Water from this feature would be outletted to a realigned and naturalized lower R2, then into the east end of R7. This arrangement would replace the *functionality* of all removed channels, as required under the HDFA management recommendations of either Mitigation or Conservation, but would not directly replace the R3 and R4 features themselves as natural channel features per their Conservation recommendations.

Compensation for R3 and R4 could be completed following two different approaches. Firstly, compensatory projects for the features could be planned offsite. Alternatively, channel improvements made on-site could provide the required replacement of functionality. For example, Channel R9 could be significantly improved to provide a naturalized watercourse instead of an ephemeral, linear drainage swale.

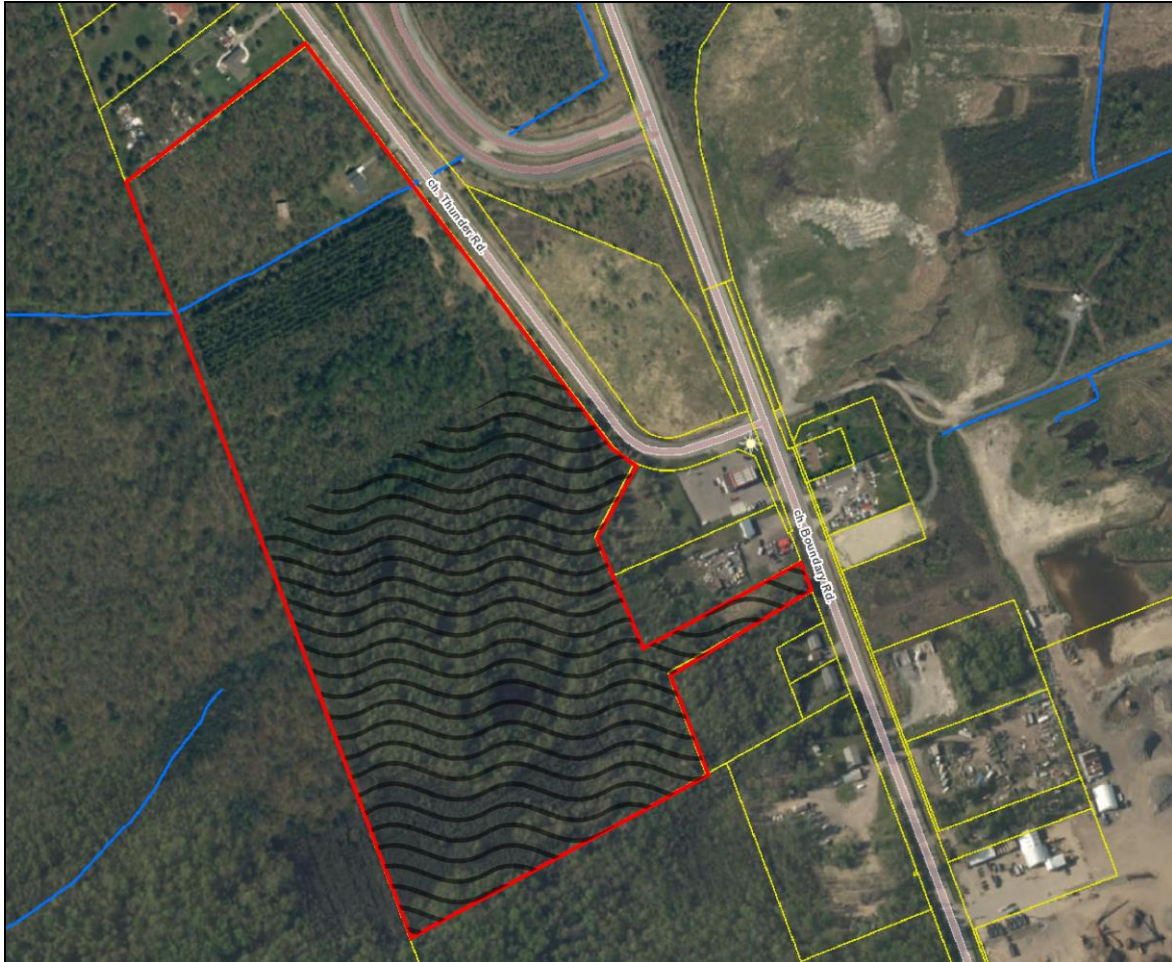
**Figure 1 Map of 6150 Thunder Road, Ottawa (project area is marked in red)**

**Figure Notes:** The south half of the site (marked in grey) was cleared and re-graded after the date of the background air photo.

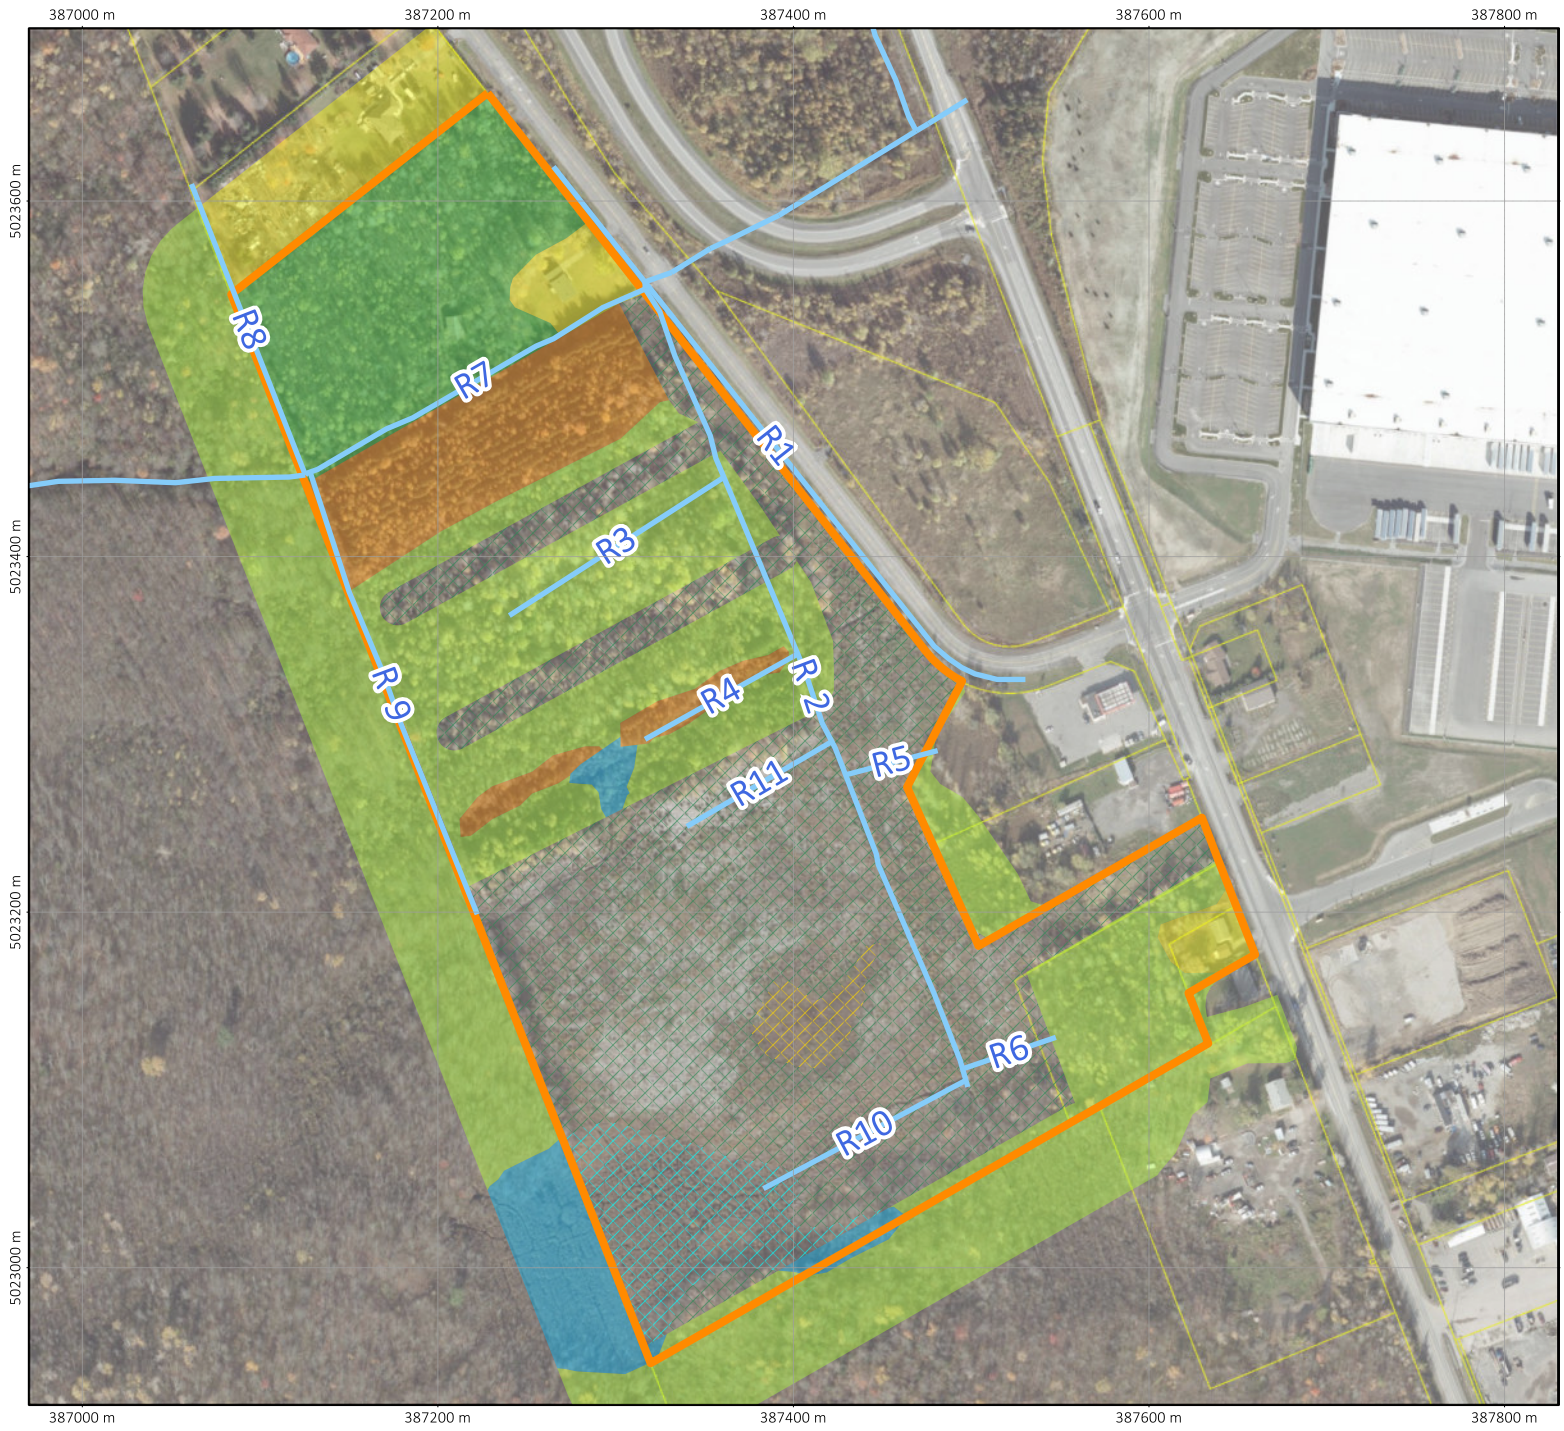
**Figure 1** HDF Reaches

Two additional existing channels have been noted since that time along the western boundary of the Site (R8 and R9), which was not part of the initial review in 2018. Two further temporary drainage channels (R10 and R11) were added to the Site in 2021.

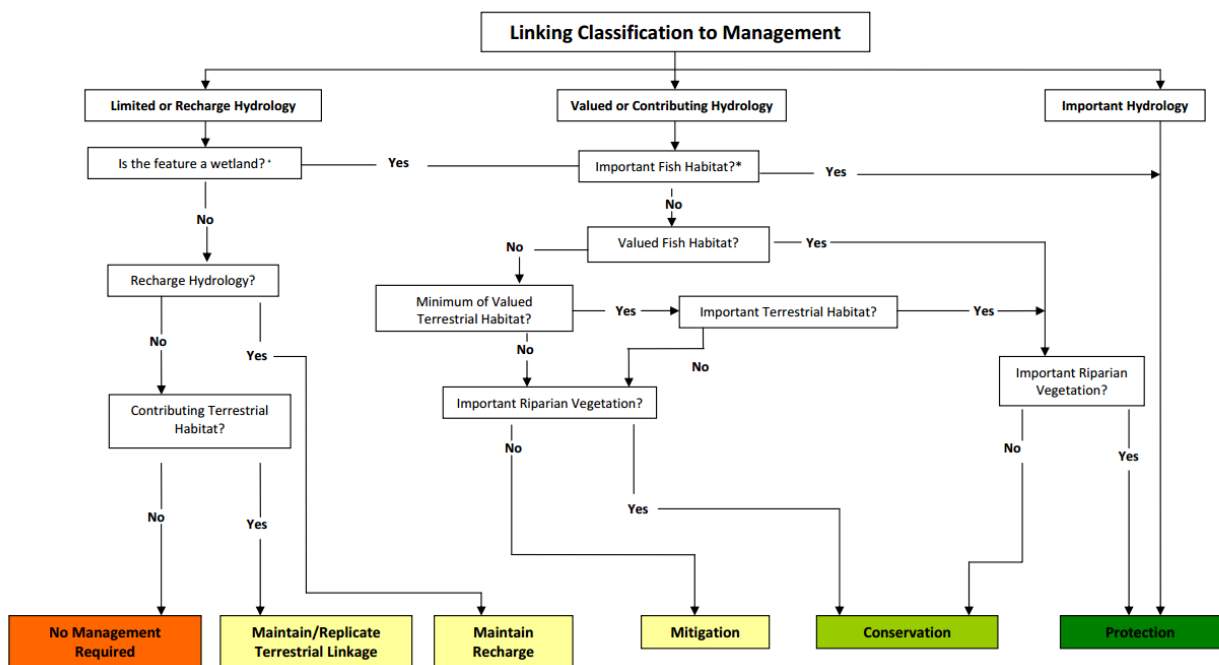
The classification categories identified in Section 2 provide the basis of the management recommendations provided here. The following flow chart (Figure 2) combines and translates the classification results to management recommendations.

Figure 2. Headwater Drainage Feature Assessment (HDFFA) flow chart providing direction on management options

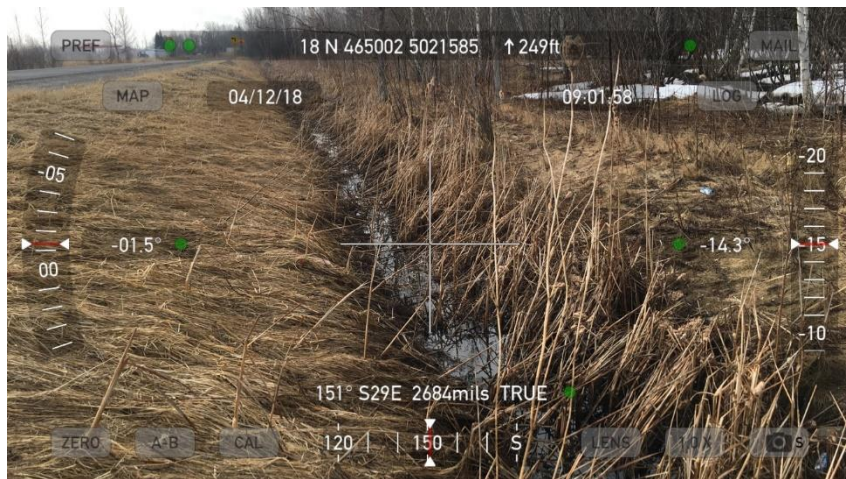
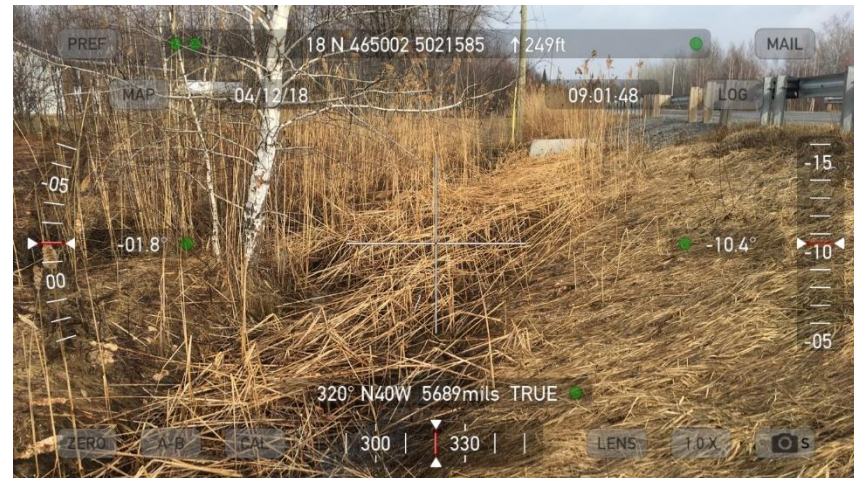
### Reach 1

Channel R1 is the roadside ditch along Thunder Road. This feature is unlikely to be altered (realigned) in any meaningful way under future development plans. All other channels on site had been (i.e. in 2018) located within young, early successional wooded areas and coniferous plantation covering former agricultural fields. A single small wetland pocket was observed at the upstream end of Channel R4. Natural landcover along Channels R6, R5 and most of R2 was completely removed in 2019.

Upstream view

Downstream view

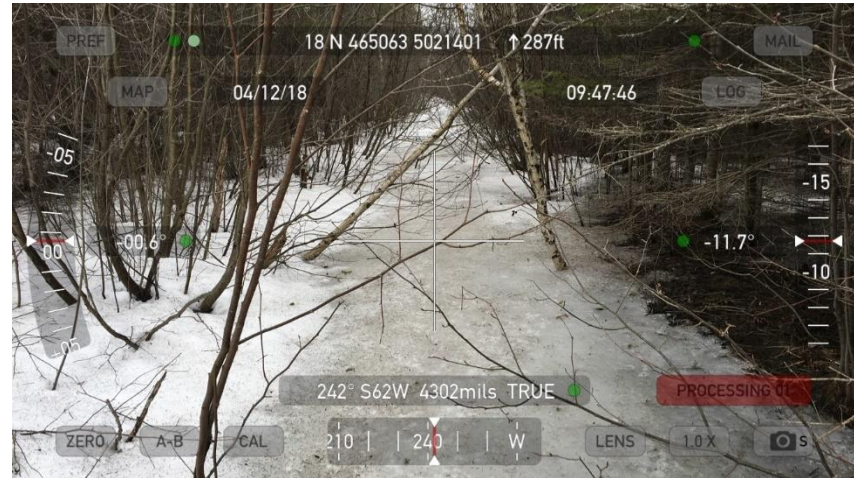
## Reach 4

Upstream view

Downstream view

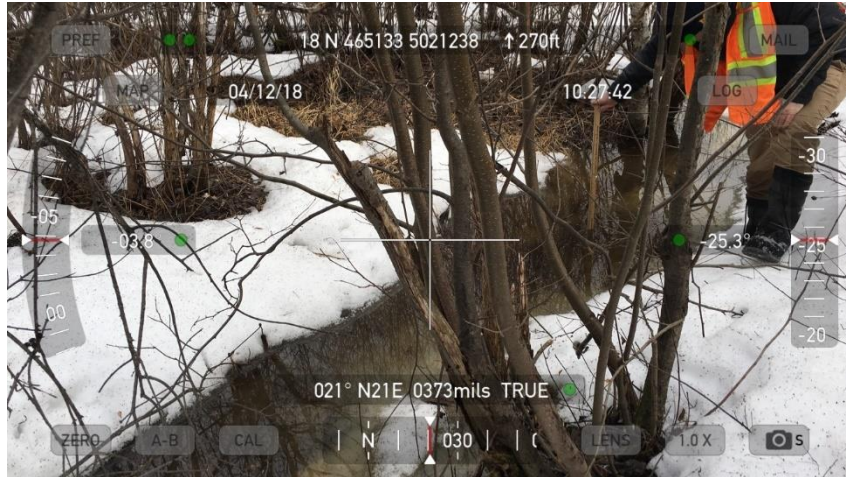
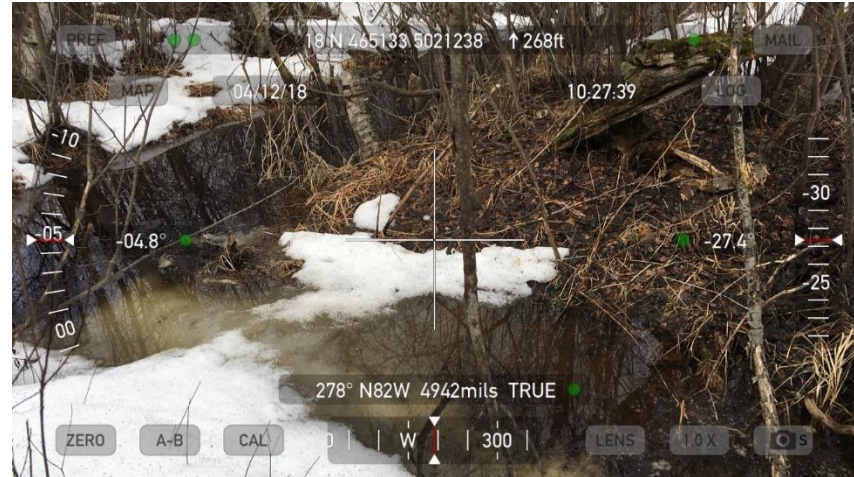
## Reach 6

Upstream view

Downstream view
