**Environmental Impact Statement
6150 Thunder Road, Ottawa**

Updated Report

July 15, 2021

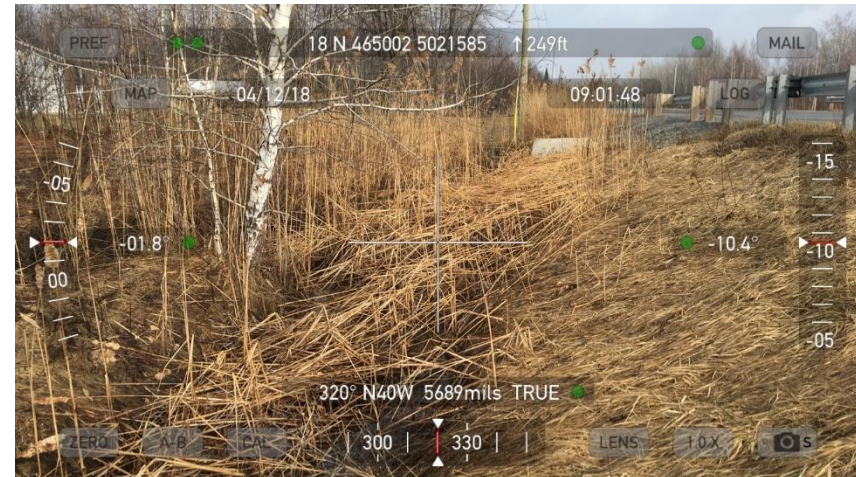
Reach 1

Upstream view

Downstream view
