## Phase I Environmental Site Assessment

Residential Property  
3996 and 3998 Innes Road - Ottawa

February 1, 2018

Report: PE4215-1

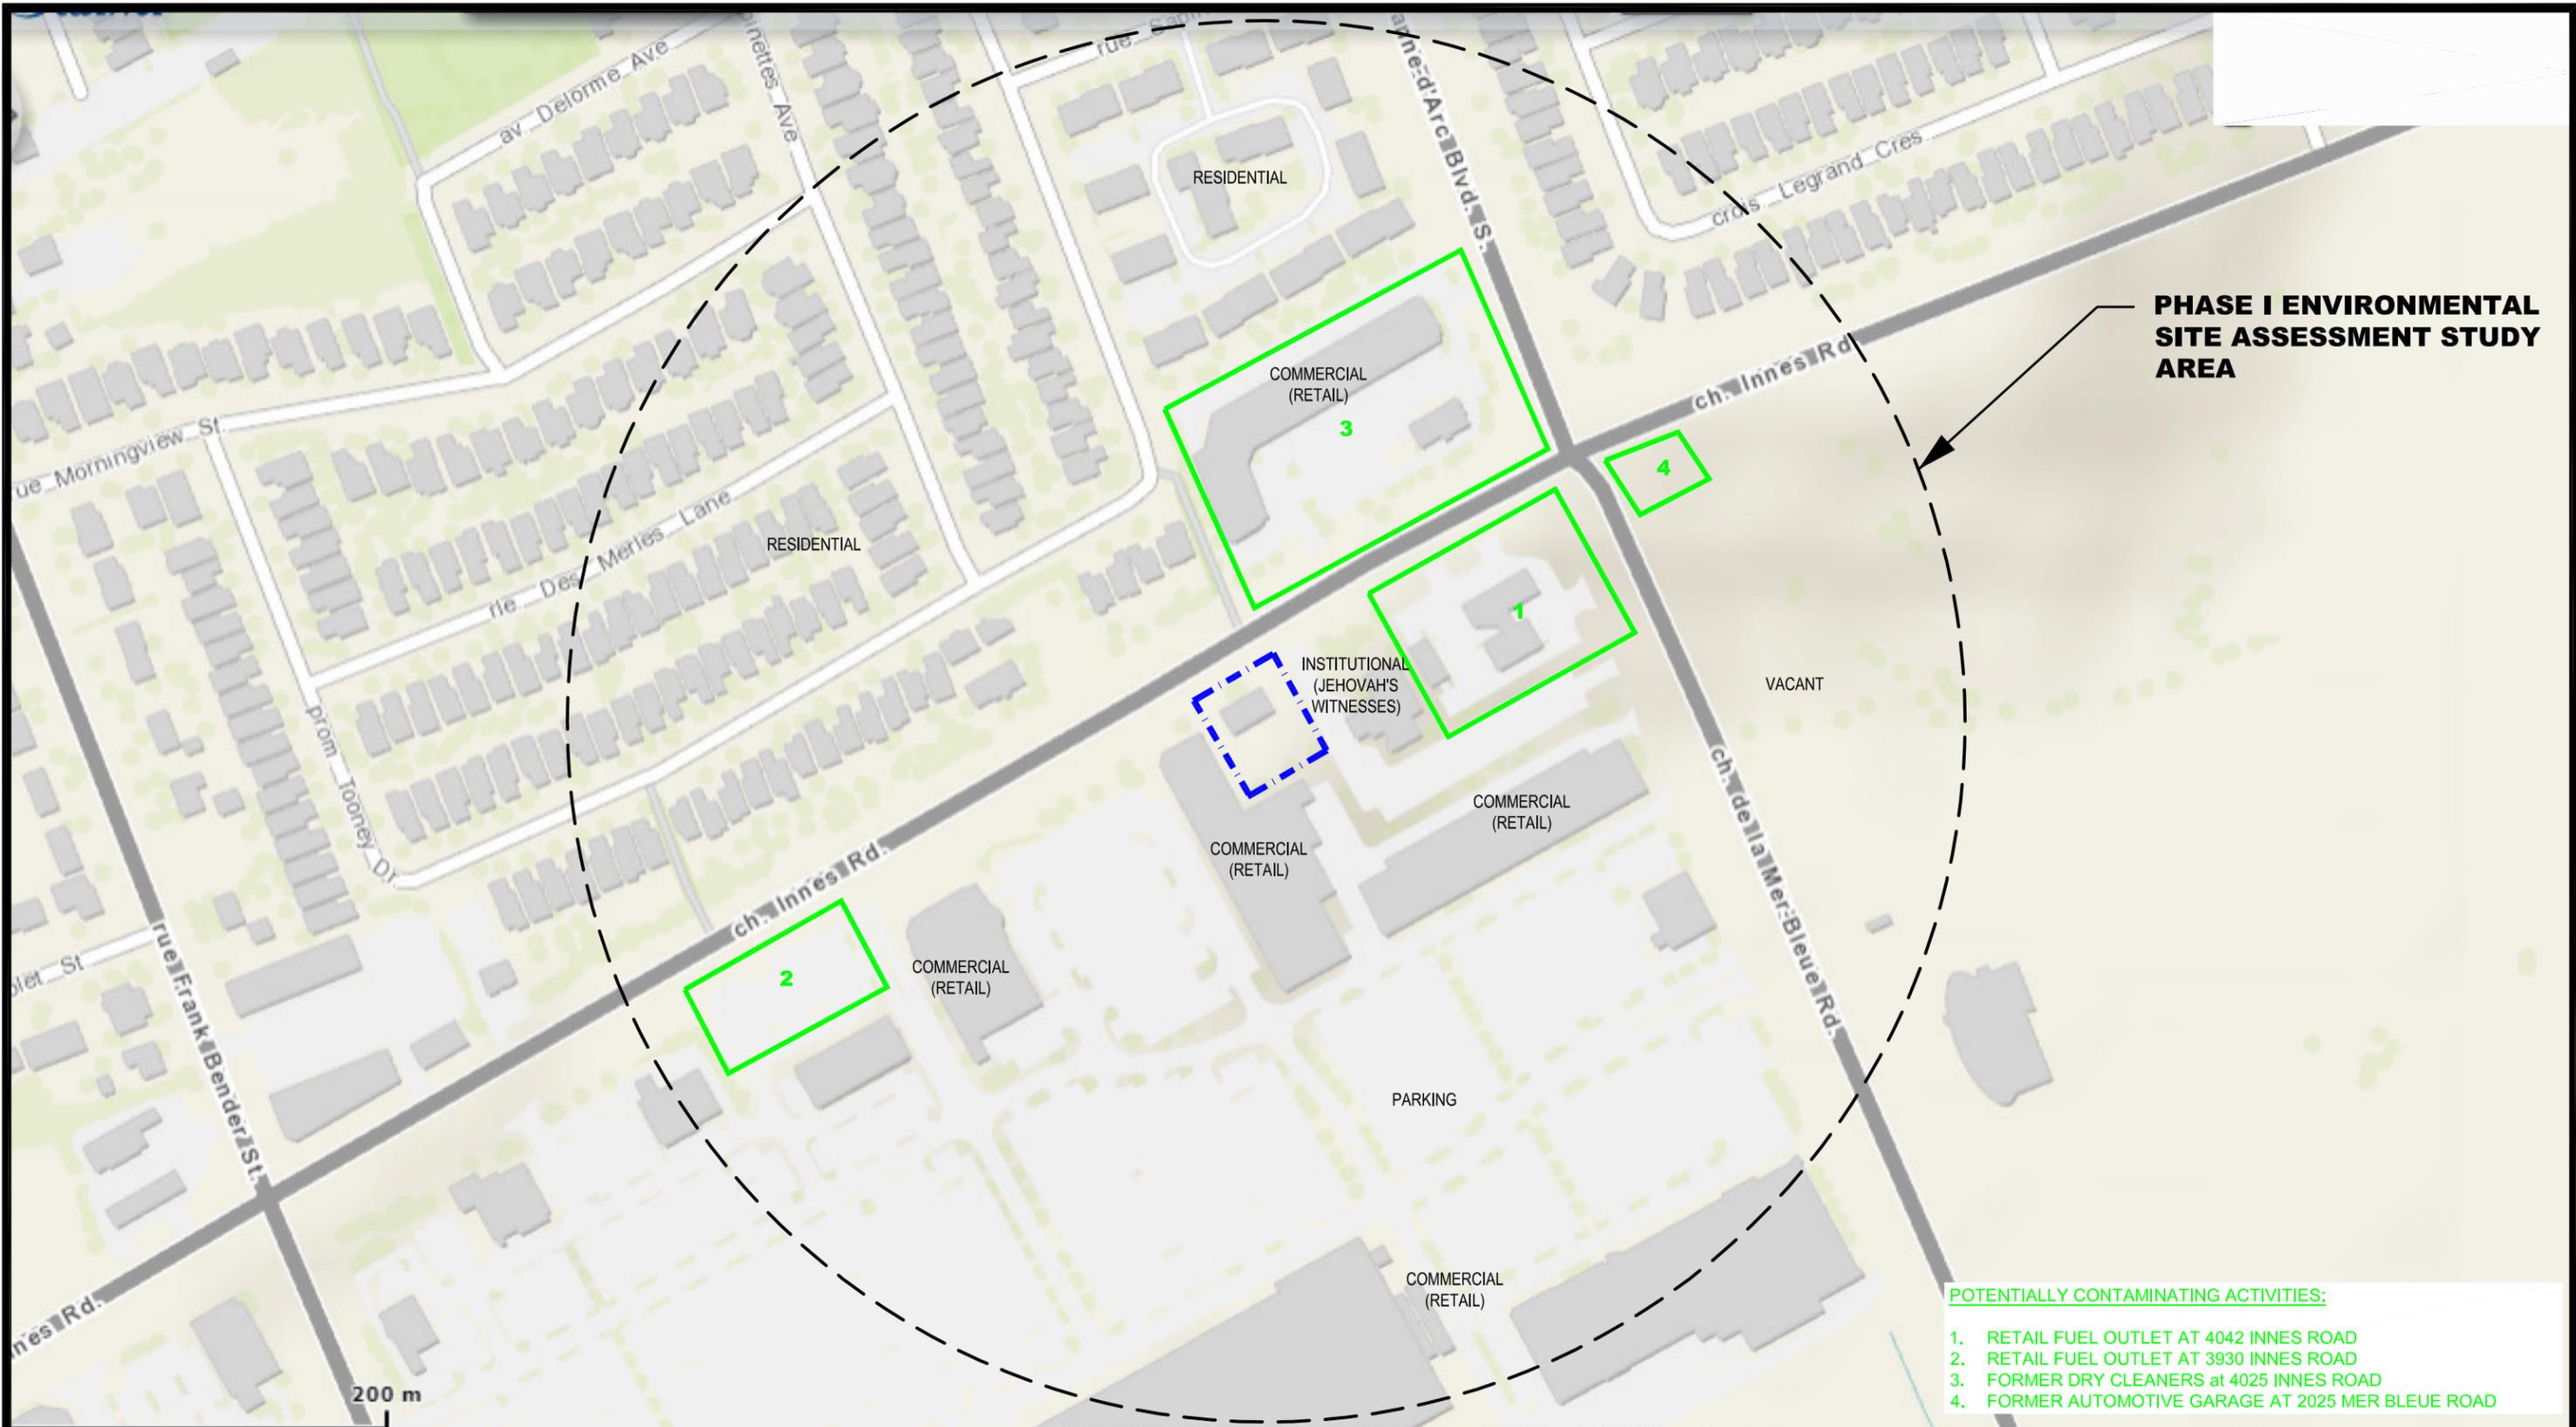
**PHASE I ENVIRONMENTAL  
SITE ASSESSMENT STUDY  
AREA**

- POTENTIALLY CONTAMINATING ACTIVITIES:**
1. RETAIL FUEL OUTLET AT 4042 INNES ROAD
  2. RETAIL FUEL OUTLET AT 3930 INNES ROAD
  3. FORMER DRY CLEANERS AT 4025 INNES ROAD
  4. FORMER AUTOMOTIVE GARAGE AT 2025 MER BLEUE ROAD

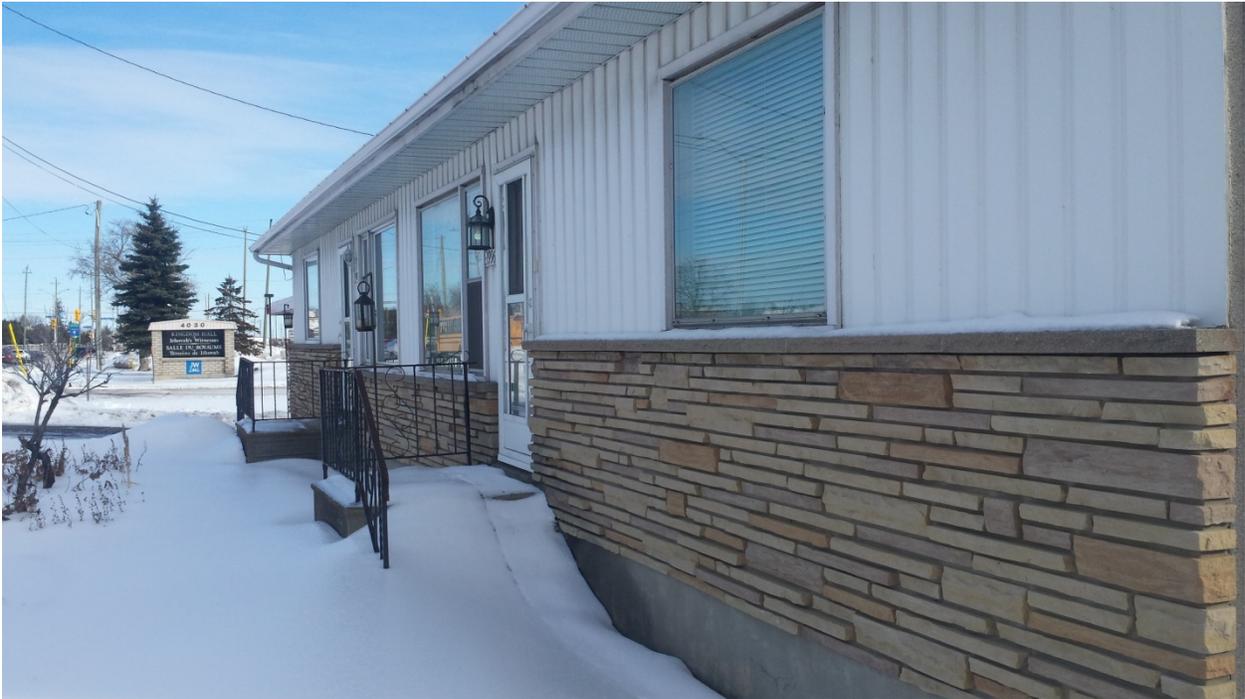
Photograph 1: Front view of the subject building, looking east.

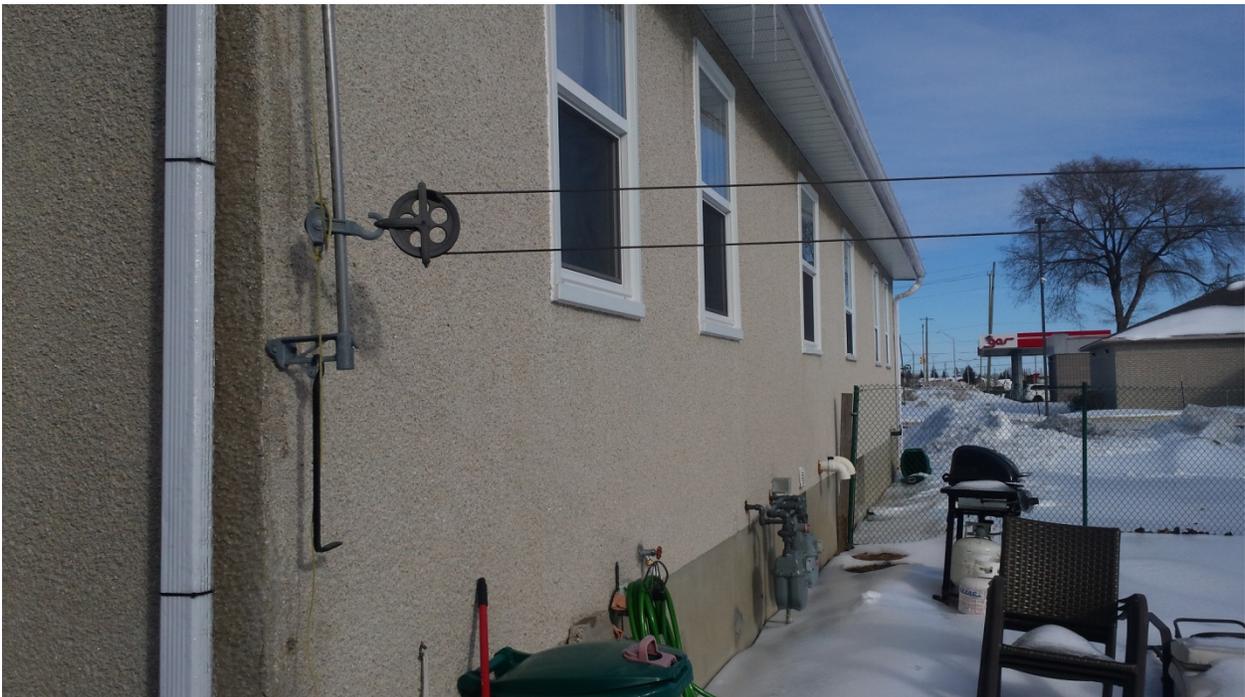
Photograph 2: Rear view of the subject building, looking east. The Mr. Gas retail fuel outlet is visible in the distance at right.

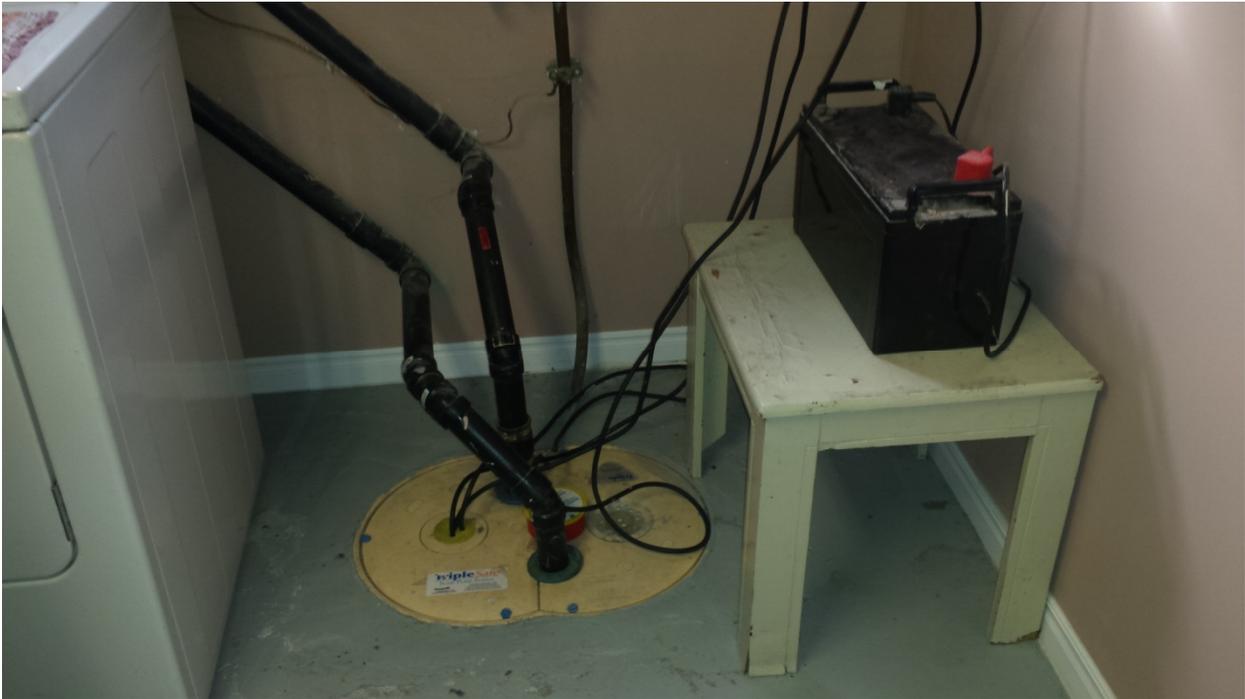
Liquid discharged from the Phase I property includes wash water and sewage. One (1) sump pit was observed in the basement. The water in the pit could not be observed at the time of the site visit.

Photograph 3: Sump pit (with two submersible pumps) and backup battery in the basement of 3996 Innes Road.

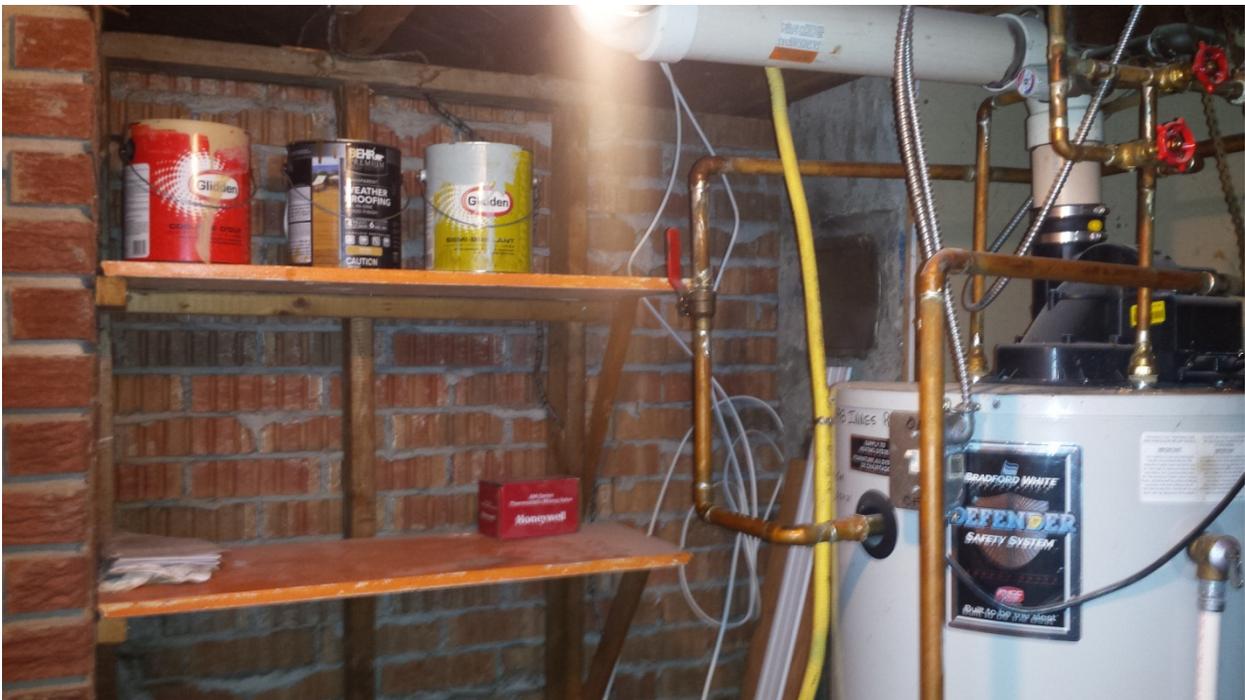
Mr. David Lewis, the property manager, was available during the site visit to respond to questions. Mr. Lewis has been managing the property for approximately ten years. According to Mr. Lewis, the sump pit in the basement of 3996 Innes Road (western unit) is serviced on an annual basis, and normally contains little, if any, water. The building has a wood-burning fireplace which has been sealed, and replaced with an electric fireplace in the basement. According to Mr. Lewis, the chimney was capped at the top.

Photograph 4: View of the basement boiler room (3996 Innes Road). The brick wall is part of the sealed chimney.
