January 31, 2018
File: PE4215-LET.01

Subject: **Phase II – Environmental Site Assessment
3996 and 3998 Innes Road
Ottawa, Ontario**

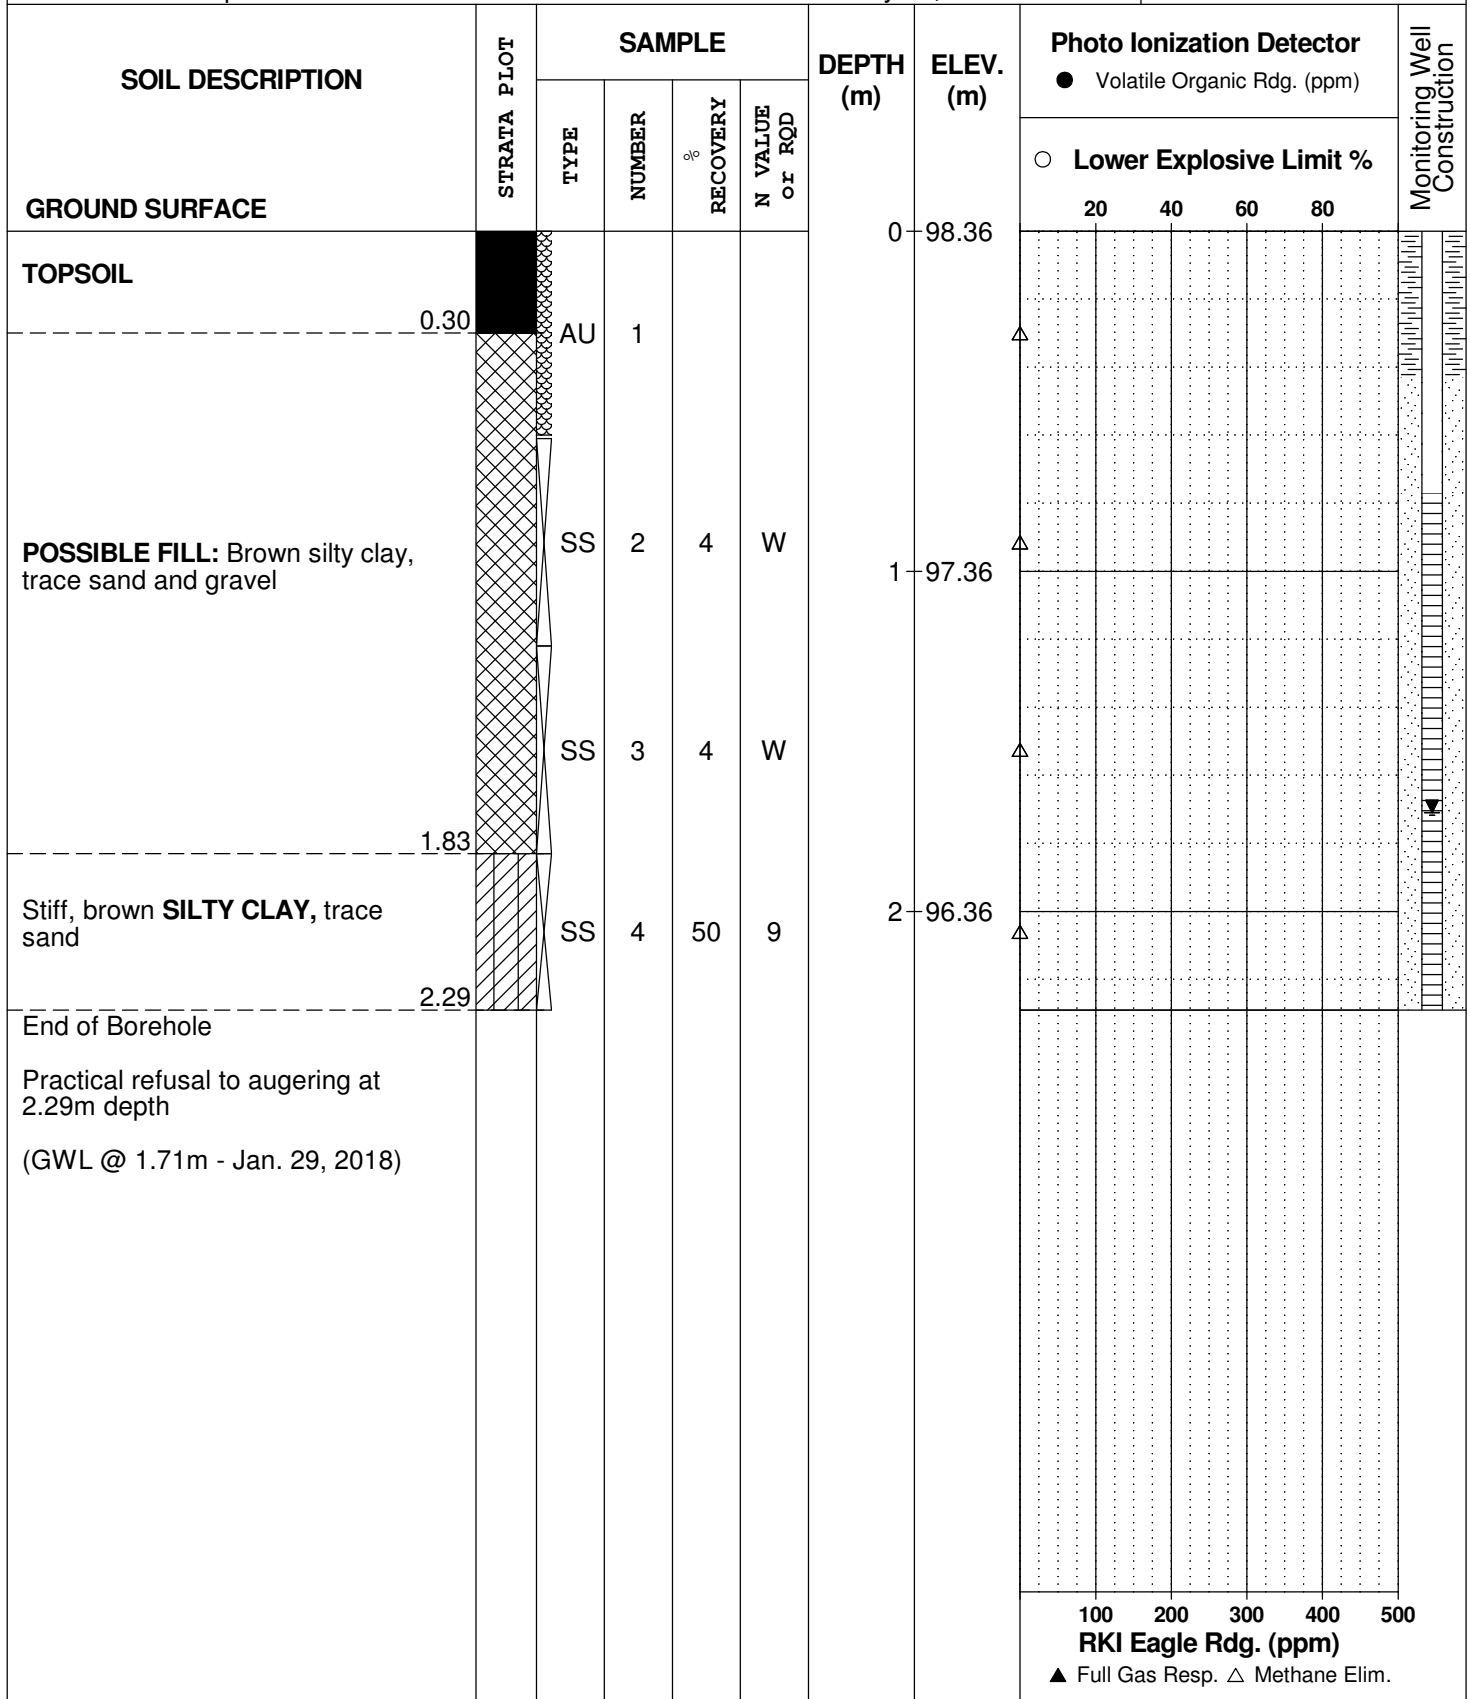
HOLE NO. BH 1

The soil profile encountered in the boreholes consisted of a layer of topsoil underlain by native brown silty clay/clayey silt with trace gravel and sand. Some fill was identified in BH1. The specific details of the soil profile at the test hole locations are presented on the attached Soil Profile and Test Data sheets.

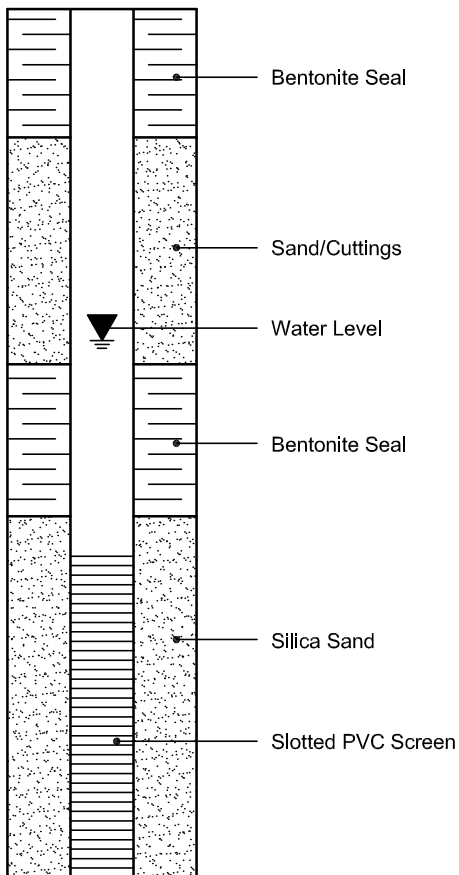
MONITORING WELL CONSTRUCTION

- Slotted 32 or 51 mm diameter PVC screen at base of borehole.
- 32 or 51 mm diameter PVC riser pipe from the top of the screen to ground surface.
- No.3 silica sand backfill within annular space around screen.
- Bentonite above sand pack to just below ground surface.
- Flushmount cap at ground surface.
