## **Phase I Environmental Site Assessment**

3484, part of 3490 and 3592 Innes Road  
Ottawa, Ontario

**July 10, 2018**

Report: PE4288-1

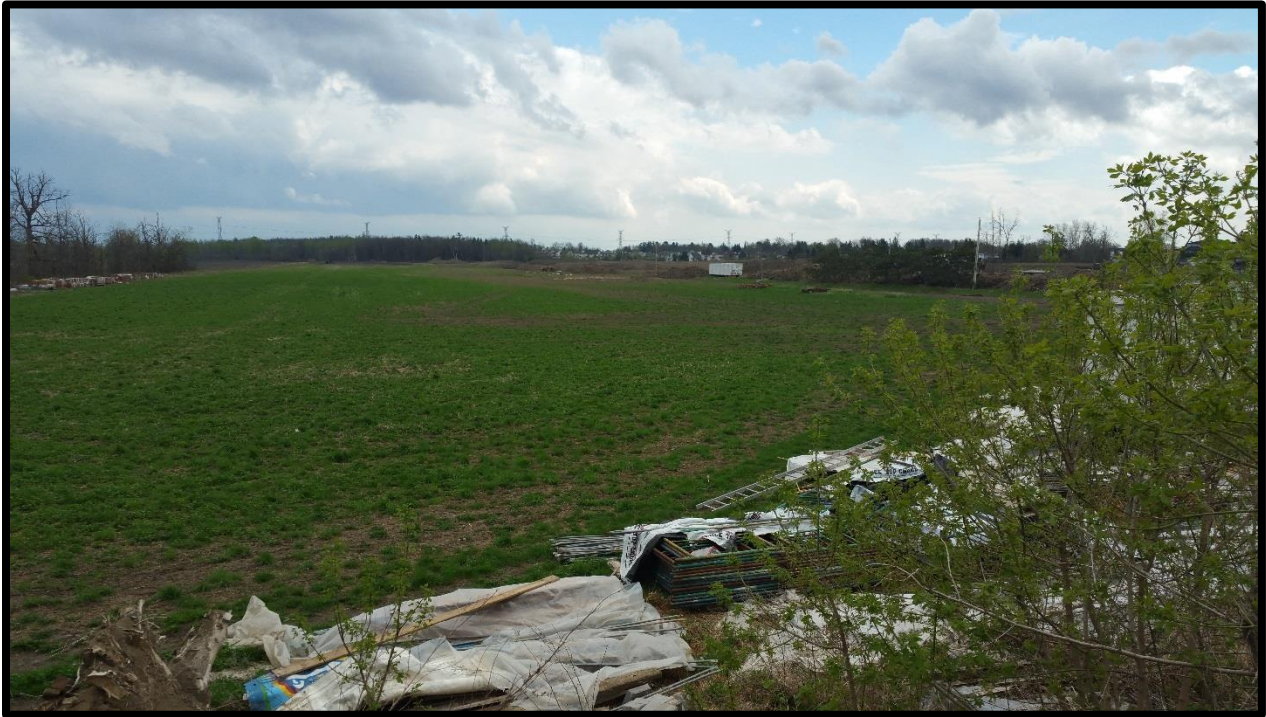
Photograph 5: View of the southern portion of the subject site, facing southwest. Photograph illustrates an undeveloped grass field.

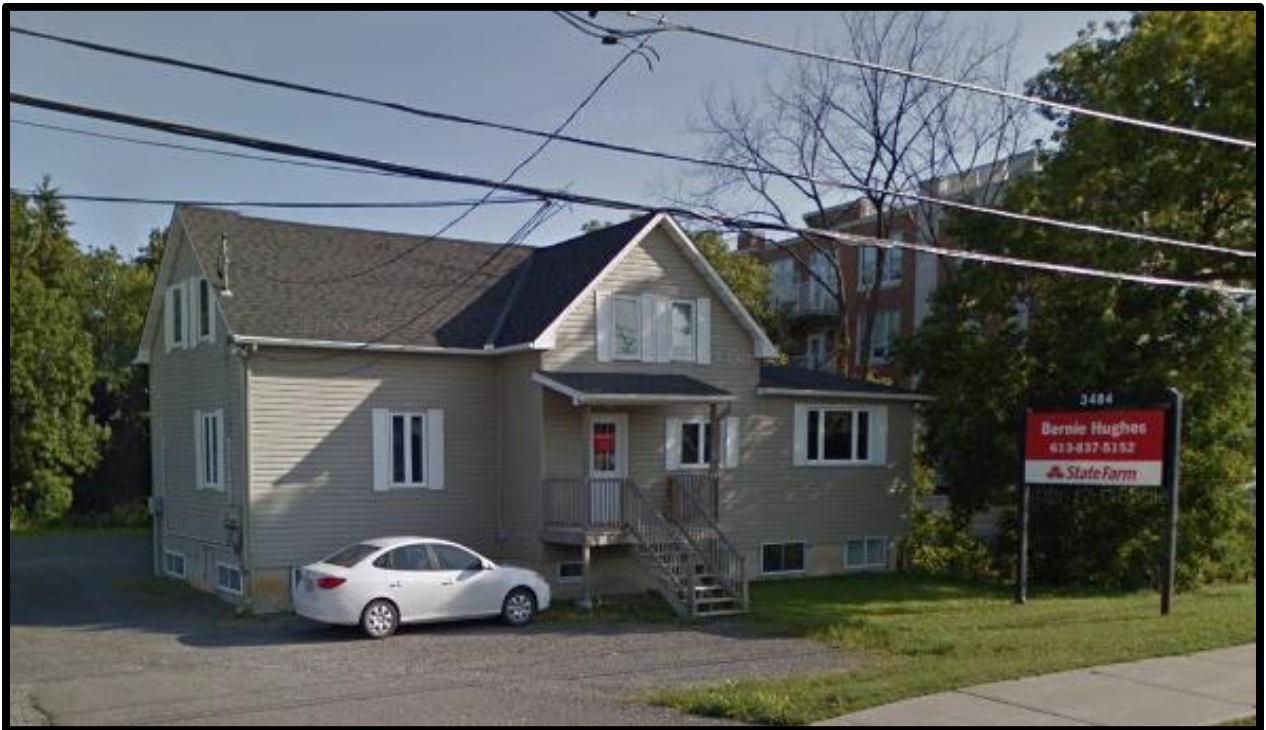
Photograph 6: View of the two-storey commercial/residential building on the northwestern portion of the site. Photograph taken facing southwest.
