# HYDROGEOLOGICAL ASSESSMENT AND TERRAIN ANALYSIS, CORKERY COMMUNITY CENTRE, 3447 OLD ALMONTE ROAD, OTTAWA, ON

Project No.: CCO-21-3339-01

March 9, 2022

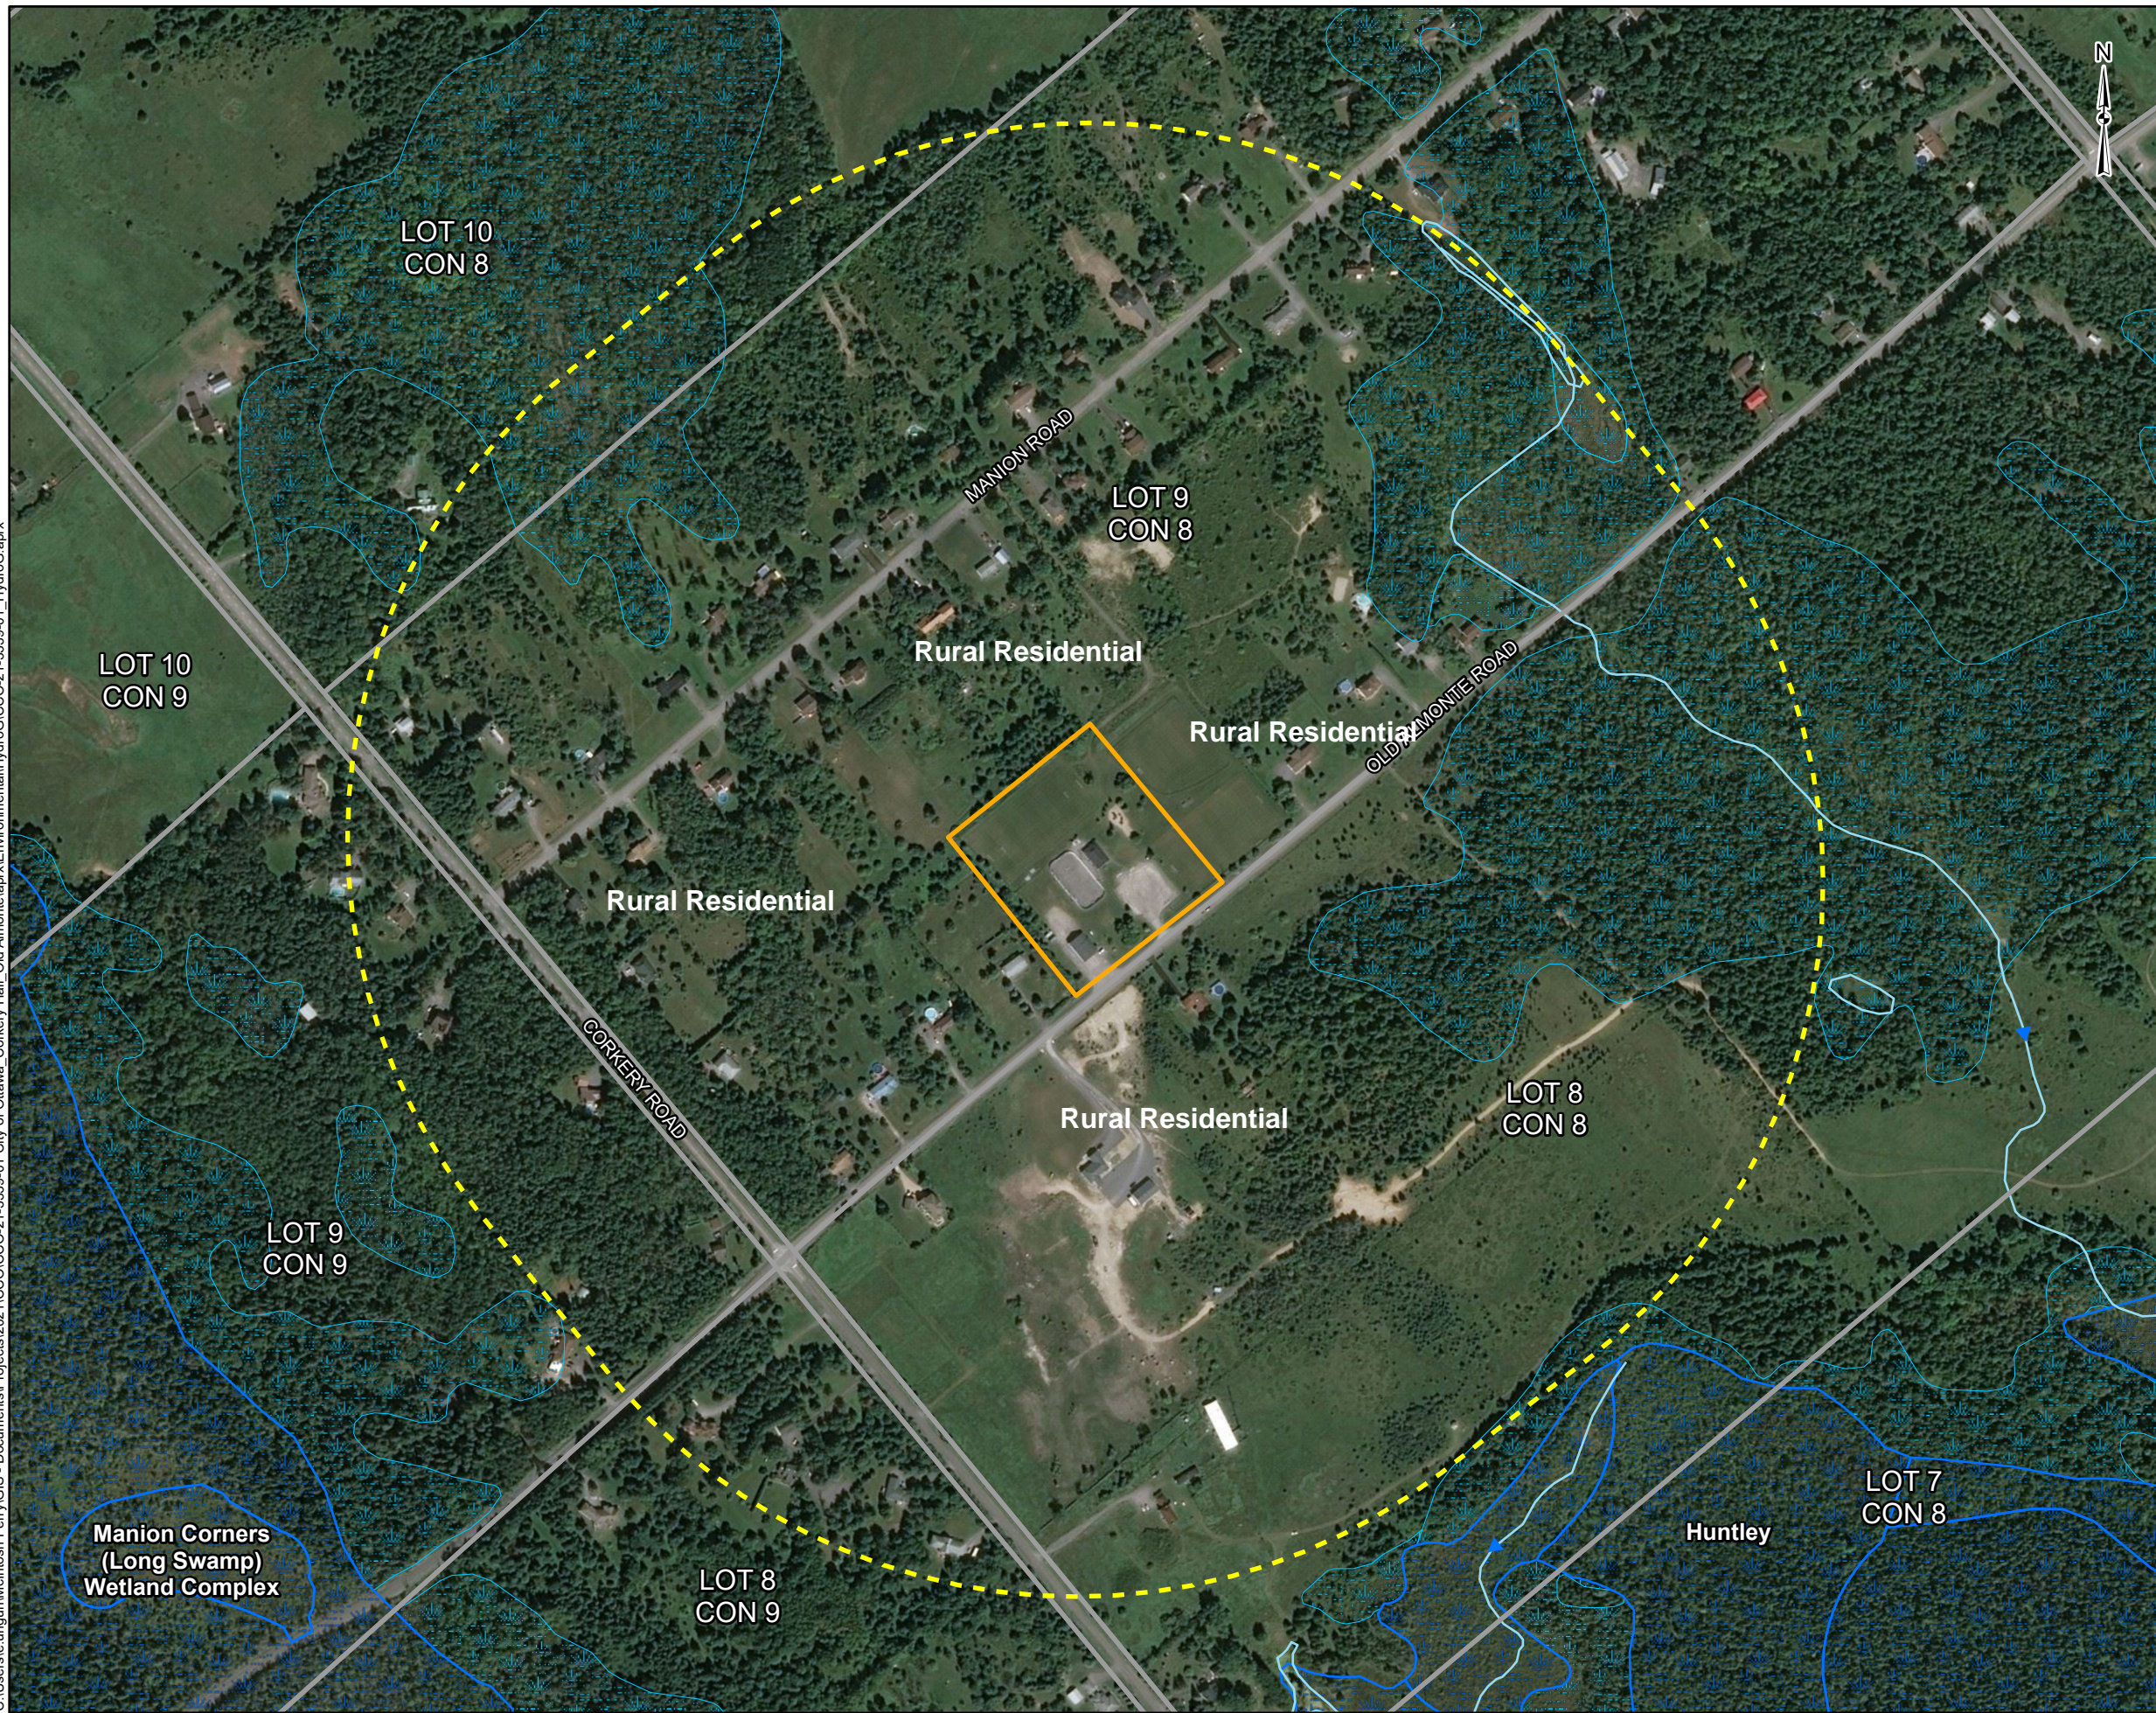
- LEGEND**
- Site Boundary
  - 500m Buffer
  - Lot & Concession
  - Watercourse
  - Waterbody
  - Unevaluated Wetland
  - Provincially Significant Wetland

A windshield survey of the surrounding area was conducted in combination with a site walkthrough and review of maps and zoning information. The Site is located in a predominantly rural residential area. This does not appear to pose any significant source of contamination to the proposed development. No obvious potentially contaminating activities (e.g. fuel outlets, improperly maintained bulk fuel storage, salt storage, manure piles, livestock yards, etc.) were observed in the vicinity of the

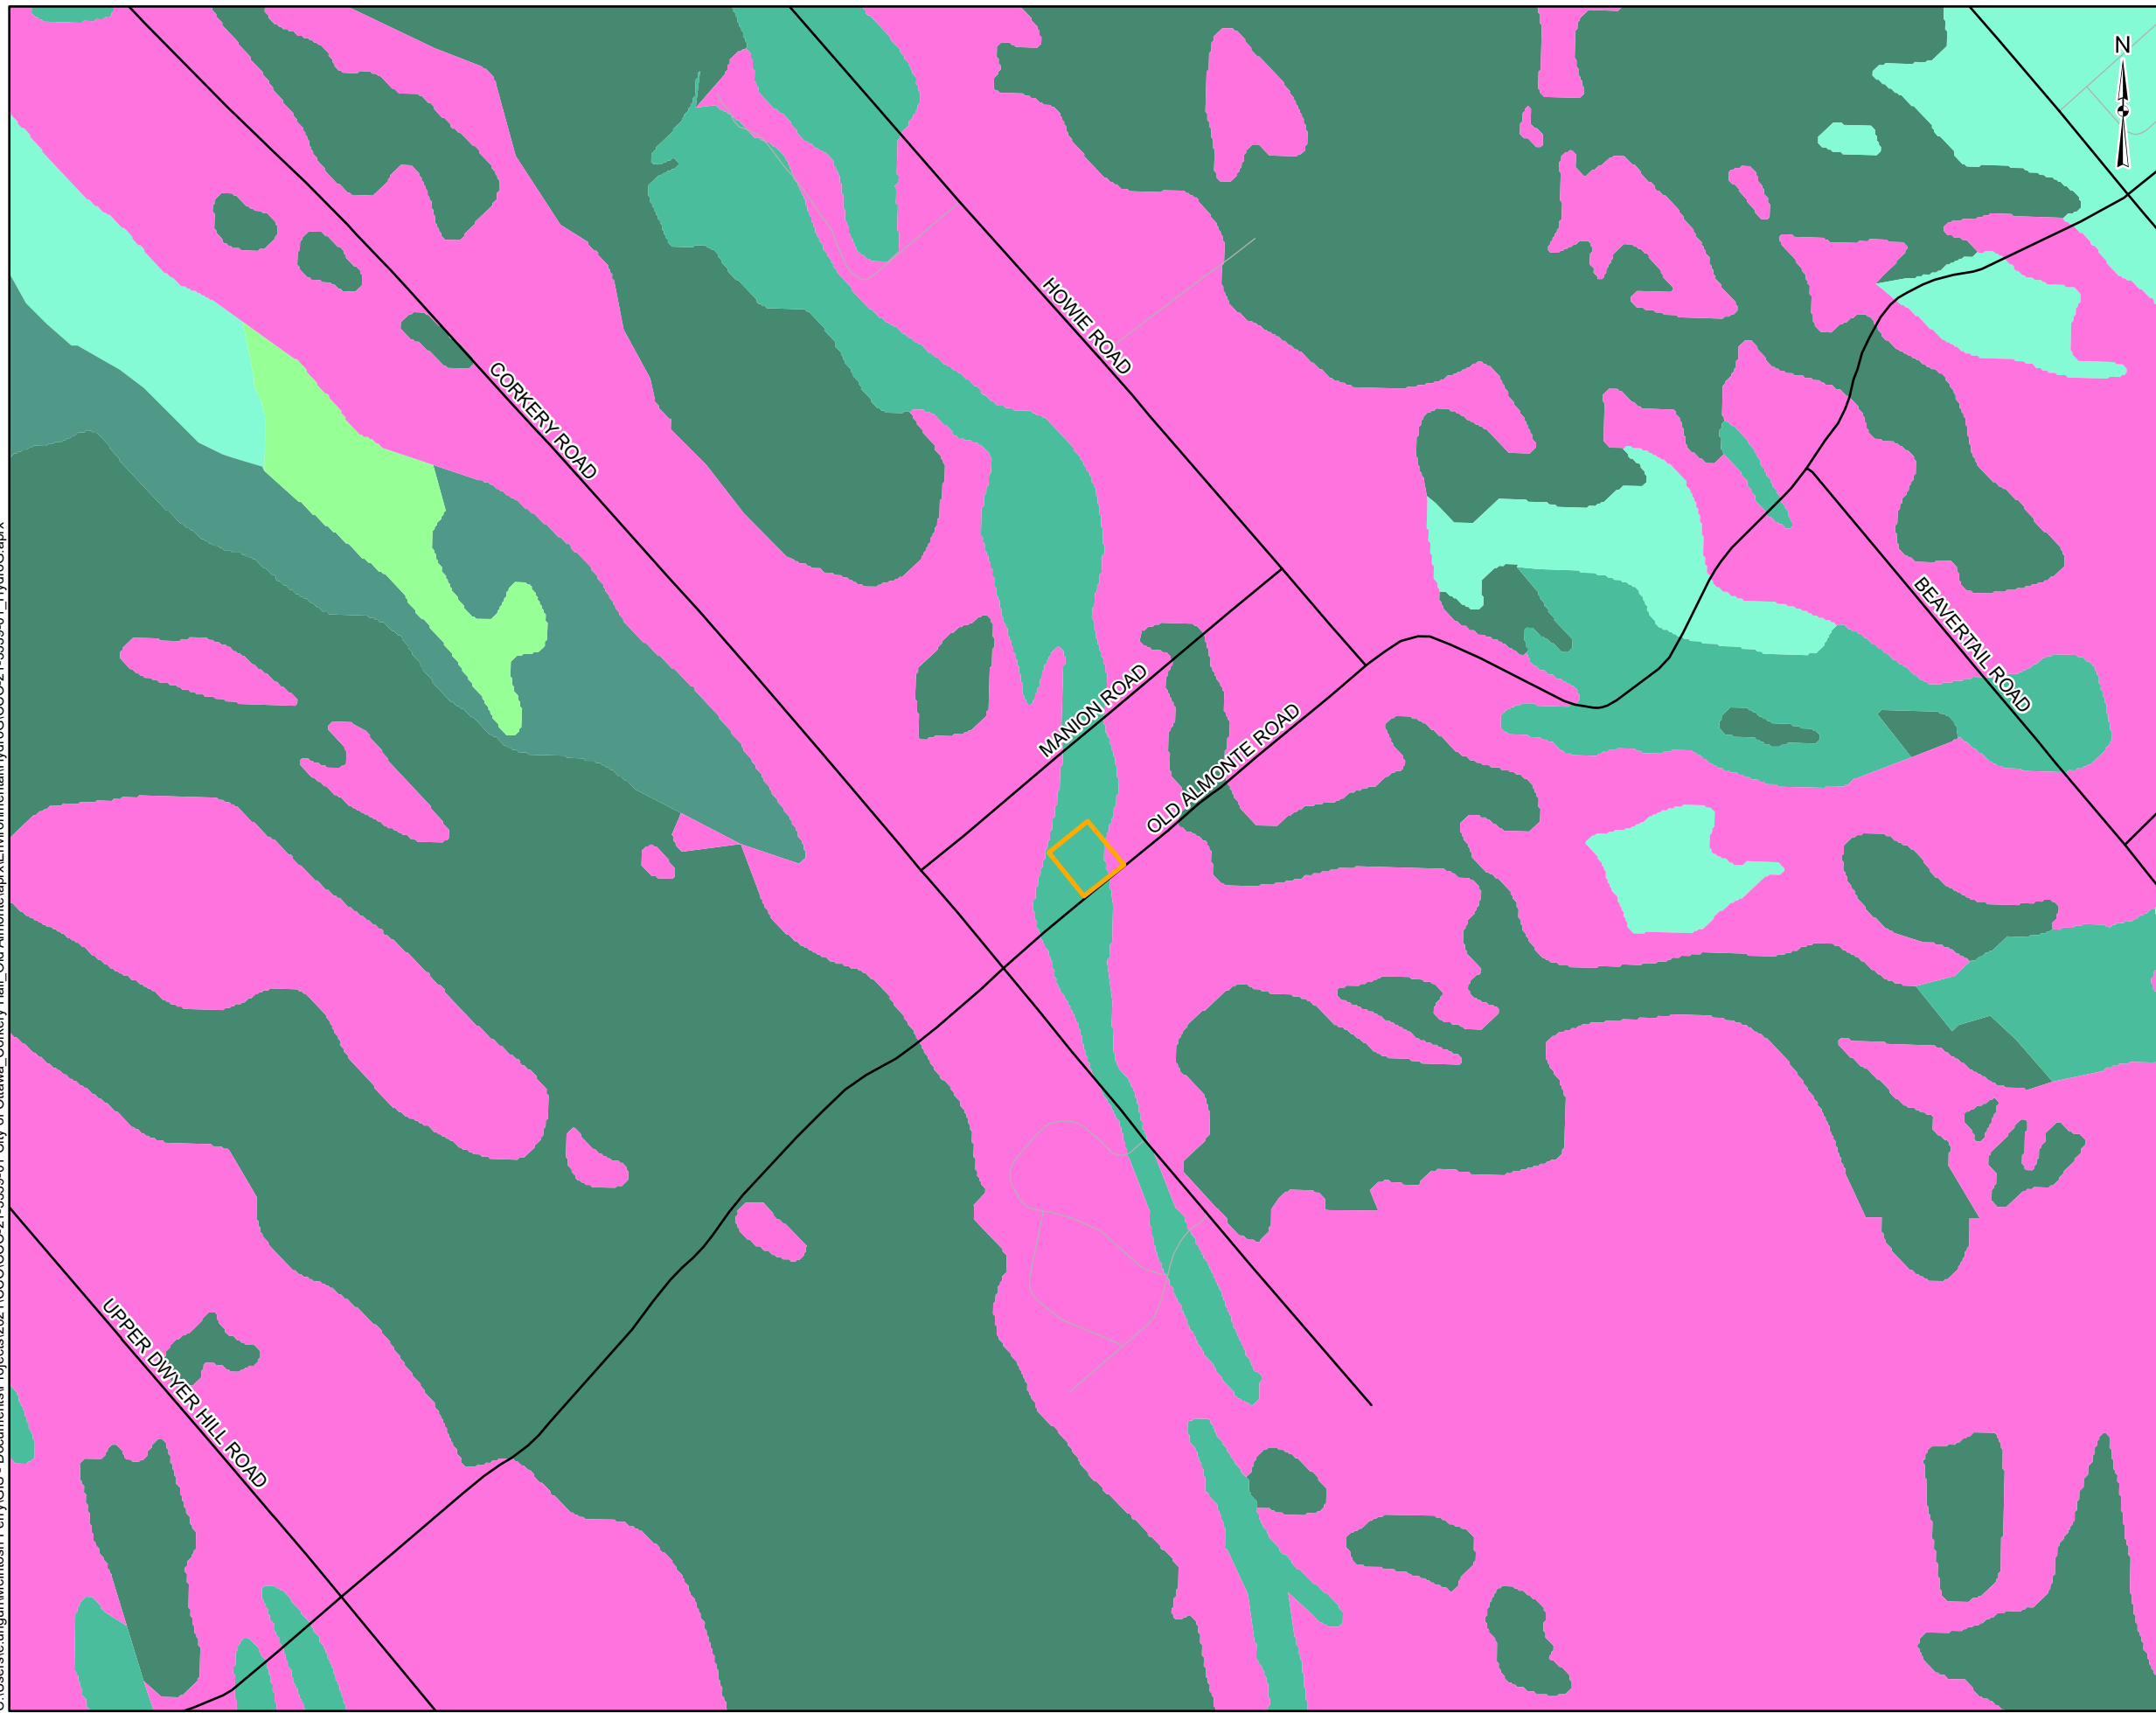
-   Site Boundary
-   Local Road
-   Major Road
- Surficial geology**
-   Organic Deposits
-

On-site overburden in the area of the subject site is listed by the Ontario Geological Survey (OGS) as bedrock-drift complex in a Paleozoic terrain, and fine-textured glaciomarine deposits, which typically indicates shallow overburden. This assertion is supported by MECP WWIS records, which indicate an average depth to bedrock of approximately 2.2 m below ground surface (bgs) for listed wells within 500 m of the Site.

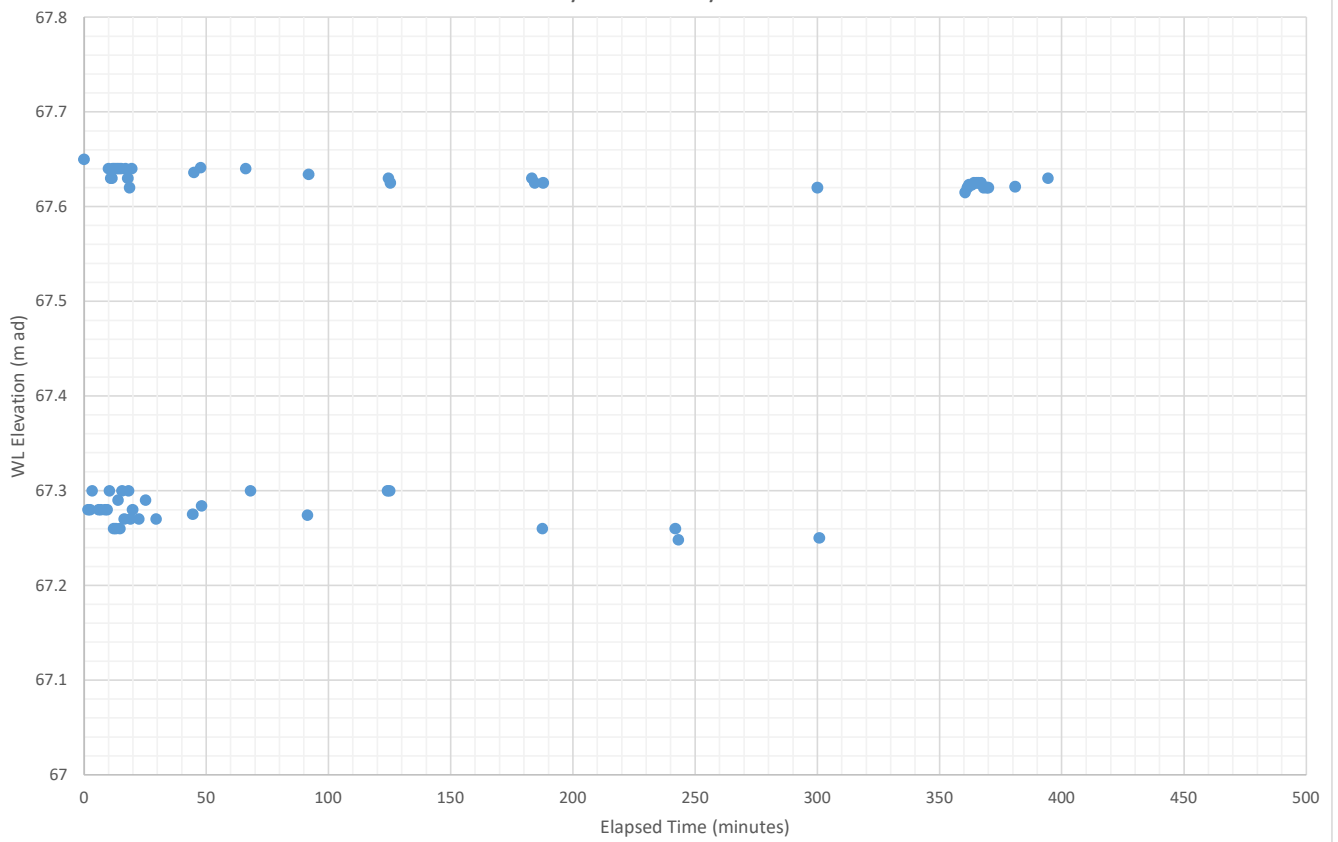
Drawdown vs Time  
Pumping Test (Drawdown), February 3, 2022  
Corkery Community Centre

The groundwater level ranged between 32.21 – 32.752 m btoc, with a maximum drawdown of 0.402 m observed. Following pump shutoff (361 minutes), drawdown was recorded at 0.02 m within 33.33 minutes (32.37 btoc, 67.63 m ad), representing approximately 95% recovery.

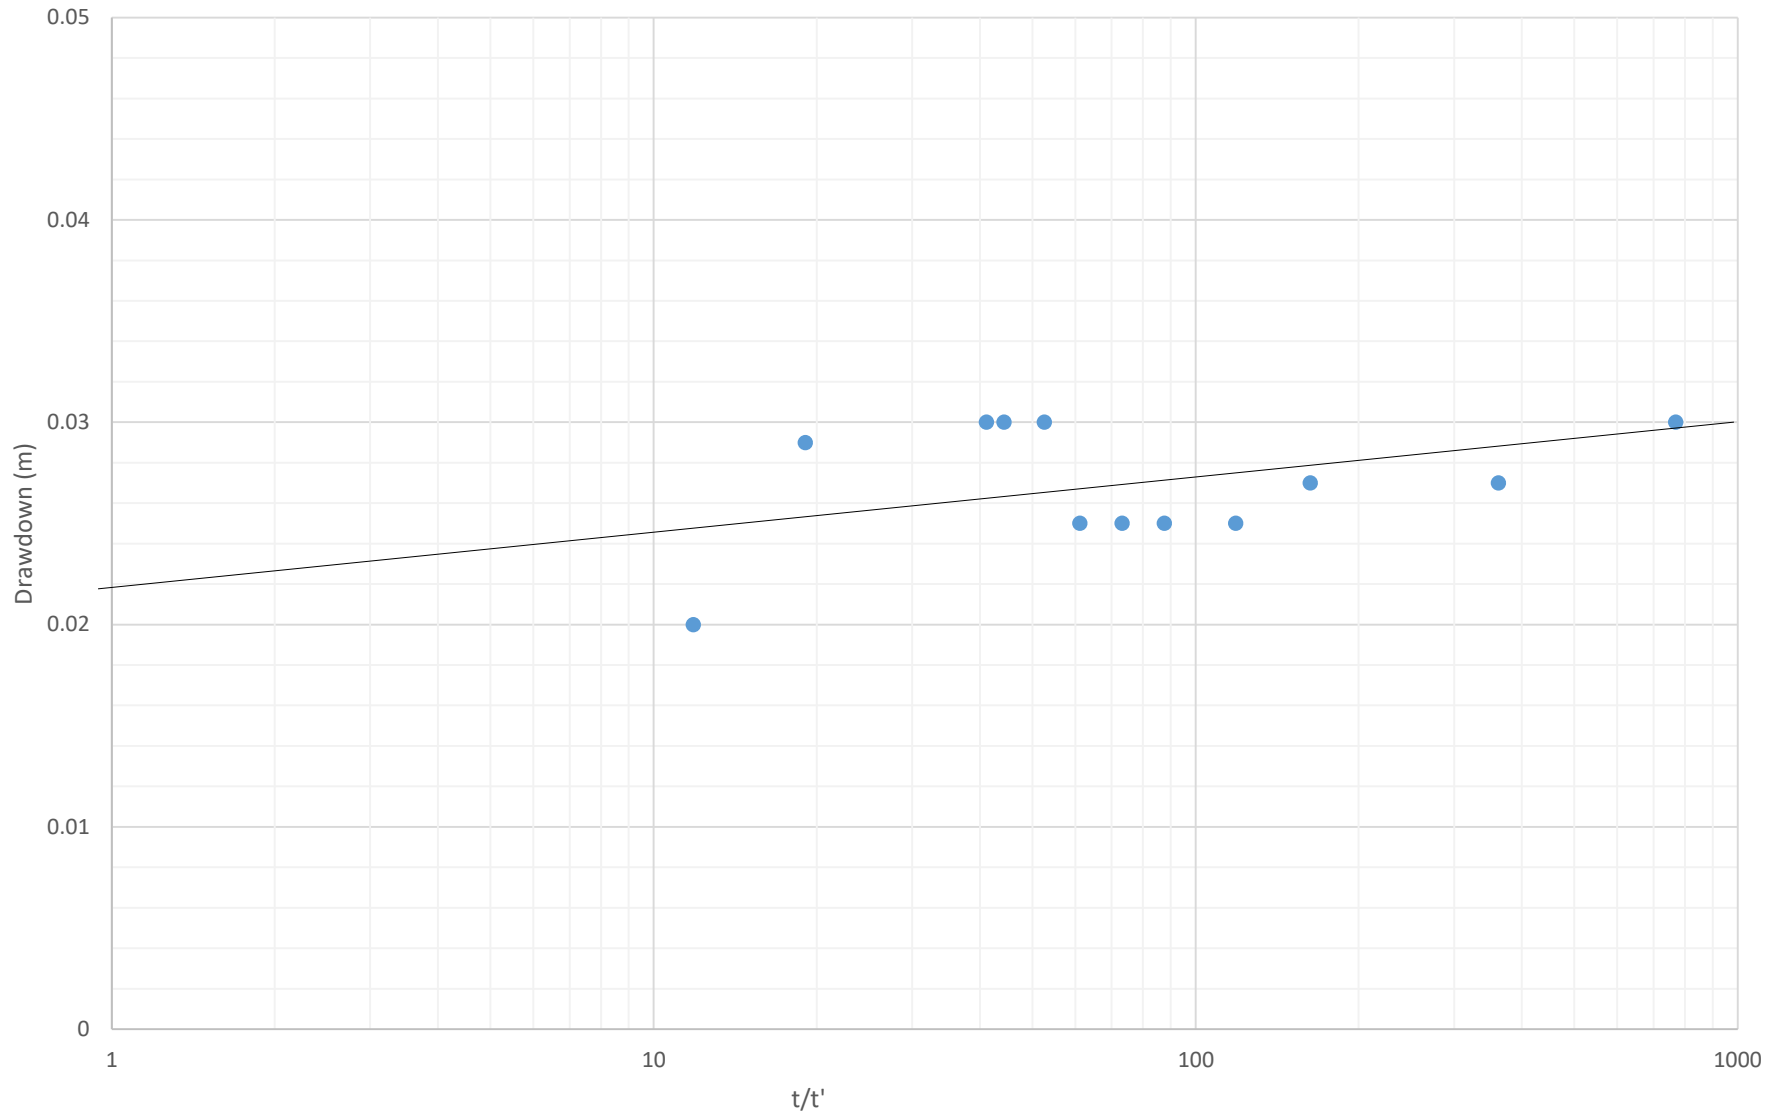
Drawdown vs Log Time  
Pumping Test (Recovery), February 3, 2022  
Corkery Community Centre

Using drawdown and recovery data, respective transmissivities of 301 m<sup>2</sup>/d and 3375 m<sup>2</sup>/day were calculated using the Cooper-Jacob method. The transmissivity of 301 m<sup>2</sup>/day calculated from the drawdown was used in the calculations as it is the more conservative value. It is noted that recovery data are likely more representative of aquifer conditions, as drawdown data were complicated by the cycling of TW1's pressure tank.

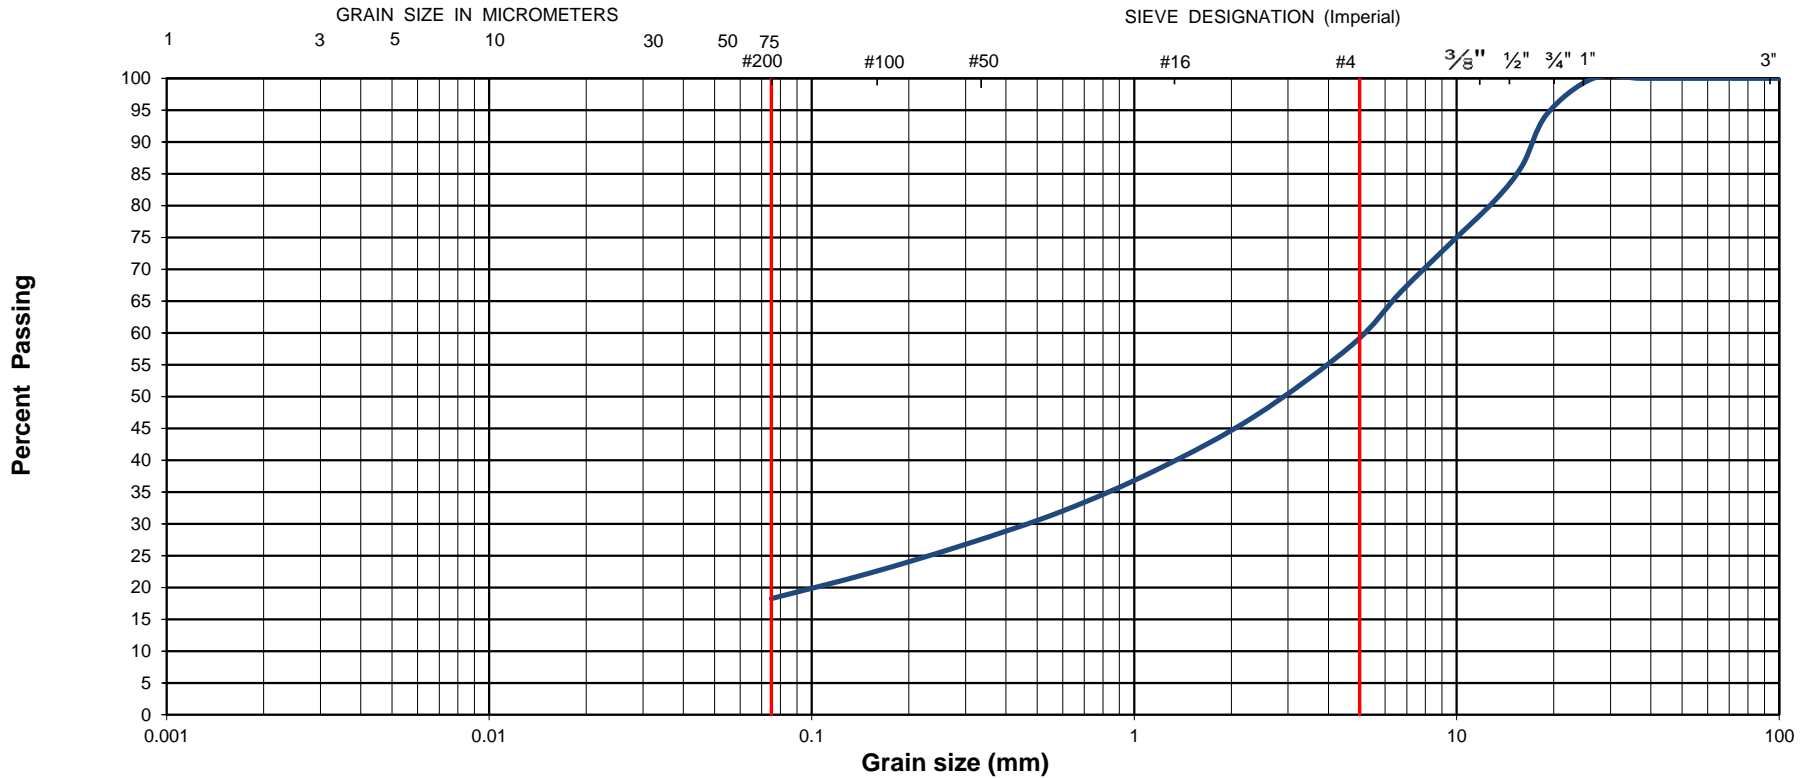
EXP Project No.:	OTT-21010977-A0	Project Name :	Corkery Community Centre Expansion					
Client :	City of Ottawa	Project Location :	3447 Old Almonte Road. Carp, Ottawa, ON					
Date Sampled :	June 17, 2021	Borehole No:	BH2	Sample:	SS3	Depth (m) :	1.5-1.8	
Sample Composition :	Gravel (%)	42	Sand (%)	40	Silt & Clay (%)	18	Figure :	10
Sample Description :	<b>FILL: Silty Gravel with Sand (GM)</b>

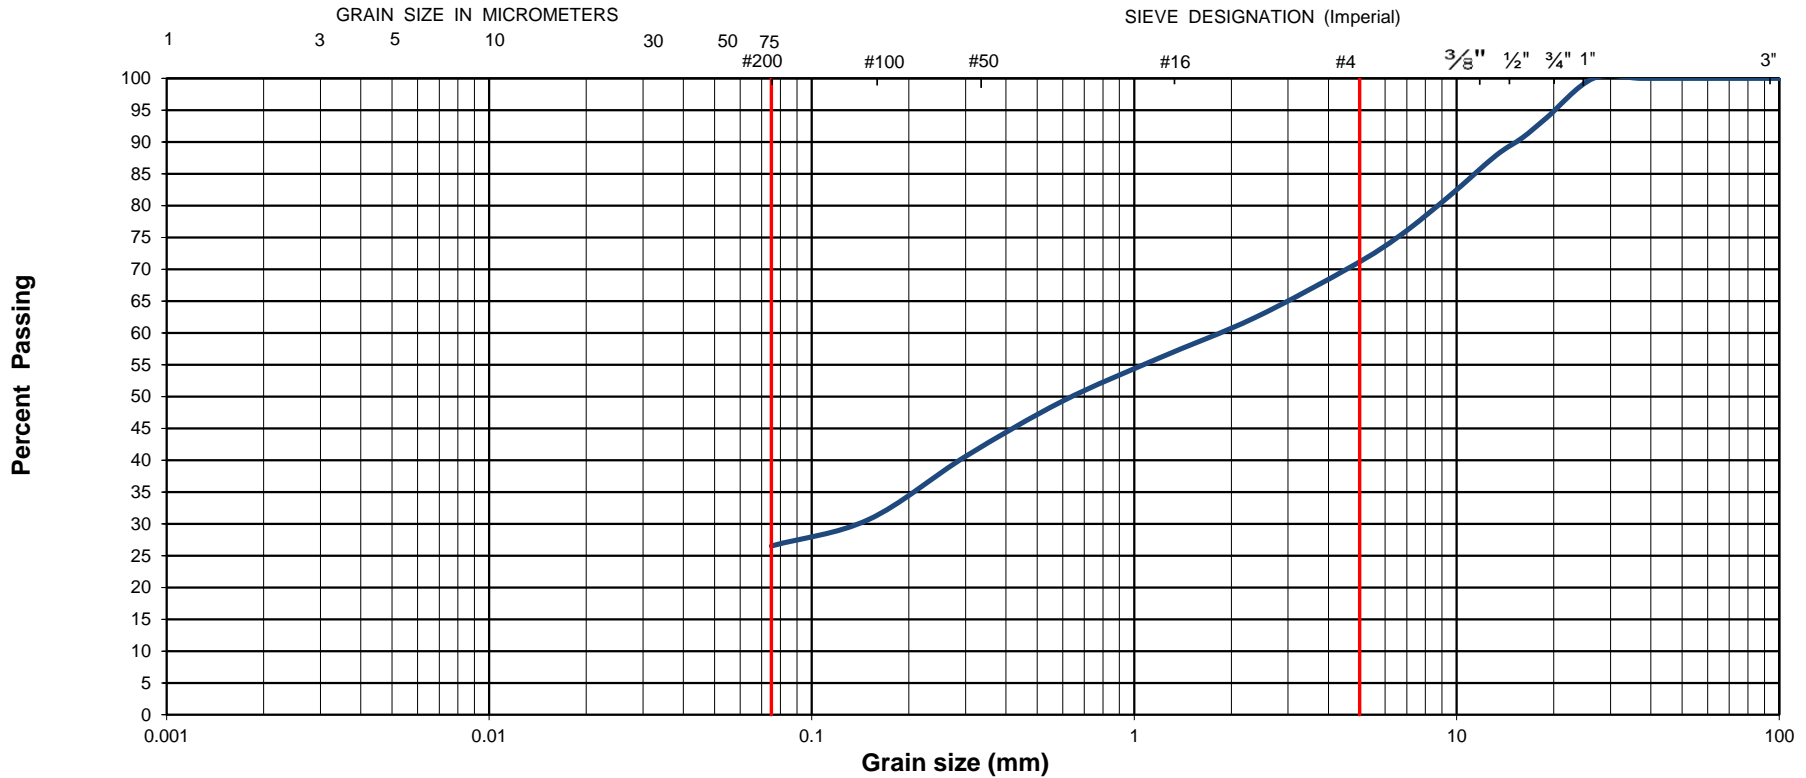
EXP Project No.:	OTT-21010977-A0	Project Name :	Corkery Community Centre Expansion			
Client :	City of Ottawa	Project Location :	3447 Old Almonte Road. Carp, Ottawa, ON			
Date Sampled :	June 17, 2021	Borehole No:	BH4	Sample:	SS2	
Sample Composition :	Gravel (%)	30	Sand (%)	43	Silt & Clay (%)	27
	Sample Description :	<b>FILL: Silty Sand with Gravel (SM)</b>			Figure :	11
