Environmental Impact Statement

**1161 Old Montreal Road
City of Ottawa, ON**

**ORLEANS LONG TERM
CARE HOME**
ENVIRONMENTAL IMPACT STATEMENT

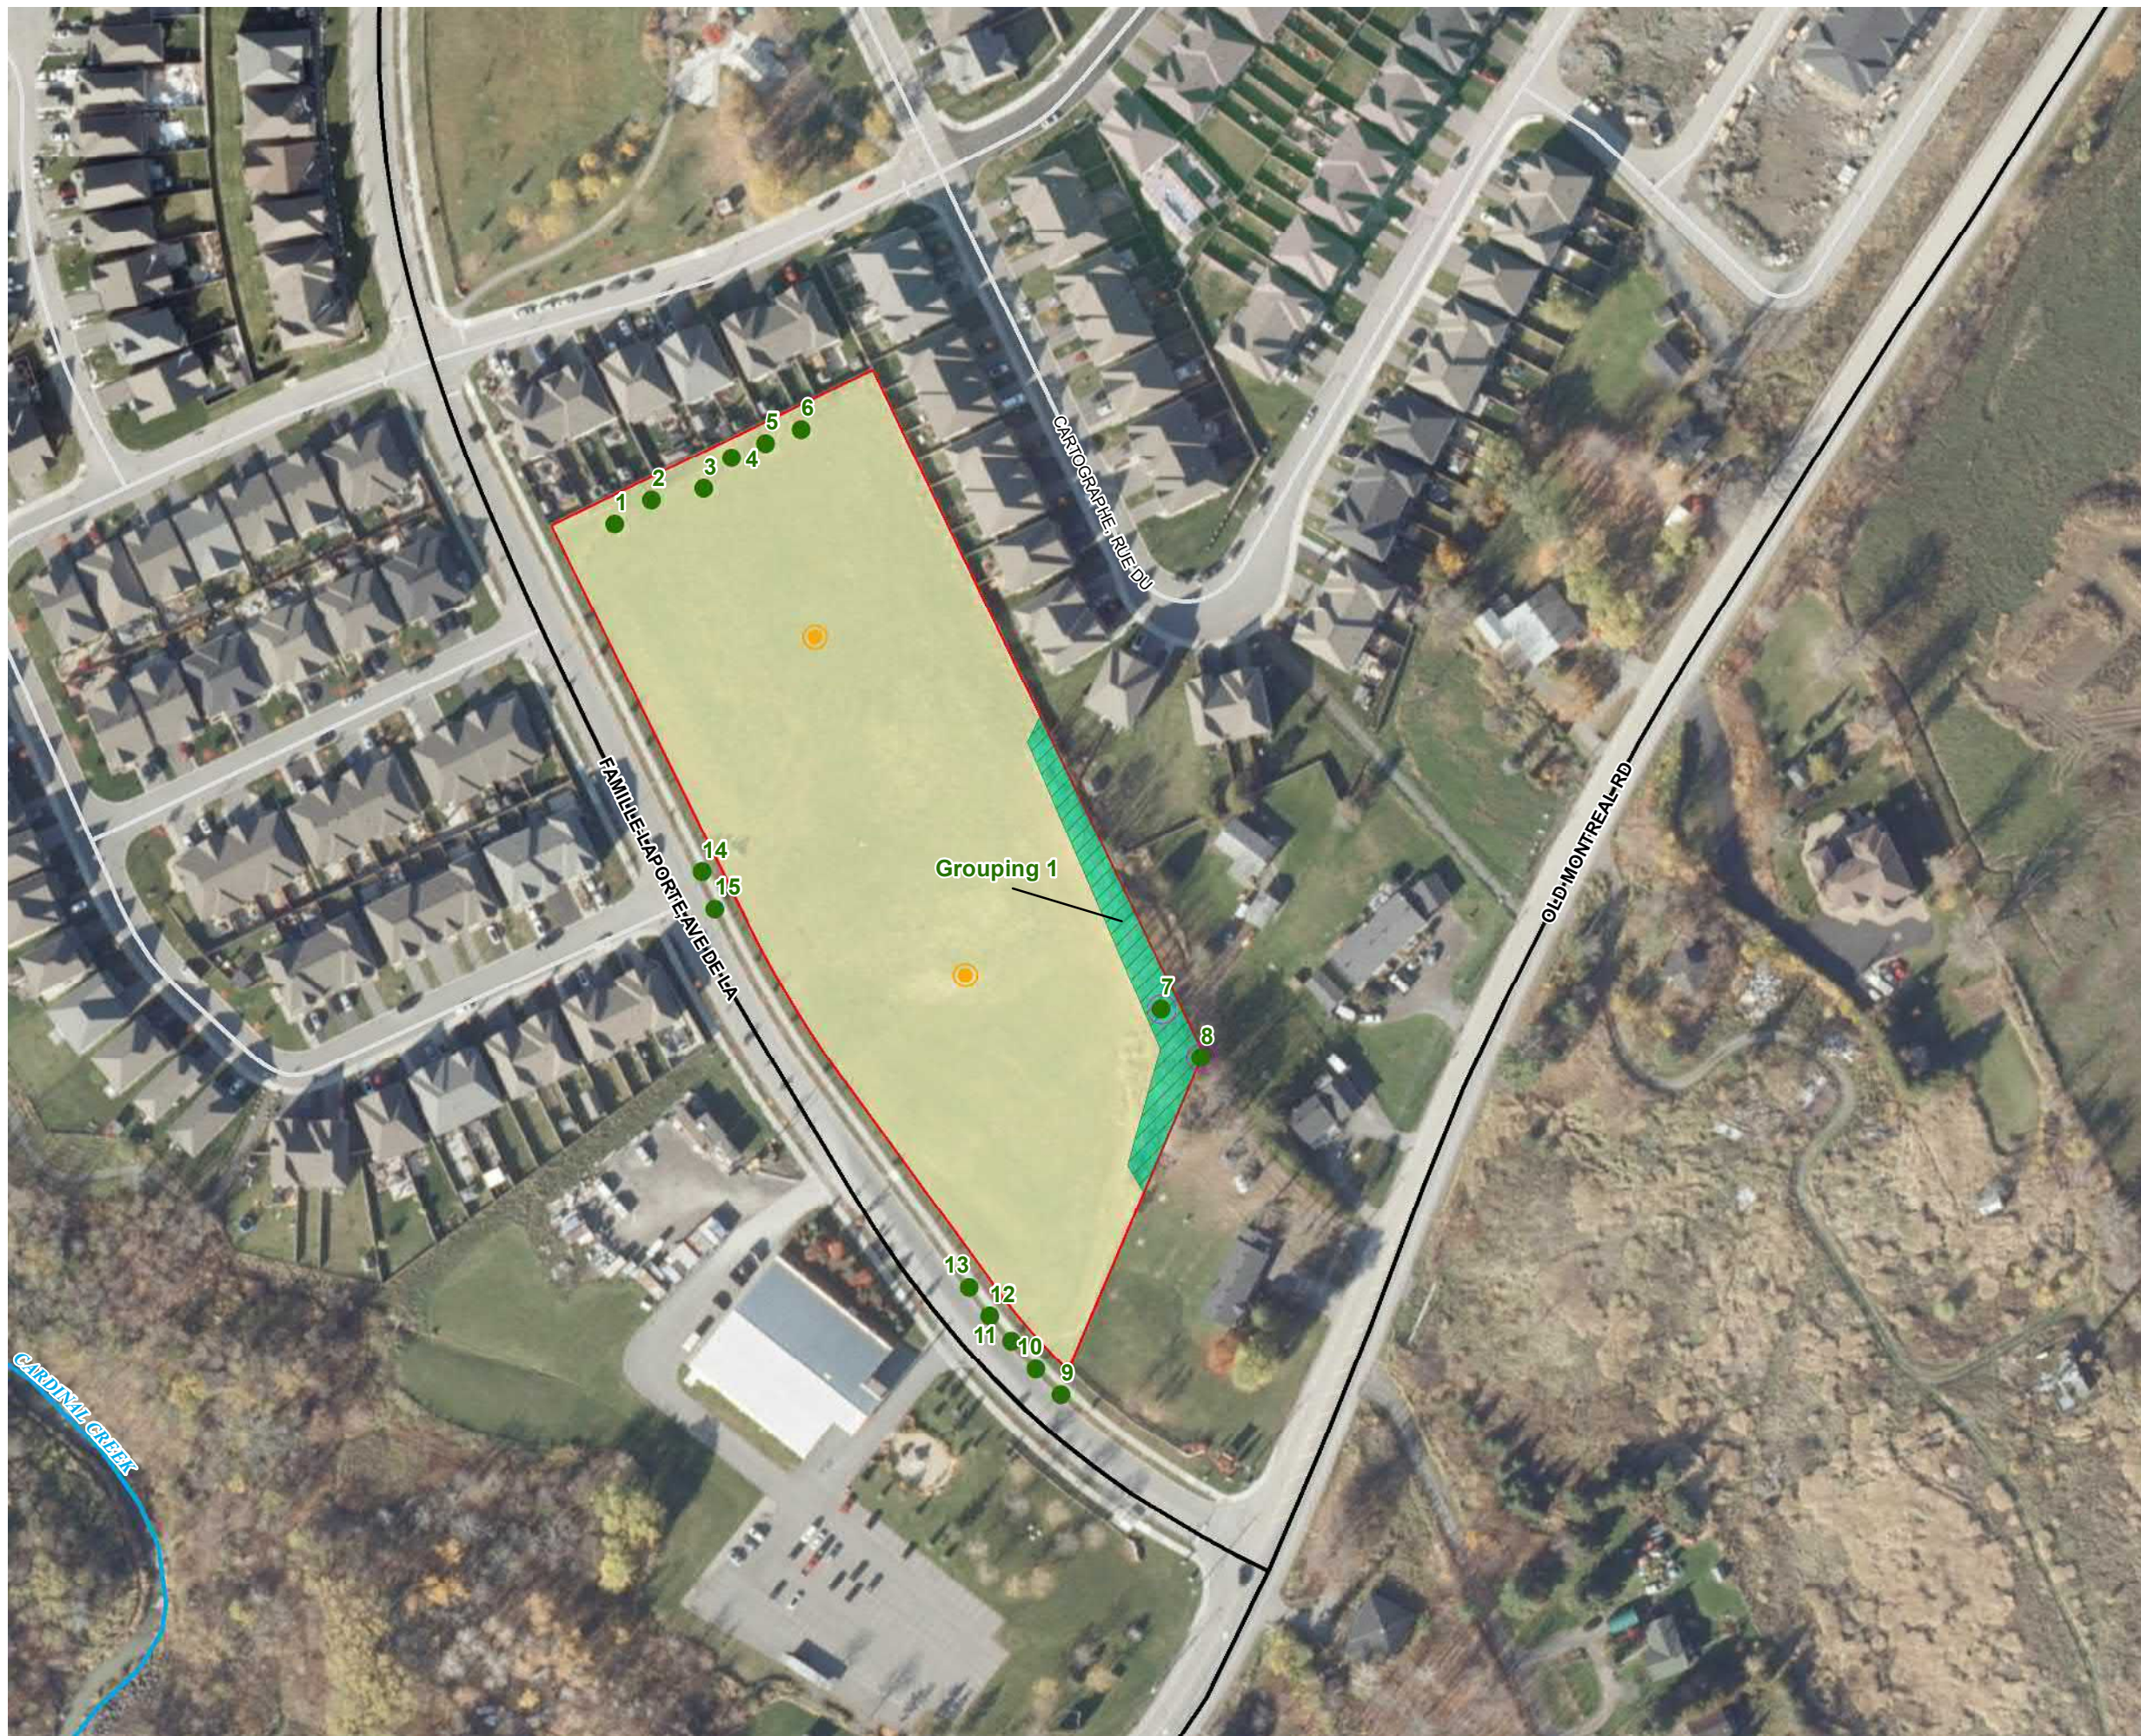
SURVEY LOCATIONS AND FIELD INVESTIGATION RESULTS
FIGURE 3

A total of two ecological communities were observed within the Property during ELC surveys, both of which are considered natural vegetation communities. The location, type, and boundaries of these communities are delineated on **Figure 3**. All vegetation communities surveyed within the Property are considered common in Ontario. **Table 6** outlines the communities documented during ELC surveys and summarizes the dominant vegetation cover. Reference photos for each of the plant communities observed can be found in **Appendix B**.

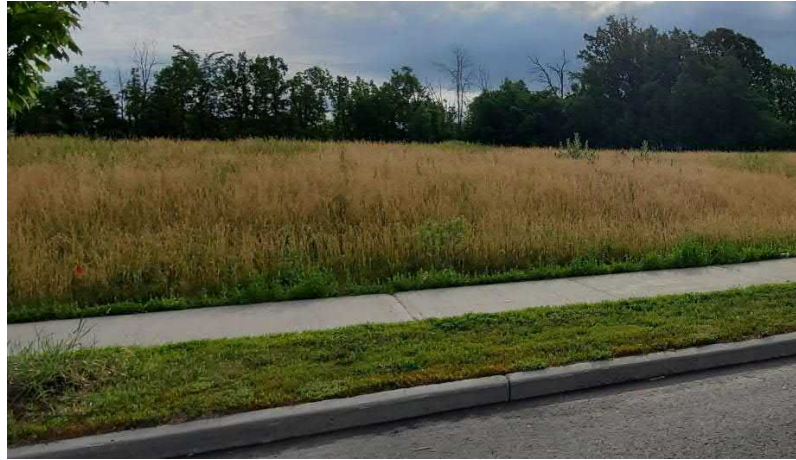
Photo #1
June 14, 2021

Notes:
Facing east from at Graminoid Meadow (MEG) (foreground) and the Fencerow (TAGM5) (background) from Famille-Laporte Avenue.

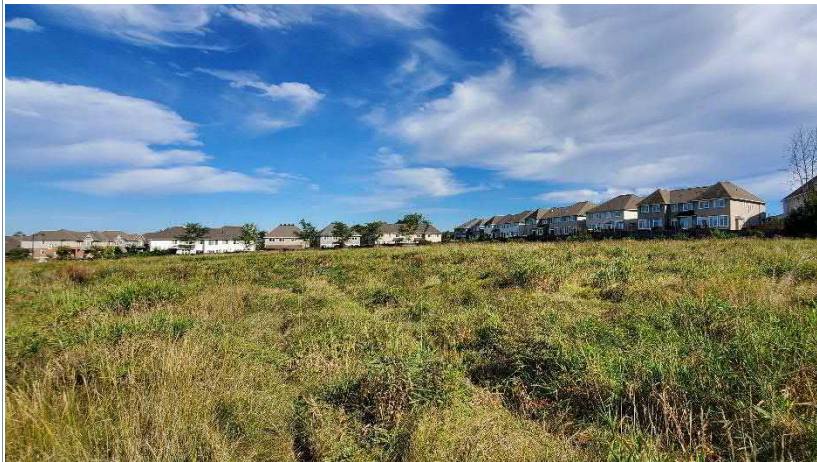
Photo #2
September 16, 2021

Notes:
Facing north from central portion of the Graminoid Meadow (MEG).

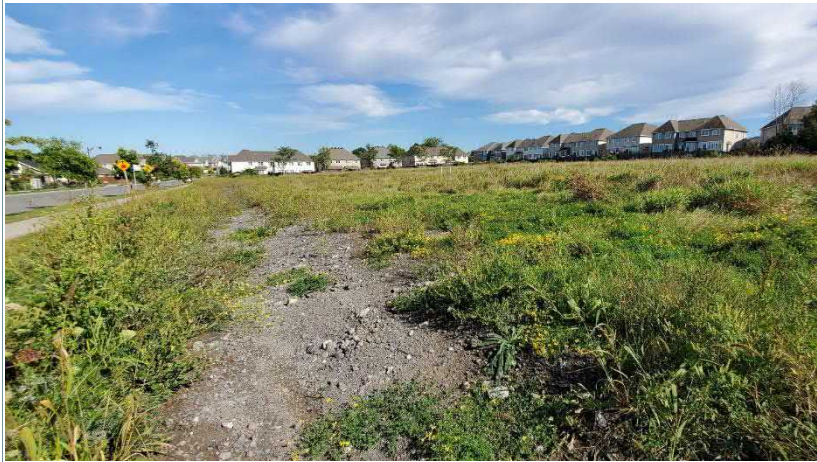
Photo #3
September 16 2021

Notes:
Facing north from western central portion of the Graminoid Meadow (MEG) at a dirt/gravel ditch that occurs parallel to Famille-Laporte Avenue and directs surface water flows north into a municipal sewer grate.

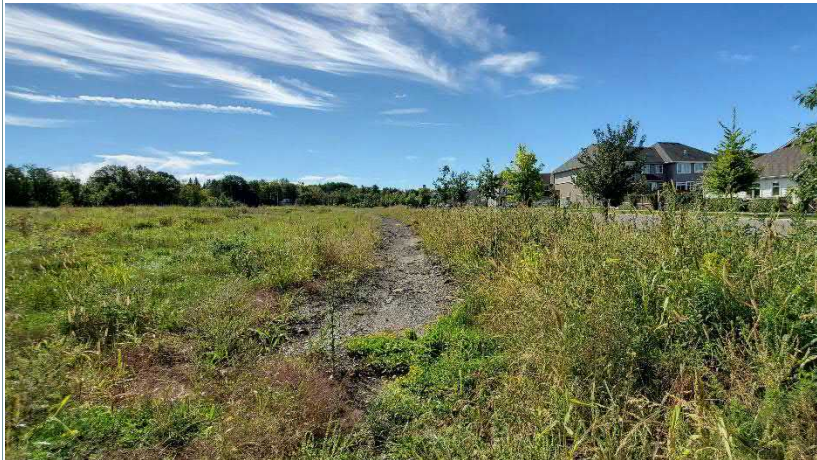
Photo #4
September 16 2021

Notes:
Facing south from northwest portion of the Graminoid Meadow (MEG) at a dirt/gravel ditch that occurs parallel to Famille-Laporte Avenue and directs surface water flows north into a municipal sewer grate.

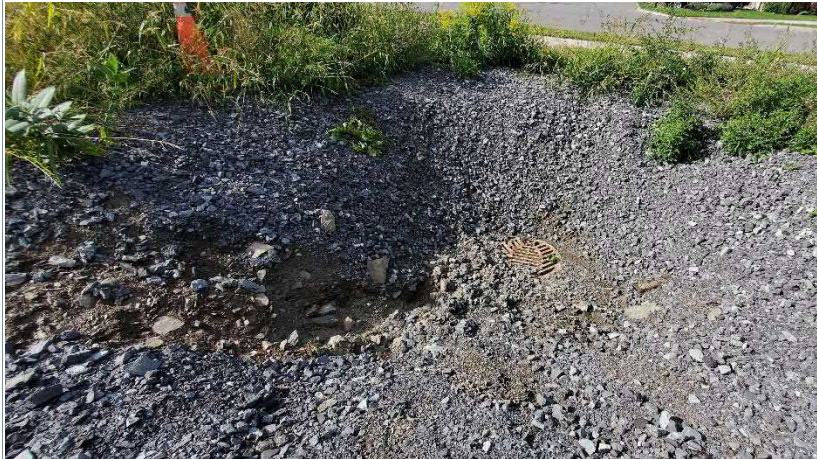
Photo #5
September 16 2021

Notes:
Facing southwest at
municipal sewer grate
located at north end of
dirt/gravel ditch.

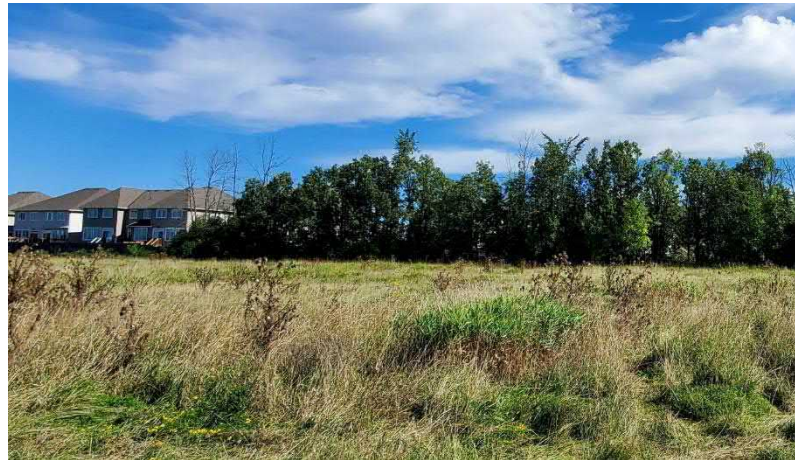
Photo #6
September 16 2021

Notes:
Facing east from at
Graminoid Meadow (MEG)
(foreground) and the
Fencerow (TAGM5) / Tree
Grouping 1 (background)
from Famille-Laporte
Avenue.

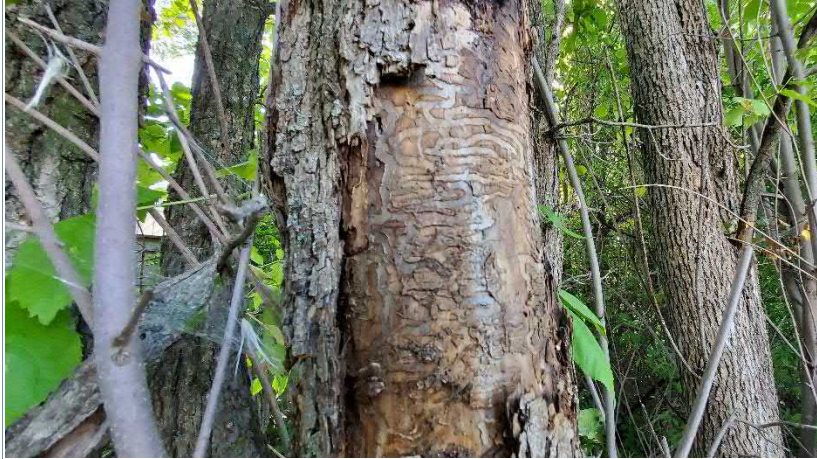
Photo #9
September 16 2021

Notes:
Emerald Ash Borer Beetle gallery on Ash tree within Fencerow (TAGM5).

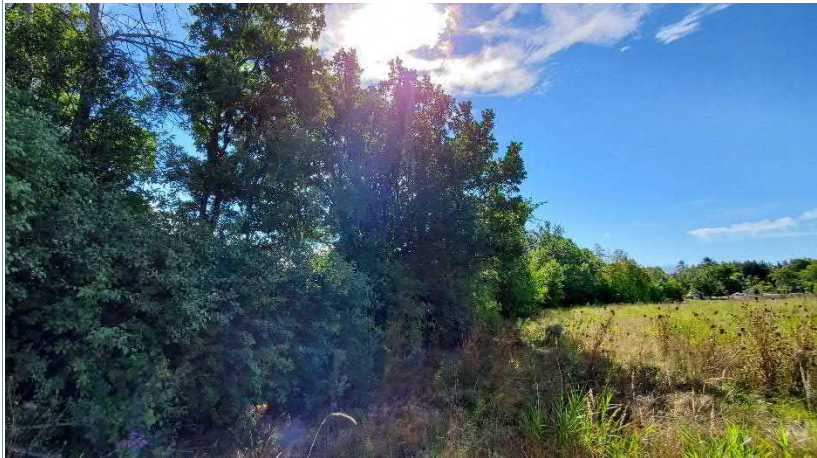
Photo #10
September 16 2021

Notes:
Facing south from north extent of Fencerow (TAGM5) at Fencerow (TAGM5) adjacent to Graminoid Meadow (MEG).

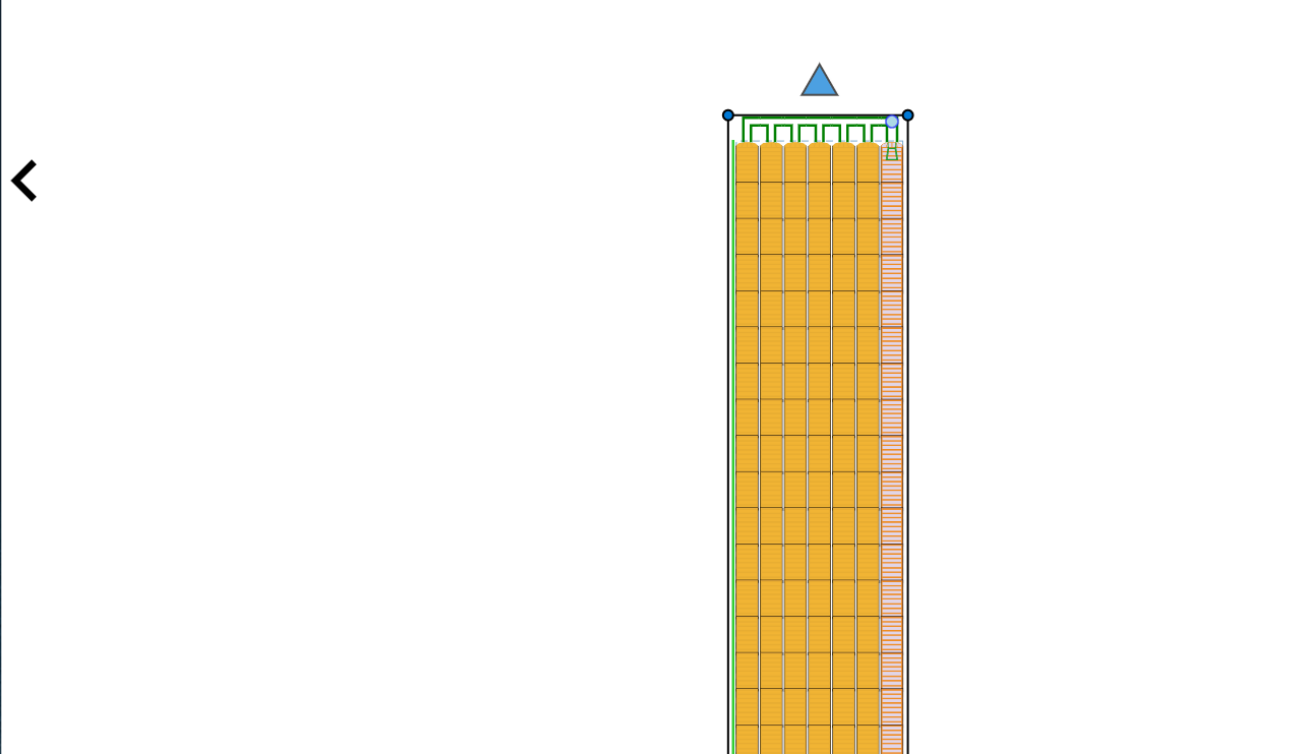
The diagram illustrates a vertical cross-section of a stormwater detention chamber. It features a grid of 14 chambers, each filled with stone. A blue triangle is positioned at the top center, and a black arrow points to the left from the parameter list. The chamber is shown with a top layer of stone and a bottom layer of stone, with a central outlet pipe.
