URBAN FORESTRY & FOREST MANAGEMENT CONSULTING

RE: TREE CONSERVATION REPORT FOR 1300 MICHAEL STREET, OTTAWA

This report details a pre-construction tree conservation report (TCR) for the above-noted commercial property at the intersection of Parisien and Michael Streets in Ottawa. The need for this TCR is related to the proposed redevelopment of the subject property to include a new automotive building.

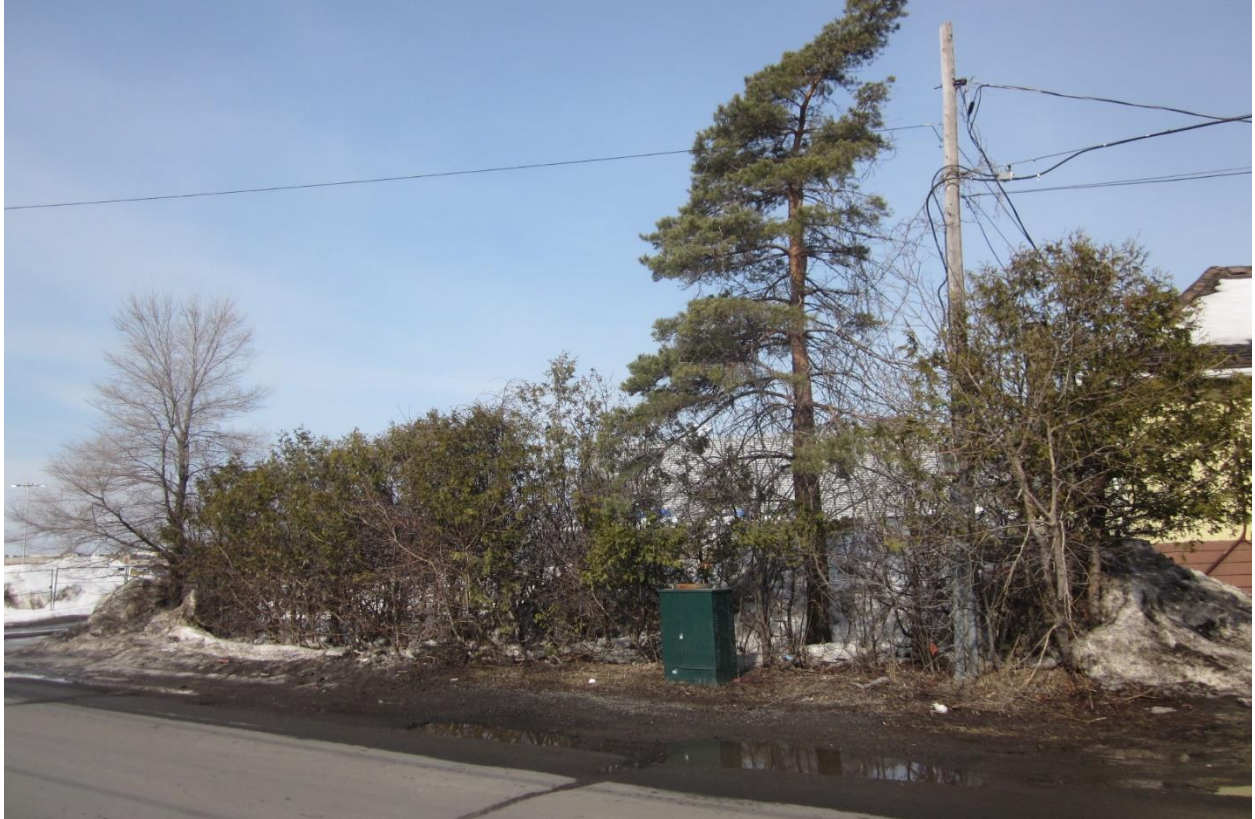
Tree No.	Tree species	Condition (VP→E)	DBH ¹ (cm)	Owner -ship	Age class, tree condition notes & preservation status (to be removed or preserved and protected)
1	Siberian elm (<i>Ulmus pumila</i>)	Good	21.1	Shared	Maturing; single upright stem with competing lateral on northwest at 3.5m from grade and competing leaders at 4m; introduced invasive species; to be removed
2	Eastern white cedar (<i>Thuja occidentalis</i>)	Poor	<10	City	Mature; heavy Manitoba maple (<i>Acer negundo</i>) and vine (<i>Vitis</i> spp.) growth throughout; poor crown density and growth increment, fair needle colour; native species; to be removed
3	Scots pine (<i>Pinus sylvestris</i>)	Fair	14.7 & 21.3	Private	Maturing; double stemmed at 0.3m from grade; fair crown density, growth increment and needle colour above hedge (poor below); introduced invasive species; to be removed
4	Siberian elm	Fair	82.2 (at 1m)	Shared	Overmature; co-dominant stems at 1.5m from grade; moderately divergent; broad crown; unmaintained – major deadwood present; to be removed

Picture 1. Trees #1-3 (left tot right) located on and adjacent to 1300 Michael Street

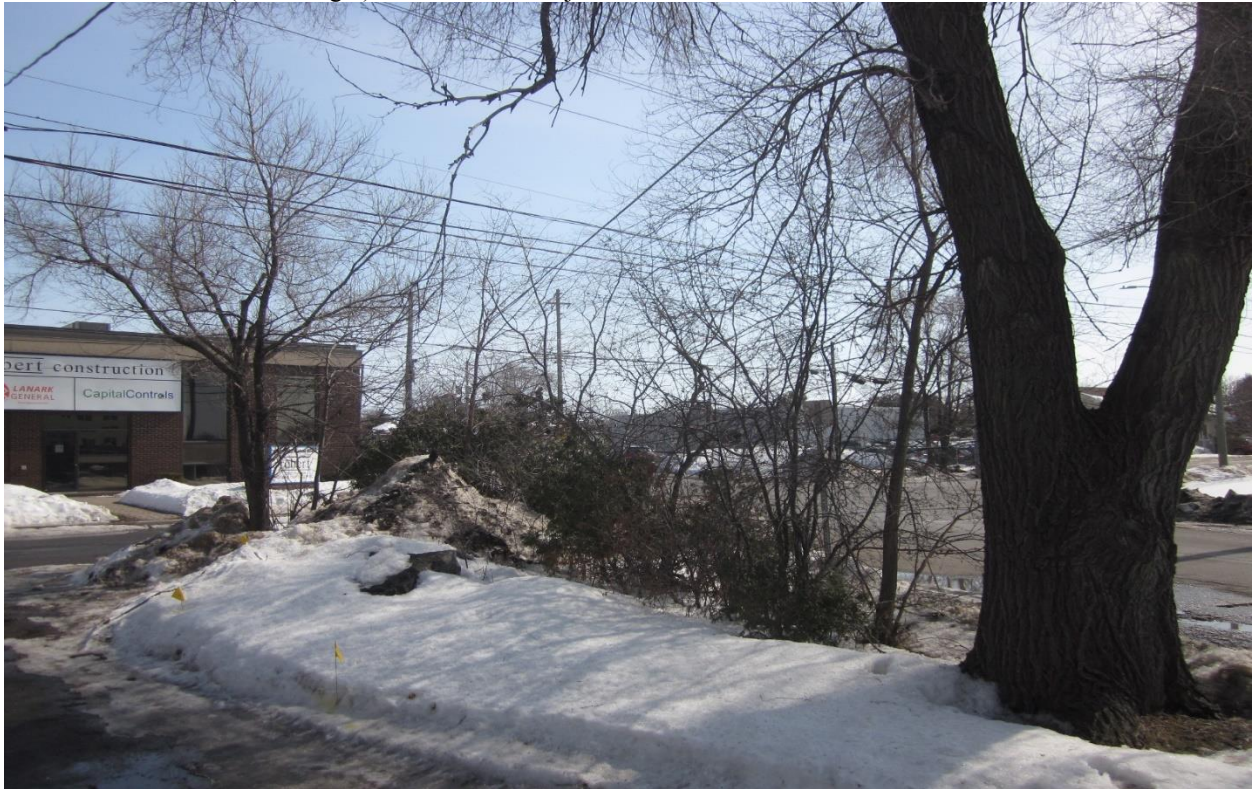
5	Eastern white cedar / Siberian elm	Very poor / Poor	Cedar <10 / Elm 16.1 & 22.6	Private	<u>Hedge</u> : maturing; dense competition from seeded ash (<i>Fraxinus</i> spp.), buckthorn (<i>Rhamnus</i> spp.) and Siberian elm growth; poor crown density, growth increment and needle colour / <u>Elm</u> : Maturing; double-stemmed at 0.5m from grade; topped by Hydro at 5m; to be removed
6	Siberian elm	Poor	53.1	Private	Mature; central stem with multiple competing laterals at 2m from grade – all divergent east-west; topped in past by Hydro; crown dense with epicormic growth; to be preserved and protected

Picture 2. Trees #4 and 5 (right to left) located on and adjacent to 1300 Michael Street

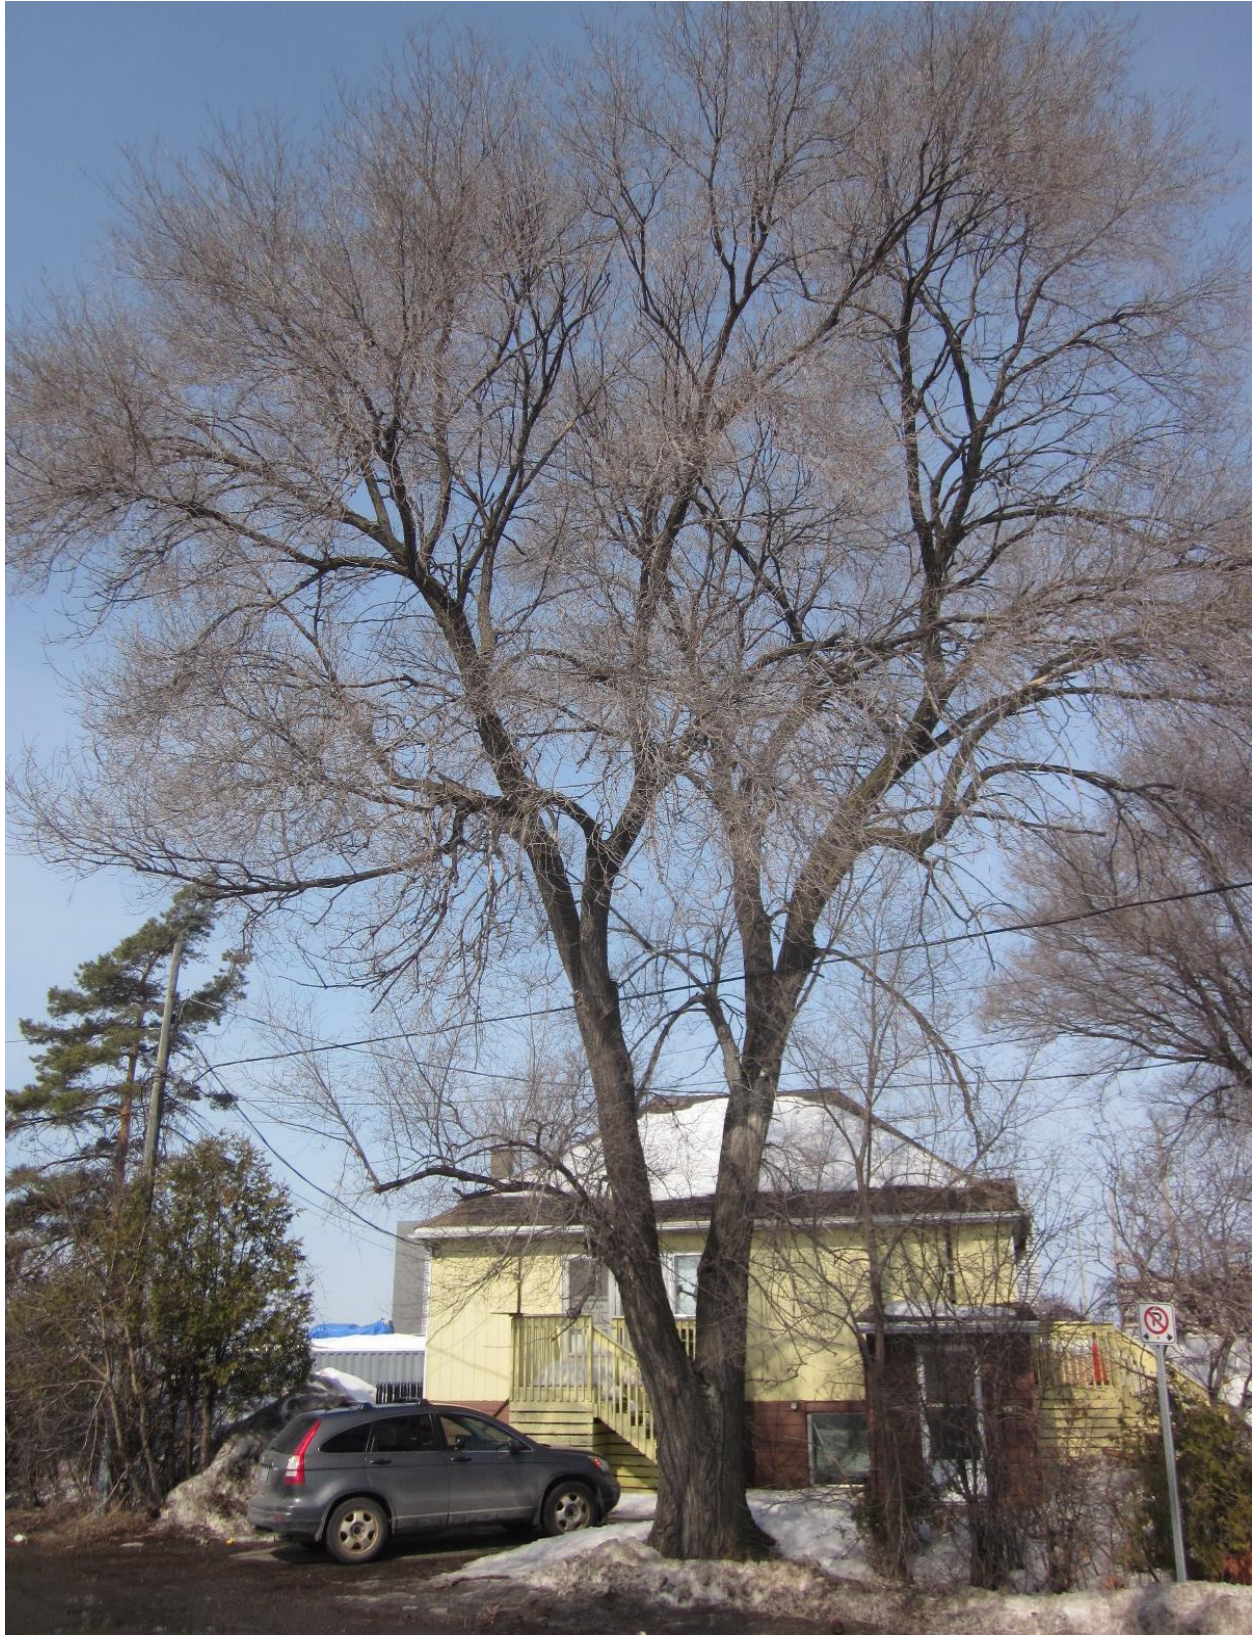
Picture 3. Shared tree #4 located at 1300 Michael Street

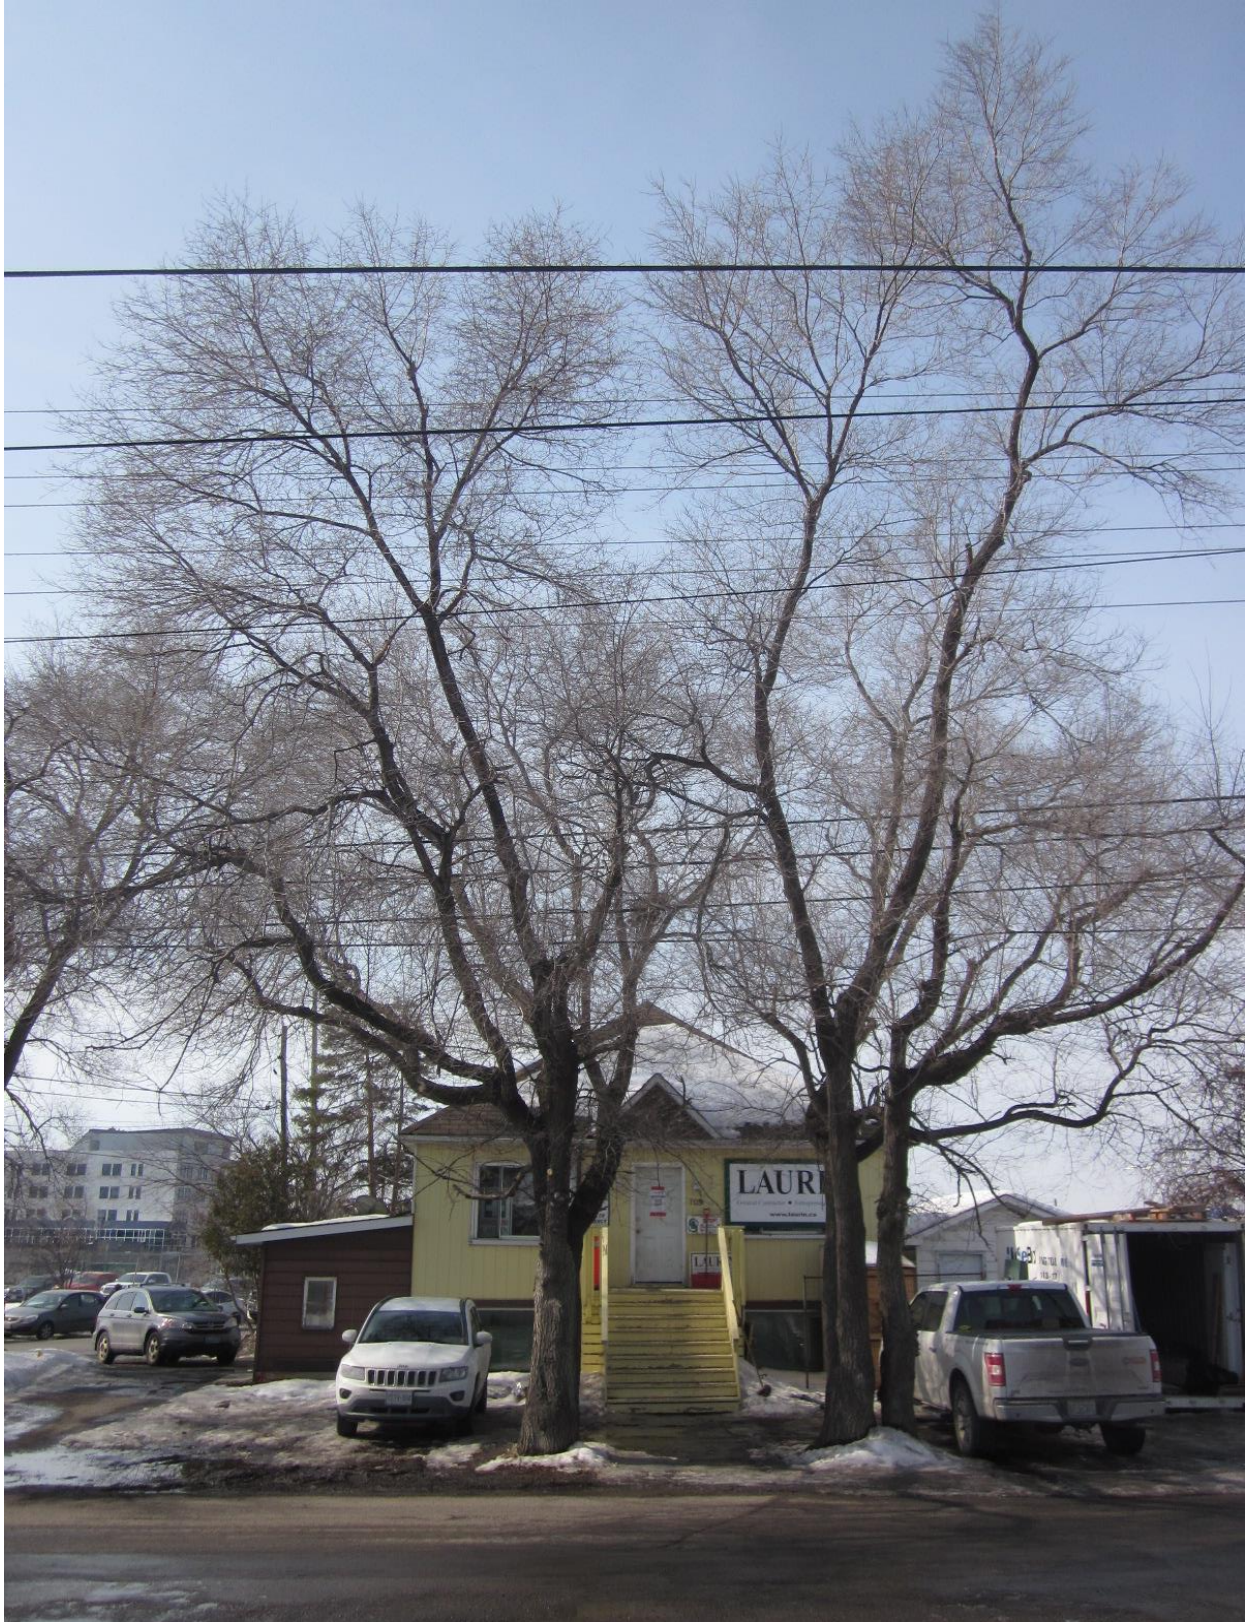
Tree No.	Tree species	Condition (VP→E)	DBH ¹ (cm)	Owner -ship	Age class, tree condition notes & preservation status (to be removed or preserved and protected)
7	Siberian elm	Poor	35.2 & 39.3	Private	Mature; double stemmed at 1m from grade; strongly divergent east-west – pruned heavily by Hydro; crown dense with epicormic growth; to be preserved and protected
8	Siberian elm	Poor	35.1	Private	Mature; strongly divergent north-northwest – pruned heavily by Hydro; crown dense with epicormic growth; to be preserved and protected

Picture 4. Privately owned trees #6-8 (left to right) located at 1300 Michael Street. These trees will be retained.

In order to improve their long-term preservation the asphalt around the three remaining elms will be carefully removed and replaced with permeable pavers placed on existing grade (see landscape plan prepared by Ruhland and Associates). Directed pruning will be undertaken to help improve their forms distorted by the need to provide clearance from overhead Hydro lines.

Protection measures are intended to prevent damage during construction. The measures detailed on page 4 are the minimum required by the City of Ottawa to ensure tree survival during and following construction. These will be applied for the three trees to be retained.

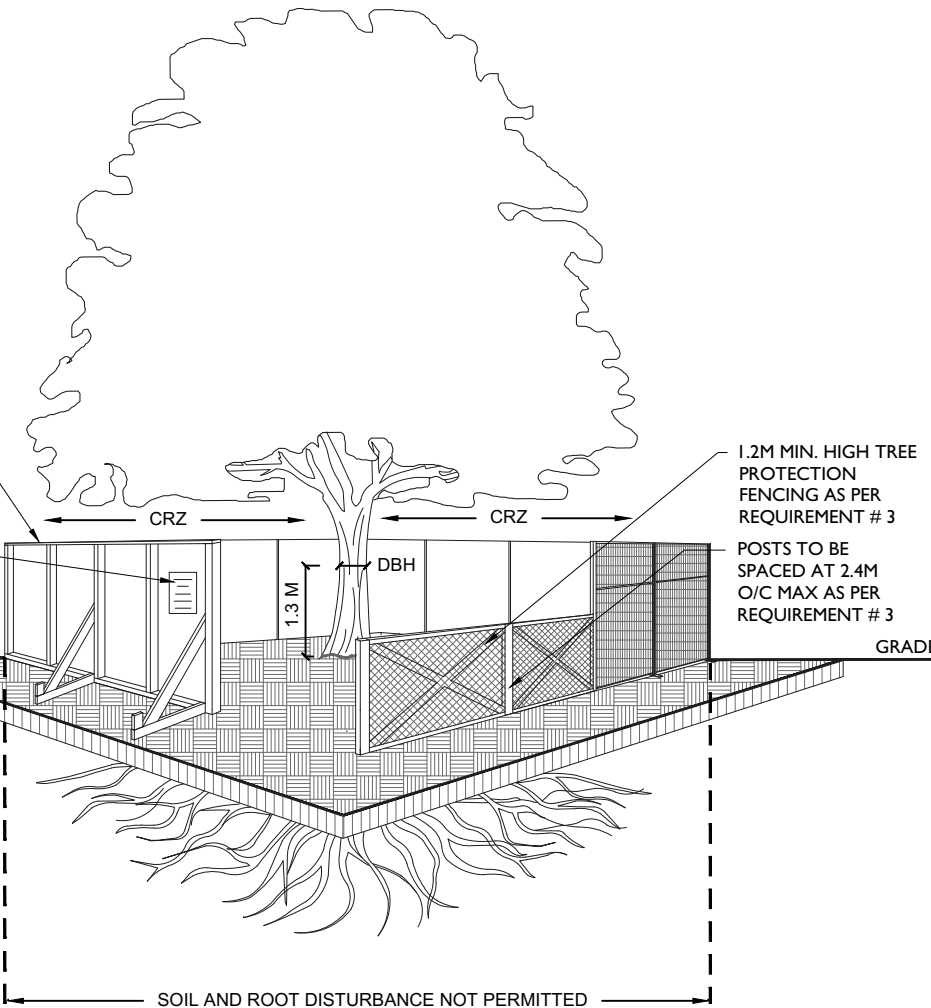
TREE PROTECTION SPECIFICATION

CRZ = DBH X 10CM.
CRZ IS TO BE MEASURED FROM THE OUTSIDE EDGE OF THE TREE BASE

1.2M MIN. HIGH TREE PROTECTION FENCING AS PER REQUIREMENT # 3

POSTS TO BE SPACED AT 2.4M O/C MAX AS PER REQUIREMENT # 3

SOIL AND ROOT DISTURBANCE NOT PERMITTED

- DO NOT EXTEND HARD SURFACE OR SIGNIFICANTLY CHANGE LANDSCAPING
3. TREE PROTECTION FENCING MUST BE AT LEAST 1.2M IN HEIGHT, AND CONSTRUCTED OF RIGID OR FRAMED MATERIALS (E.G. MODULOC - STEEL, PLYWOOD HOARDING, OR SNOW FENCE ON A 2"X4" WOOD FRAME) WITH POSTS 2.4M APART, SUCH THAT THE FENCE LOCATION CANNOT BE ALTERED. ALL SUPPORTS AND BRACING MUST BE PLACED OUTSIDE OF THE CRZ, AND INSTALLATION MUST MINIMISE DAMAGE TO EXISTING ROOTS. (SEE DETAIL)

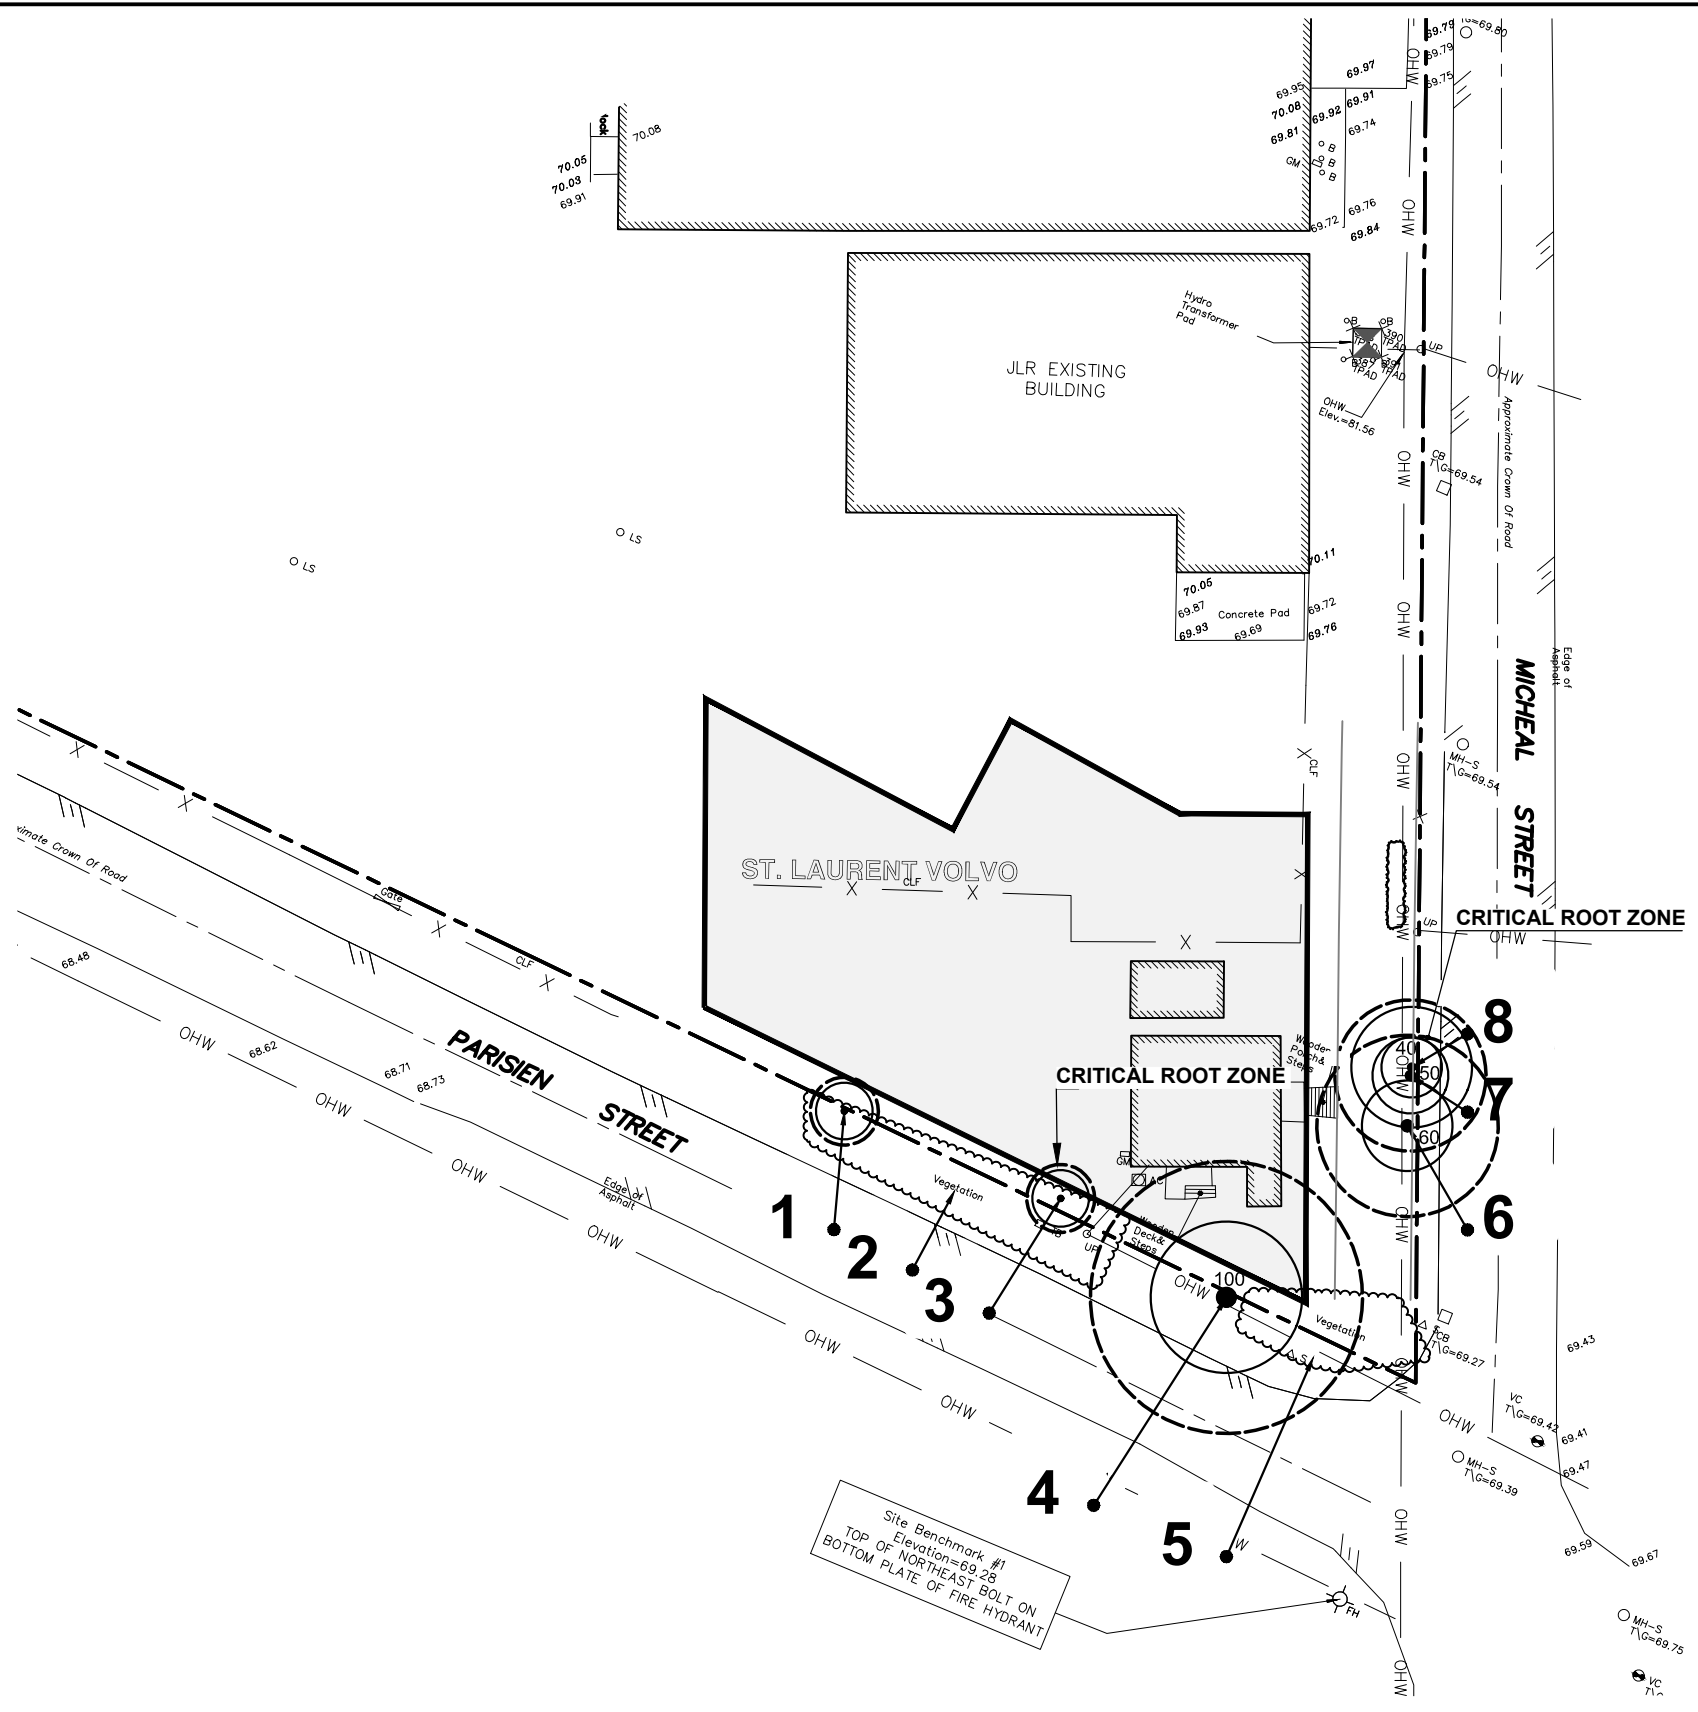
**REFER TO CHART FOR TREE ID,
CONDITION, ACTION**

stamp	project			drawing			
	VOLVO SAINT LAURENT ADDITION			MAP # 1 - CURRENT VEGETATION			
	Ruhland & Associates Ltd <small>200-1750 Courtwood Crescent, Ottawa, Ontario K2C 2B5 P (613) 224-4744 x 222 F (613) 224-1131 info@rala.ca www.rala.ca</small>			scale	date	project no.	dwg. no.
				1:500	January, 2022	21-1635	
				drawn by	checked by	revision no.	
				M.Malkov	M.Ruhland	.

Table 1 on pages 2 and 3 details the species, condition, size (diameter), ownership and status of the individual trees on and adjacent to the subject property. Each of these trees are referenced by the numbers plotted on the accompanying Map #1 – current vegetation prepared by Ruhland and Associates.

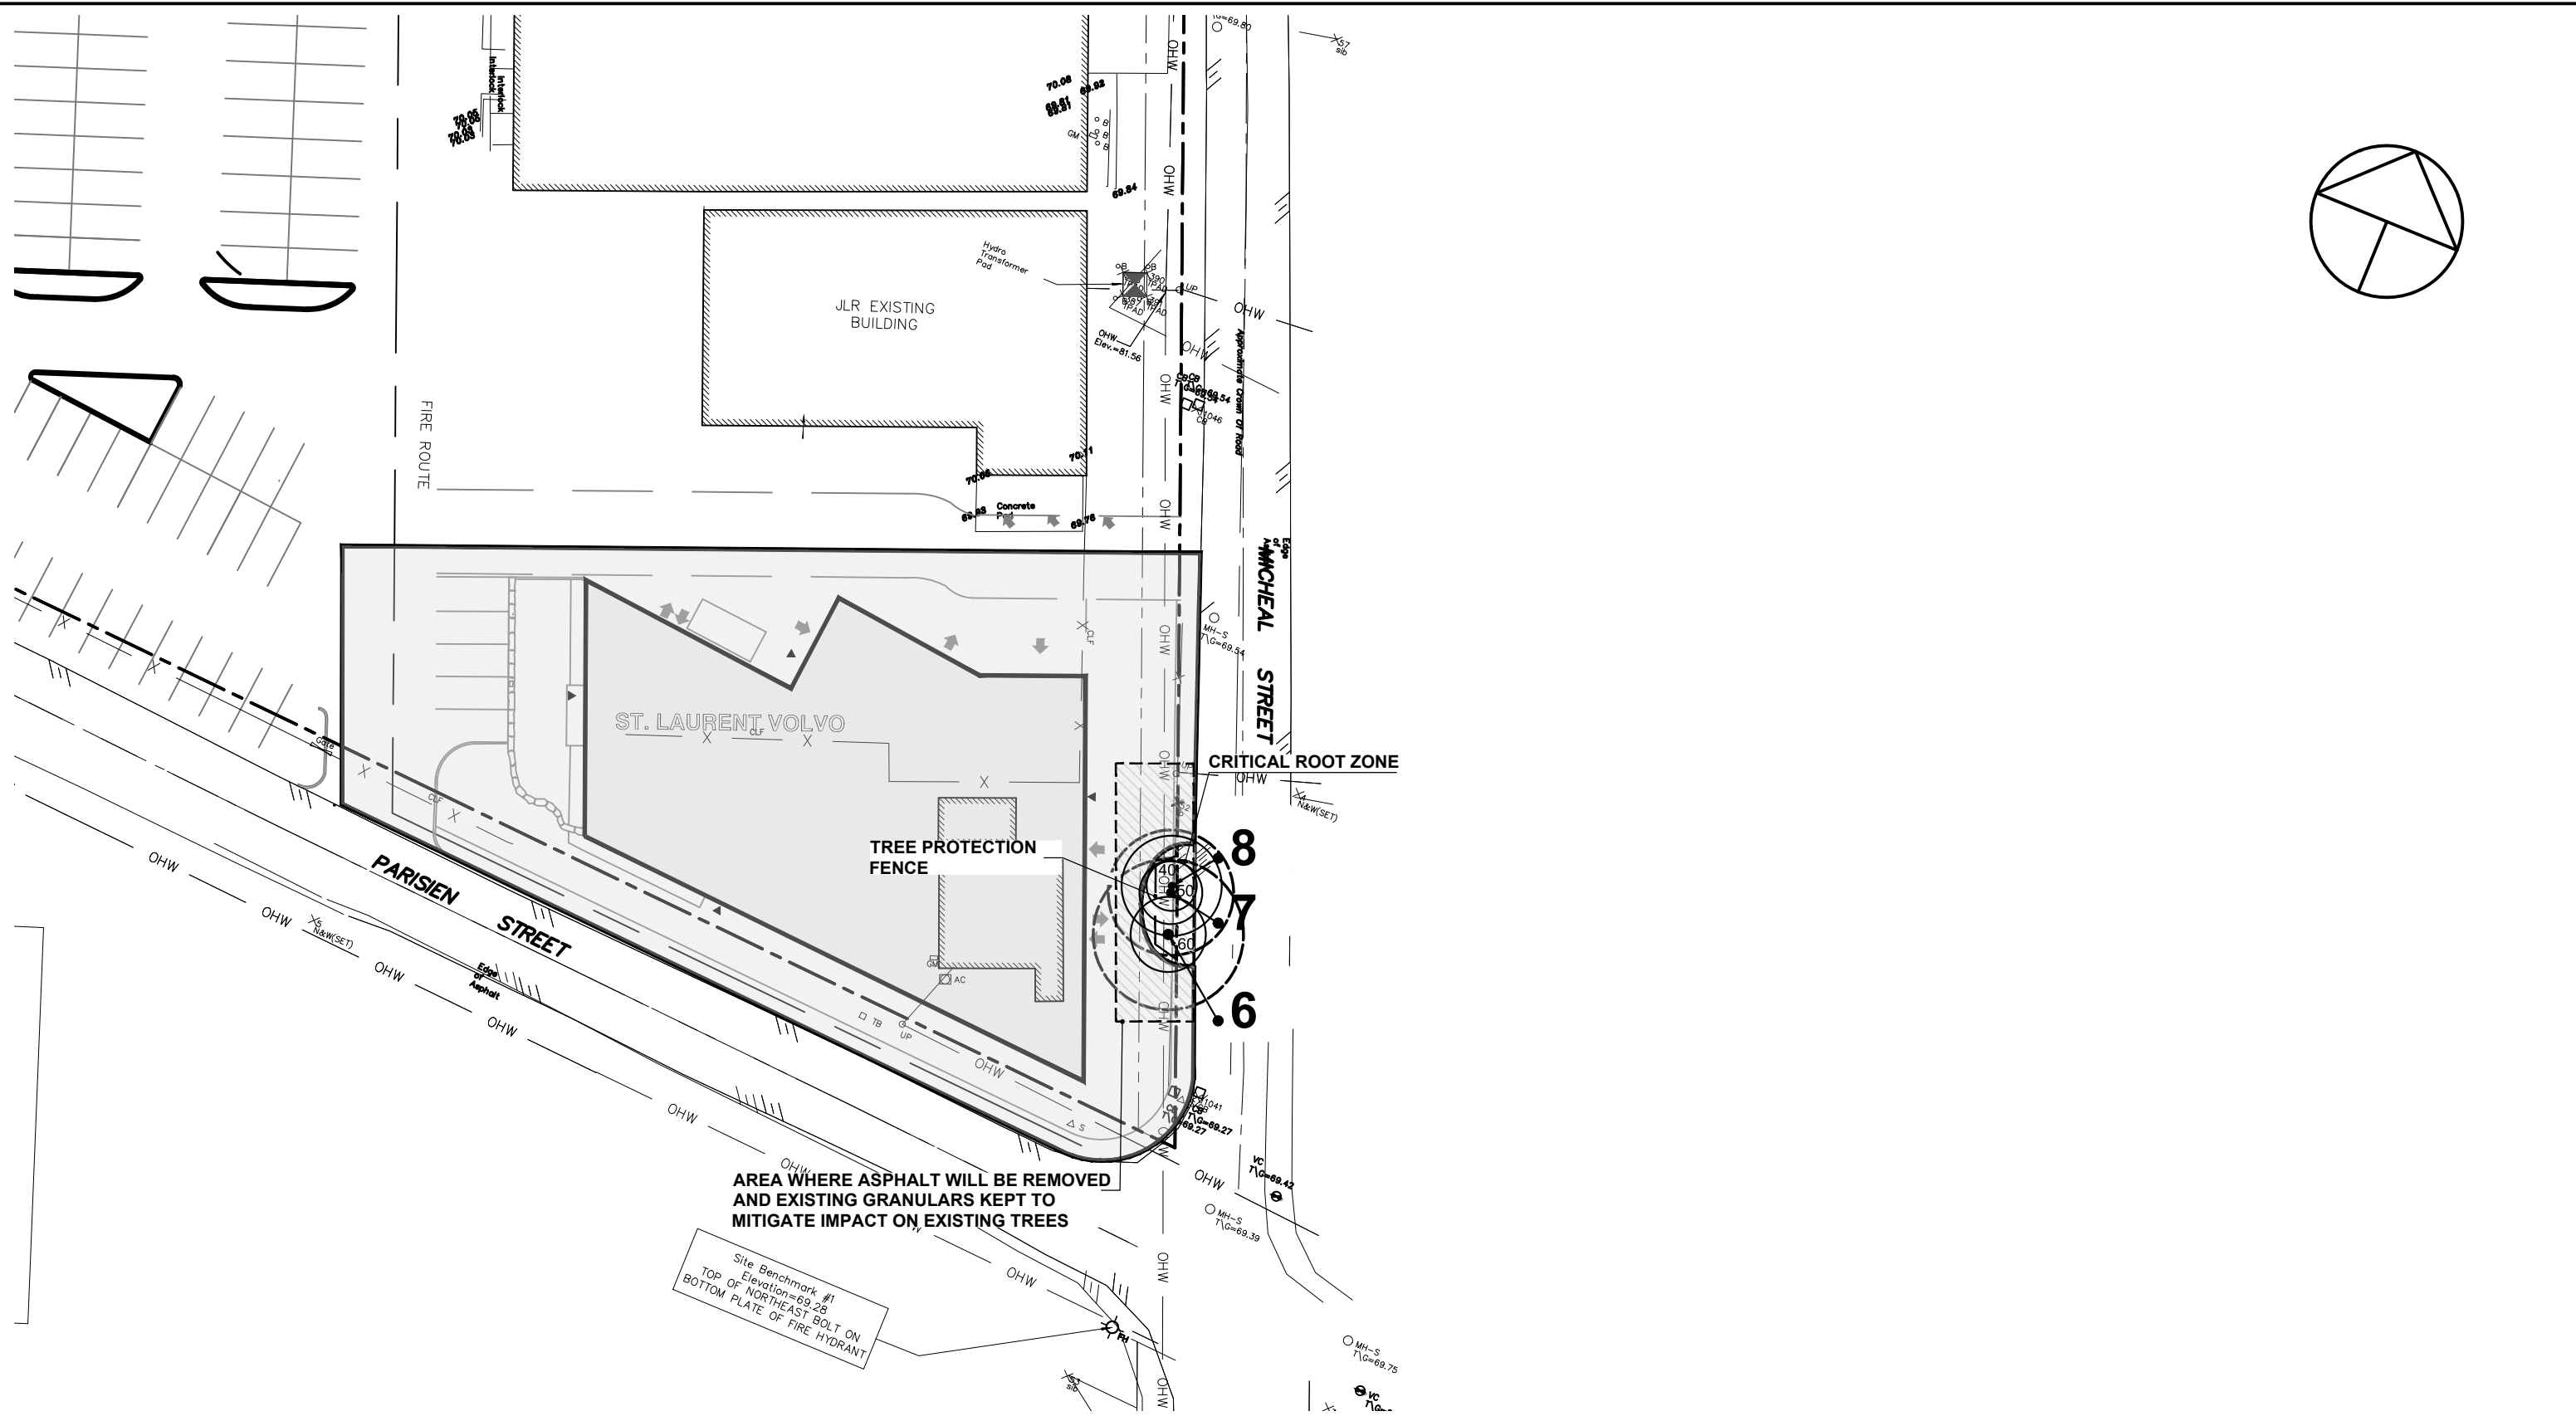
stamp	project			drawing				
	VOLVO SAINT LAURENT ADDITION			MAP # 2 - PROPOSED DEVELOPMENT				
	<p>Ruhland & Associates Ltd 200-1750 Courtwood Crescent, Ottawa, Ontario K2C 2B5 P (613) 224-4744 x 222 F (613) 224-1131 info@rala.ca www.rala.ca</p>		<p>IFS ASSOCIATES</p>		scale	date	project no.	dwg. no.
			1:500	January, 2022	21-1635	MAP #2		
		drawn by	checked by	revision no.				
		M.Malkov	M.Ruhland	.

1. As per the City of Ottawa's tree protection barrier specification shown in Map #2, erect a fence as close as possible to the CRZ of the tree(s);
2. Do not place any material or equipment within the CRZ of the tree(s);
3. Do not attach any signs, notices or posters to any tree;
4. Do not raise or lower the existing grade within the CRZ without approval;
5. Tunnel or bore instead of trenching within the CRZ of any tree;
6. Do not damage the root system, trunk or branches of any tree;
7. Ensure that exhaust fumes from all equipment are NOT directed towards any tree's canopy.
