Phase I Environmental Site Assessment

109-115 Dalhousie Street
Ottawa, Ontario

July 31, 2020

Report: PE4977-1

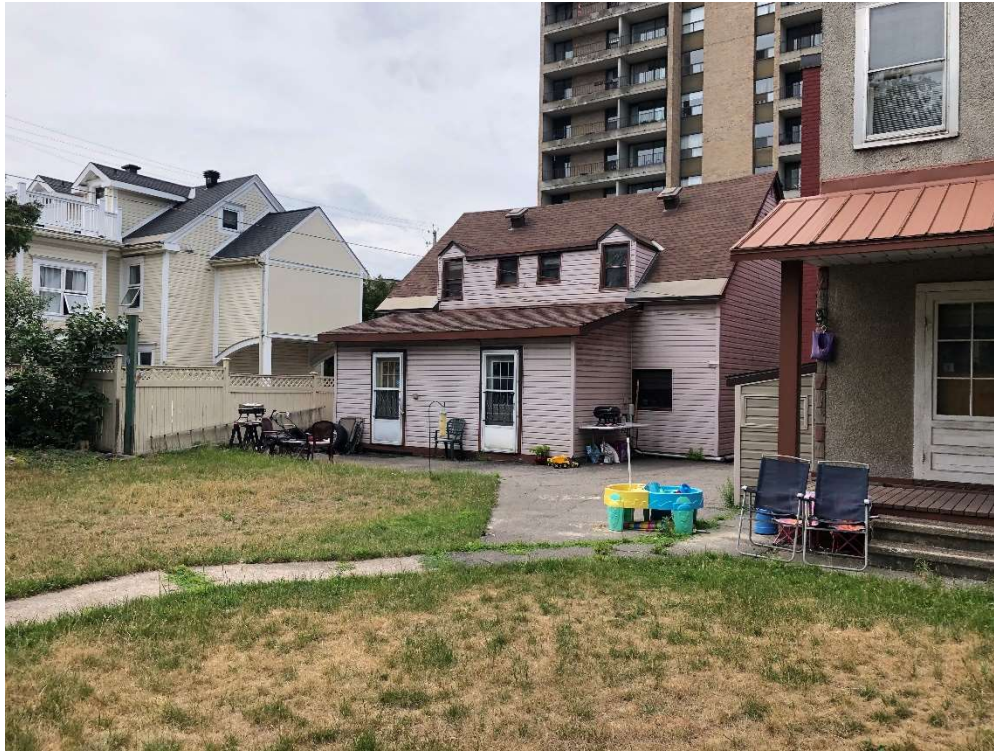
Photograph 1: Rear view of 113/115 Dalhousie Street.

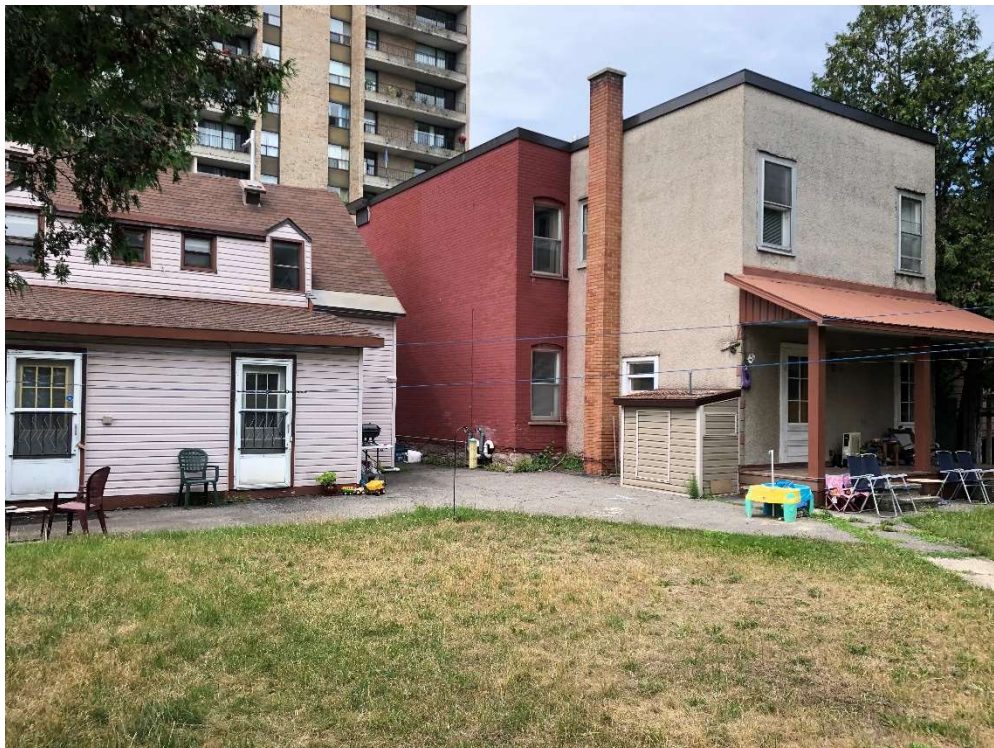
The site is occupied by 2 two-unit residential buildings and a storage shed, which occupy approximately half of the property. The remainder of the site is grassed and/or paved with asphalt. The Phase I property is generally flat and site drainage consists of infiltration and overland flow toward Dalhousie Street.

Photograph 2: Rear view of 113/115 Dalhousie (left) and 109/111 Dalhousie Street (right).

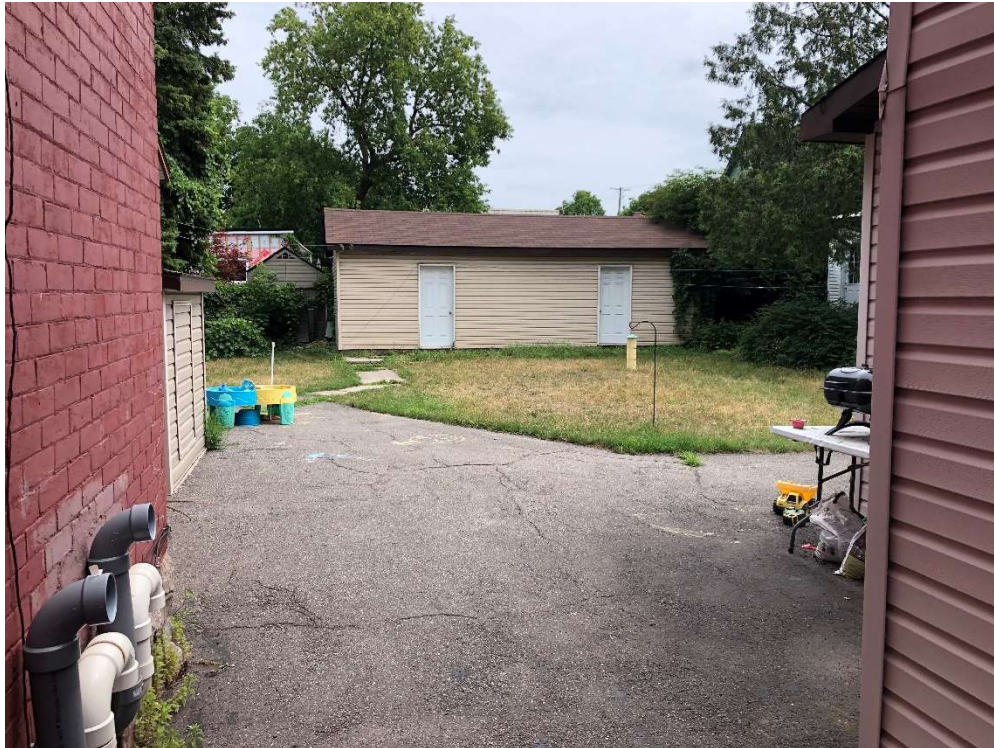
Following the historical review, a site visit was conducted. Paterson personnel noted that the detached (private) garage, as shown on the FIPs, was converted to a large storage shed at some point since the mid-1950s (date unknown). An out-of-service, 910 L, double-walled fibreglass, furnace oil AST was noted during the site visit, which, reportedly, is to be removed in the coming days. There was no evidence of historical releases or that the former use of furnace oil has had any adverse effects on the Phase I property. As such, this is not considered a PCA.

Photograph 3: Driveway (foreground) and storage shed (background).

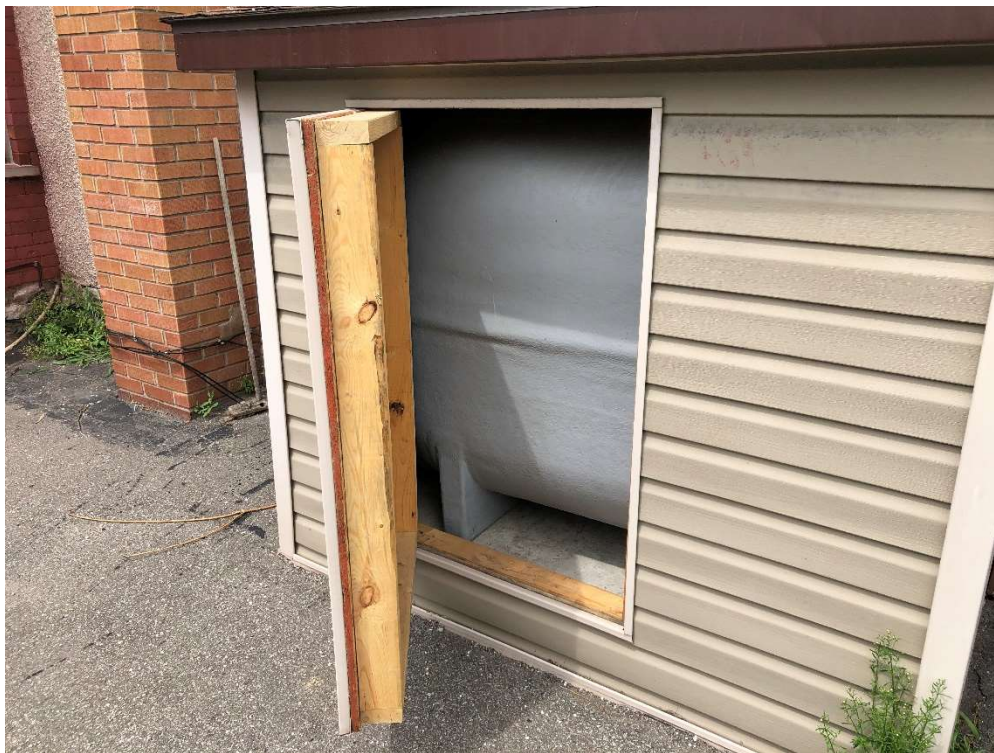
No bulk chemical storage areas or evidence of underground storage tanks (USTs) were observed on-site. An out-of-service, 910 L, double-walled fibreglass aboveground storage tank (AST), formerly used to store furnace oil, was observed on-site during the site visit. No evidence of leaks or spills was observed; the tank appeared to be in good condition, as was the concrete pad supporting it. The fill and vent pipes were capped in the basement of 111 Dalhousie Street, and were observed at the rear of the unit, in a location approximately corresponding to the exterior location of the AST. There was no evidence suggesting that there are or have been environmental issues associated with the former use of furnace oil and the presence of the AST. Therefore, the presence and former use of the AST is not considered a PCA. No other hazardous materials, unidentified substances, spills, abnormal odours, or indications of potential sub-surface contamination were observed on the Phase I property at the time of the site visit.

Photograph 4: Out-of-service fibreglass AST at rear of 111 Dalhousie Street.
