## Phase I Environmental Site Assessment

961-979 Wellington Street West &  
26-40 Armstrong Avenue  
Ottawa, Ontario

July 31, 2020

Report: PE4752-1R

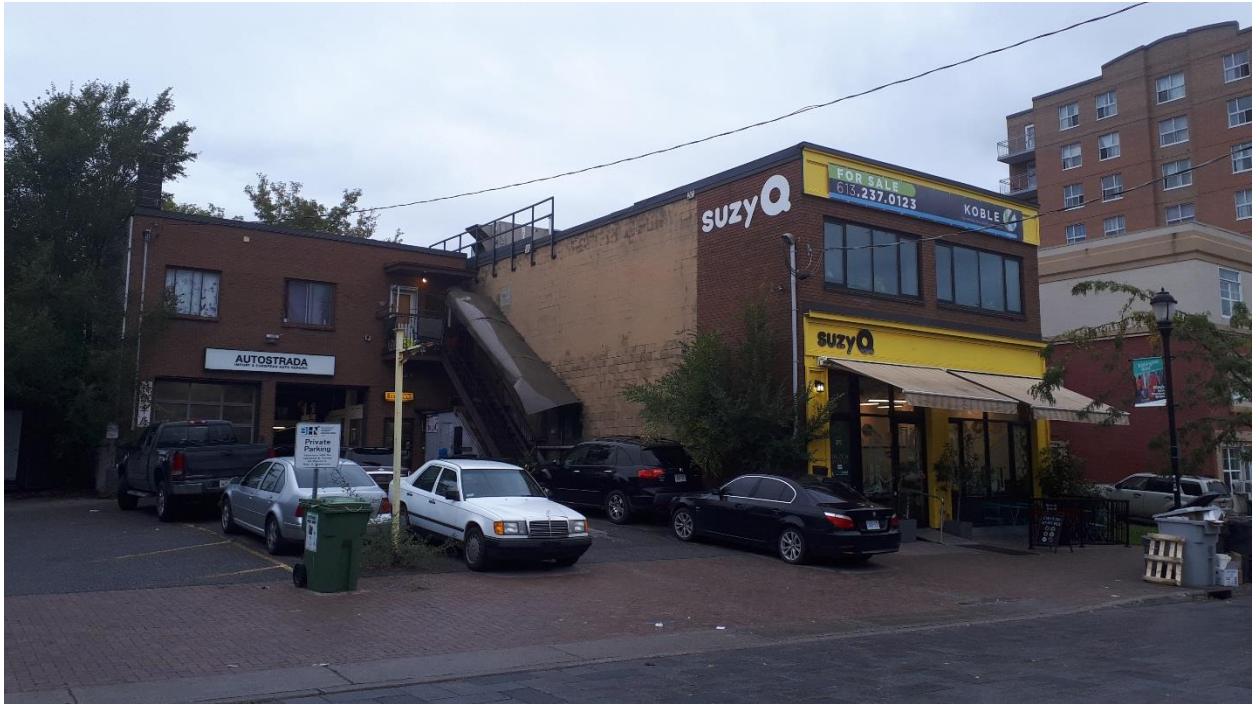
Photograph 1: View of 973 and 969 Wellington Street West looking north, from Wellington Street West.

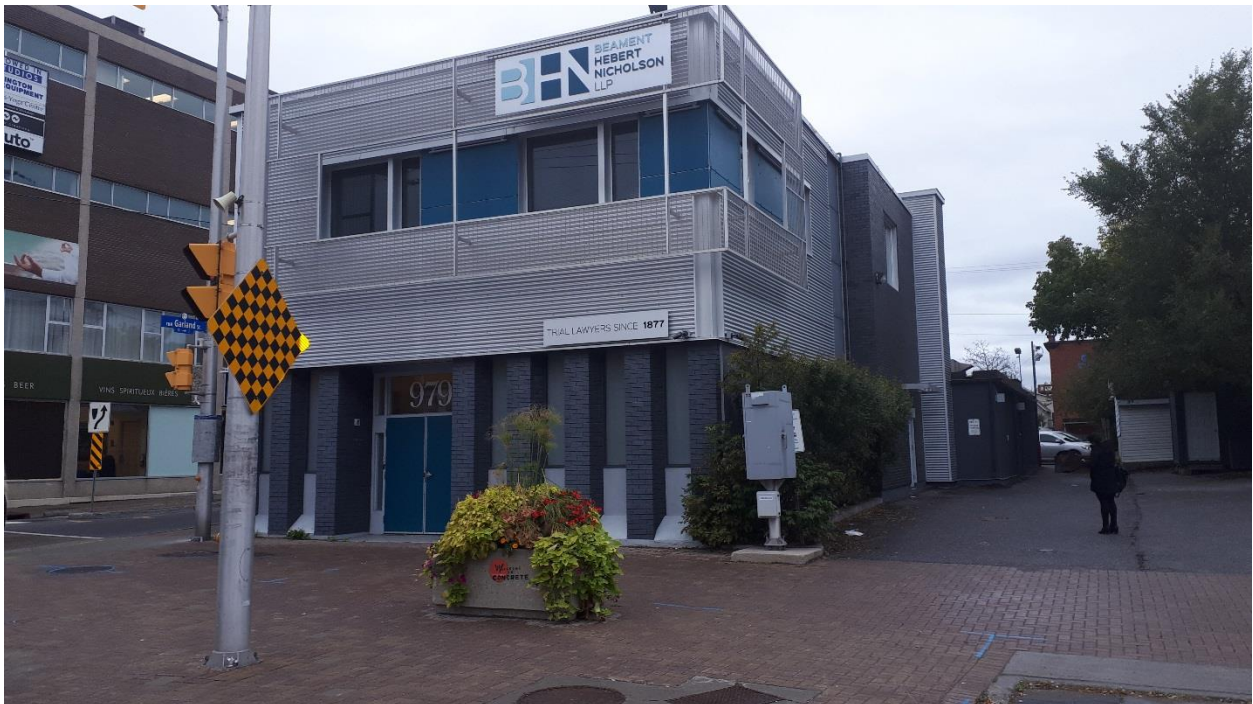
Photograph 2: View of 979 Wellington Street West, looking north from Wellington Street West.

This property is currently occupied with a two (2) storey commercial office building with one (1) basement level. A one (1) storey, slab-on-grade style addition has been constructed on the rear of the building. The building is constructed with a steel frame, poured concrete foundation, and is finished on the exterior with brick, metal siding, as well as a plaster and pebble finish, in addition to a flat tar-and-gravel style roof. The building is currently heated via three (3) natural gas-fired rooftop HVAC units.

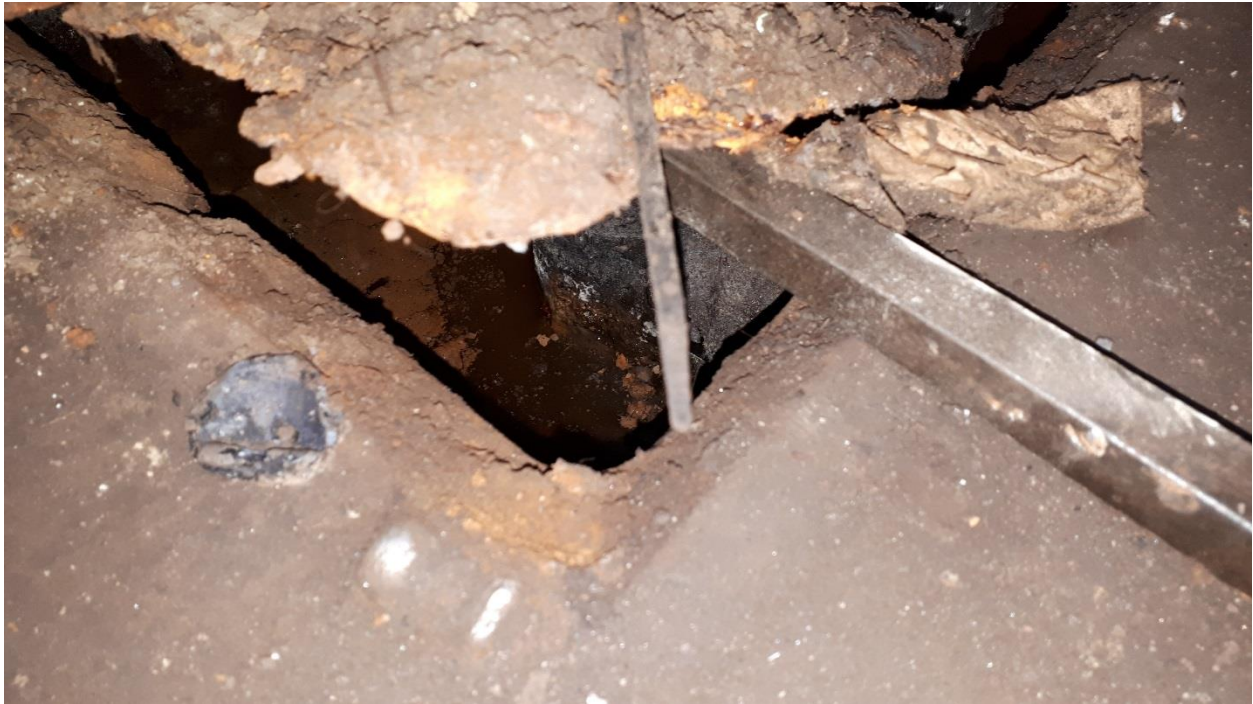
Photograph 5: View of the oil-water separator pit in the northeast corner of the service garage building.

One (1) sump pit was observed in the basement of the commercial office building at 979 Wellington Street West. The interior of the pit was not accessible at the time of the site inspection. An oil/water separator was also observed within the auto service garage. The interior of the separator was not accessible at the time of the site inspection. No floor drains were observed in the interior of the subject buildings at the time of the site inspection.

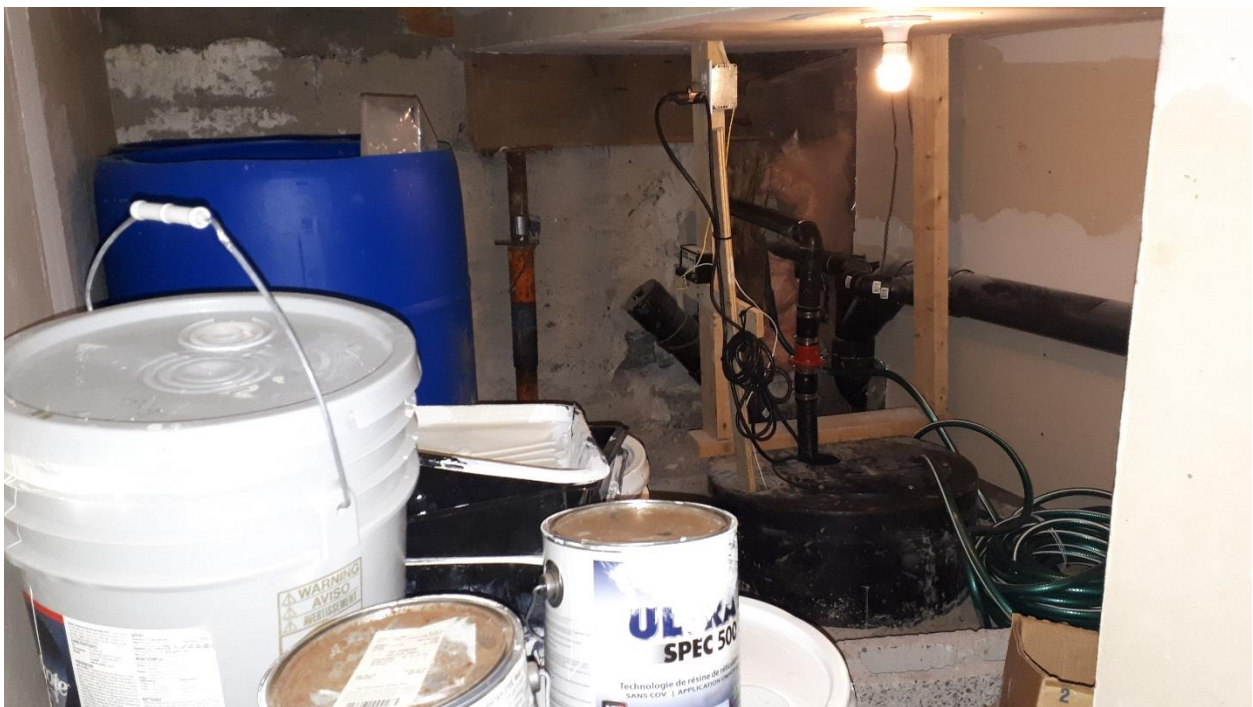
Photograph 6: View of sump pit crawlspace in the basement of the office building at 979 Wellington Street West.
