Phase I - Environmental Site Assessment

326 & 330 Wilbrod Street
Ottawa, Ontario

Dolyn Construction Ltd.

Report: PE5378-1

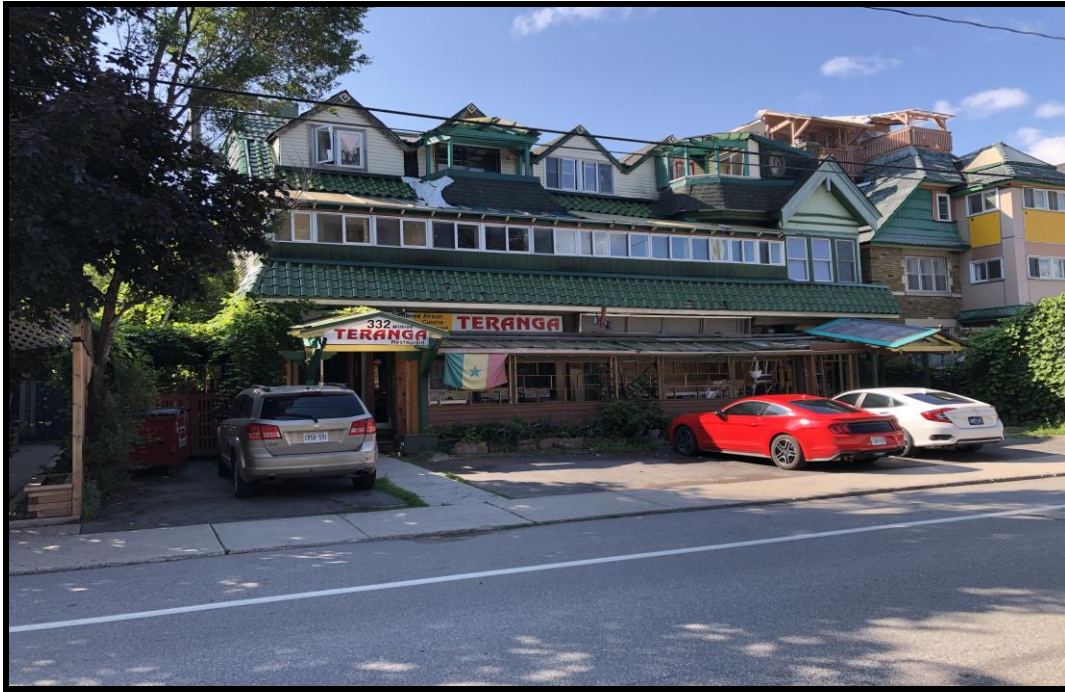
Photograph 1: View of the northeastern portion of the subject site, facing south from Wilbrod Street.

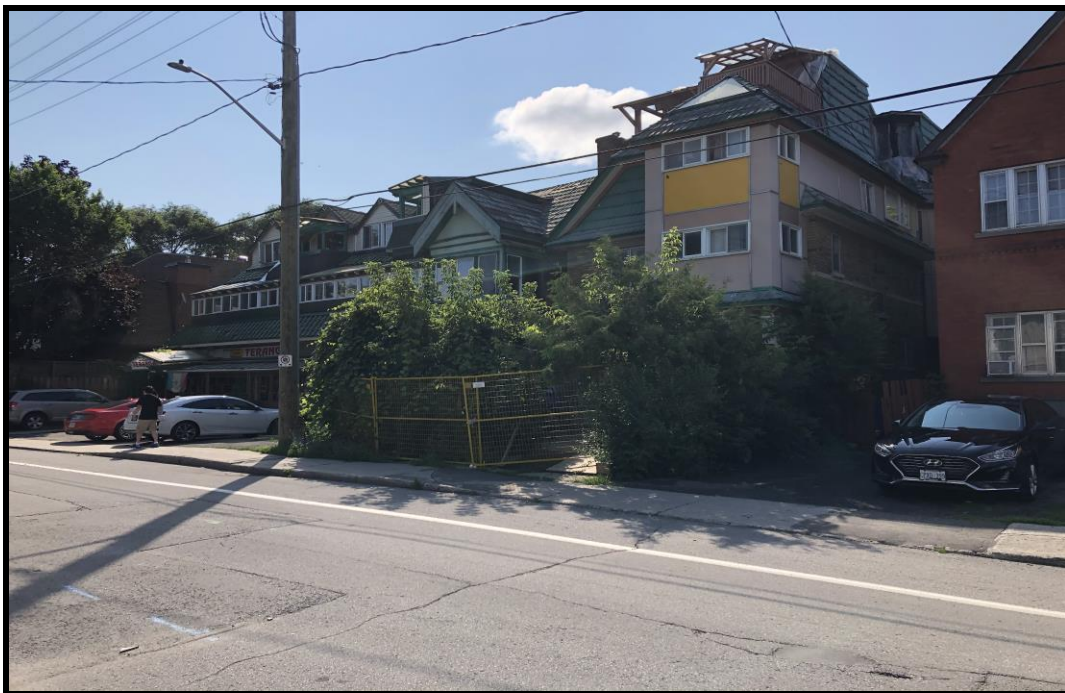
Photograph 2: View of the northwestern portion of the subject site, facing south from Wilbrod Street

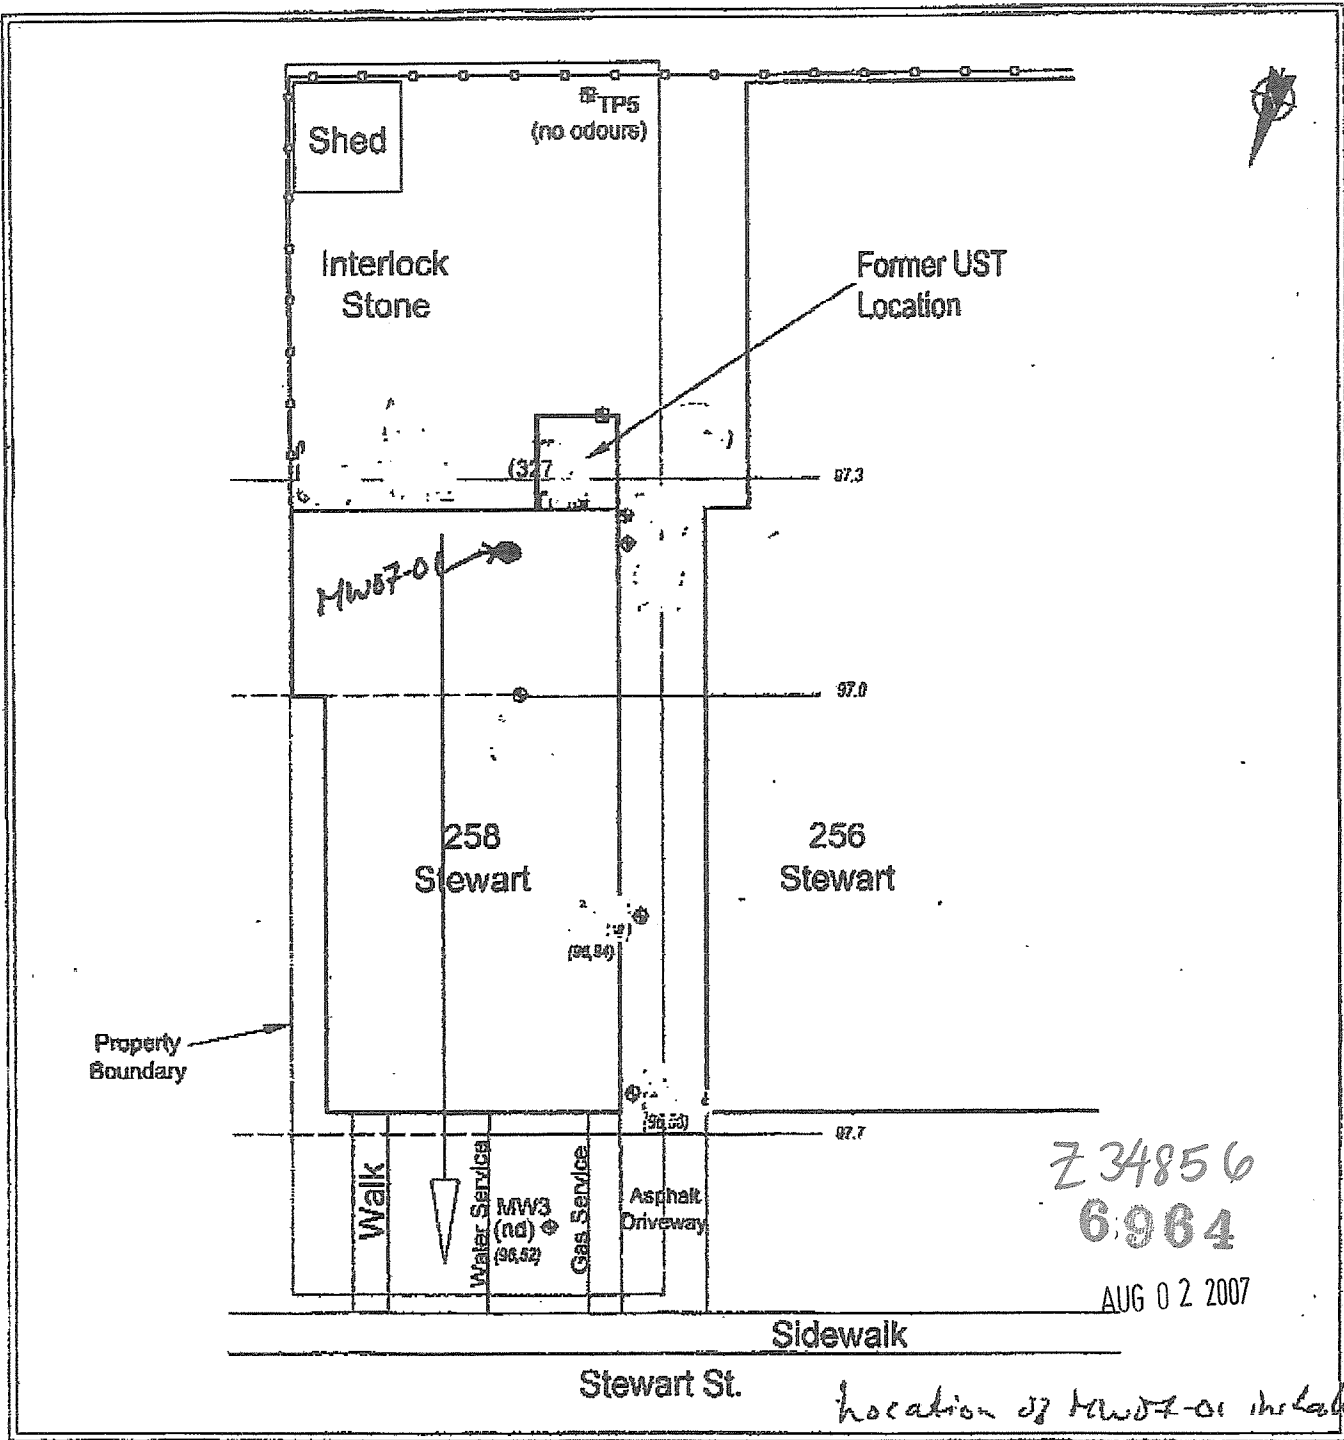
- TPY ⊕ Test Pit
- BH1 ⊕ Bore Hole
- MW2 ⊕ Monitoring Well
- (1440) ⊕ Soil TPH gas/diesel concentration in mg/kg (MOE Table 8 criteria 1000 mg/kg)
- Fence
- House Perimeter
- 97.0 — Water-level (Maal)
- ↓ Conceptual GW Flow Direction

<p>File: TPH SOIL CONCENTRATIONS AND GROUNDWATER FLOW DIRECTION</p>	
	<p>Project: C OF A 258 STEWART STREET</p>
<p>Date: DECEMBER 2004</p>	<p>Client: GISELE FORTIER</p>
<p>SCALE 1:200</p>	
<p>FIGURE 2</p>
