PROJECT NAME
CIRCLE K STORES INC.
R&R No. 5287
NEPEAN ONTARIO
1545 WOODROFFE AVENUE
NEPEAN, ON, CANADA
K2G 1W2

SHEET TITLE
TREE PRESERVATION AND PROTECTION EXISTING CONDITIONS PLAN

SHEET NUMBER
L1.0

SHEET TITLE
PROPOSED DEVELOPMENT
CONSERVED VEGETATION
PLAN

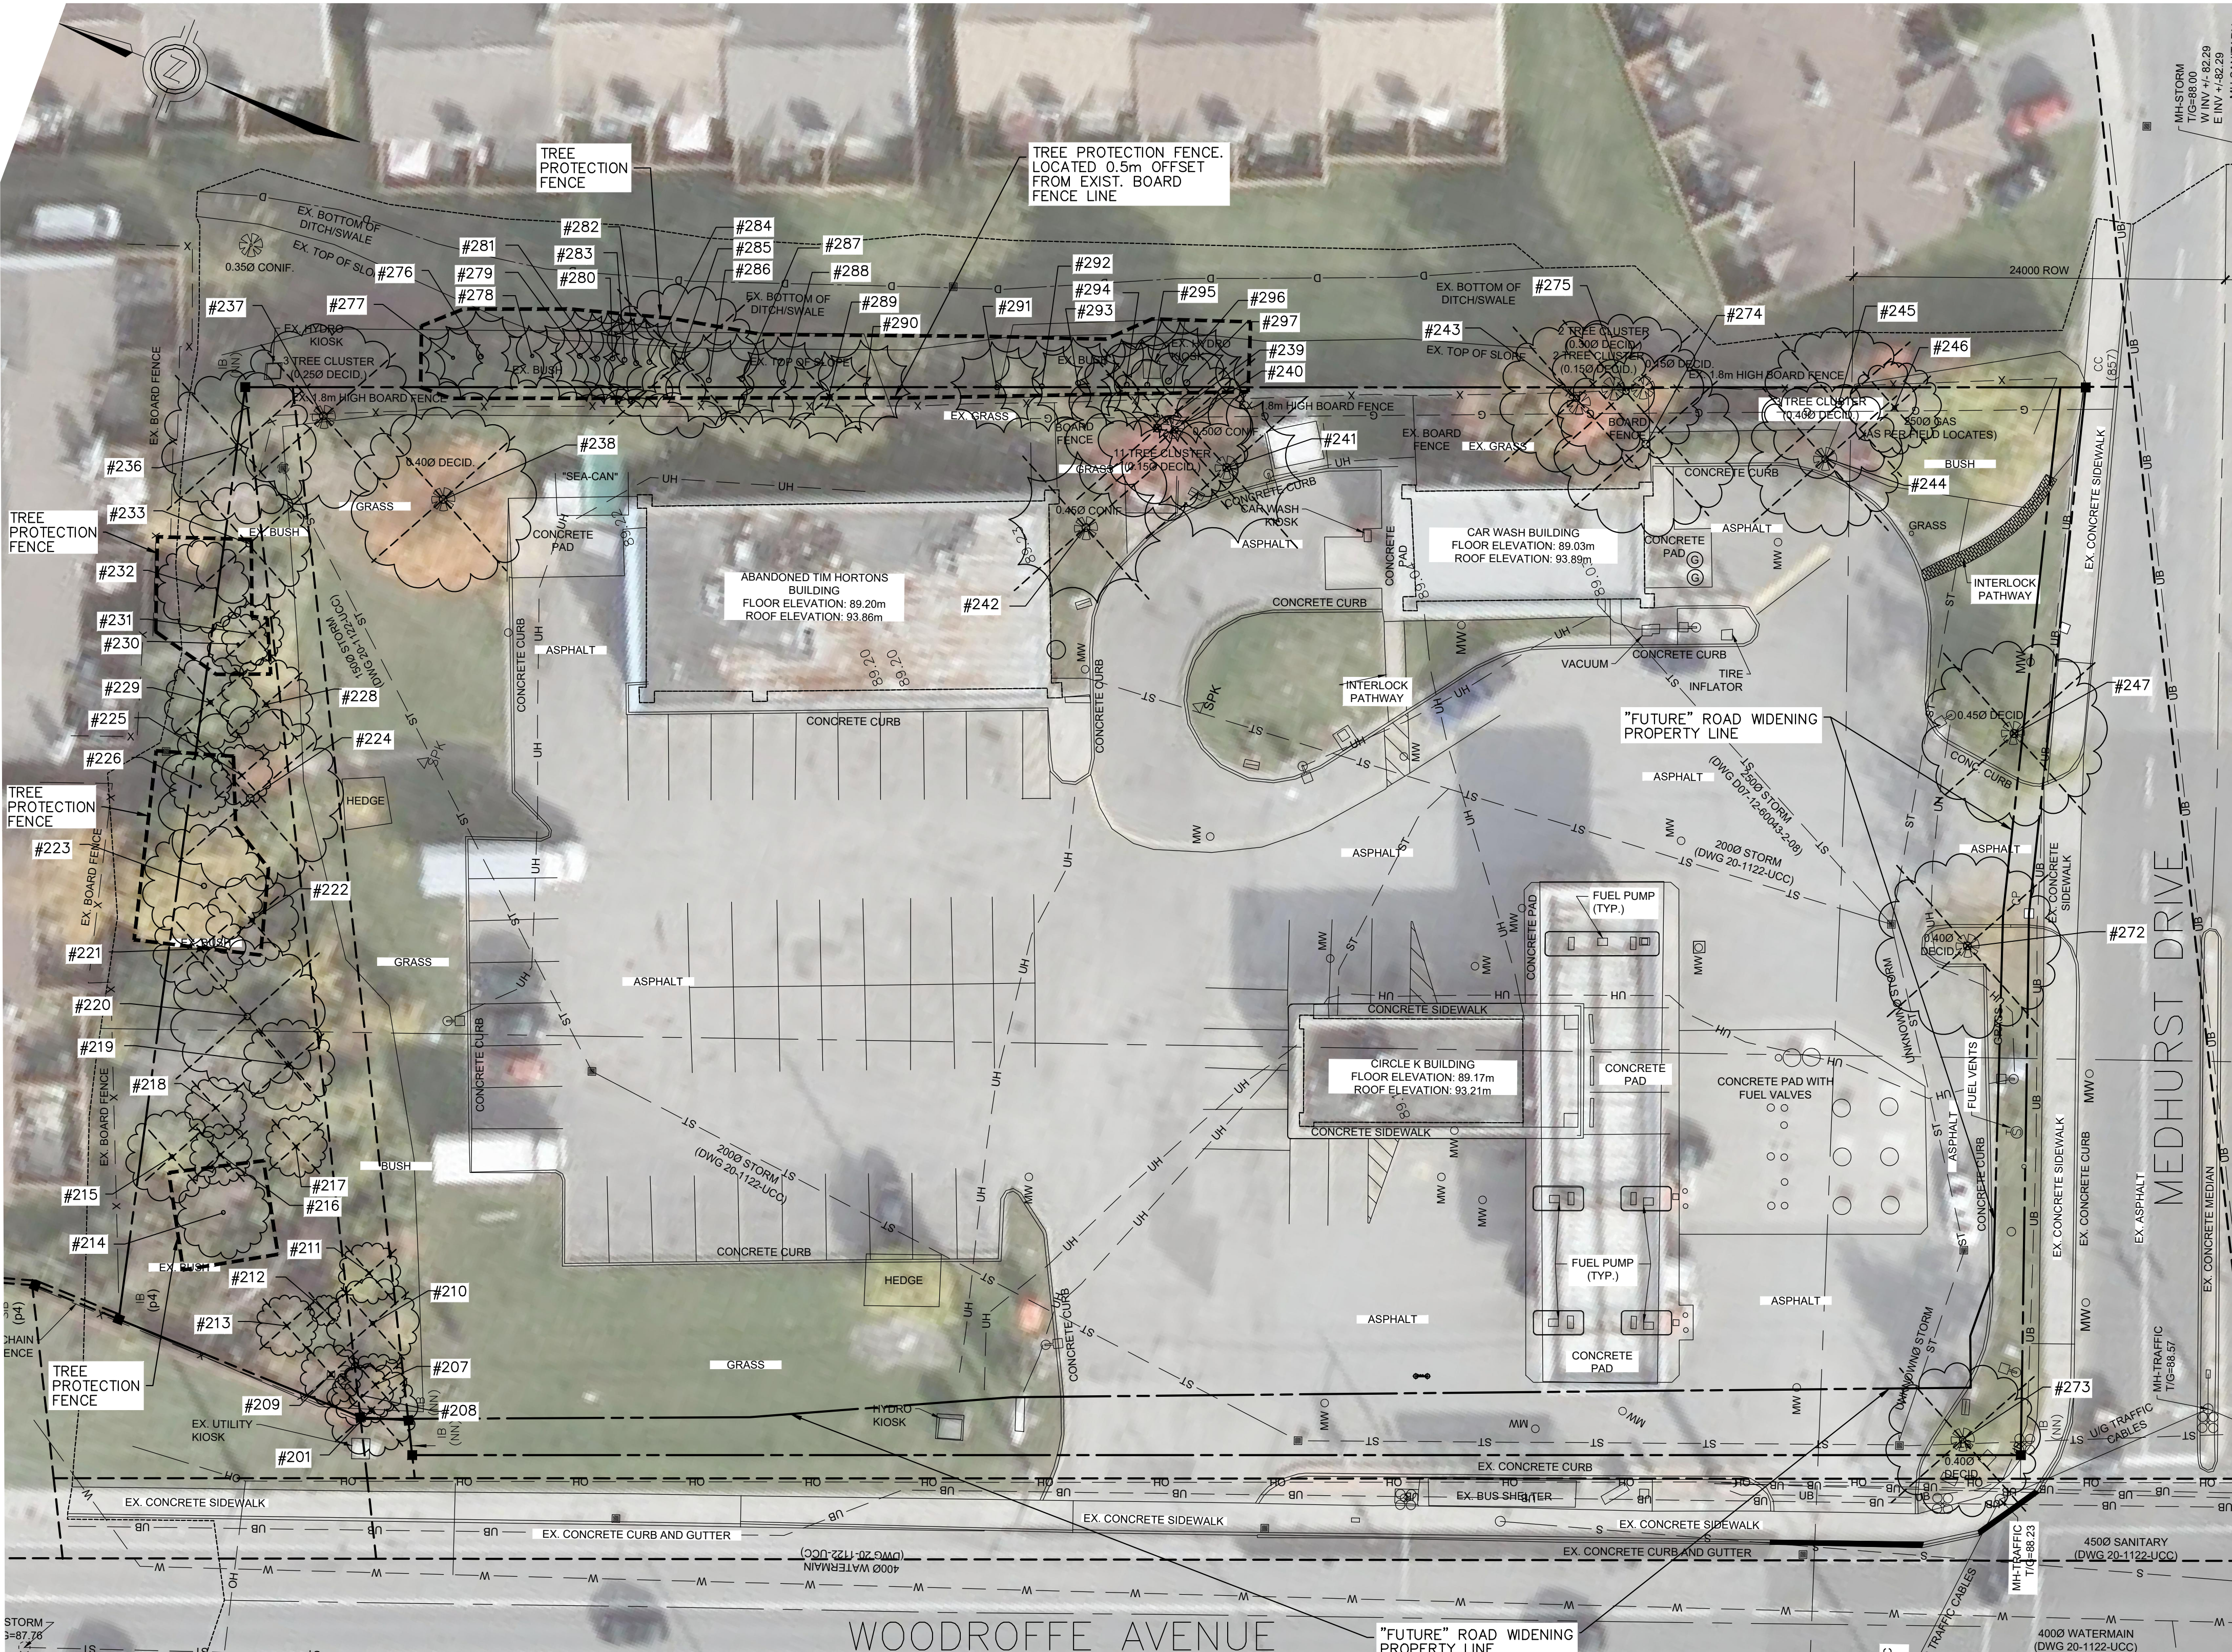
- DENOTES SURVEYED LOCATION OF EXISTING TREES, & # SPECIES / CALIPER / CONDITIONS /REMARKS ARE AS NOTED IN ARBORIST REPORT & TREE INVENTORY LIST
- TREE PRESERVATION FENCE, PER OTTAWA TREE PROTECTION SPECIFICATION DETAIL
- DENOTES EXISTING TREES TO BE REMOVED FOR DEVELOPMENT, AS NOTED, SEE ARBORIST REPORT

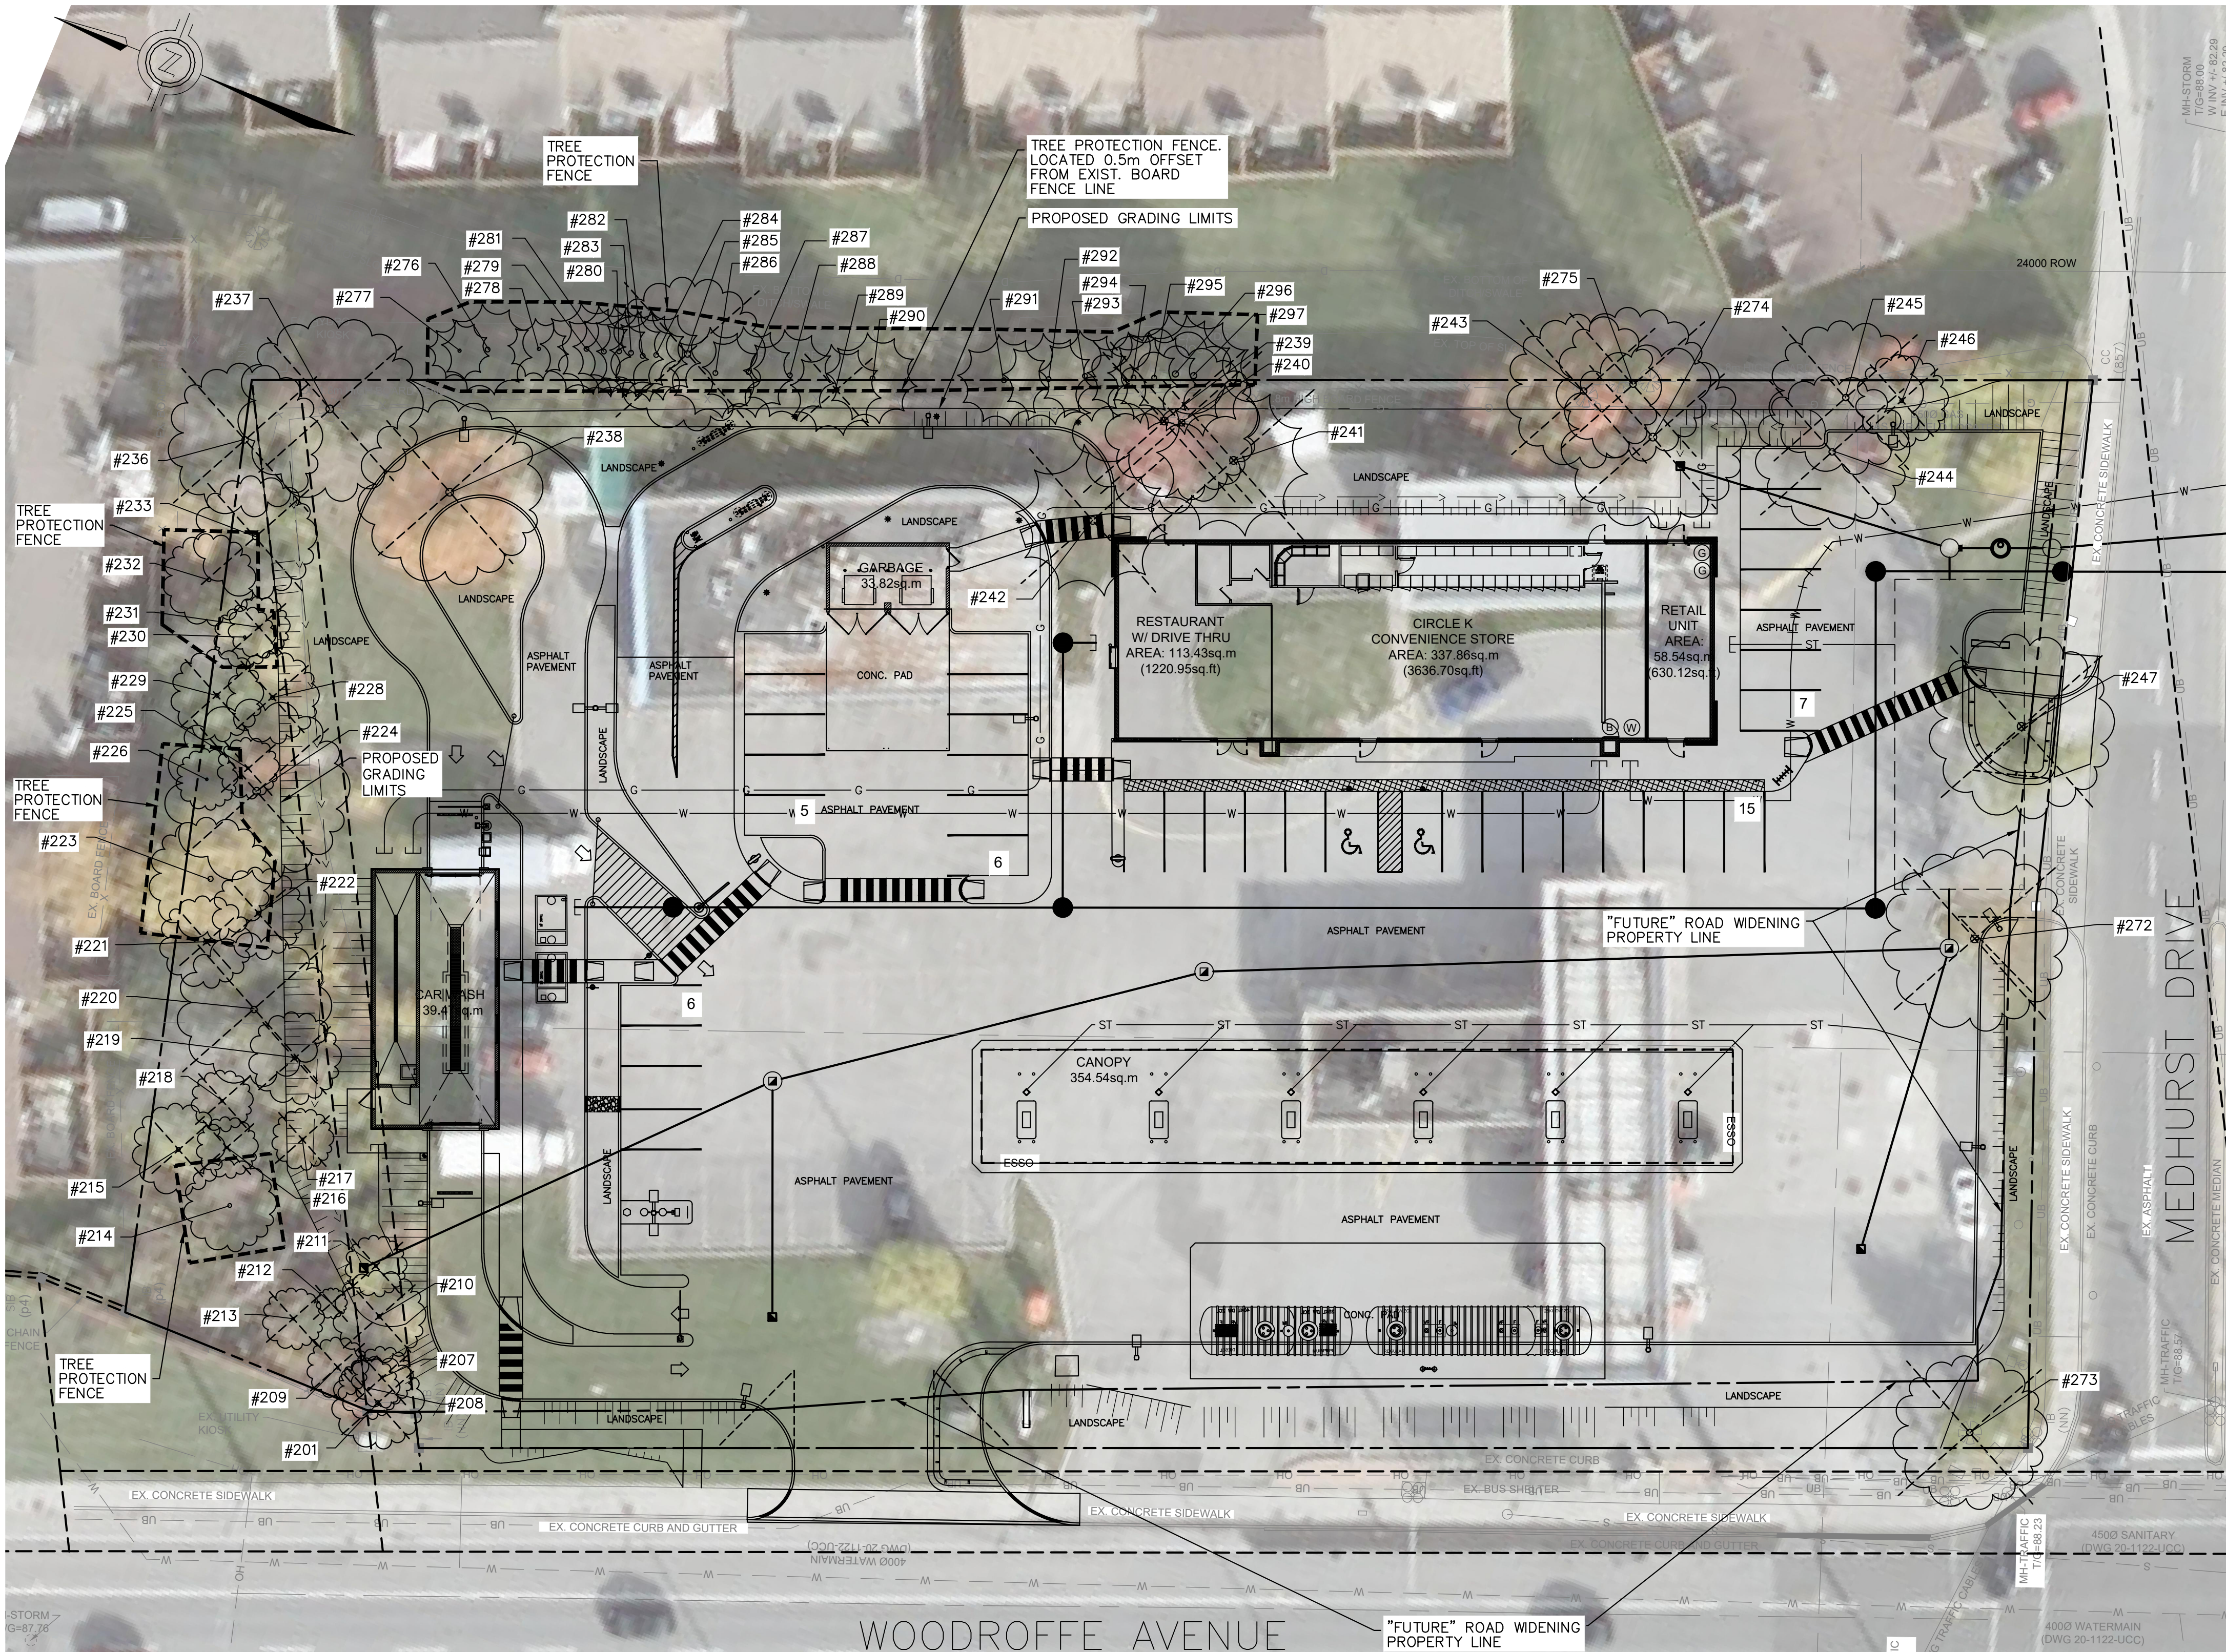
SHEET NUMBER
L1.1

- DENOTES SURVEYED LOCATION OF EXISTING TREES, & # SPECIES / CALIPER / CONDITIONS / REMARKS AS AS NOTED IN ARBORIST REPORT & TREE INVENTORY LIST
- TREE PRESERVATION FENCE, PER OTTAWA TREE PROTECTION SPECIFICATION DETAIL
- DENOTES EXISTING TREES TO BE REMOVED FOR DEVELOPMENT, AS NOTED, SEE ARBORIST REPORT
