## **Phase II Environmental Site Assessment**

Part of 525 Legget Drive and  
Part of 359 Terry Fox Drive  
City of Ottawa, Ontario

KRP Properties

Report: PE5413-2R

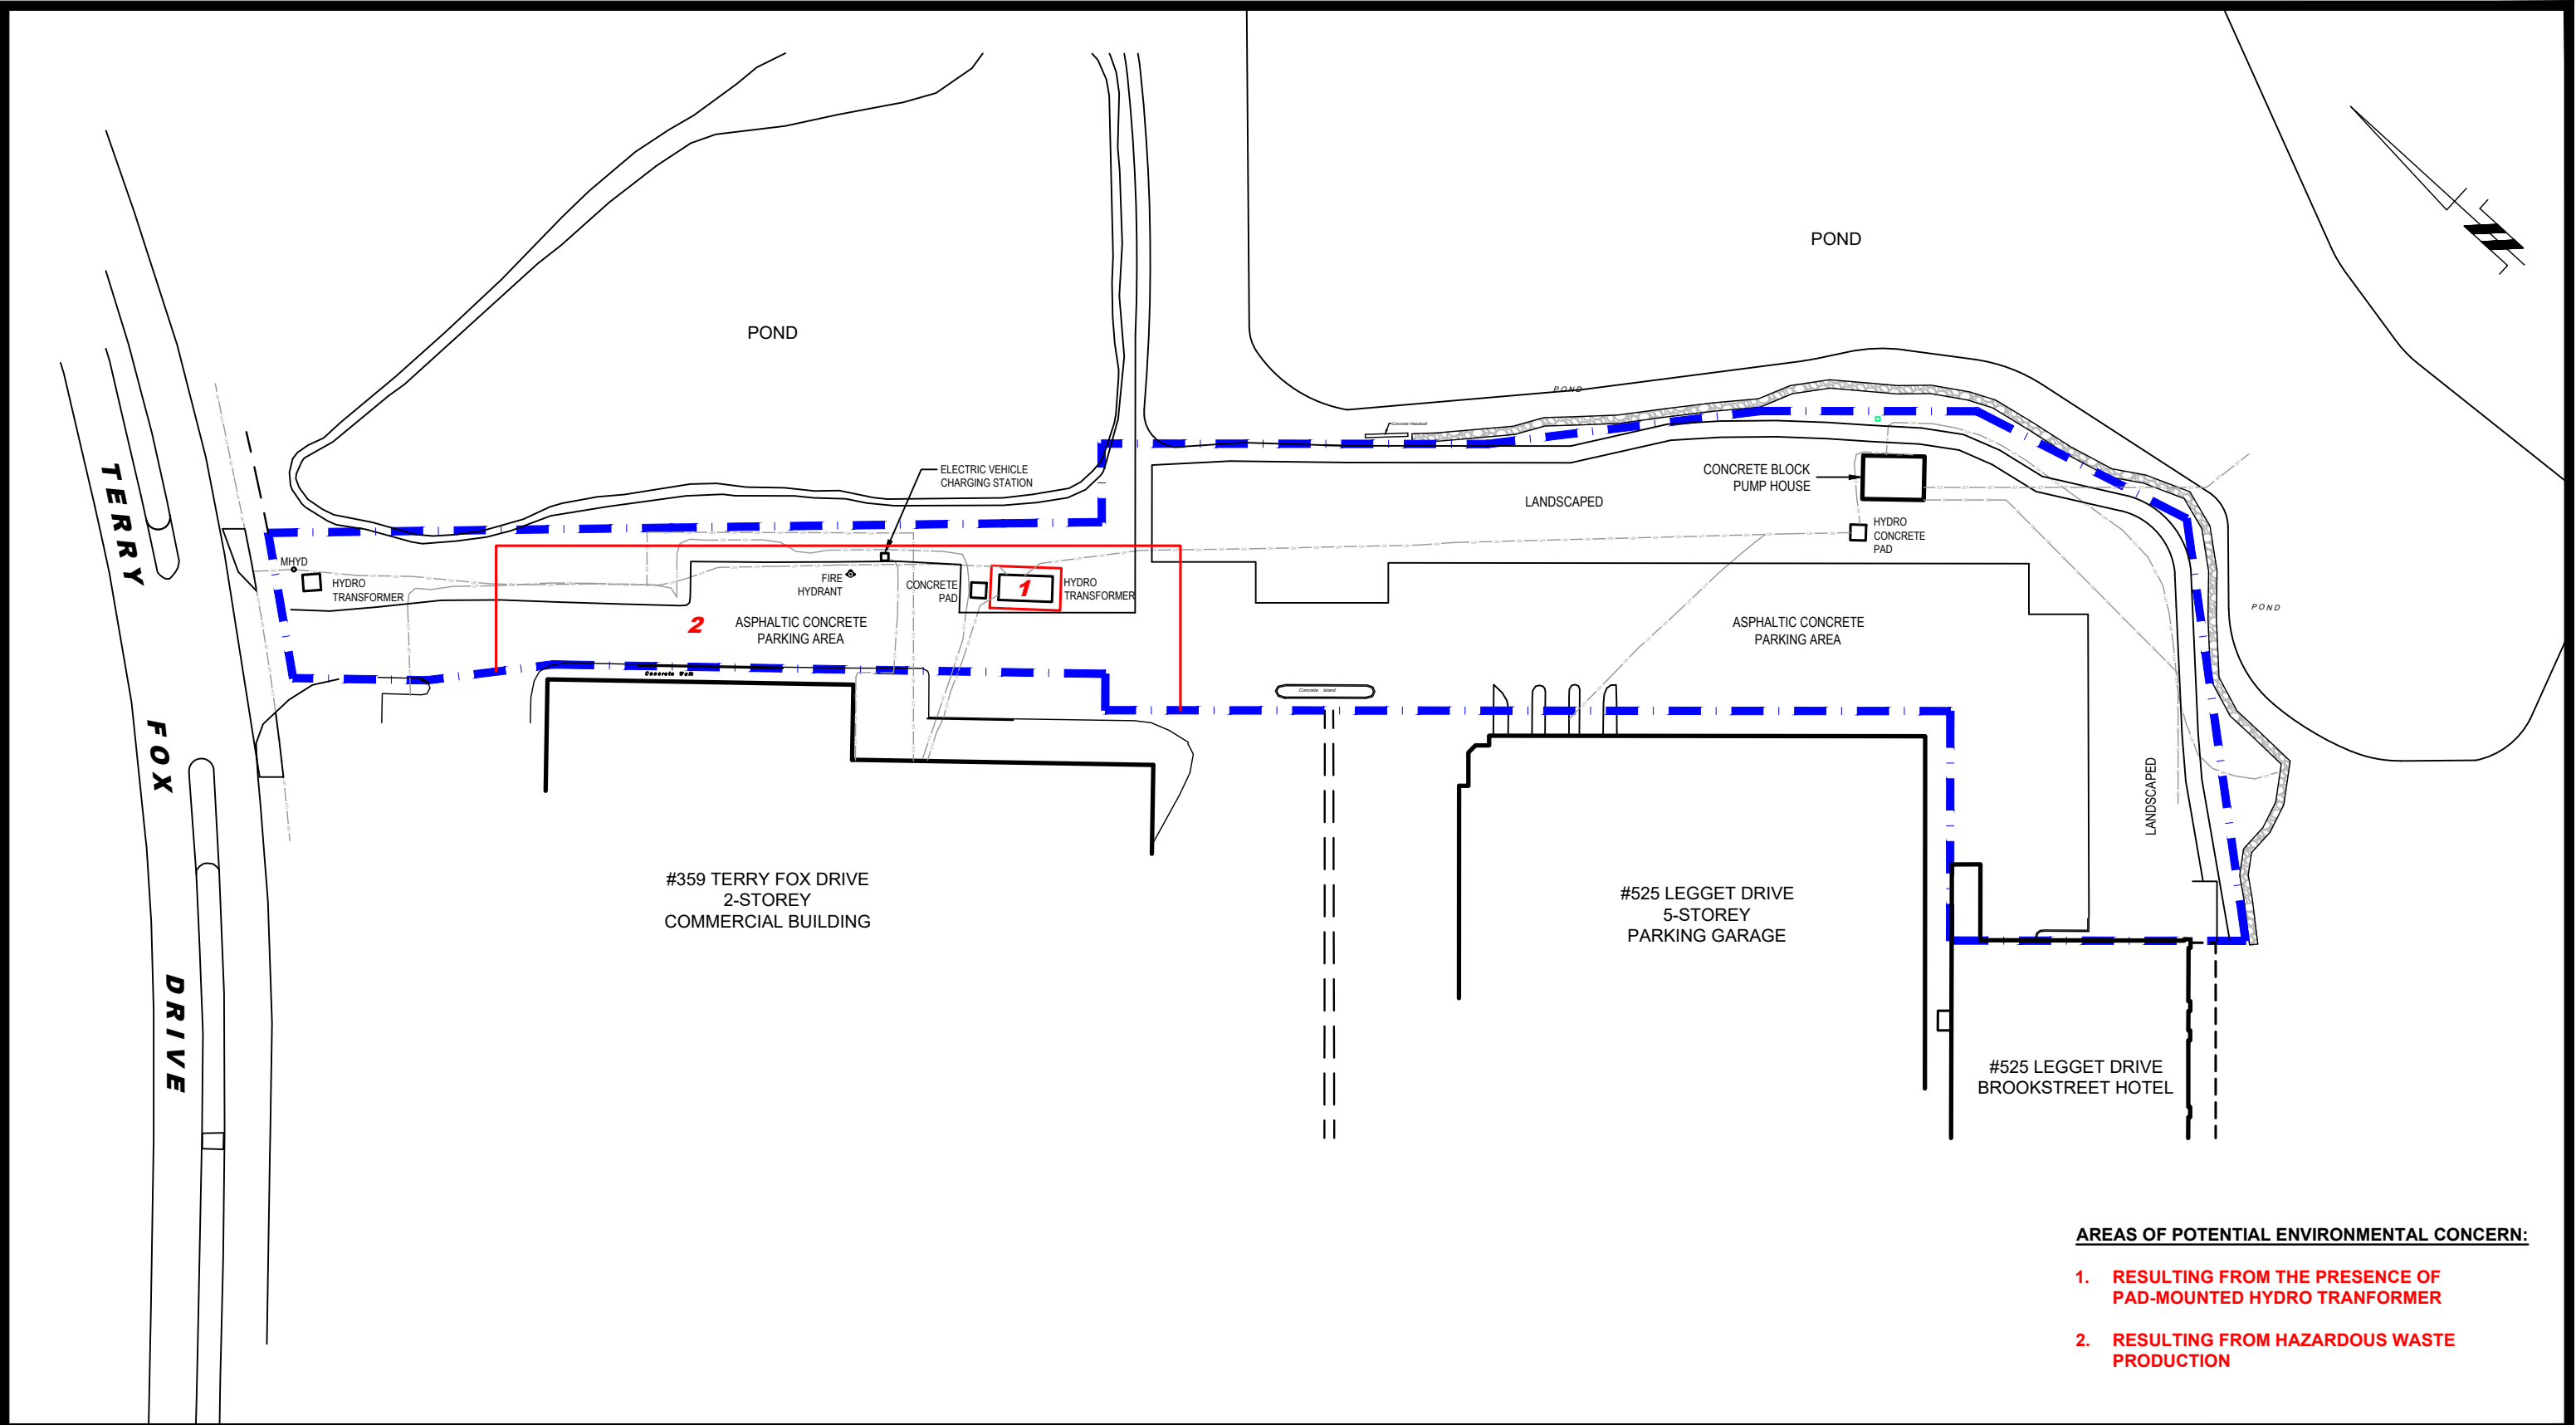
**PE5413-1**

AREAS OF POTENTIAL ENVIRONMENTAL CONCERN:

- 1. RESULTING FROM THE PRESENCE OF PAD-MOUNTED HYDRO TRANFORMER
- 2. RESULTING FROM HAZARDOUS WASTE PRODUCTION

The APECs are shown on Drawing PE5413-1–Site Plan, while the corresponding PCAs are shown in red on Drawing PE5413-2 – Surrounding Land Use Plan, in the Figures section of this report.

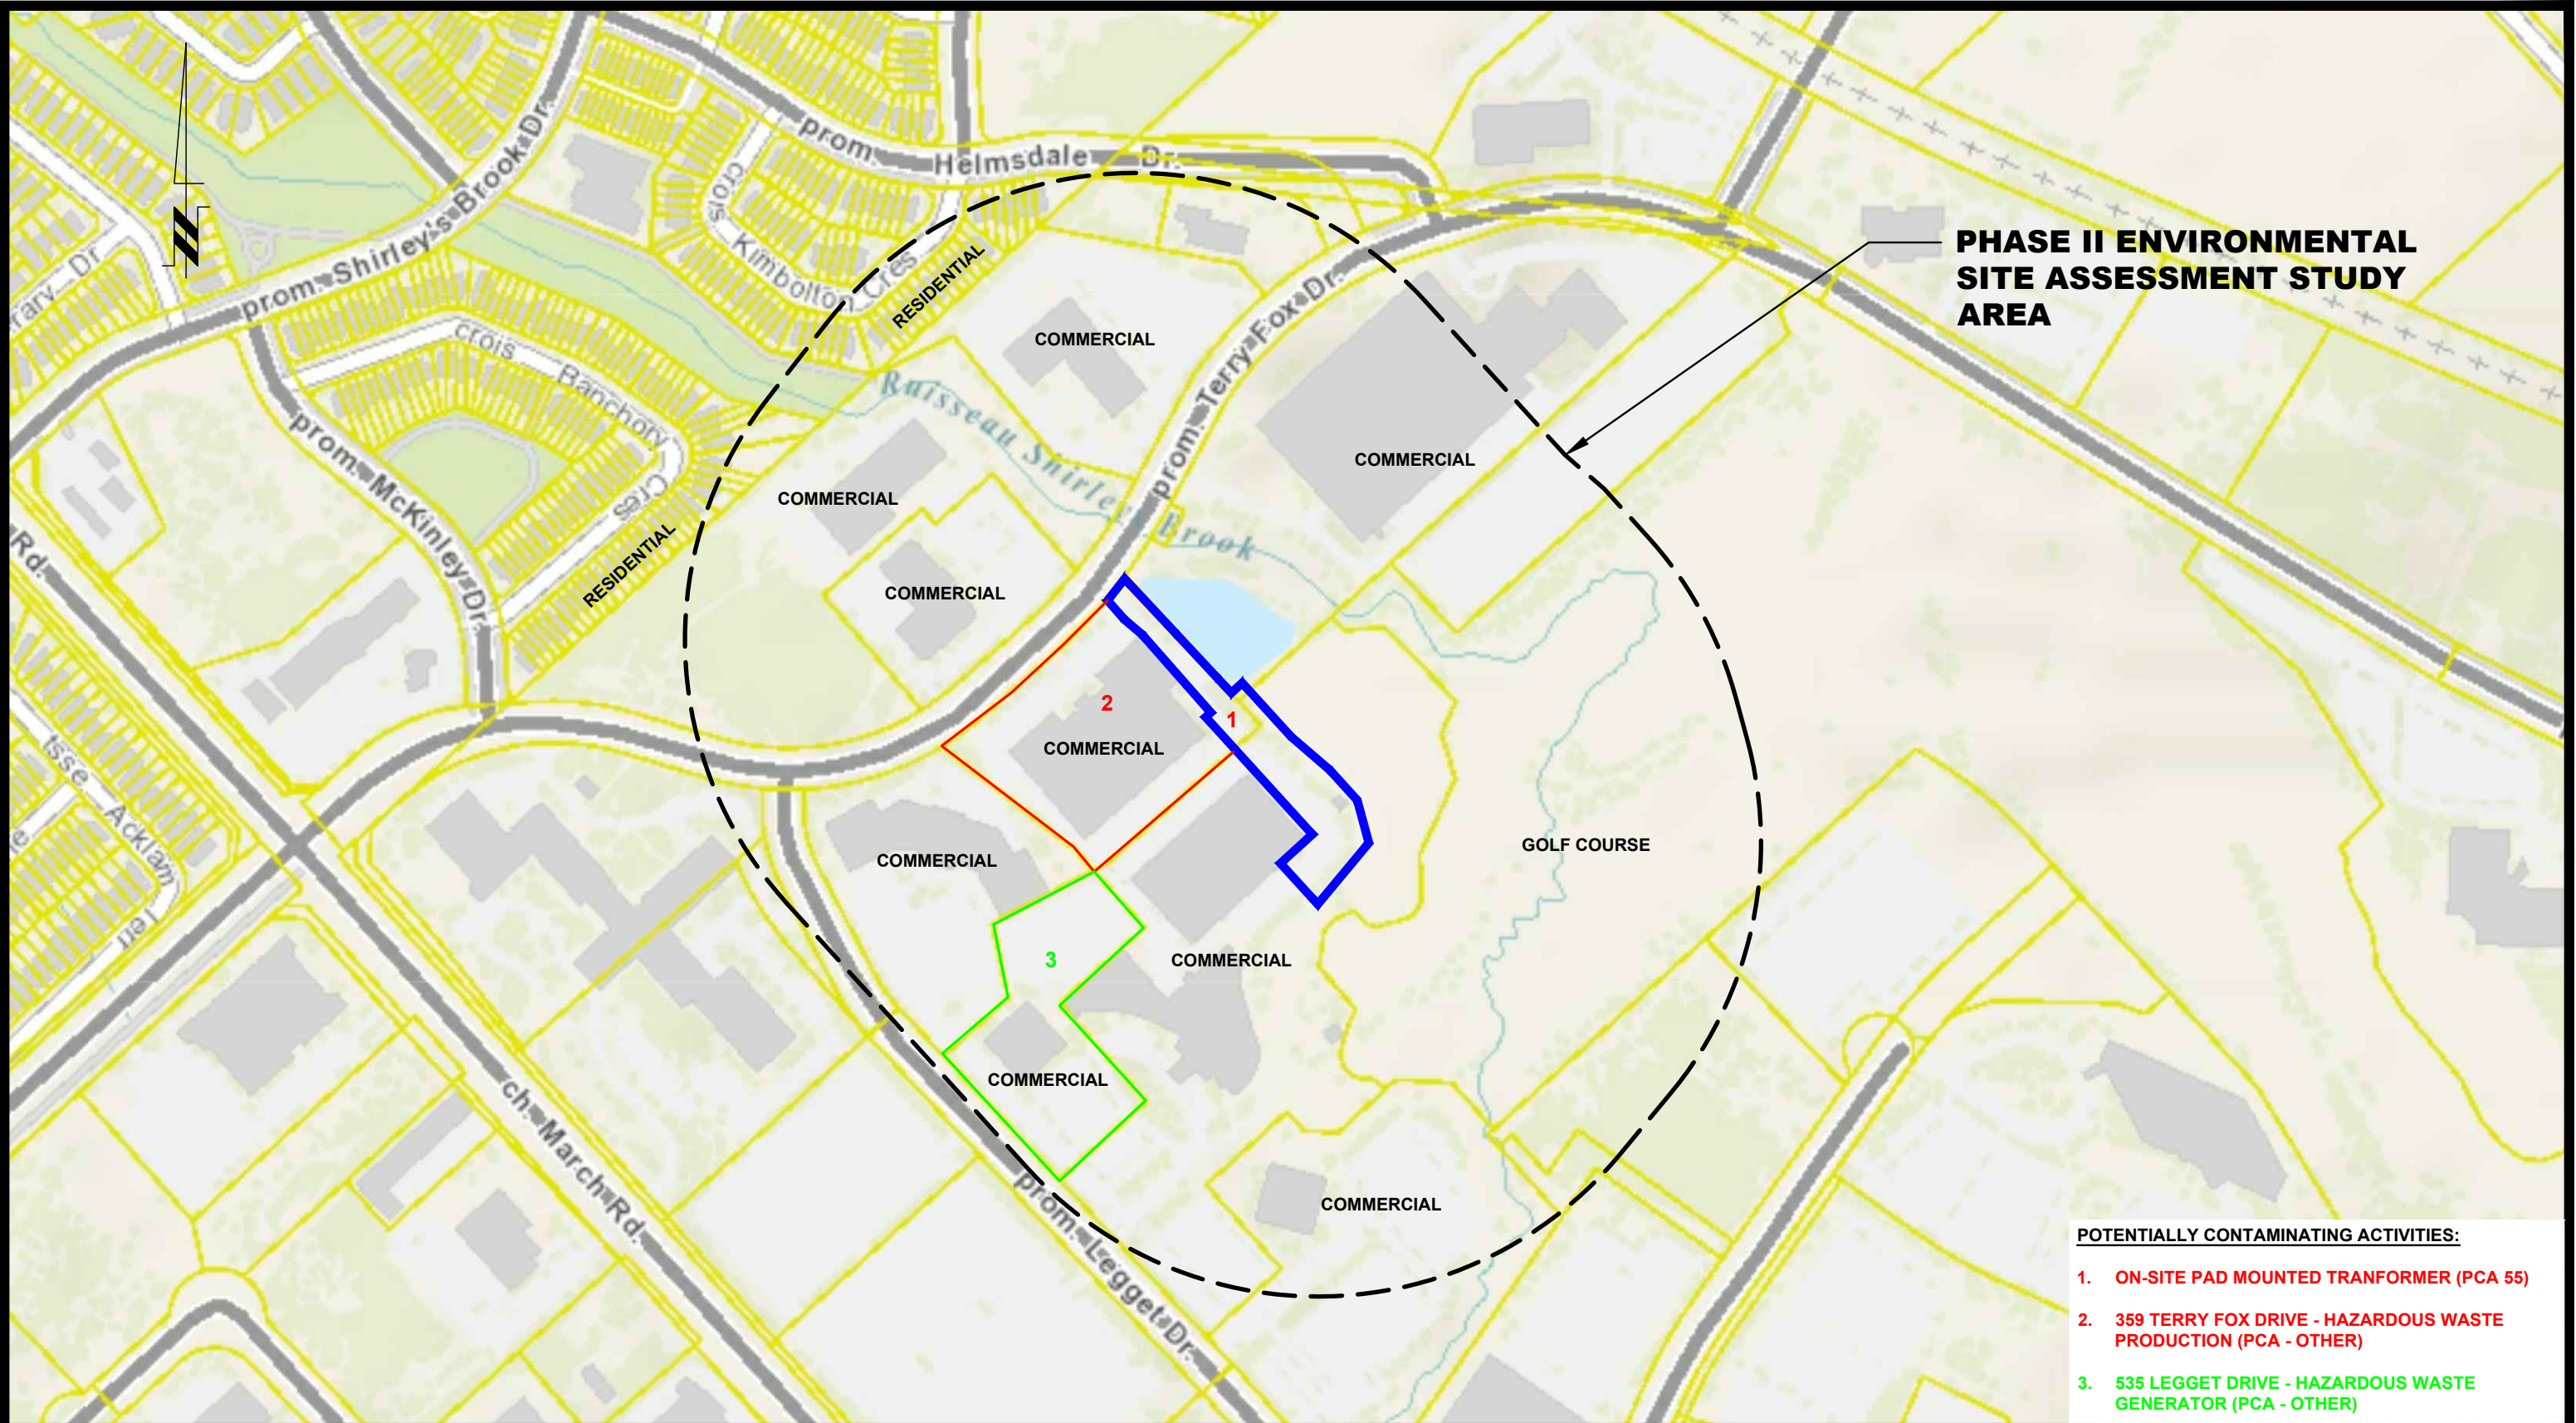
Scale:	1:4000	Date:	09/2021
Drawn by:	MPG	Report No.:	PE5413-1
Checked by:	MW	Dwg. No.:	<b>PE5413-2</b>
Approved by:	MSD	Revision No.:

**POTENTIALLY CONTAMINATING ACTIVITIES:**

- 1. ON-SITE PAD MOUNTED TRANFORMER (PCA 55)**
- 2. 359 TERRY FOX DRIVE - HAZARDOUS WASTE PRODUCTION (PCA - OTHER)**
- 3. 535 LEGGET DRIVE - HAZARDOUS WASTE GENERATOR (PCA - OTHER)**

Neighbouring land use in the Phase I study area consists primarily of commercial (hotel and office buildings). Land use is shown on Drawing PE5413-2 - Surrounding Land Use Plan.

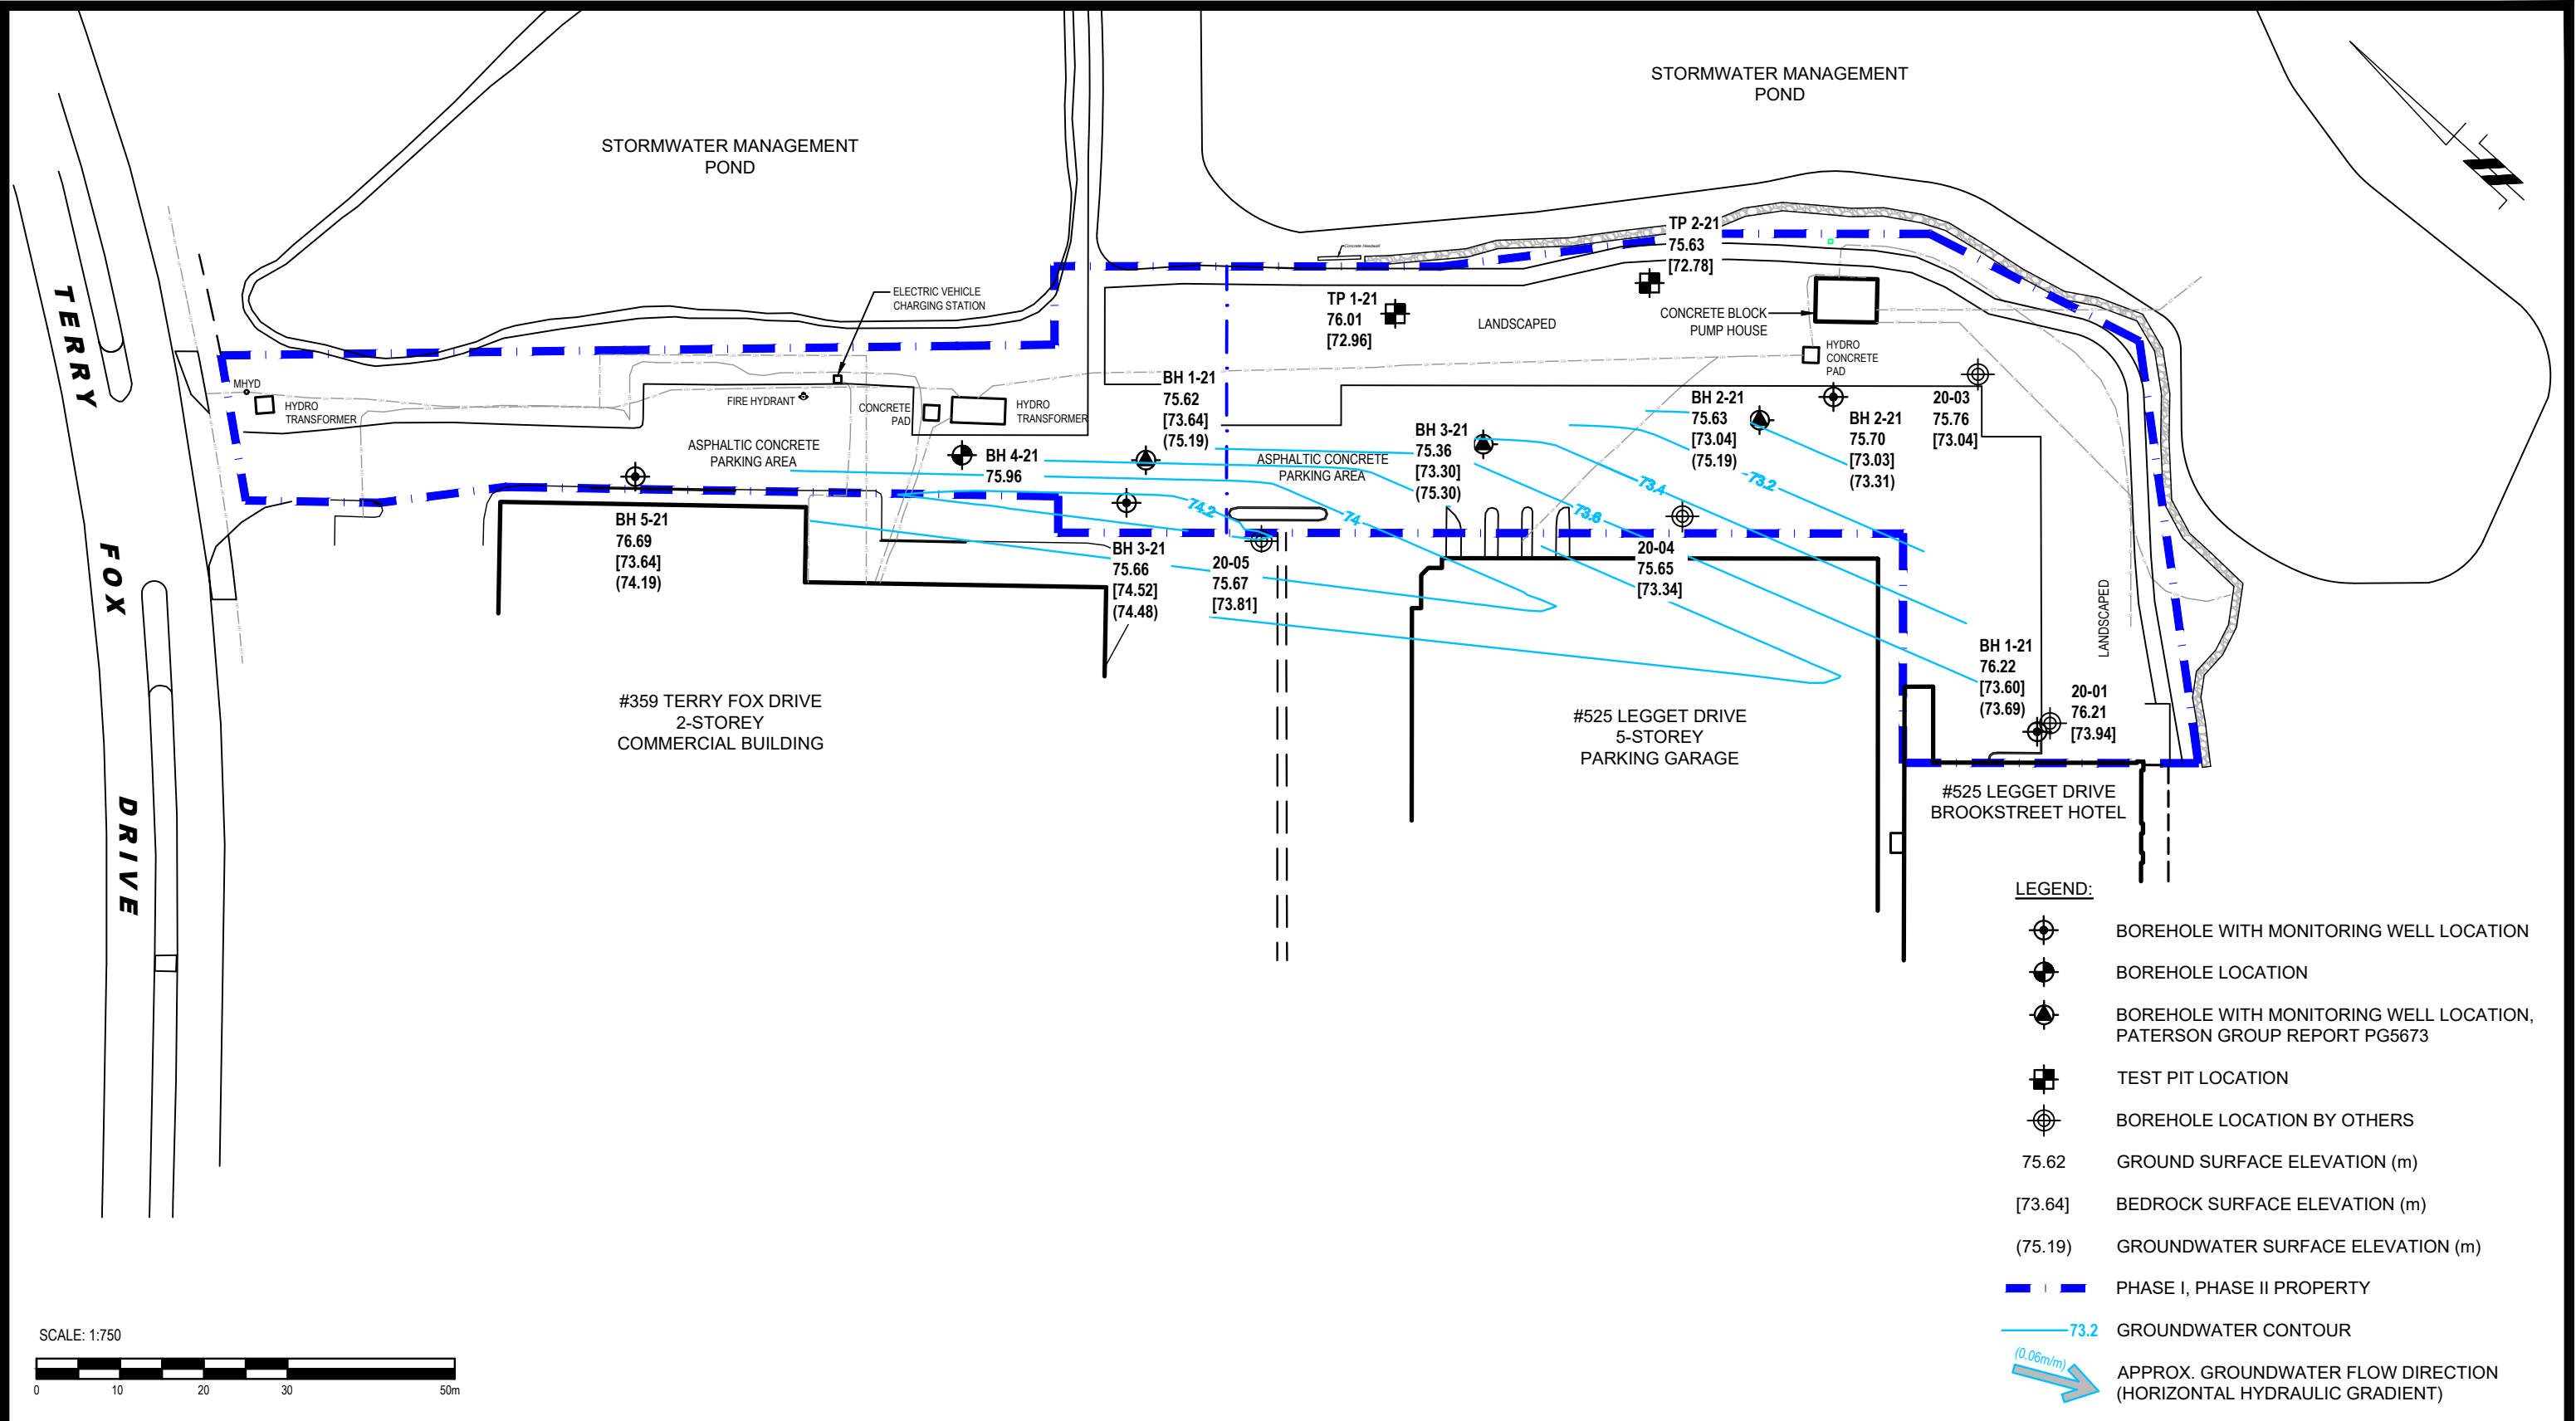
Scale:	1:750	Date:	12/2021
Drawn by:	MPG	Report No.:	PE5413-2
Checked by:	MW	Dwg. No.:	PE5413-3
Approved by:	MB	Revision No.:

TEST HOLE LOCATION PLAN

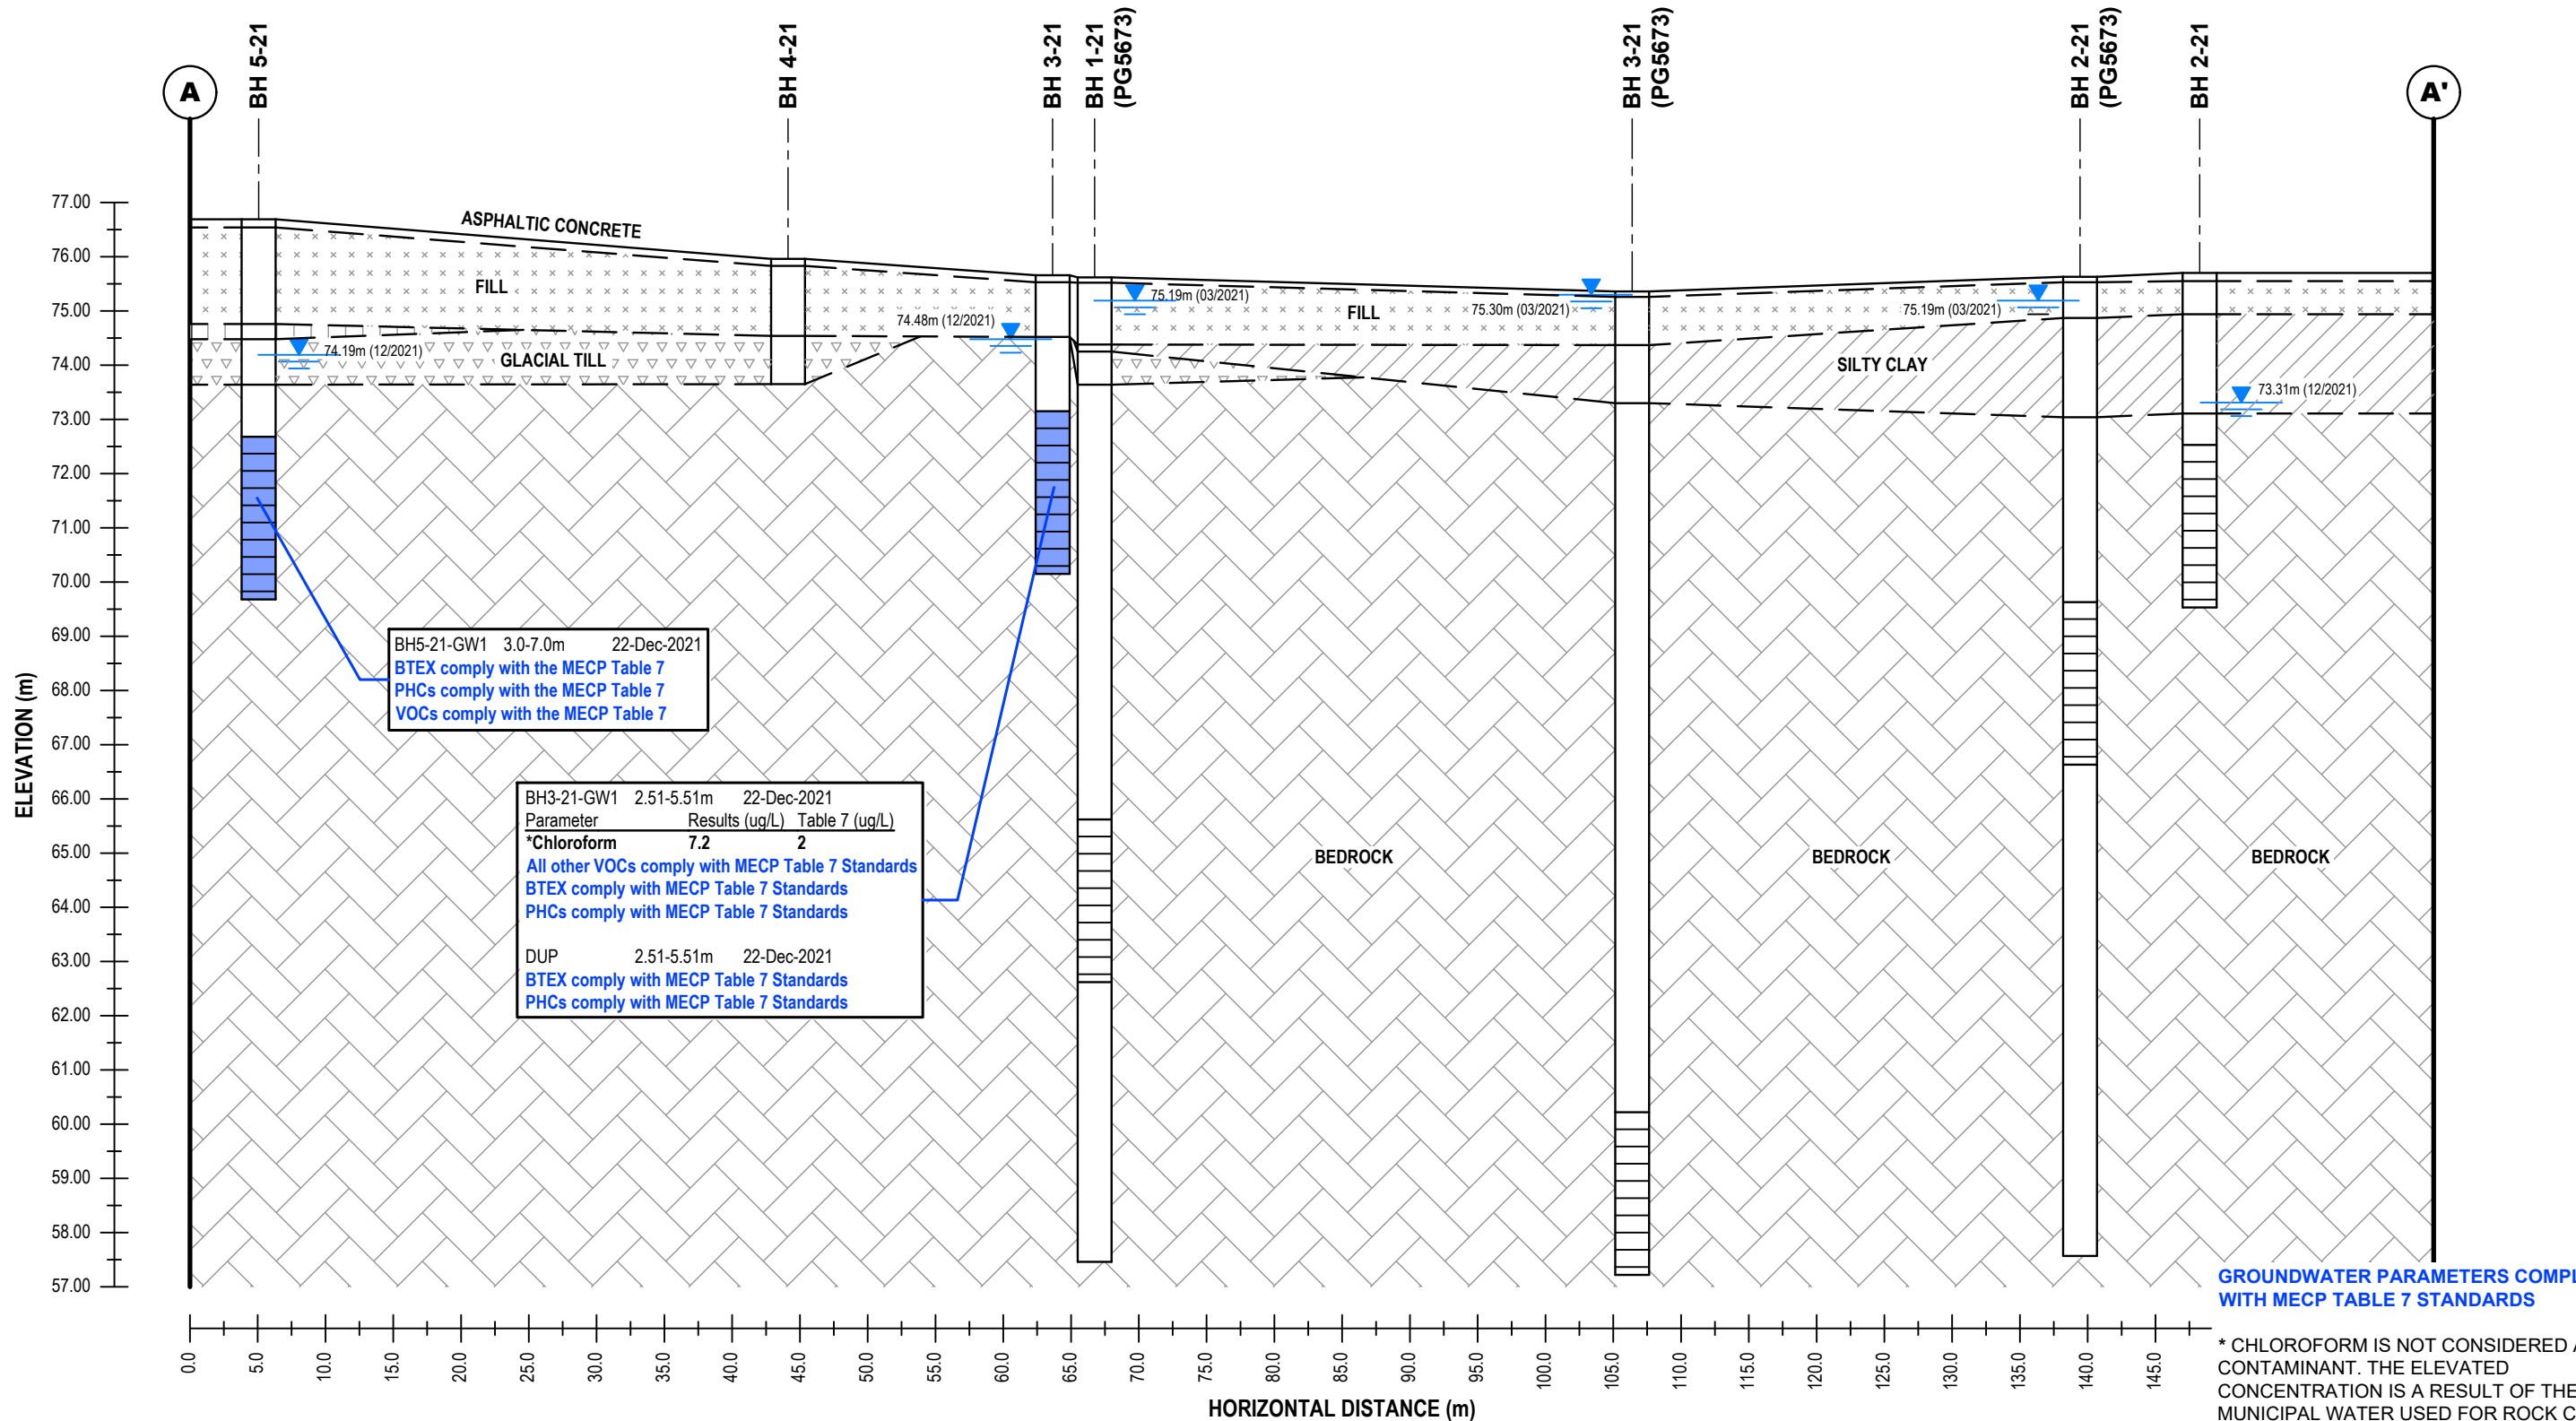
Scale:	AS SHOWN	Date:	01/2022
Drawn by:	MPG	Report No.:	PE5413-2
Checked by:	MW	Dwg. No.:	PE5413-5A
Approved by:	MB	Revision No.:

GROUNDWATER PARAMETERS COMPLY WITH MECP TABLE 7 STANDARDS

\* CHLOROFORM IS NOT CONSIDERED A CONTAMINANT. THE ELEVATED CONCENTRATION IS A RESULT OF THE MUNICIPAL WATER USED FOR ROCK CORING AND AS SUCH, THE CONCENTRATION IS EXPECTED TO DISSIPATE OVER TIME.

Title: CROSS-SECTION A-A' - GROUNDWATER

The chloroform concentration in excess of the standards is not considered a contaminant as the elevated concentration was due to the use of municipal water during bedrock coring and is expected that this concentration will dissipate over time.

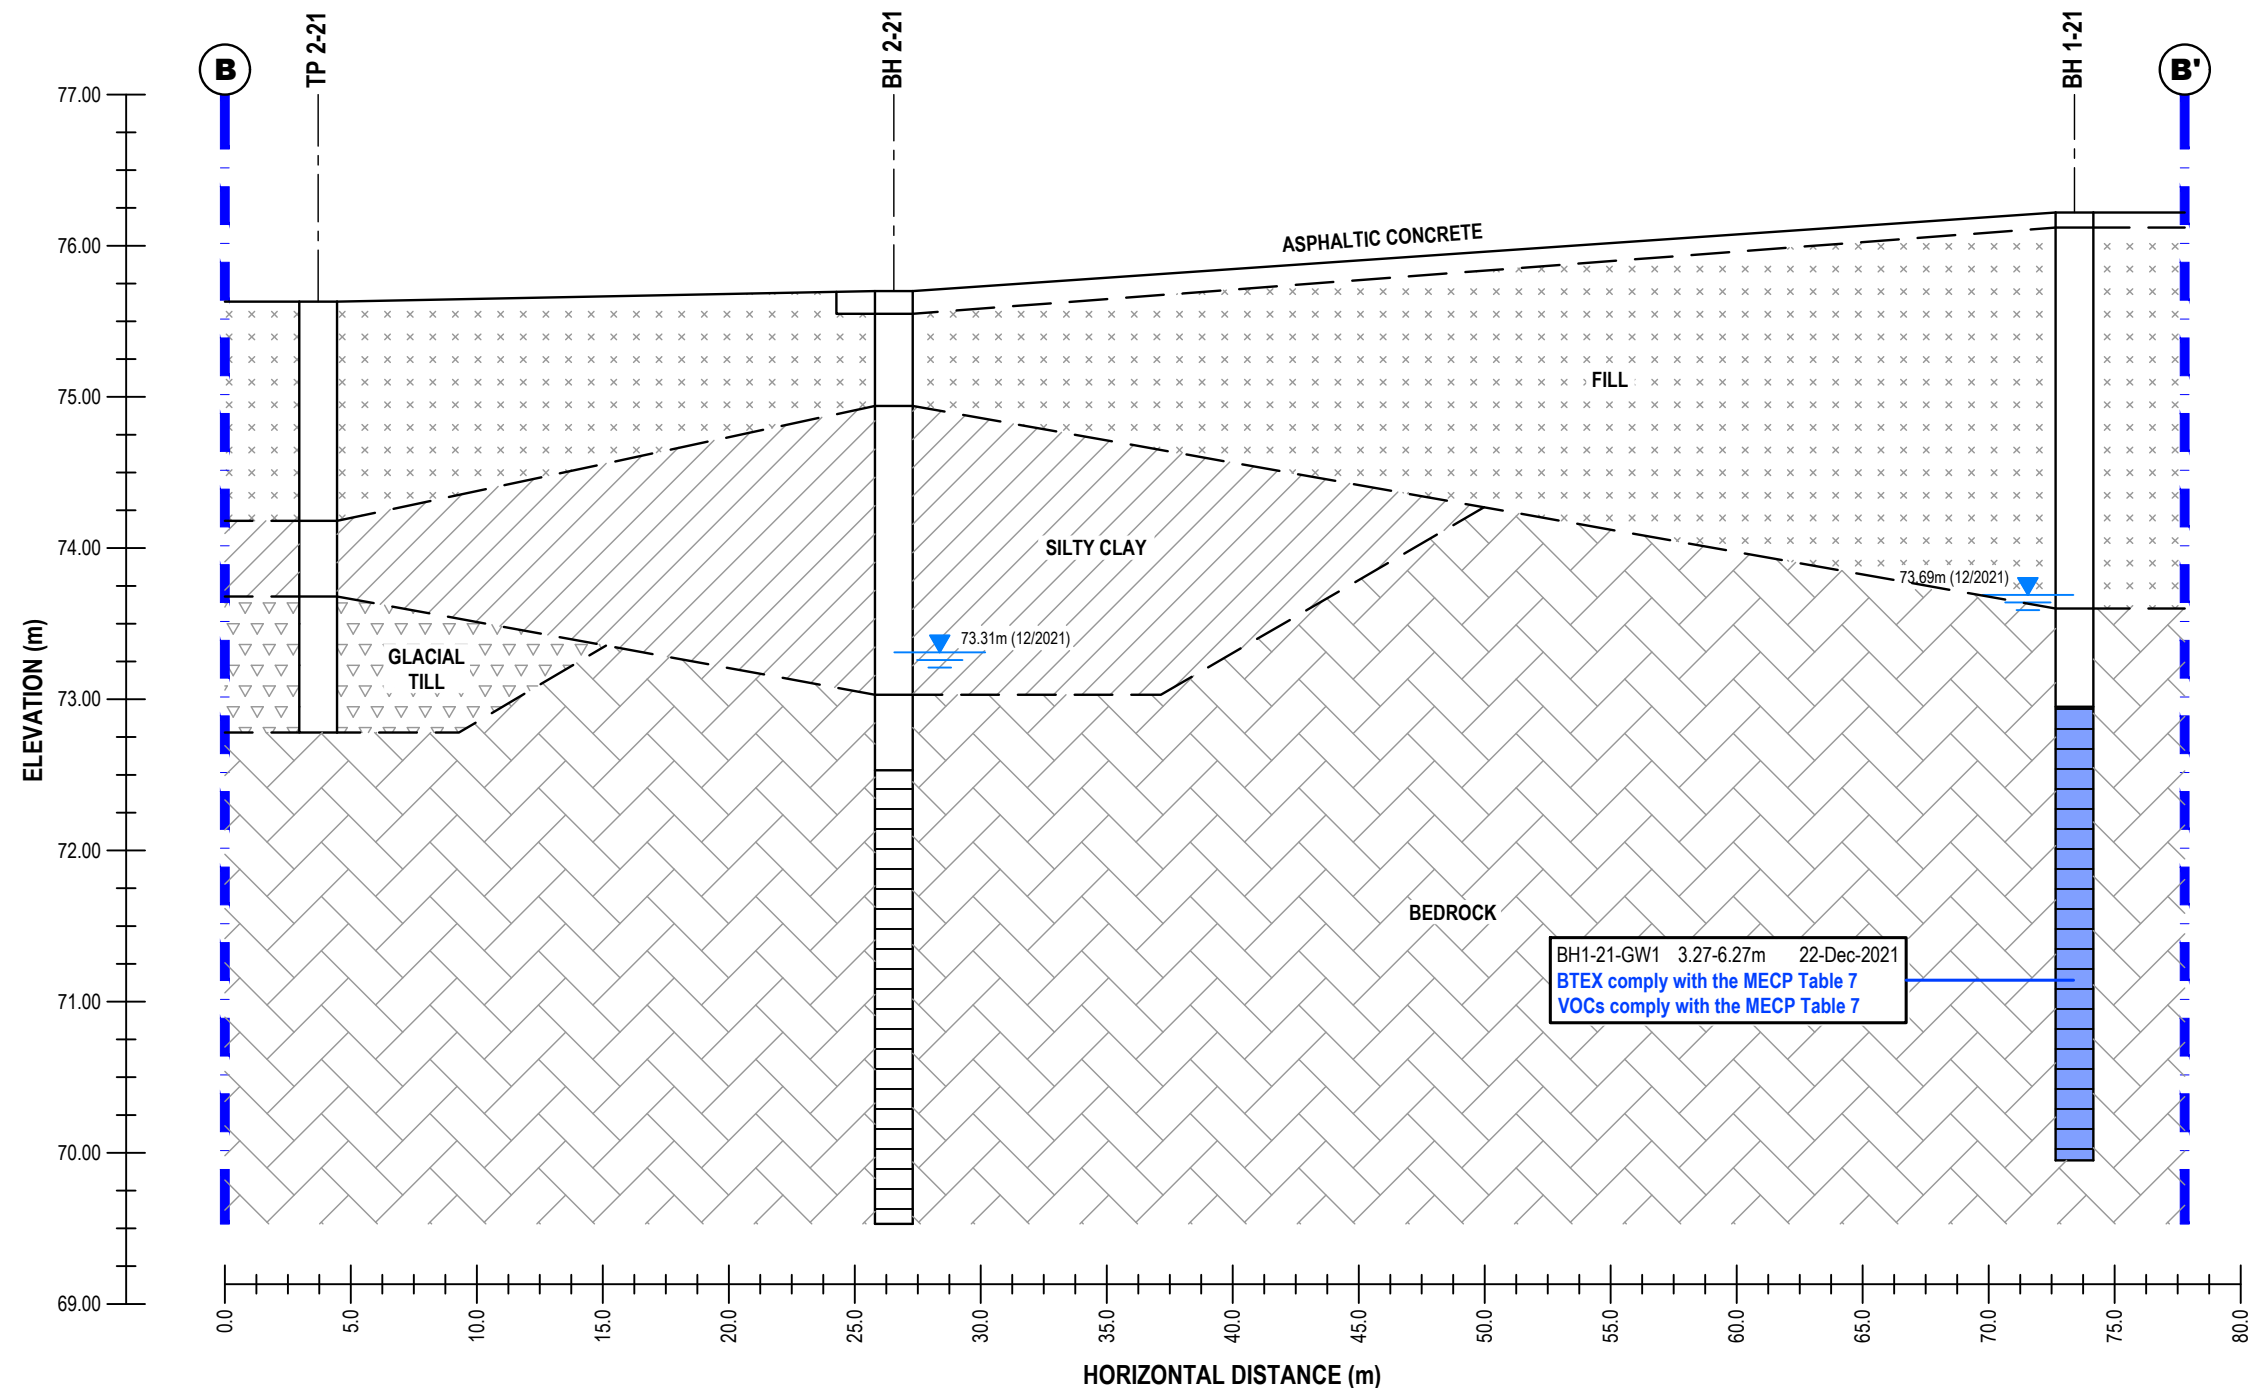
GROUNDWATER PARAMETERS COMPLY WITH MECP  
TABLE 7 STANDARDS
