## **Phase I Environmental Site Assessment**

The Salvation Army Barrhaven Church  
102 Bill Leathem Drive  
Ottawa, Ontario

**April 12, 2016**

Report: PE3779-1

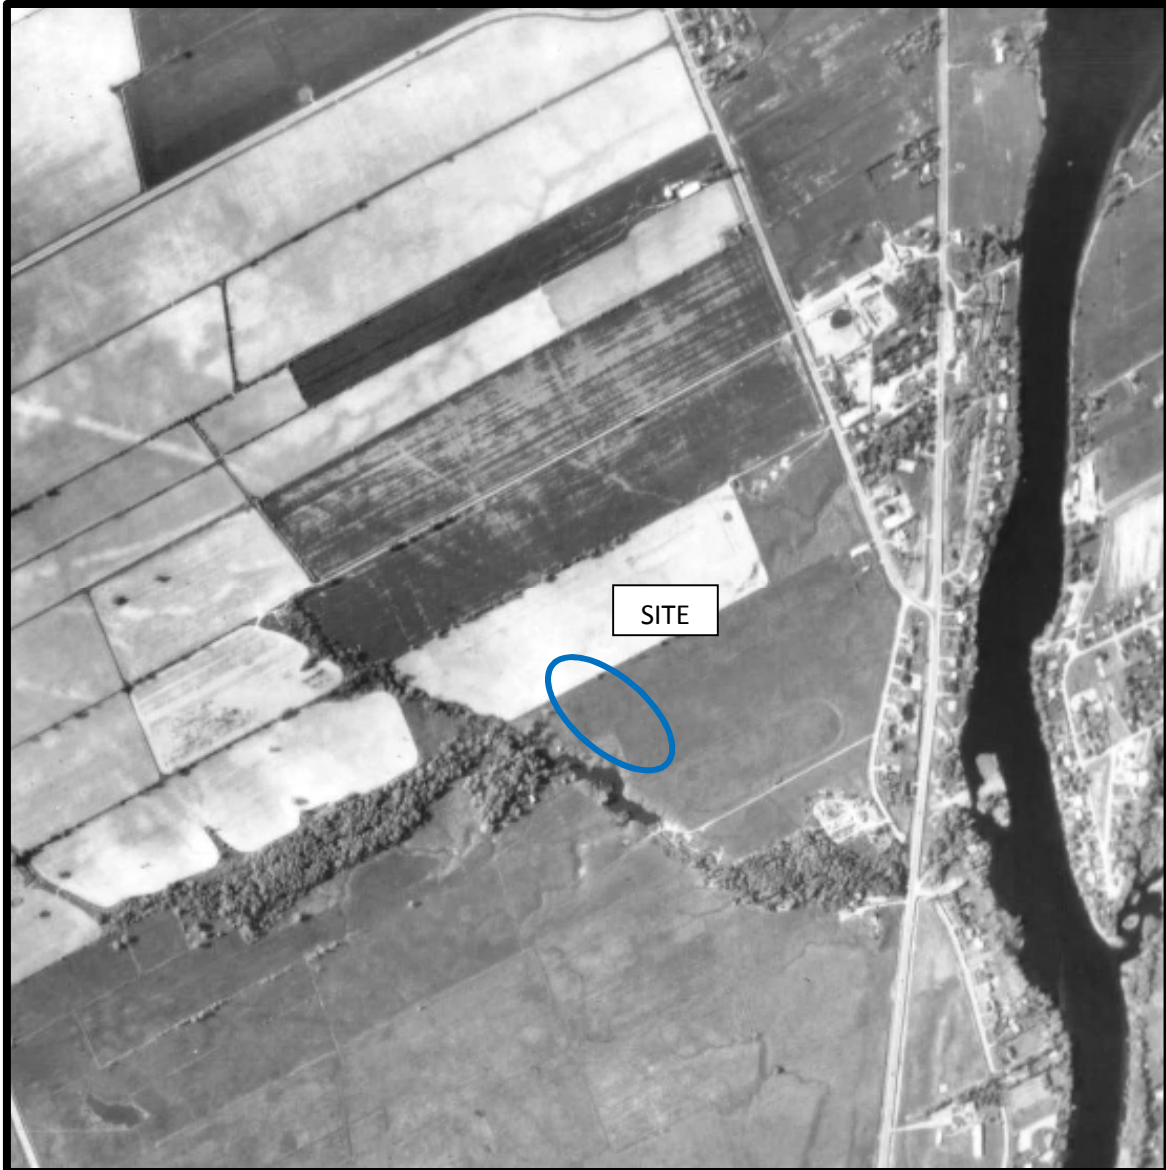
AERIAL PHOTOGRAPH  
1979

| 1979 | No apparent changes have been made to the Phase I property. What appears to be a pathway is present further to the south of the subject land. The roadway extends in an easterly direction from the aforementioned creek (clearly seen in this photo) to Queen Anne Crescent. Otherwise the adjacent and neighbouring properties appear to remain unchanged. |

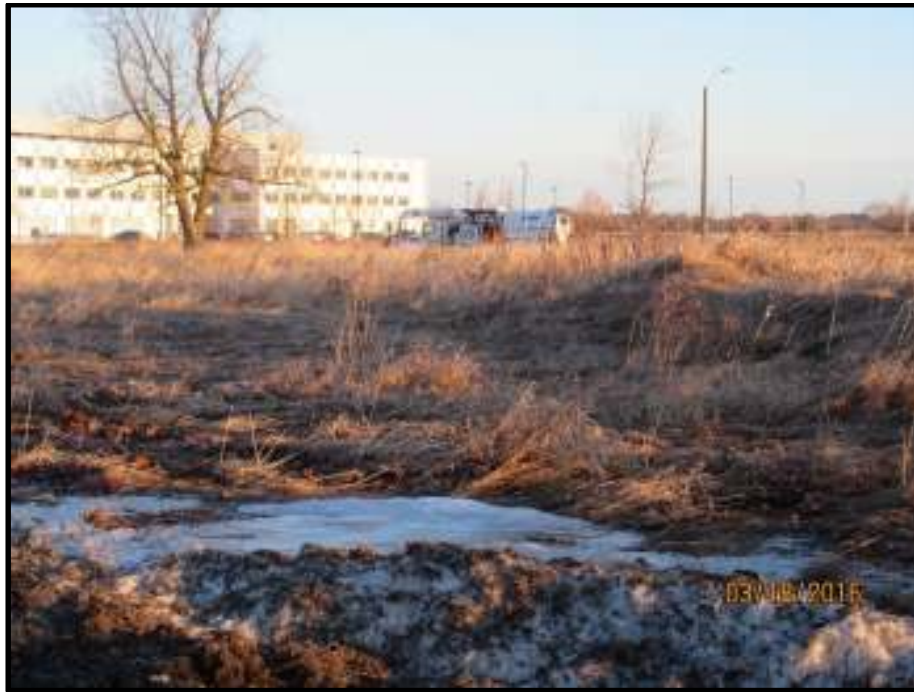
A small amount of fill material was noted on the southeastern portion of the site at the time of the site visit. As discussed previously, fill material was noted on adjacent and neighbouring properties during a previous Phase I ESA and also identified on the eastern portion of the subject site during a previous Geotechnical Investigation. The fill material consisted of native silty clay with some sand and gravel, and was considered to have resulted from the construction of the storm water management pond and pathway to the south and the construction of the adjacent roadways. The fill material was not considered to represent an APEC on the Phase I property.

Photograph 1: View of eastern portion of the site and some fill material, facing northwest.

Based on the findings of a current Geotechnical Investigation carried out for the Phase I property by Paterson in March of 2016, fill material was not identified in boreholes placed in the vicinity of the material noted above, or in any of the remaining boreholes placed on the site. The fill material discussed above is considered to be limited in quantity.

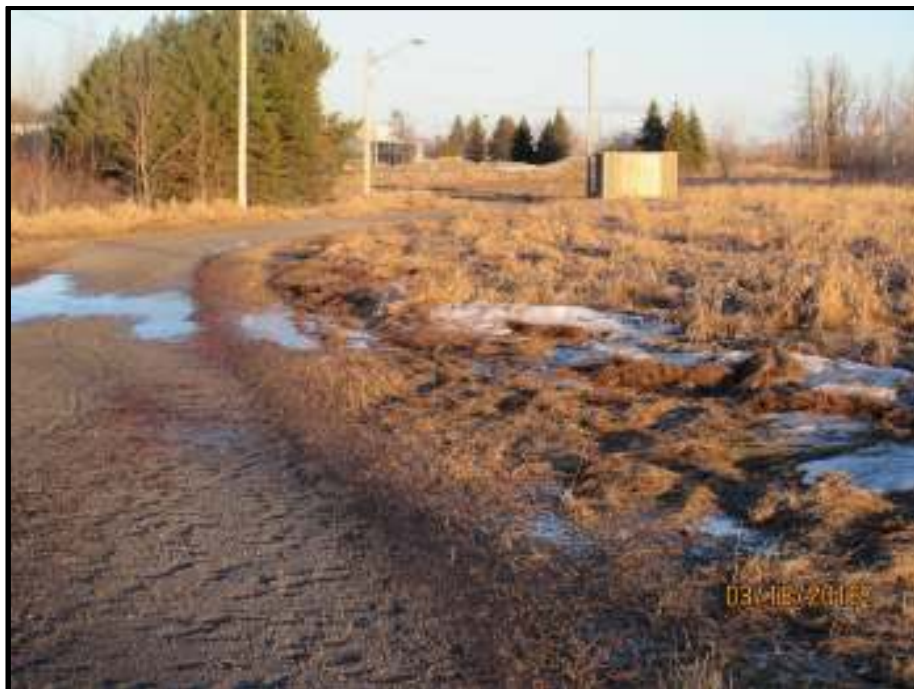
Photograph 2: View of the southeastern portion of the site, the adjacent path to the south, and the pumping station situated on the south-central portion of the property (not part of the subject property), facing east.

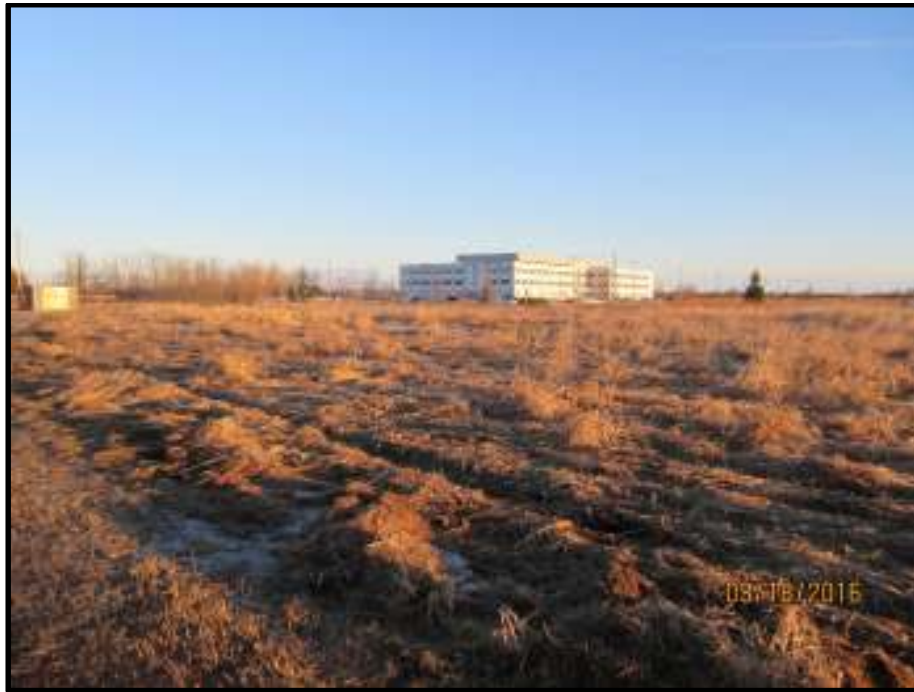
Photograph 3: View of eastern and central portions of site, facing northwest. Photo also shows JDS Uniphase building to the north, across Bill Leathem Drive.

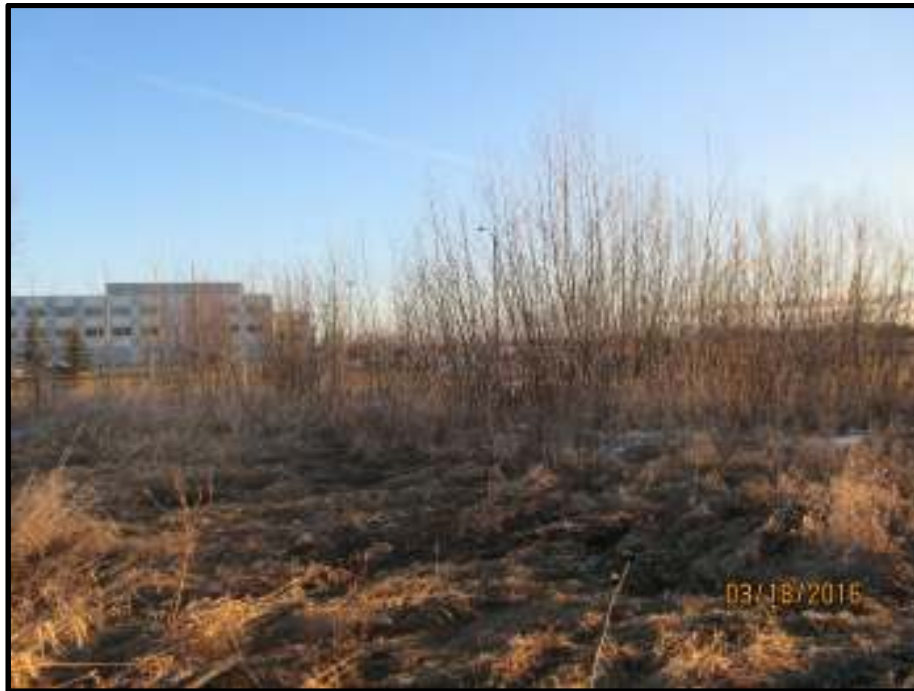
Photograph 4: View of treed area on central portion of site, facing north.

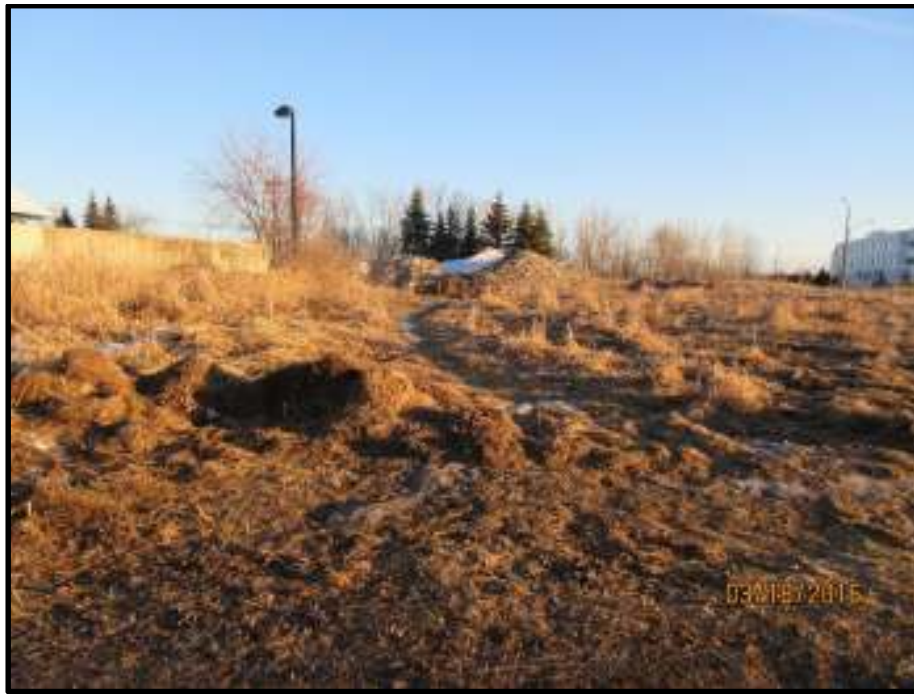
Photograph 5: View of western portion of site and some remaining snow, facing north.

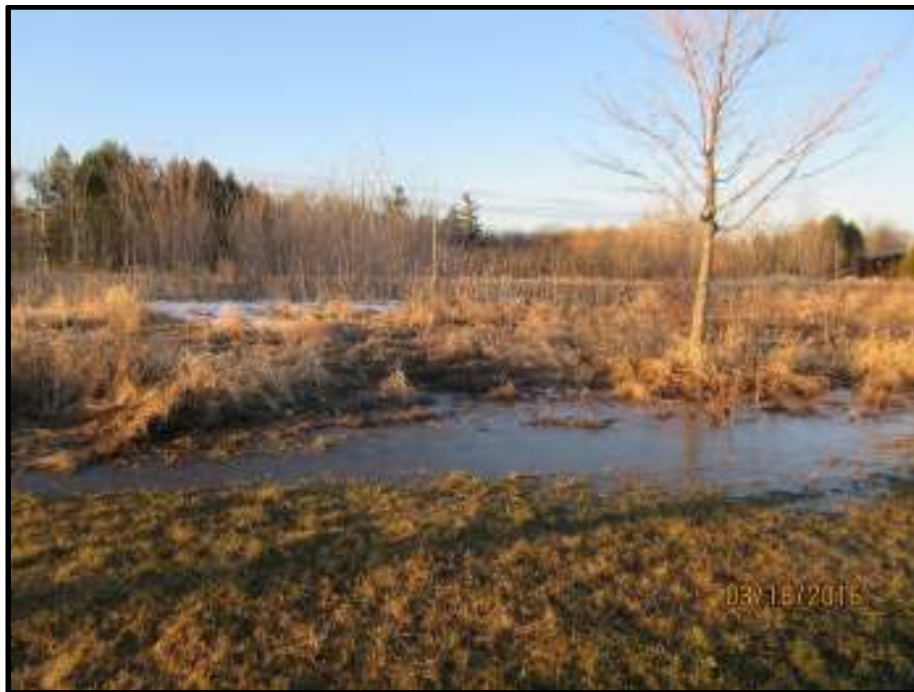
The subject site is currently vacant and predominantly grass/brush covered. A small treed area was observed on the north-central portion of the site. Site drainage consists of infiltration. There was ponded water on the property at the time of the site visit. The water was clear with no signs of contamination. No areas of stained soil, vegetation or stressed vegetation, soil disturbance, or grading were observed on-site. Several small areas remained snow covered at the time of the site visit.

Photograph 6: View of ponded water on north-central portion of site, facing southwest.
