Phase I-Environmental Site Assessment

403 Richmond Road and 389 Roosevelt Avenue
Ottawa, Ontario

April 4, 2022

Report: PE4744-1R

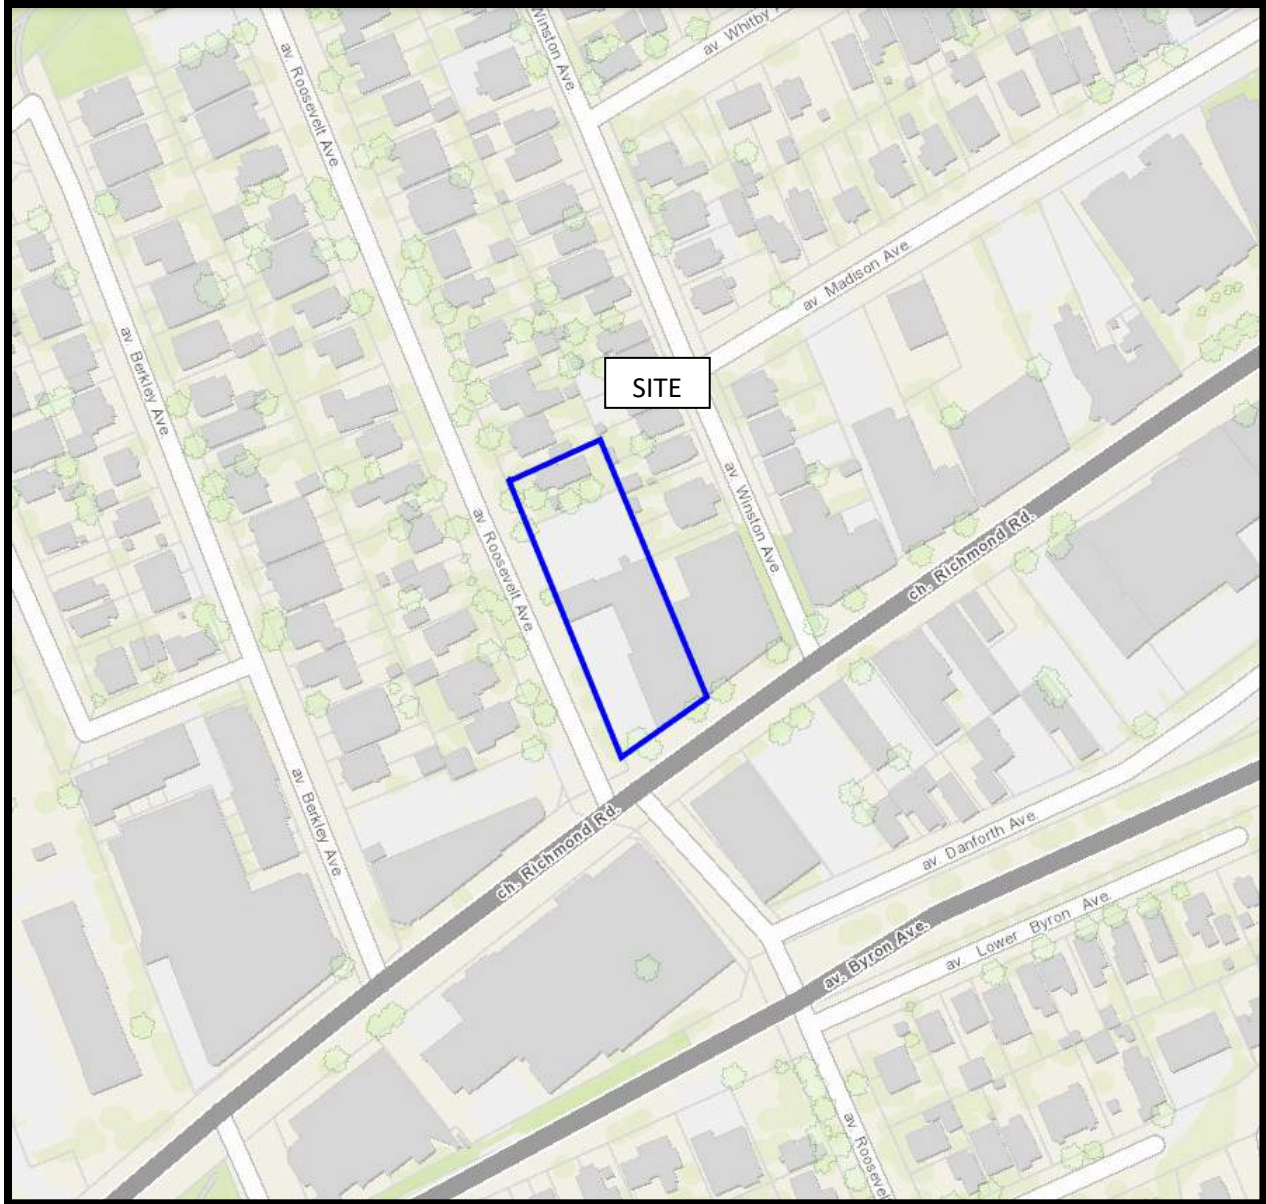
FIGURE 1
KEY PLAN

Location: The site is located on the northeast quadrant of the
Richmond Road and Roosevelt Avenue intersection, in
the City of Ottawa, Ontario. Refer to Figure 1 - Key
Plan in the Figures section following the text.

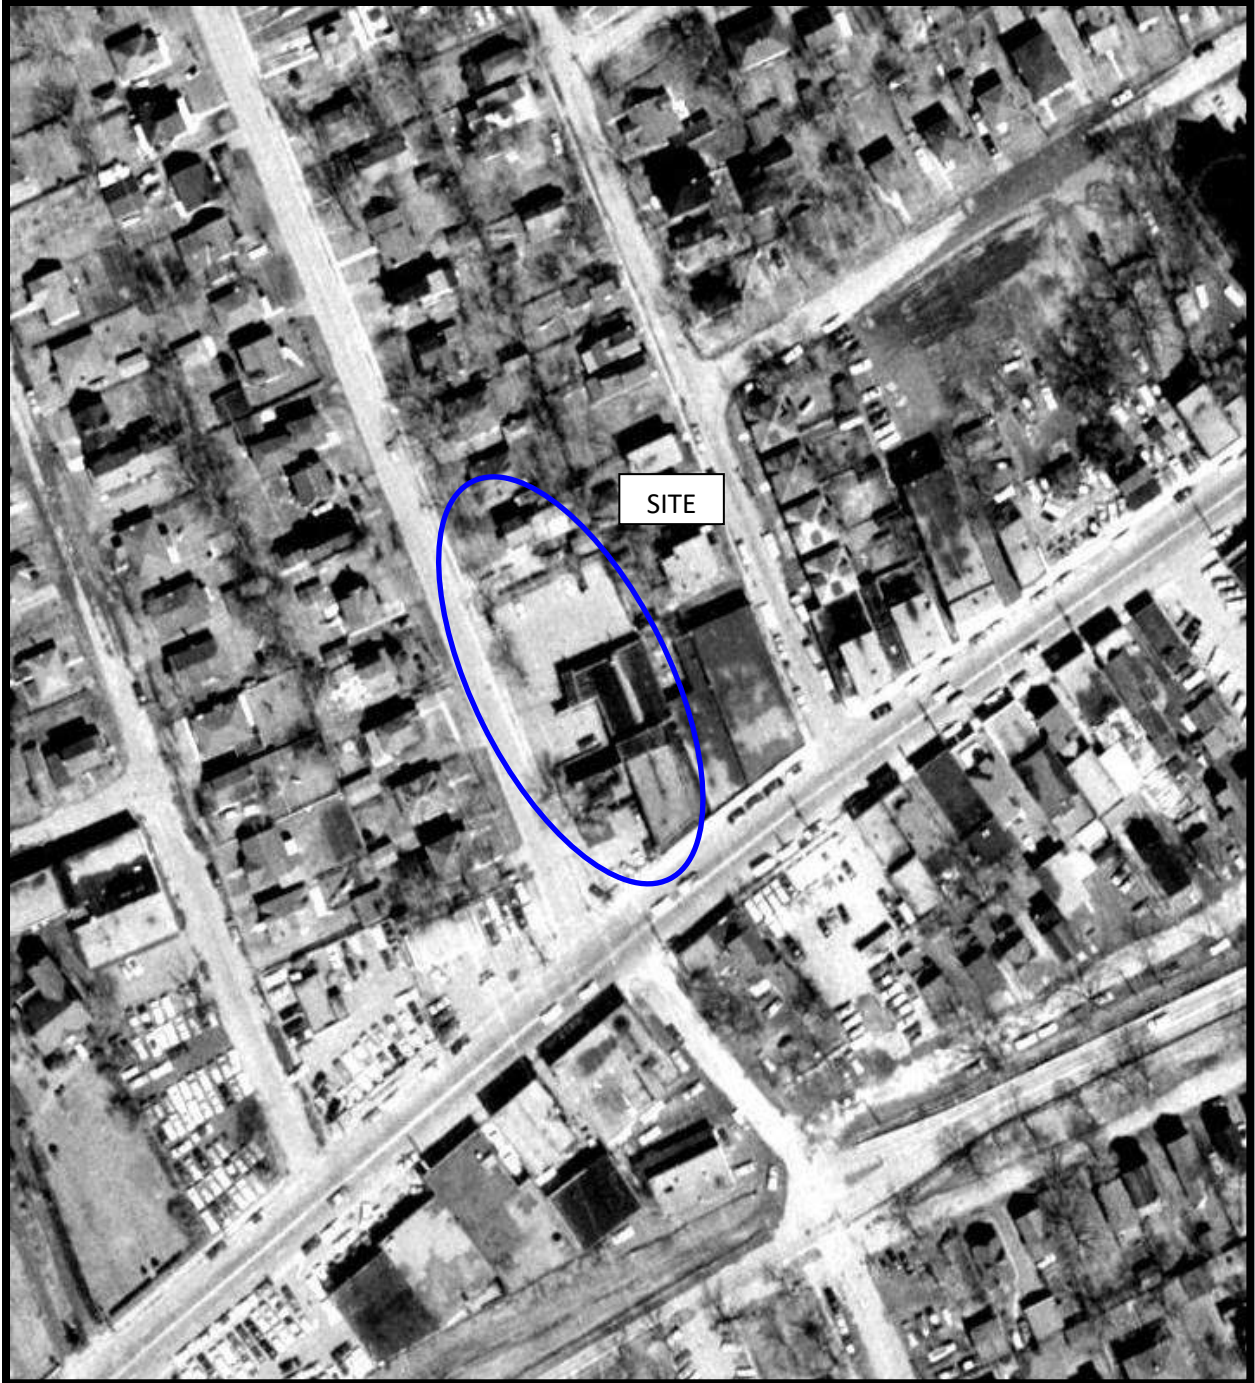
AERIAL PHOTOGRAPH
1958

1958	No significant changes are apparent on the Phase I Property or on the surrounding lands.
1965	The funeral parlour appears to have been extended with a north wing addition, while the residence remains unchanged. Properties along Richmond Road remain commercial, while properties on the neighbouring streets are occupied by residences.
1976	The small commercial building on the southern western portion of the site is no longer present at this time. No significant changes are apparent on the surrounding lands.
1995	The Phase I Property and surrounding lands remain unchanged from the previous photograph.
2007	No significant changes are apparent on the Phase I Property or surrounding lands.
2019	The Phase I Property and surrounding lands remain unchanged from the previous photograph.

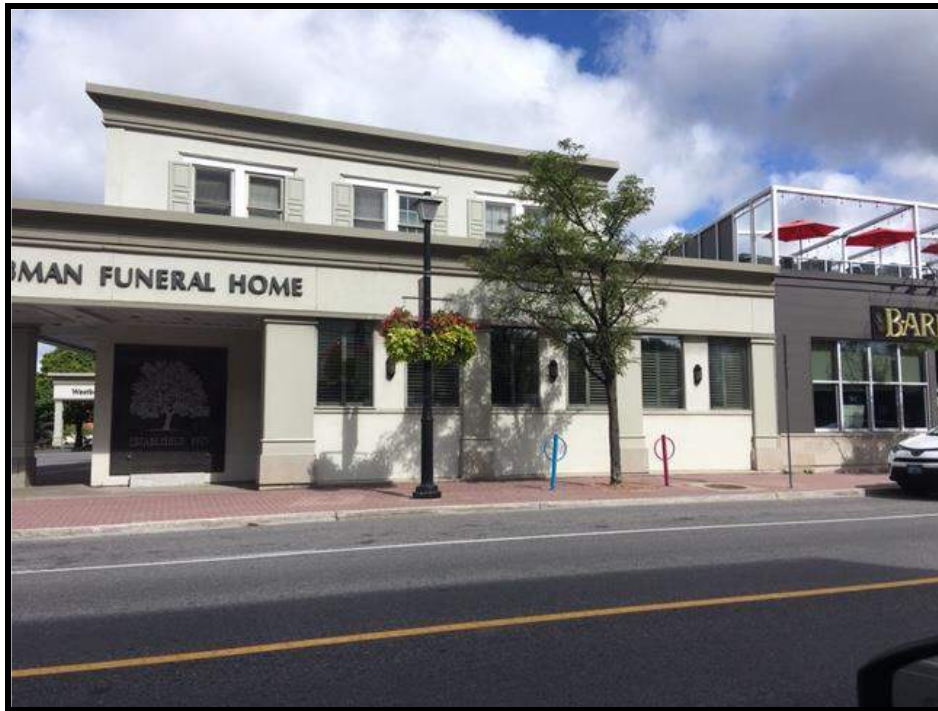
Photograph 1: The subject building at 403 Richmond Road, looking north.

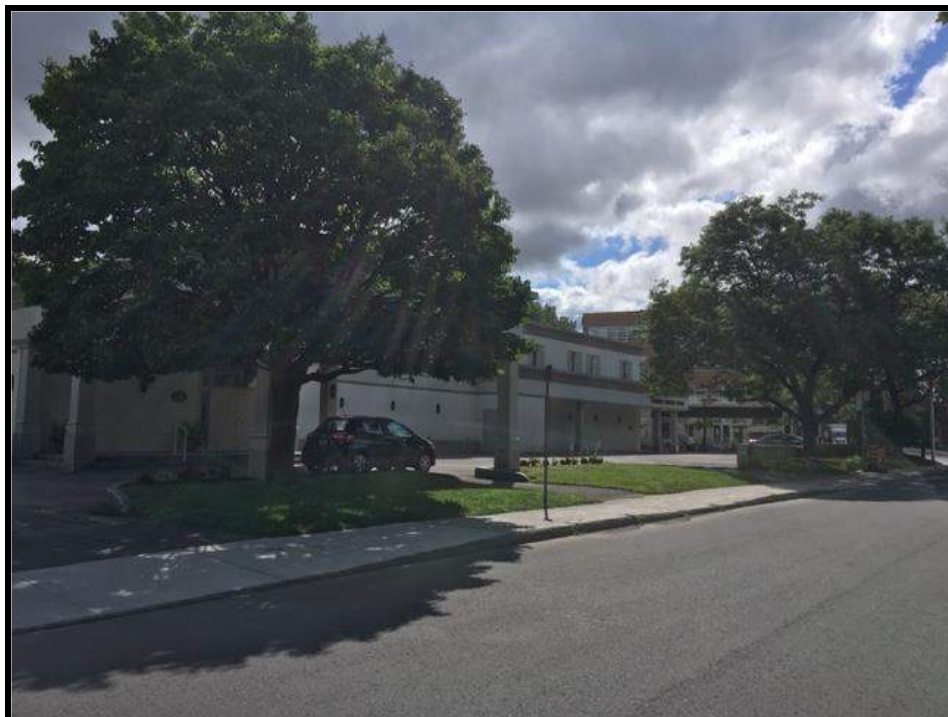
Photograph 2: The western side of the subject building, looking southeast.

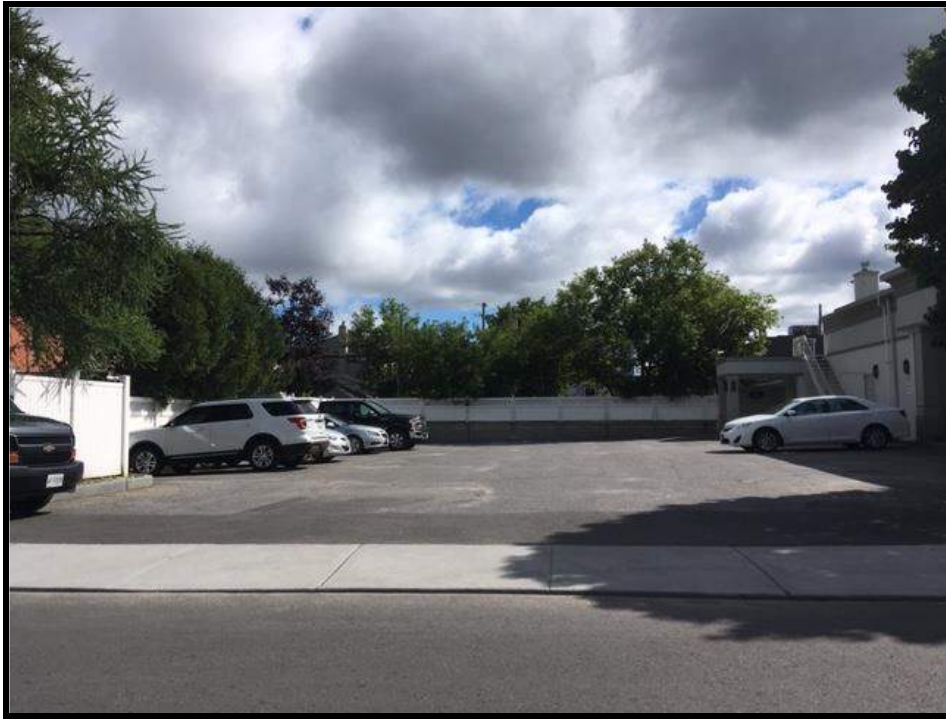
Photograph 3: Parking lot located on the north side of the subject site, taken from Roosevelt Avenue.

Based on the findings of the Phase I ESA, it is considered likely that road salt was applied to the surface of the walkways, paved access lane and parking lot on the northern portion of the 403 Richmond Road for the safety of vehicular and pedestrian traffic under conditions of ice and/or snow.

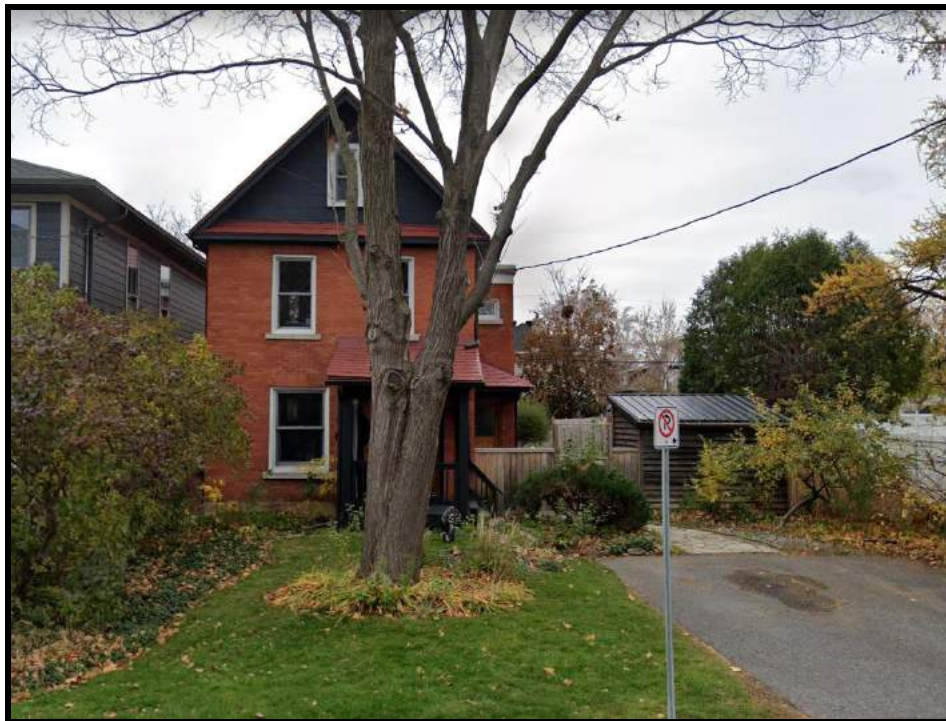
Photograph 4: The residential dwelling at 389 Roosevelt Avenue.

The northern portion of the Phase I Property, addressed 389 Roosevelt Avenue, is occupied by 2-storey residential dwelling that was construction prior to 1928 and a small shed that was constructed circa 2000. The exterior of the dwelling is finished in red brick with a sloped shingle style roof and a stone and mortar foundation.

Based on the age of the age of the residential dwelling, potential asbestos containing materials (ACMs) maybe present in the subject building, which include drywall joint compound and hard plaster. Lead-based paints may also be present in the subject building. Prior to any disturbance of potentially hazardous building materials, a designated substance survey (DSS) must be conducted on the existing structure, in accordance with Ontario Regulation 490/09 under the Occupational Health and Safety Act.
