Phase I Environmental Site Assessment

436 Athlone Avenue Ottawa, Ontario

Tel: (613) 226-7381 Fax: (613) 226-6344 www.patersongroup.ca October 29, 2021

Report: PE5428-1

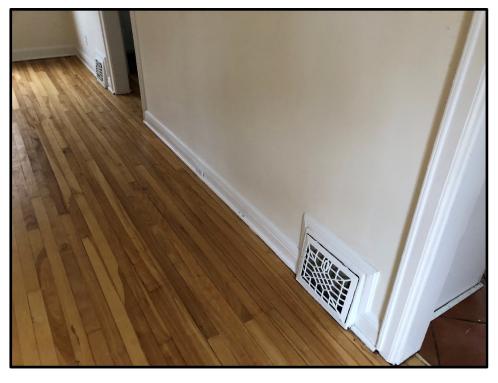
Photograph 1: Floor and walls of the first-floor living room.

A	general description of the interior of the residential dwelling is as follows:	
	The floors throughout the building consist of concrete, laminate, hardwood and ceramic tile.	
	Wall materials consist of drywall and/or plaster, and ceramic tile.	
	The ceilings consist of stippled finishes and drywall.	
	Lighting throughout the building is provided by incandescent and fluorescen fixtures.	
Potentially Hazardous Building Products		
	Asbestos-Containing Materials (ACMs)	
	Based on the age of the subject building (pre-1945), asbestos containing building materials may be potentially present within the structure. Potential ACMs observed on-site include the drywall joint compound, plaster, and stipple plaster ceilings. These ACMs were observed to be in good condition at the time of the site inspection and do not represent an immediate concern to the building's occupants.	
	Lead-Based Paint	
	Based on the age of the subject building, lead-based paints may be present or any original or older painted surfaces. Painted surfaces were generally observed to be in good condition at the time of the site inspection and do no represent an immediate concern.

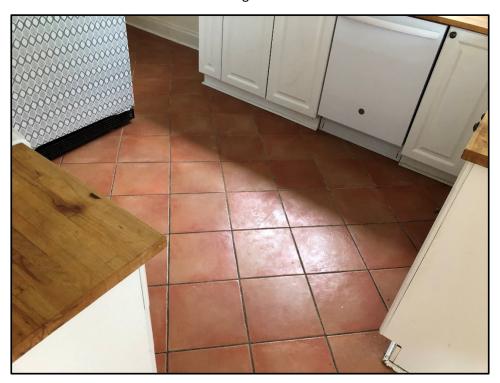
Photograph 2: Ceramic tile flooring in the first-floor kitchen.

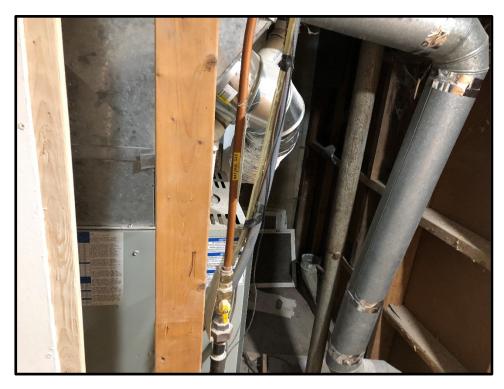
Photograph 3: Natural Gas furnace located in the basement of the property.

The property is currently occupied with a two-storey residential dwelling, with one basement level. Built sometime prior to the 1940s, the subject building is constructed with a poured concrete foundation and is finished with exterior stucco siding, in addition to a sloped-shingled roof. The subject building is currently heated via a natural gas-fired furnace, located in the basement.

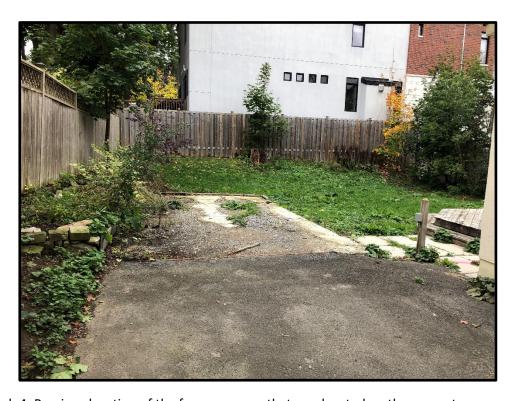
Photograph 4: Previous location of the former garage that was located on the property.
