Phase One Environmental Site Assessment

1209 St. Laurent Boulevard & 1200 Lemieux
Street, Ottawa, Ontario

Canderel Management Inc. & Fengate Development
Holdings

January 10, 2022

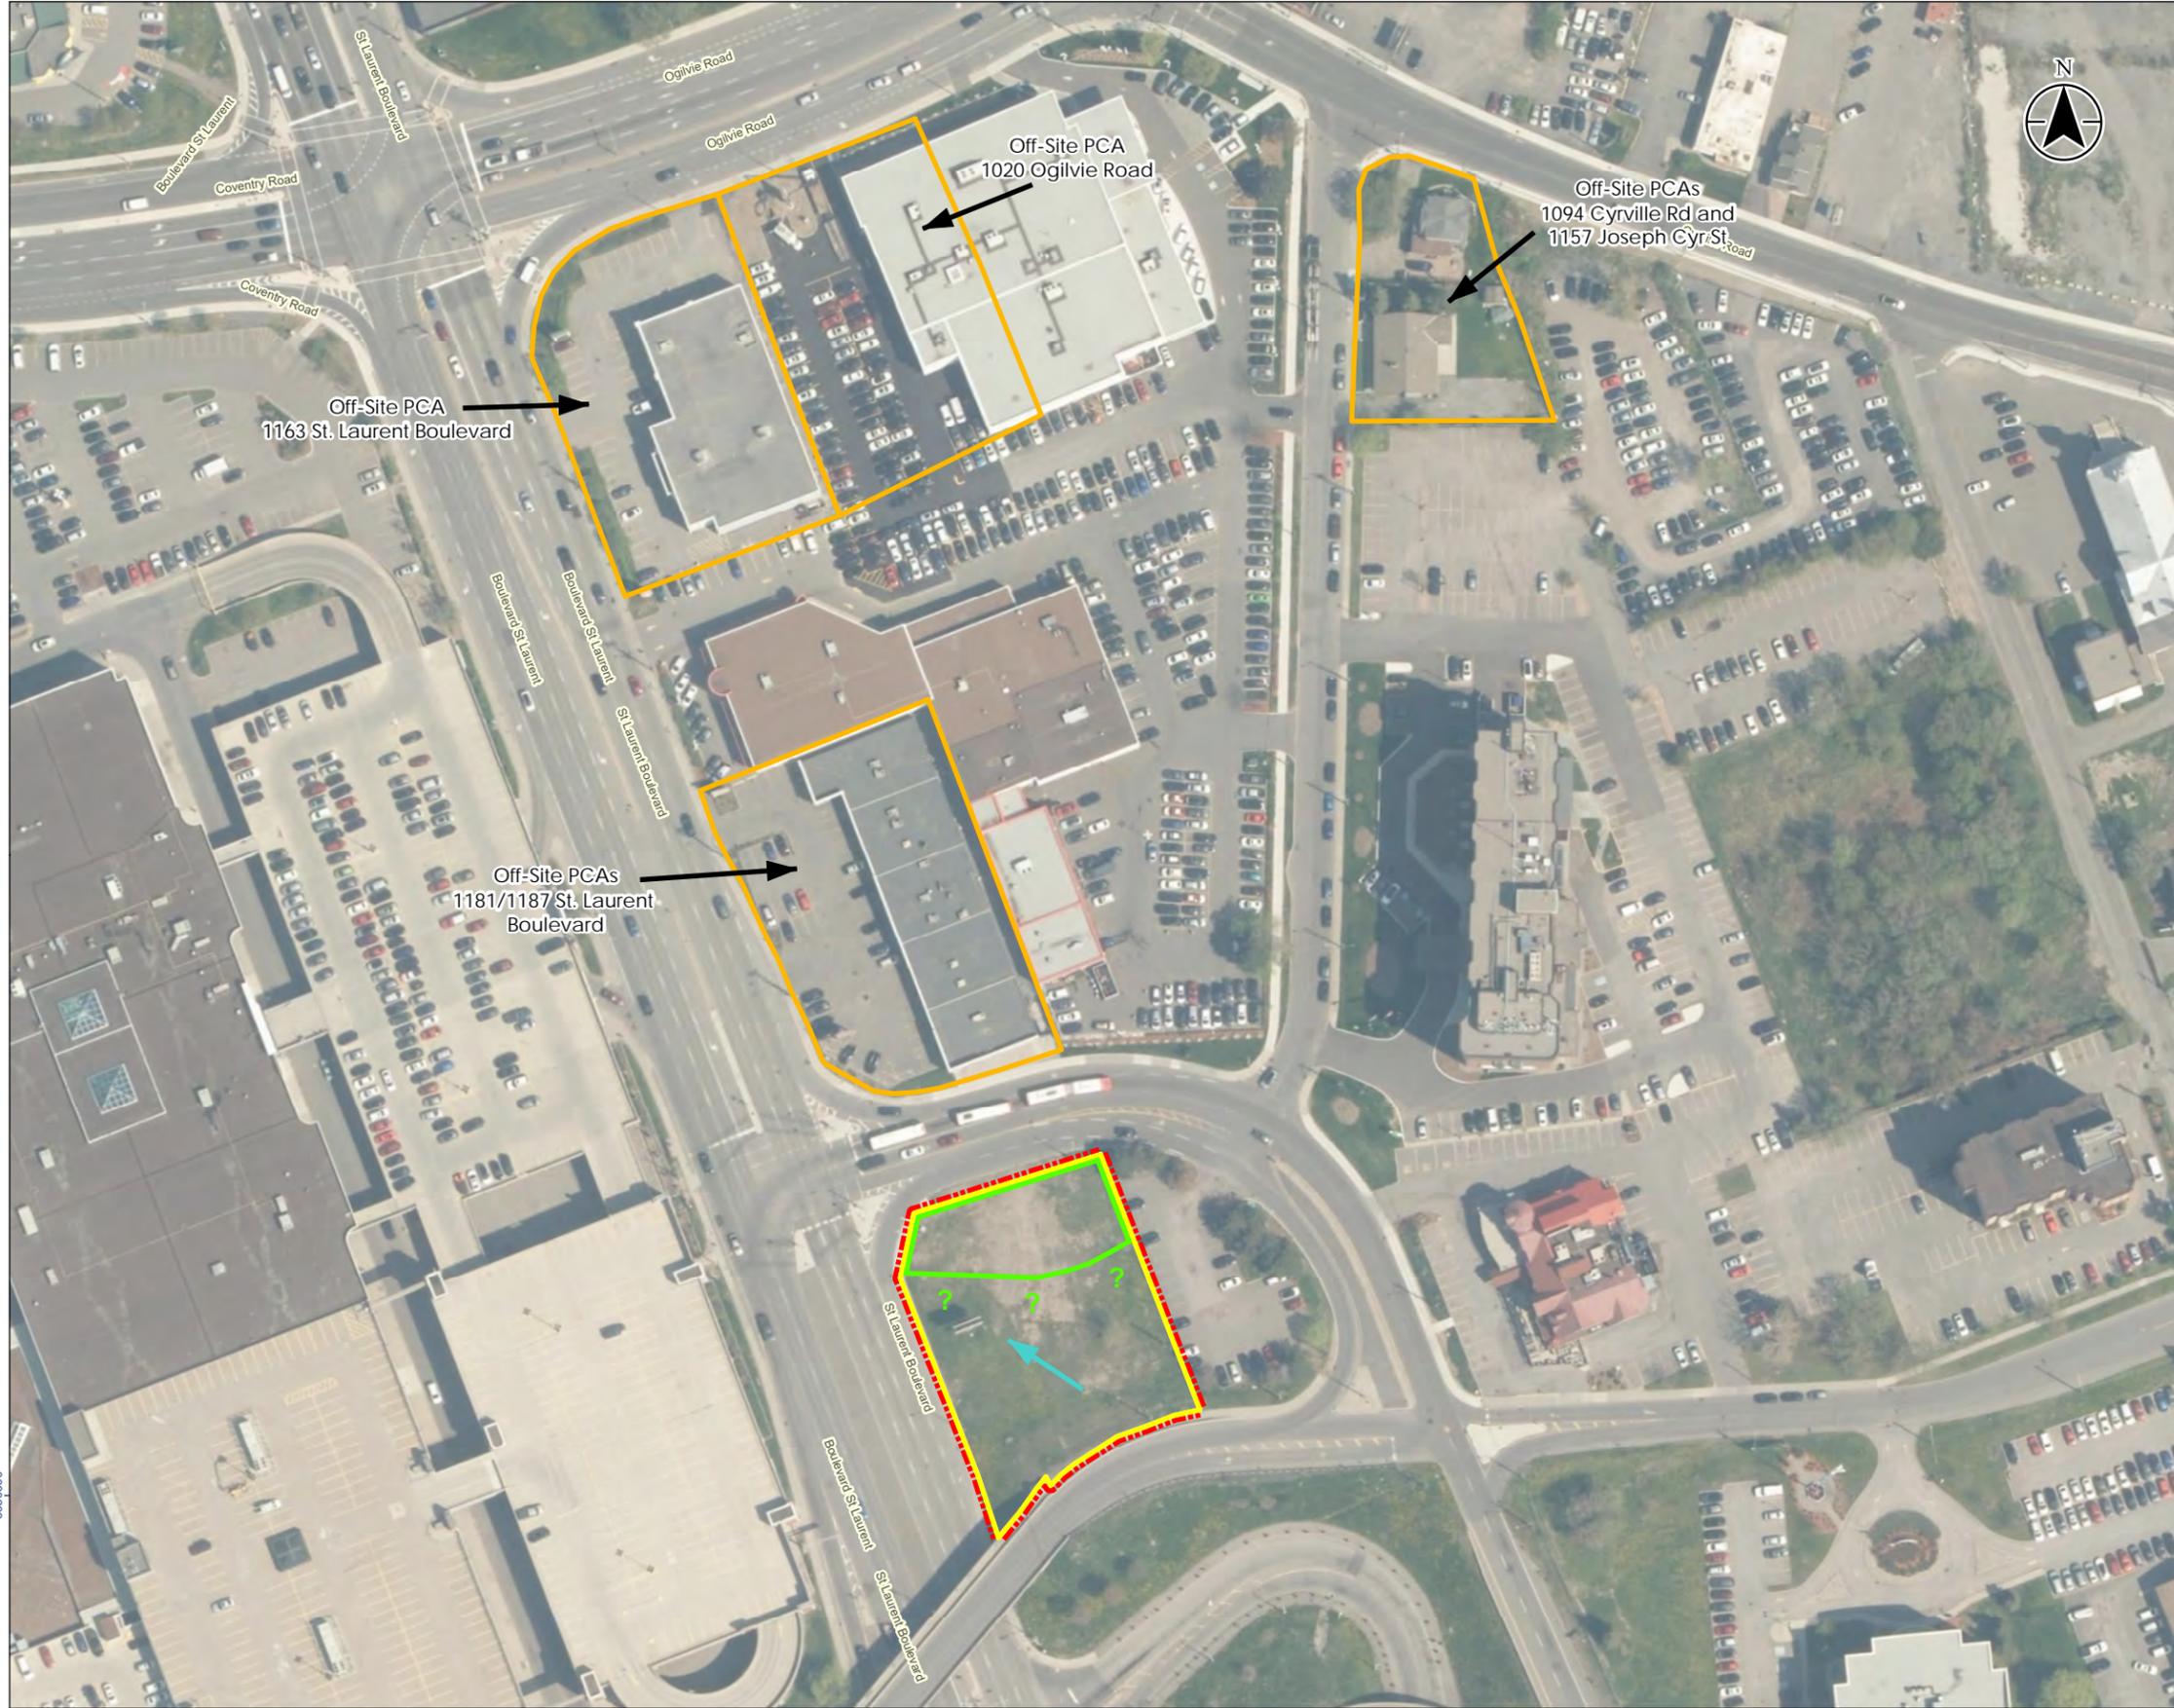
- Approximate Site Boundary
- Inferred Groundwater Flow Direction
- On-Site APEC and PCA #1
- On-Site APEC #2
- Off-Site PCAs

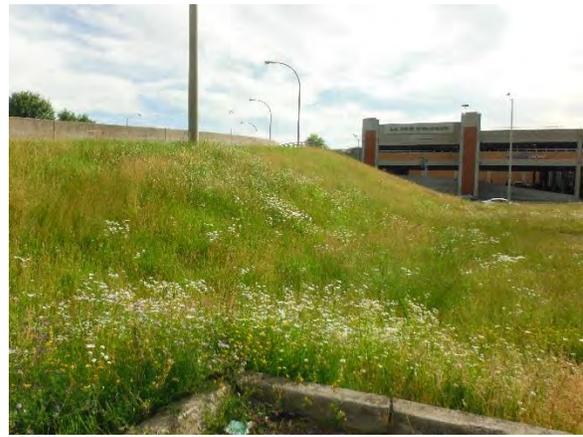
Photo 2: Embankment along the southern property boundary.

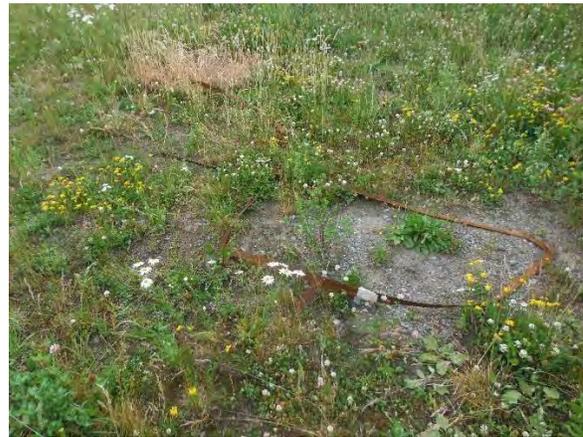
Photo 4: Metal debris in the northern portion of the Site.

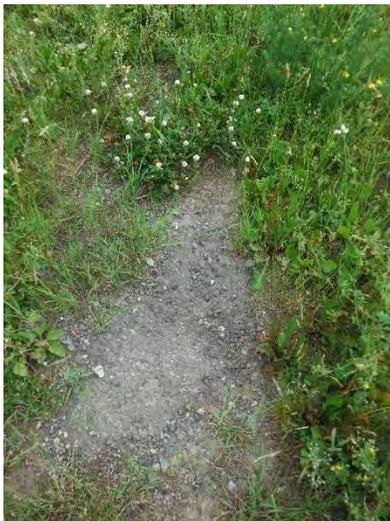
Photo 5: Gravel fill/asphalt in northeastern portion of Site.

Based on review of the aerial photographs, fill placement was observed throughout the Site due to previous residential and highway developments. In addition, the residential structures may have used heating oil as a heating fuel source. Stantec previously conducted a Phase II ESA (2018) in which all "measured concentrations of COPCs were below applicable Ontario Table 3 standards" in soil and groundwater samples submitted for laboratory analysis. No environmental soil or groundwater testing was conducted by Pinchin for either Phase One Property parcels (2020). Due to no soil data collected on the 1200 Lemieux Street property, as well as age of soil data collected by Stantec, GHD has identified on the Site the presence of fill of unknown quality on Site as a PCA (#30 – Importation of Fill Material of Unknown Quality) as defined in O. Reg. 153/04, and the entire Site was identified as APEC (**APEC #1**).

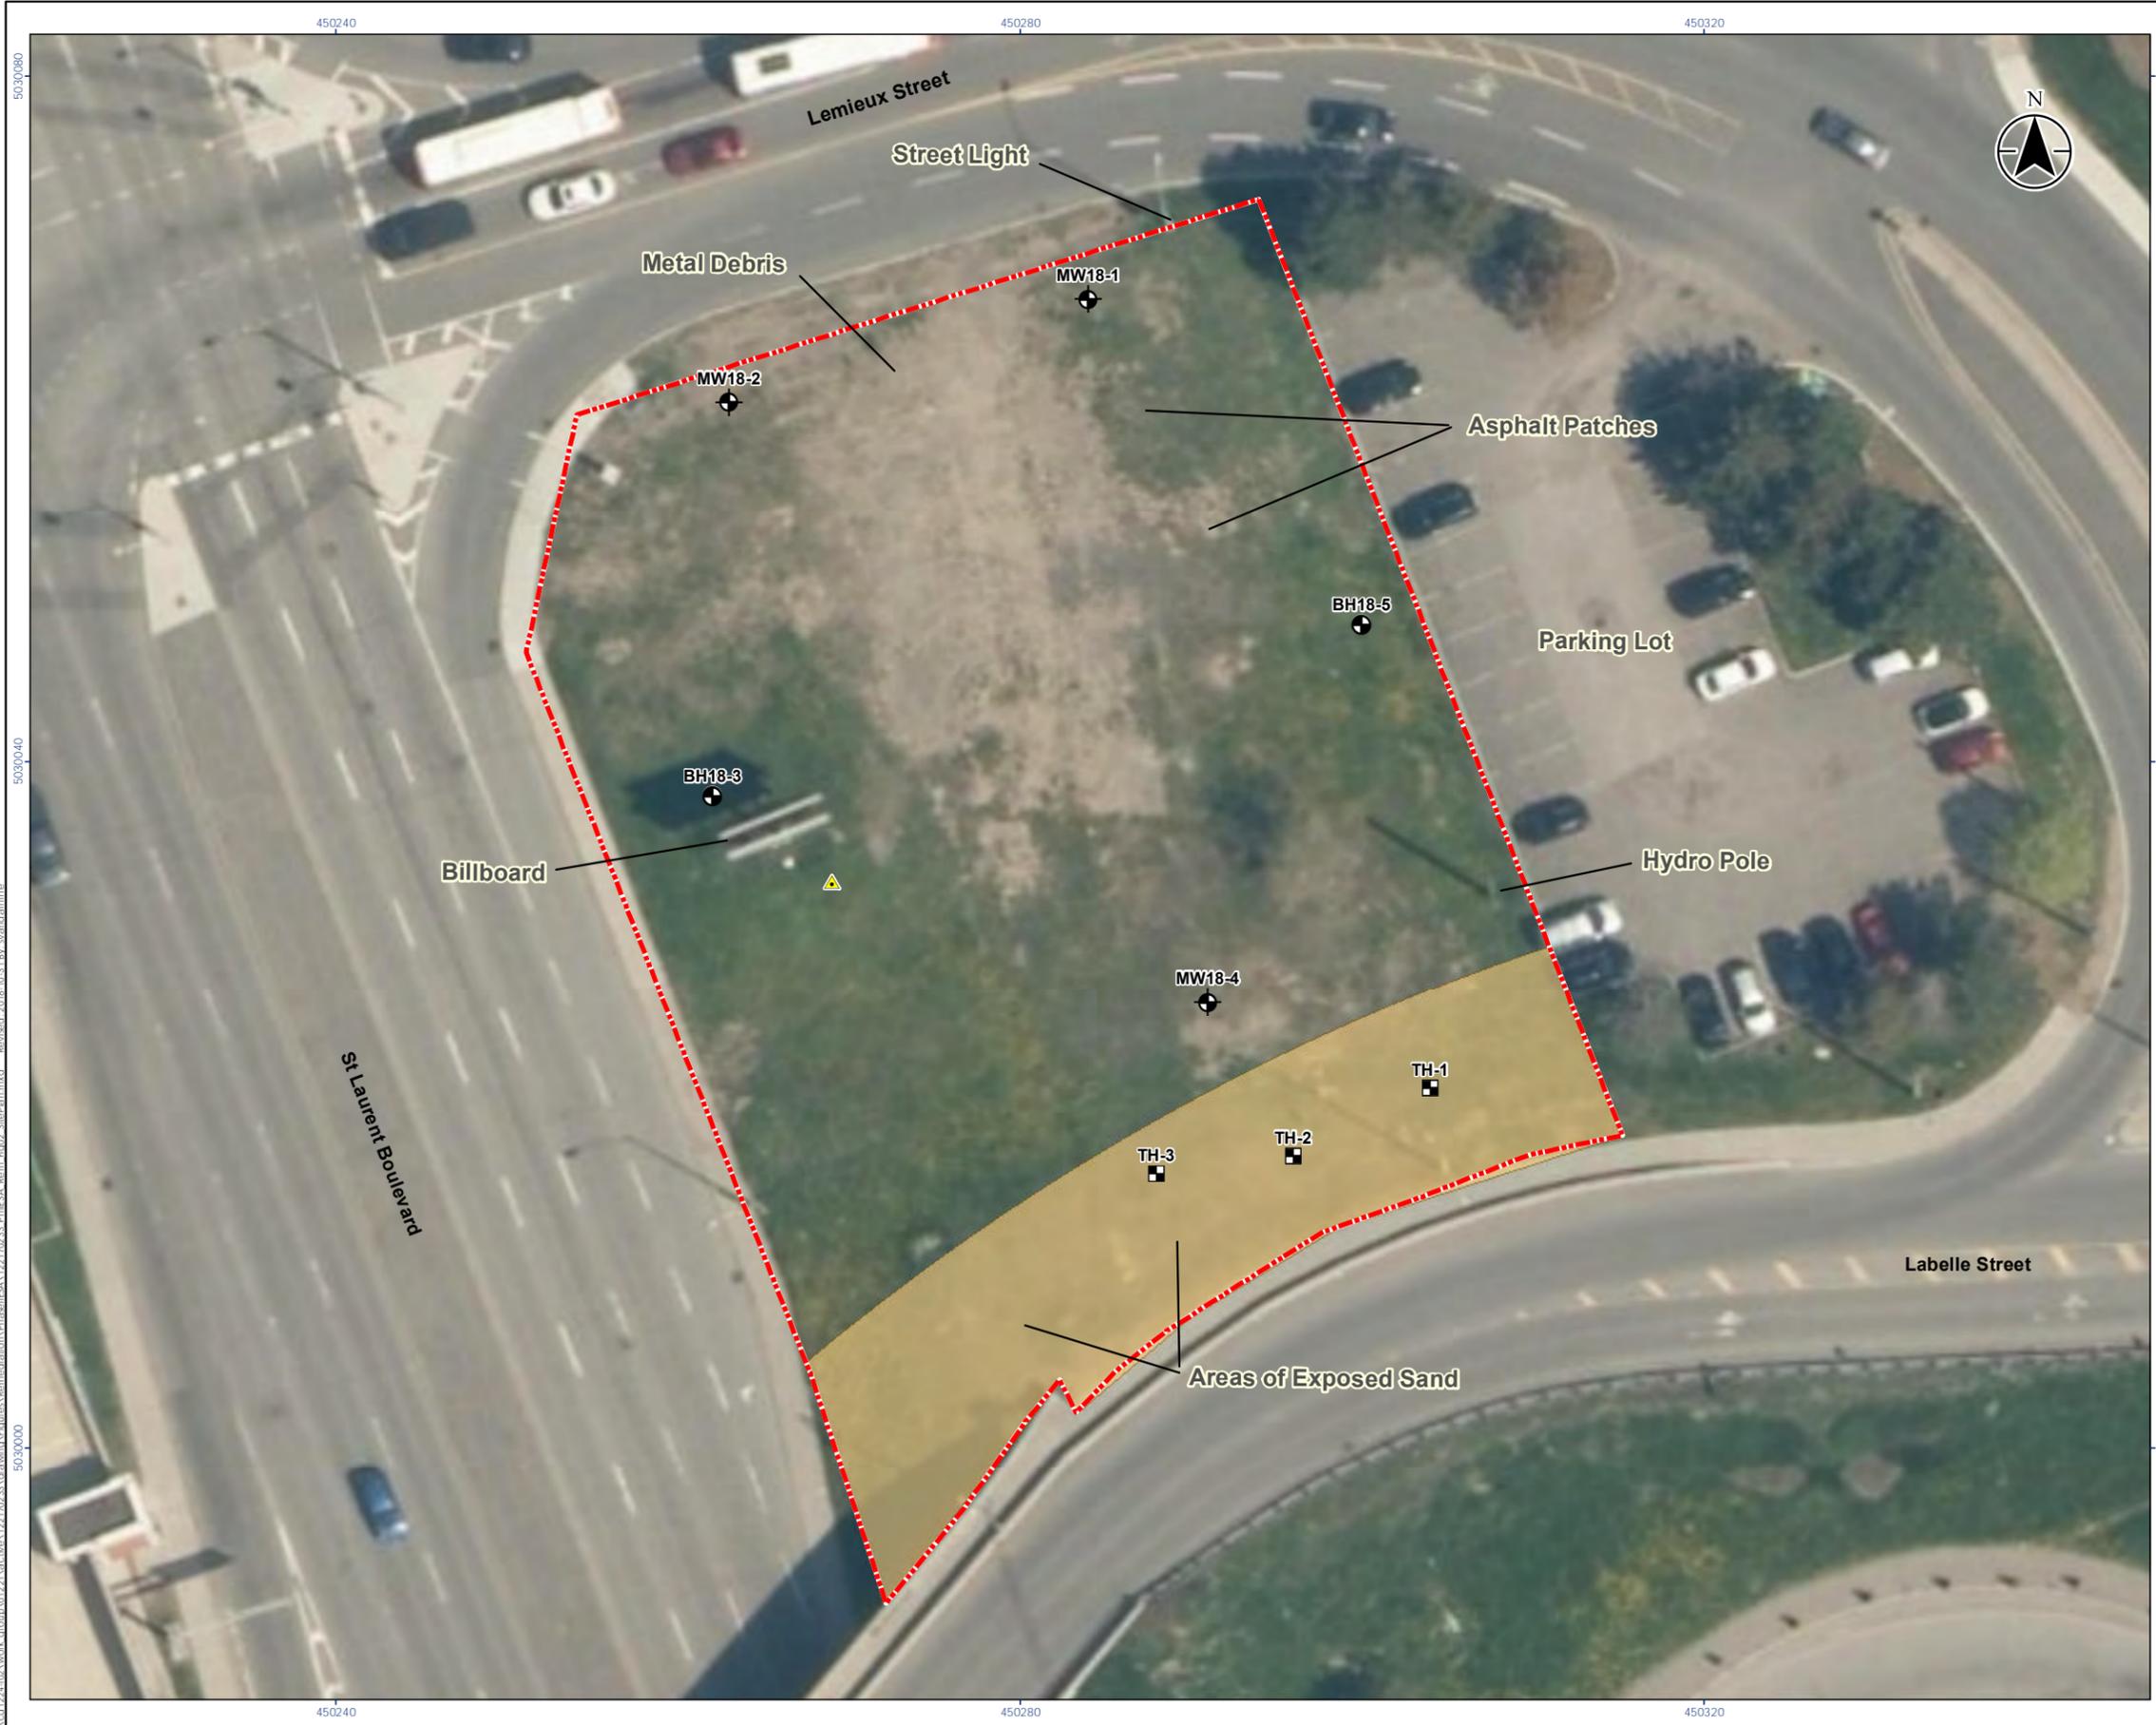
- Borehole Location (Stantec, 2018)
- Monitoring Well Location (Stantec, 2018)
- Test Hole Location (Stantec, 2018)
- Temporary Benchmark
- Approximate Site Boundary
- Approximate Fill Area

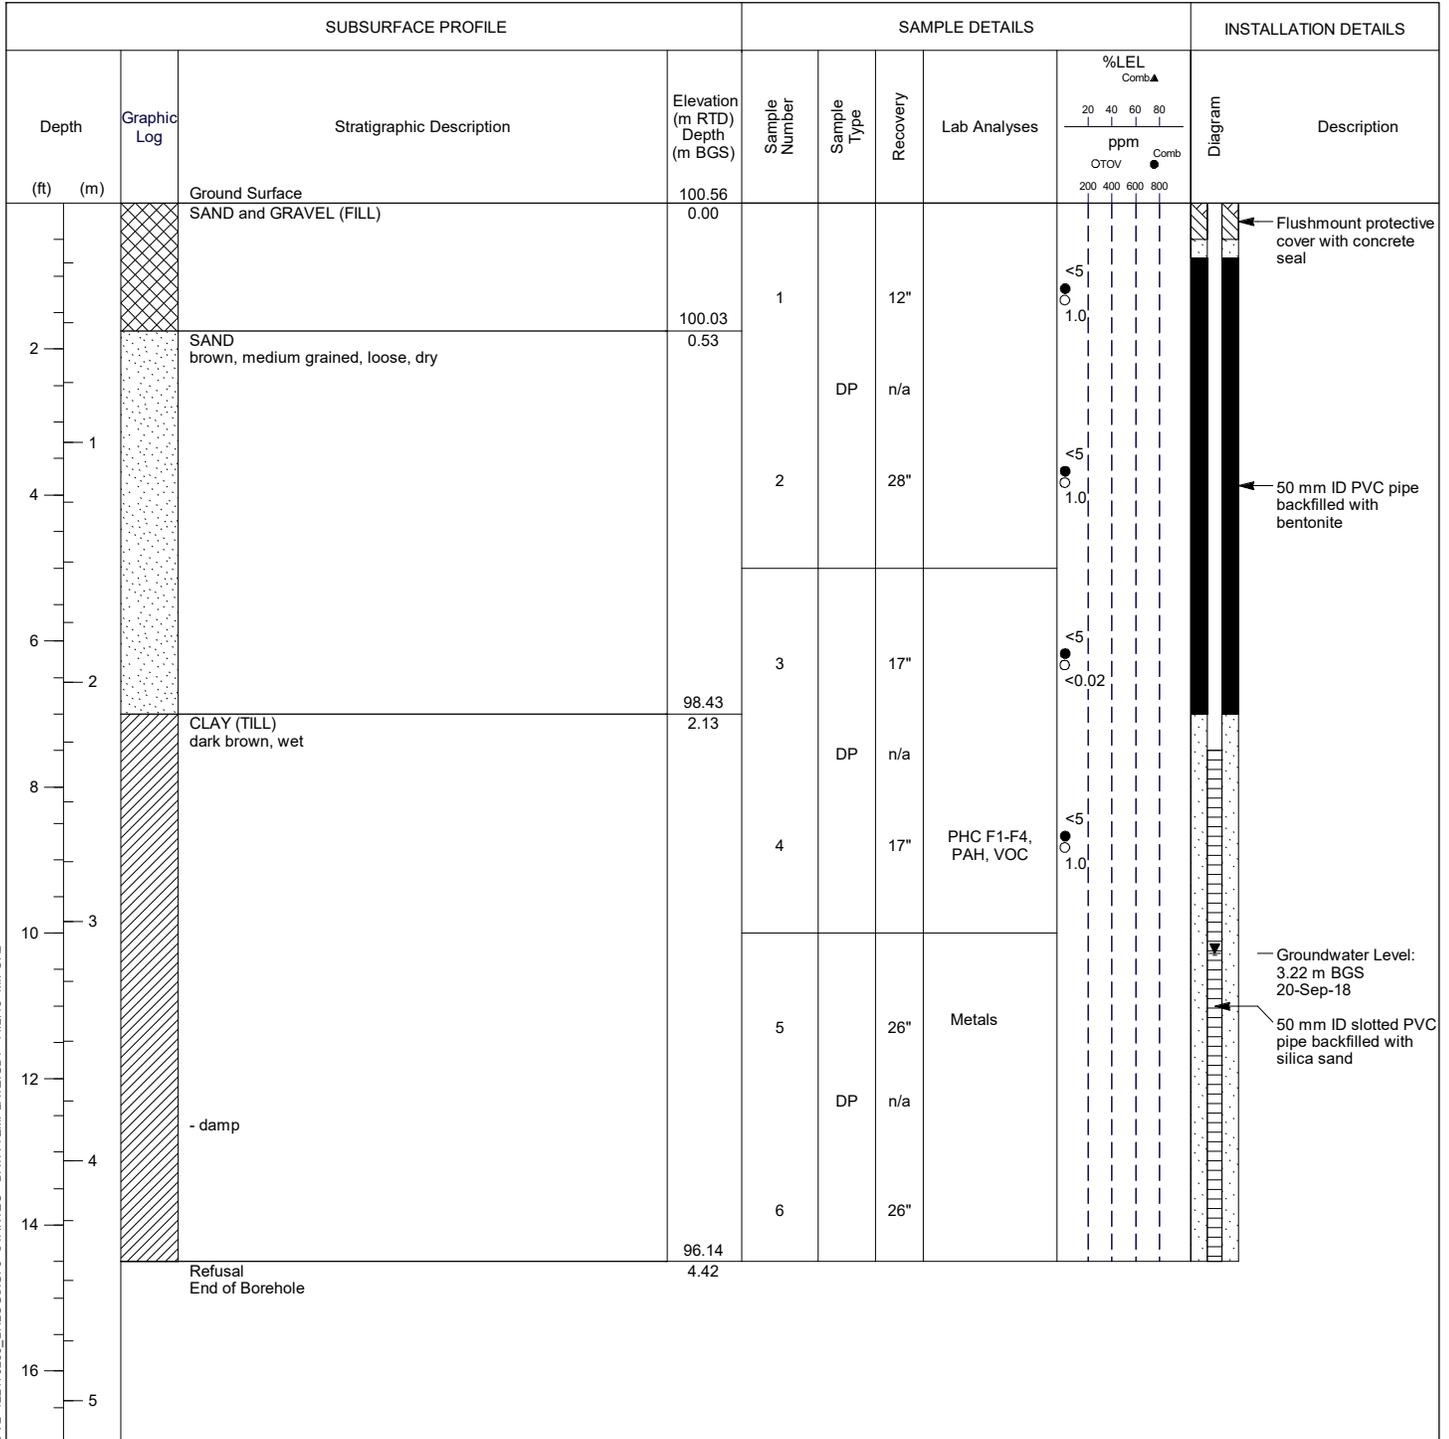
Drilling method: Geoprobe 7822DT (Direct Push)
Date started/completed: 13-Sep-2018
Ground surface elevation: 100.56 m RTD
Top of casing elevation: 100.47 m RTD
Easting: 5030067
Northing: 450284

Screen Interval: 2.29 - 4.42 m BGS
 Sand Pack Interval: 2.13 - 4.42 m BGS
 Well Seal Interval: 0.23 - 2.13 m BGS

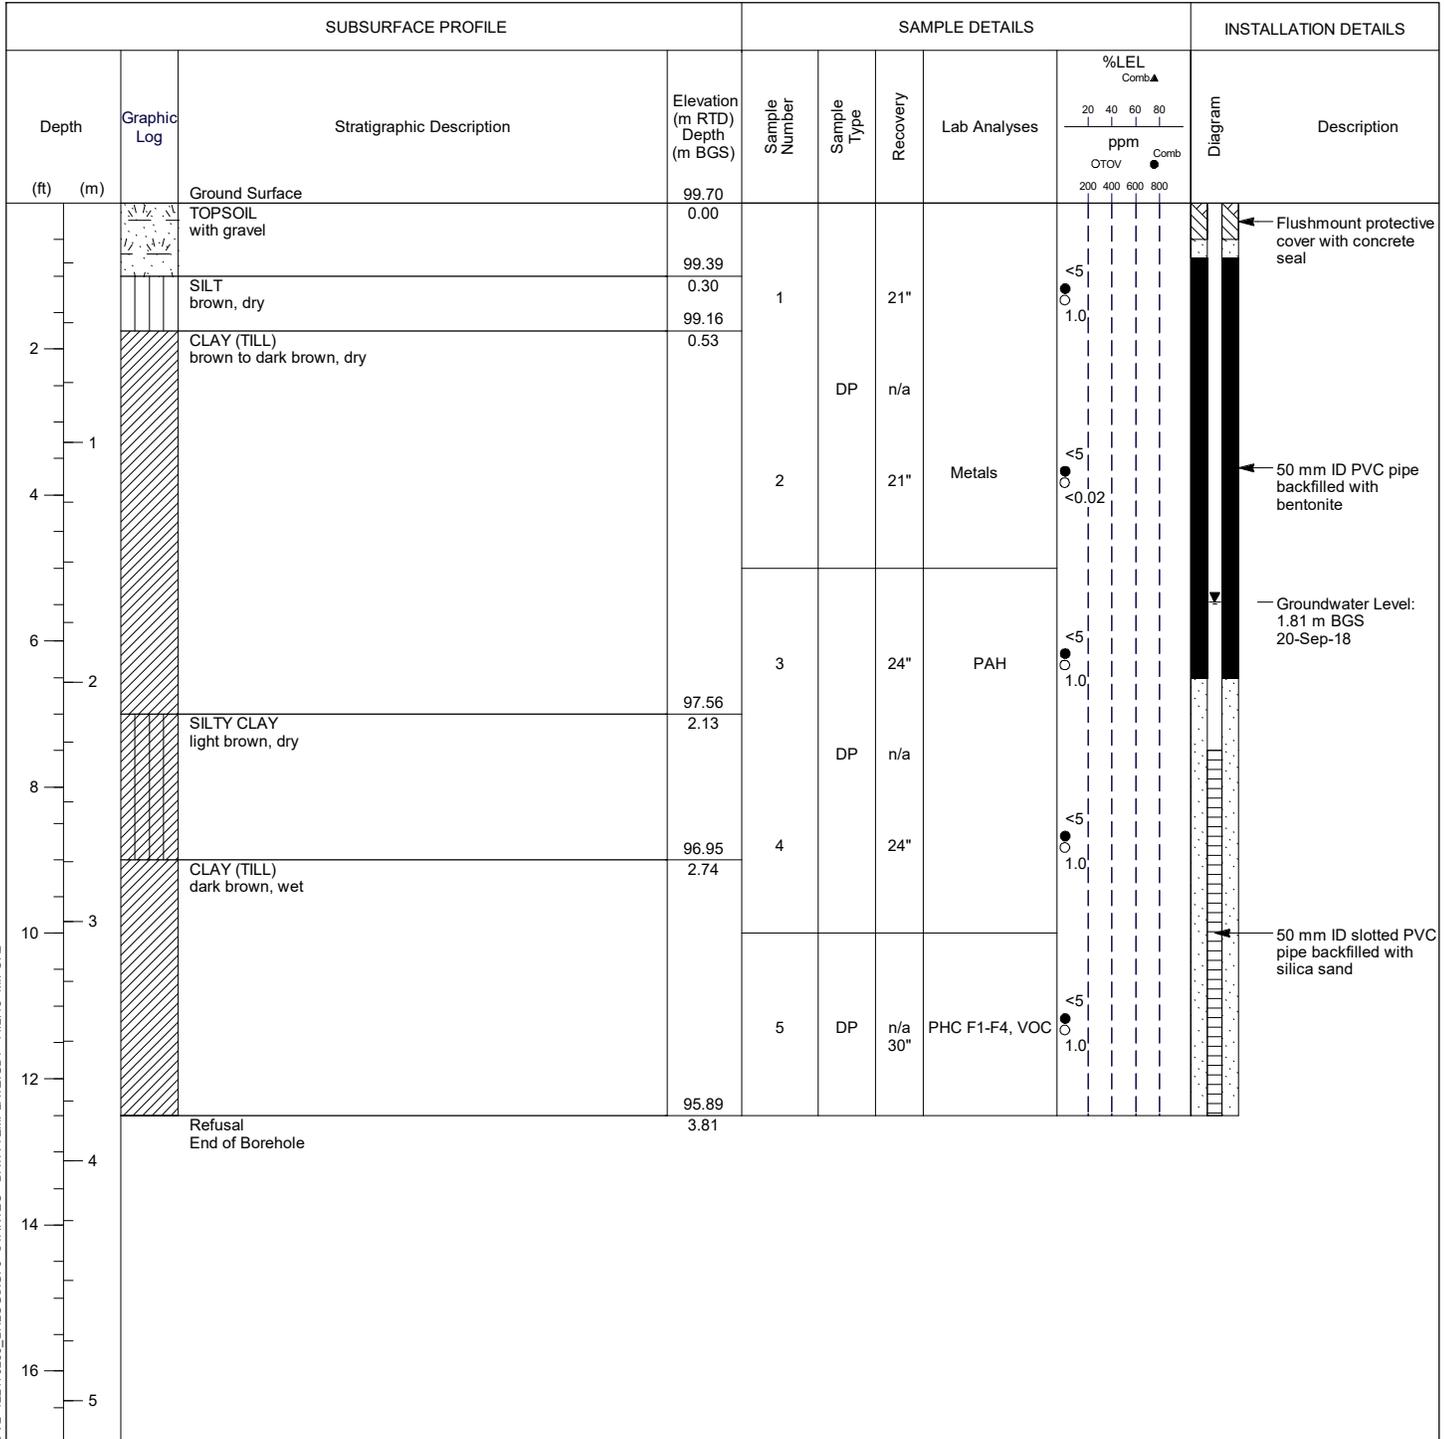
Drilling method: Geoprobe 7822DT (Direct Push)
Date started/completed: 13-Sep-2018
Ground surface elevation: 99.70 m RTD
Top of casing elevation: 99.56 m RTD
Easting: 5030061
Northing: 450263

Screen Interval: 2.29 - 3.81 m BGS
 Sand Pack Interval: 1.98 - 3.81 m BGS
 Well Seal Interval: 0.23 - 1.98 m BGS

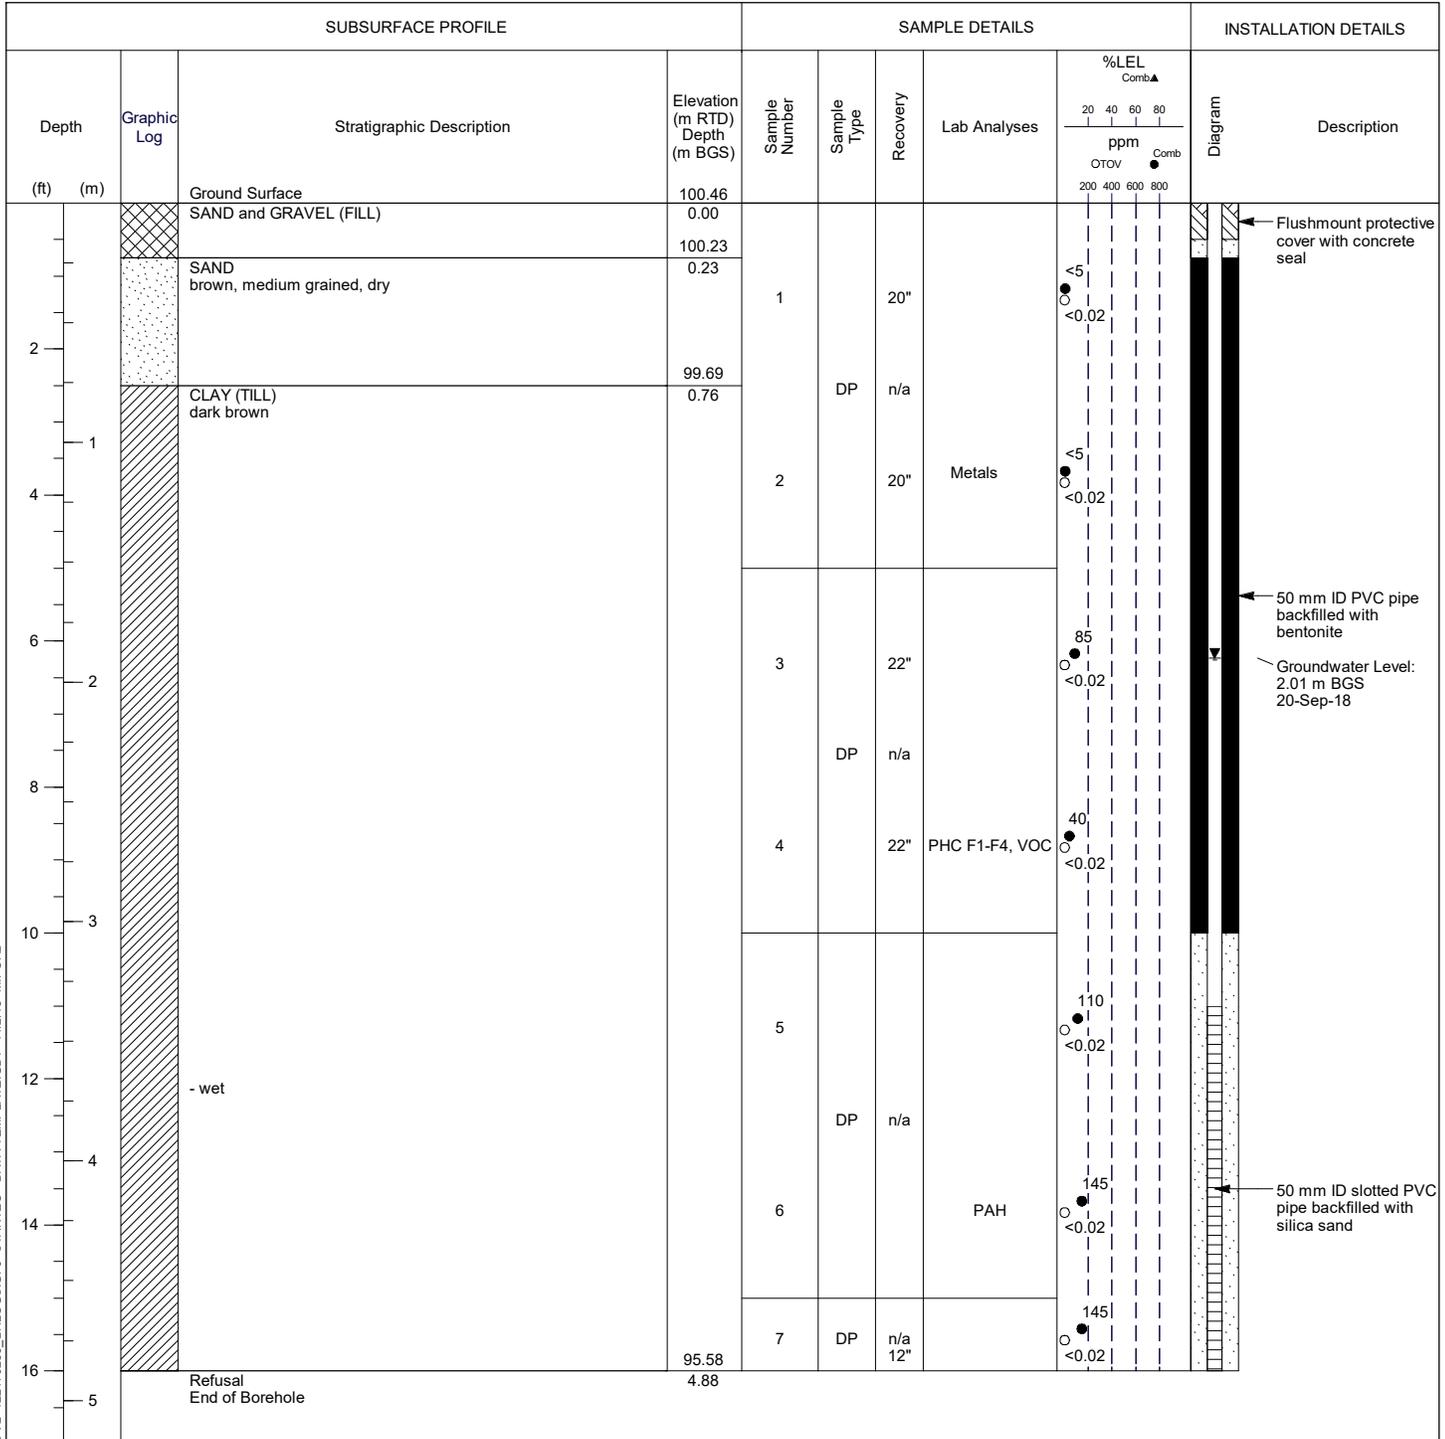
Drilling method: Geoprobe 7822DT (Direct Push)
Date started/completed: 13-Sep-2018
Ground surface elevation: 100.46 m RTD
Top of casing elevation: 100.35 m RTD
Easting: 5030026
Northing: 450291

Screen Interval: 3.35 - 4.88 m BGS
 Sand Pack Interval: 3.05 - 4.88 m BGS
 Well Seal Interval: 0.23 - 3.05 m BGS

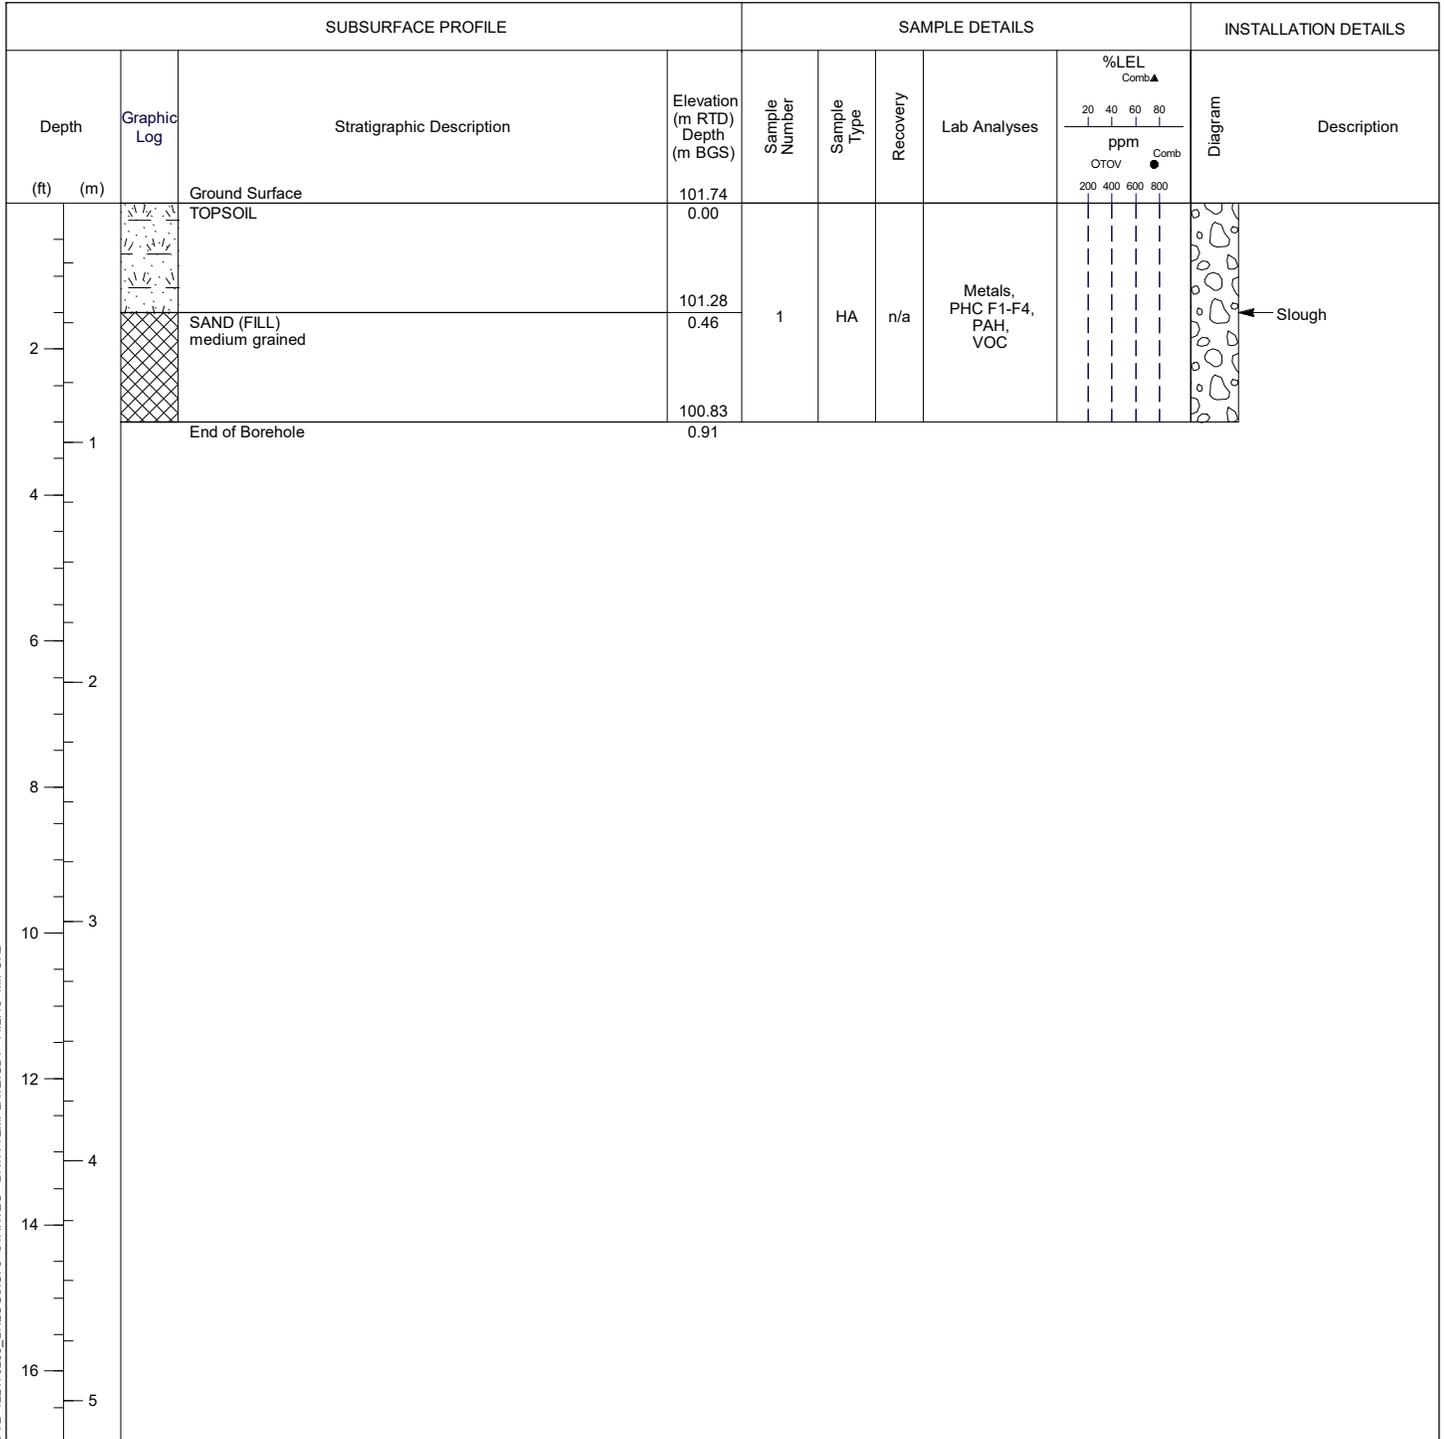
Drilling method: Hand Auger
Date started/completed: 13-Sep-2018
Ground surface elevation: 101.74 m RTD
Top of casing elevation: n/a
Easting: n/a
Northing: n/a

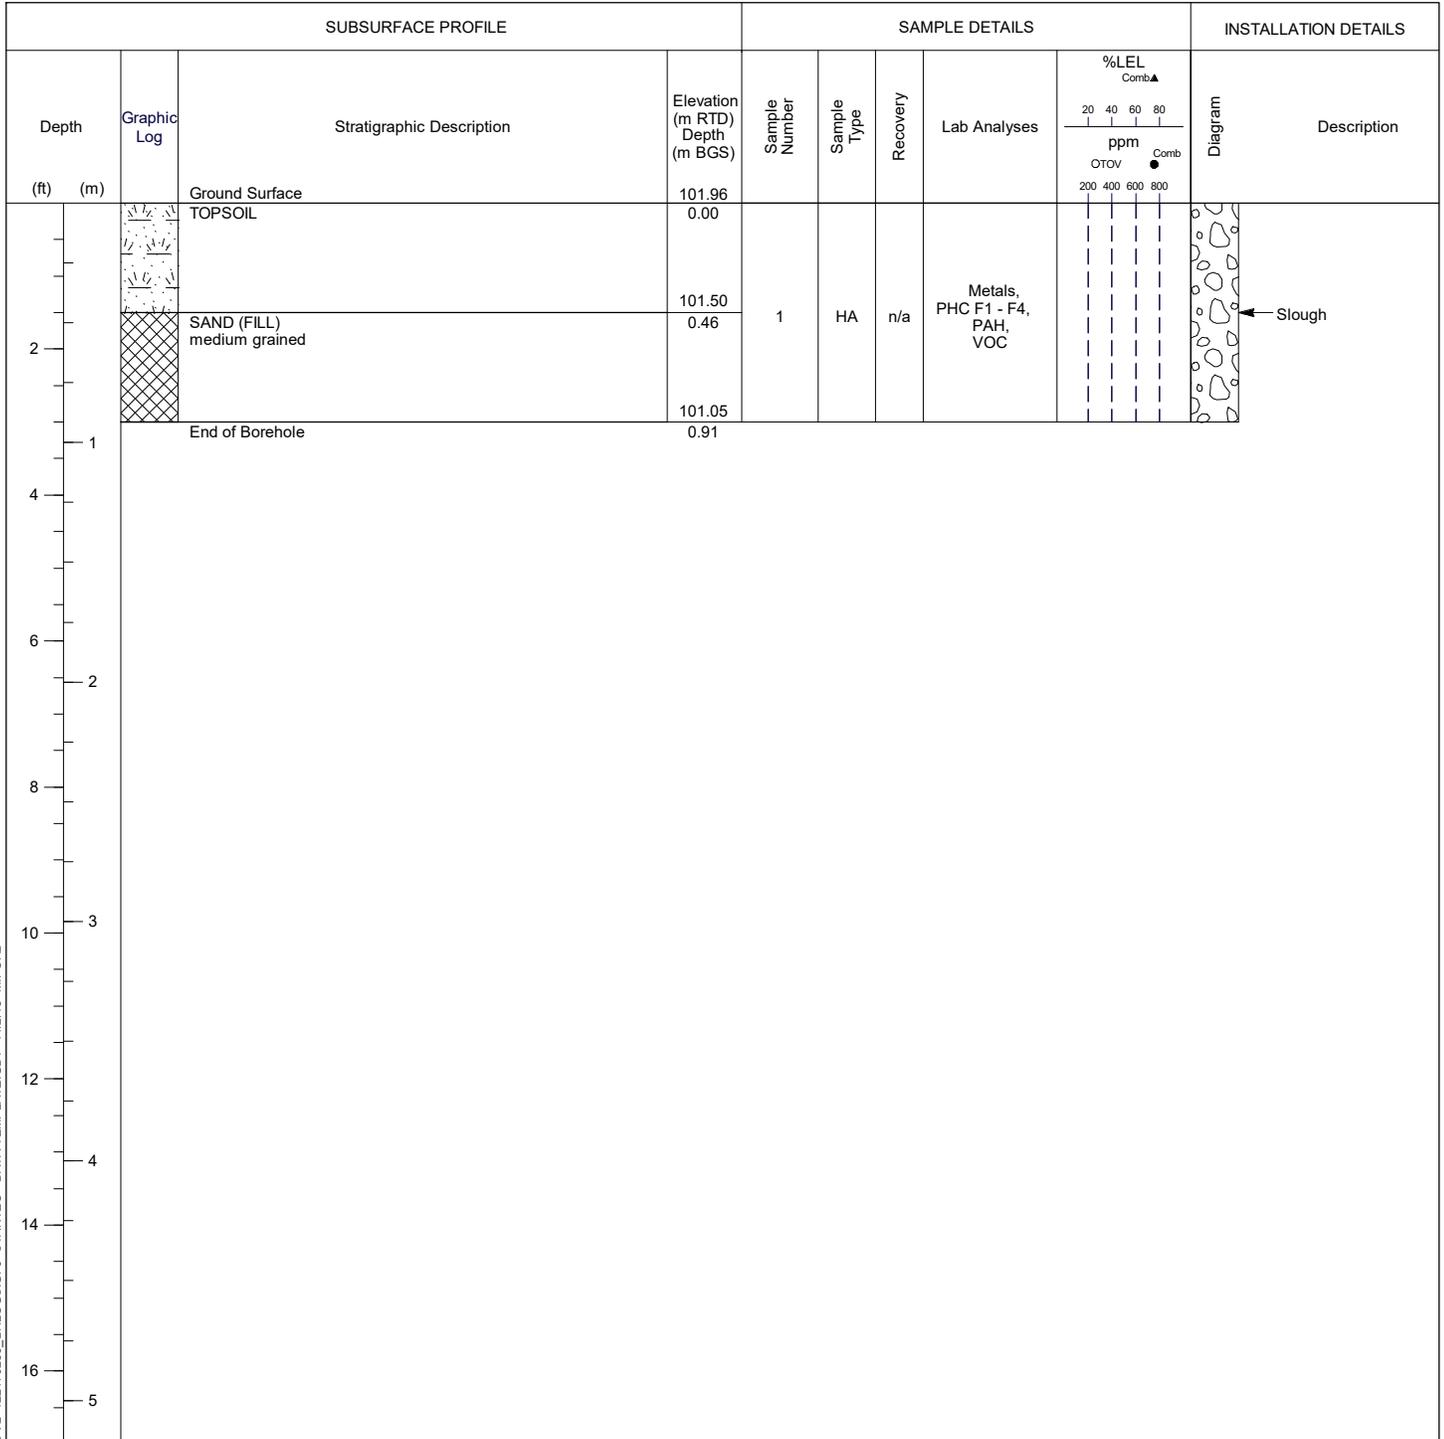
Drilling method: Hand Auger
Date started/completed: 13-Sep-2018
Ground surface elevation: 101.96 m RTD
Top of casing elevation: n/a
Easting: n/a
Northing: n/a

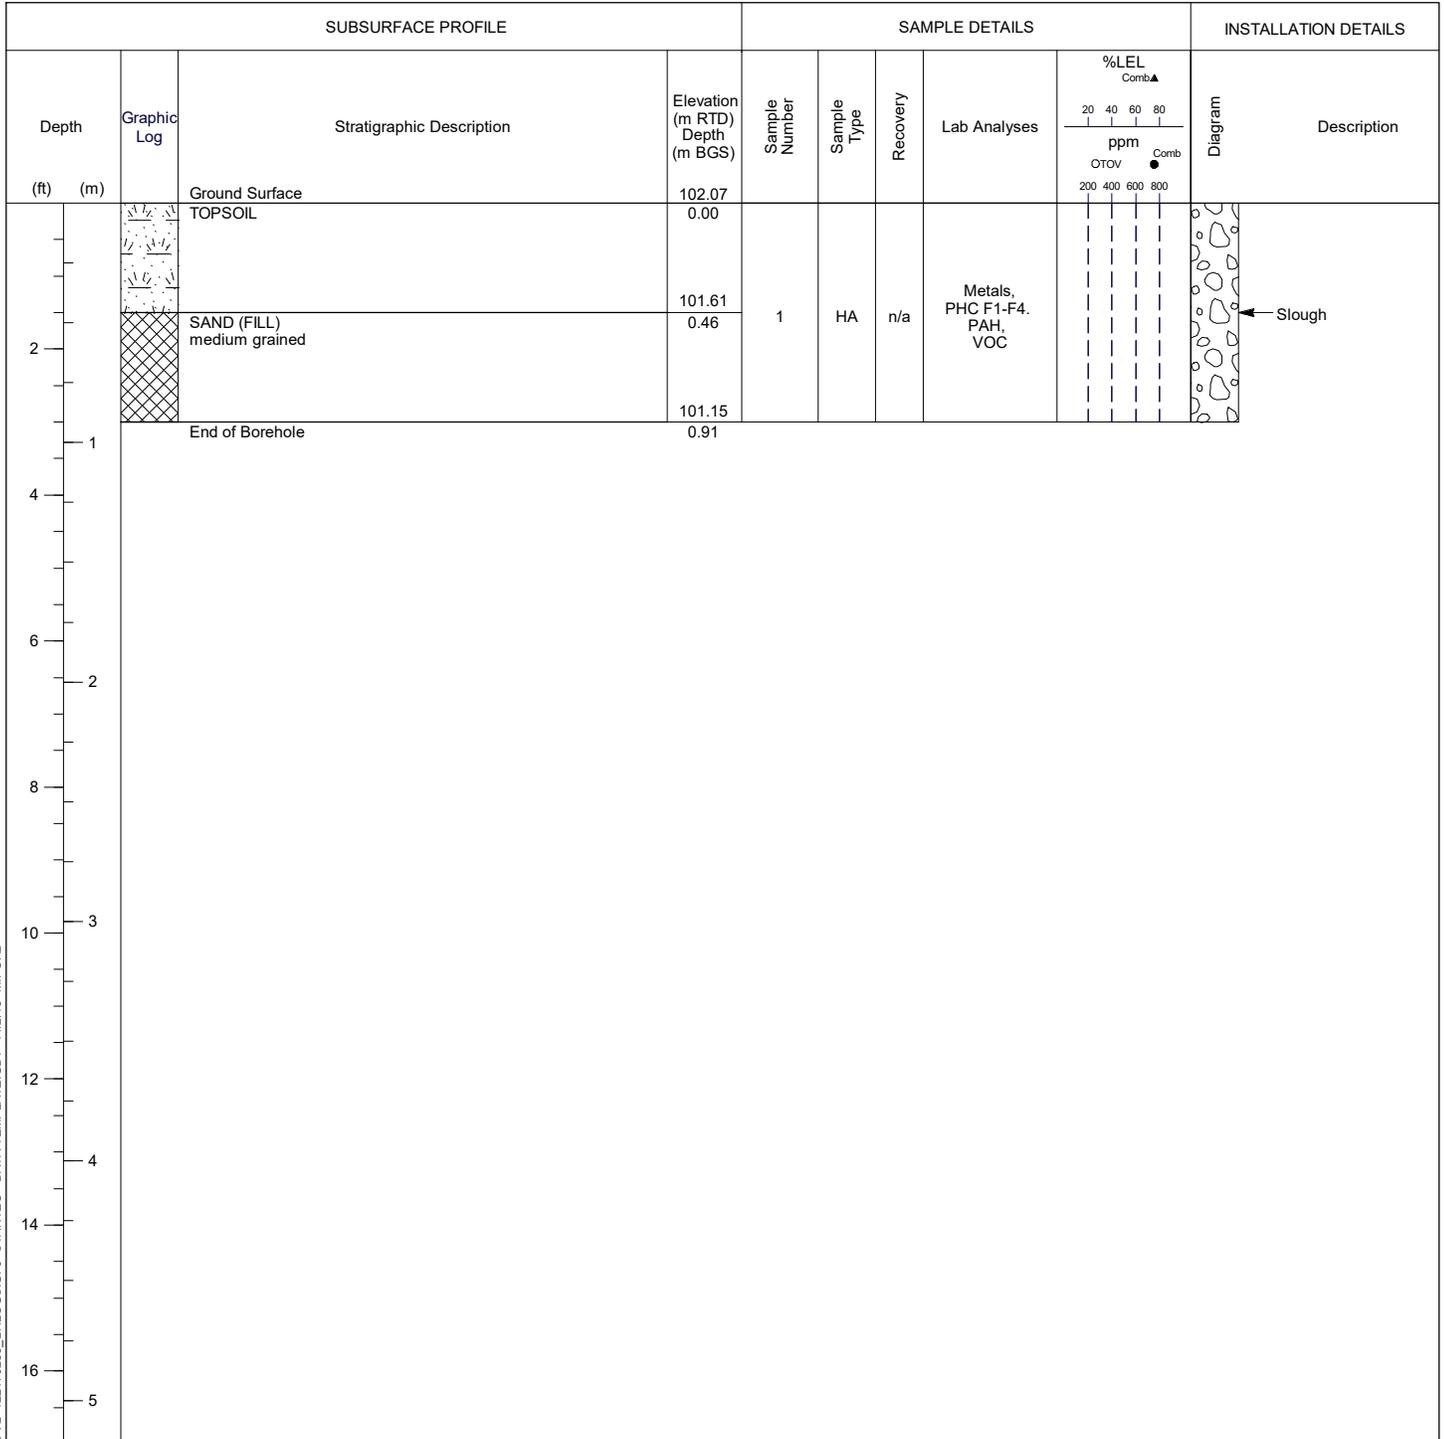
Drilling method: Hand Auger
Date started/completed: 13-Sep-2018
Ground surface elevation: 102.07 m RTD
Top of casing elevation: n/a
Easting: n/a
Northing: n/a

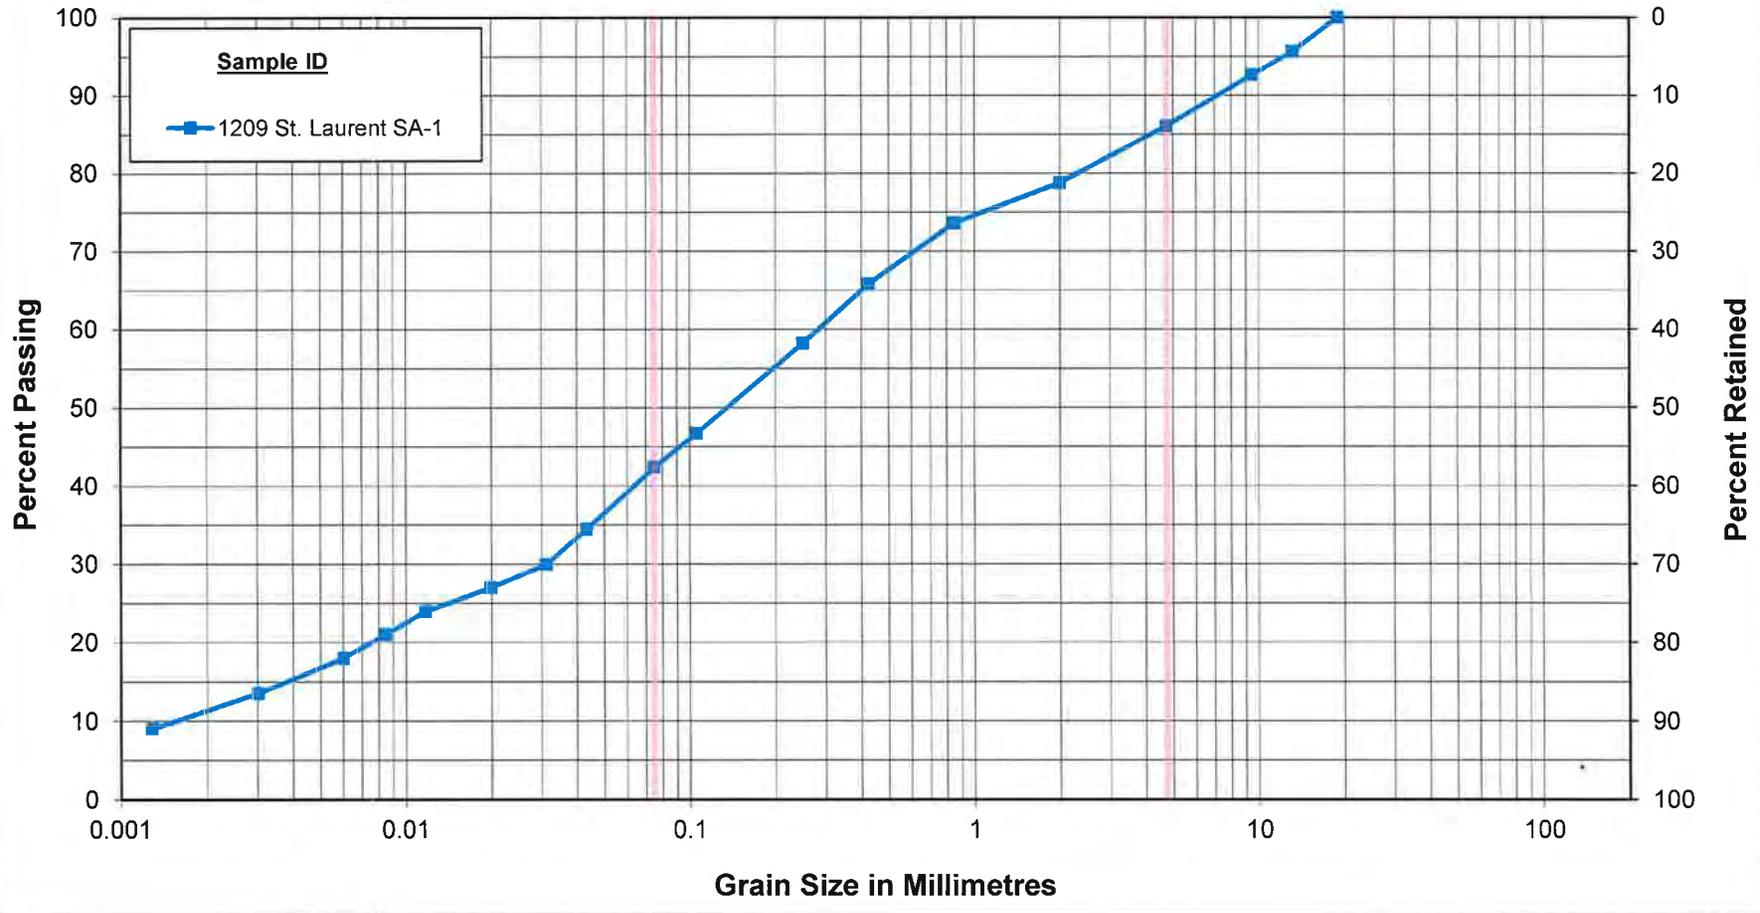
GRAIN SIZE DISTRIBUTION

U.S. Std. Sieve No. 200 100 50 30 16 8 4
