Phase One Environmental Site Assessment

1209 St. Laurent Boulevard & 1200 Lemieux
Street, Ottawa, Ontario

Canderel Management Inc. & Fengate Development
Holdings

January 10, 2022

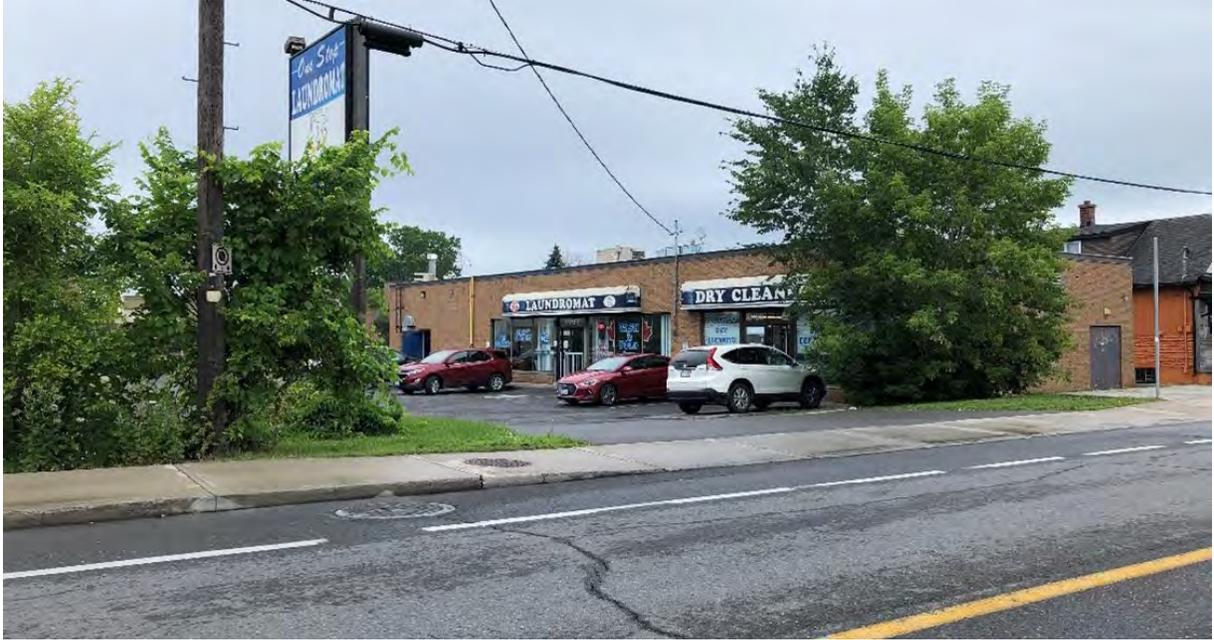
Photo 7 View of Dry Cleaner north of Cyrville Road (surrounding property), facing northeast.

- Stantec previously identified an APEC described as Bonnie's Cleaners (potential operation of dry cleaning equipment) formerly located at 1181 and 1187 St. Laurent Boulevard on the adjacent strip mall property to the north, based on City of Ottawa land use inventory and being registered as a hazardous waste generator between 1988 and 1998 for halogenated solvents (company described as soap/cleaning, as well as laundries/cleaners facility). Stantec conducted a Phase II ESA in which all "measured concentrations of COPCs [contaminants of potential concern] were below applicable Ontario Table 3 standards" in soil and groundwater samples submitted for laboratory analysis. No environmental soil or groundwater testing was conducted by Pinchin for either Phase One Property parcels. Due to no soil/groundwater data collected on the 1200 Lemieux Street property, as well as age of soil/groundwater data collected by Stantec, GHD has identified the adjacent former potential dry cleaners as a PCA (#37 – Operation of Dry Cleaning Equipment) as defined in O. Reg. 153/04, and the northern portion of the Site was identified as APEC (**APEC #2**).
