# PHASE ONE ENVIRONMENTAL SITE ASSESSMENT

2020 BANTREE STREET, OTTAWA, ONTARIO

Date: March 30, 2022 Project #: 11556-01

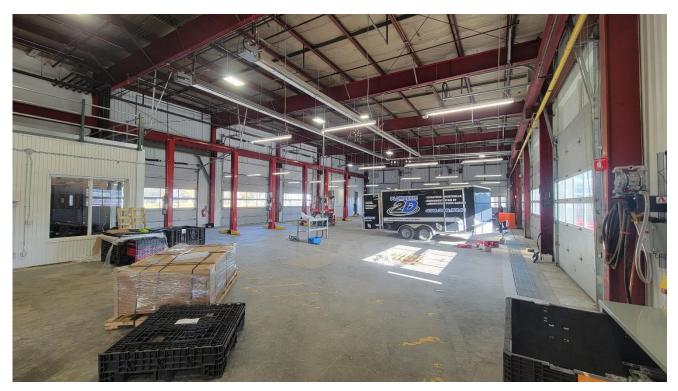
Photo 1: Facing Northeast, northeast corner of the Site, this section of the Site had been renewly renovated. Four aboveground Hydraulic Hoists can be seen in the background.

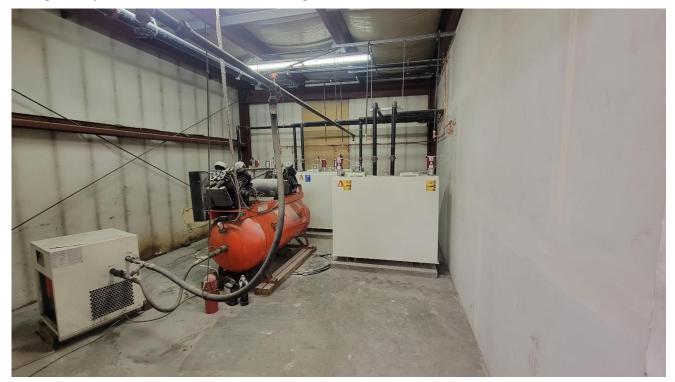
Photo 2: Facing Northeast, second floor northeast corner of the Site building. Three 2200L Active ASTs containg engine oil along with a compressor present.

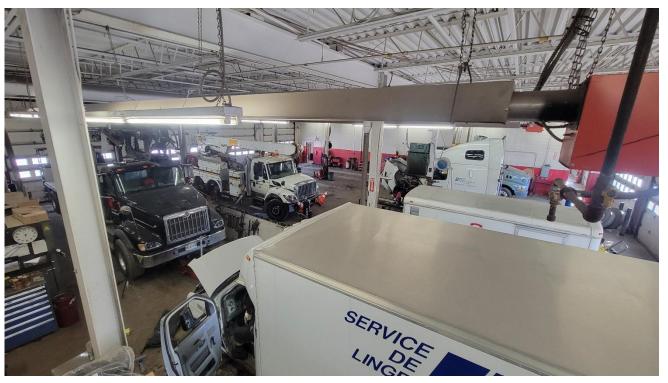
Photo 3:Facing northwest, heavy trucks service bay area located at the west side of the building

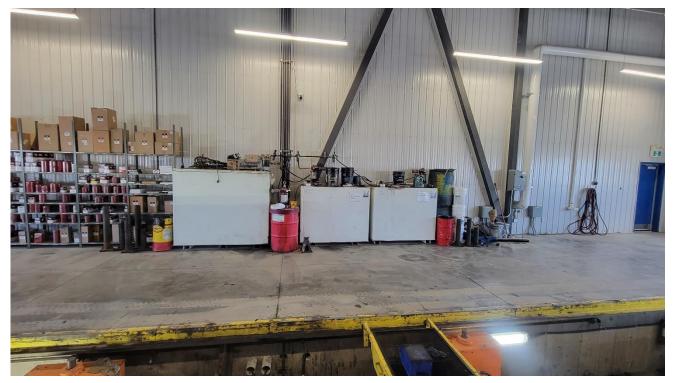
Photo 4: Facing south, three active ASTs containing engine oils present at the southwest corner of the building.

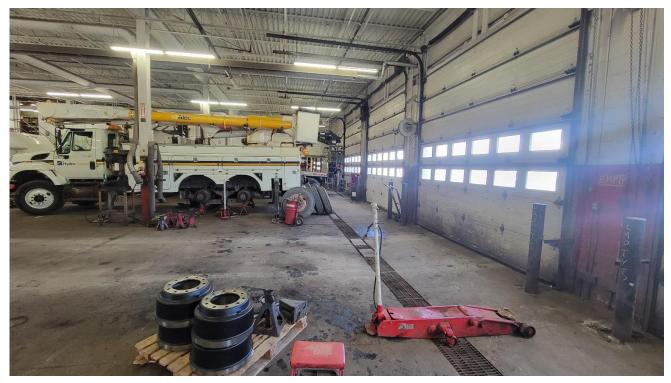
Photo 5: Facing south, moderate levels of oil stains observed on the concrete floor, floor drains leading to an Oil Water Separator present along the western portion of the building.

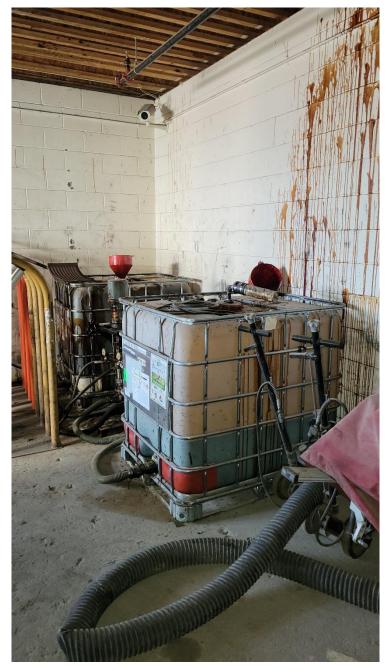
Photo 6: Facing northwest, two 275 Gal totes containg Hydraulic Fluid present, staining present on the totes and the neighbouring wall.

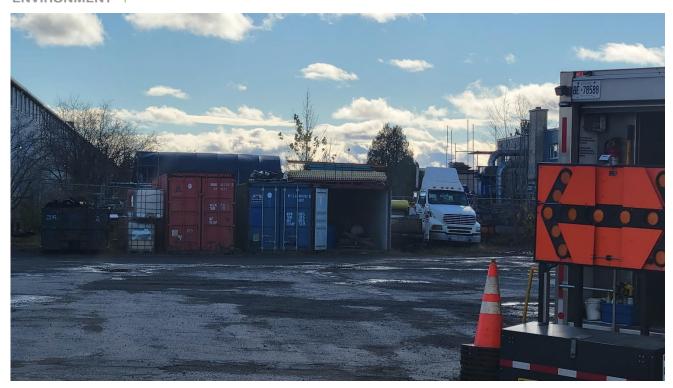
Photo 7: Facing south, southern perimeter of the Site used for storage and parking.
