PHASE ONE ENVIRONMENTAL SITE ASSESSMENT 78 ROSEMOUNT AVENUE, OTTAWA, ONTARIO

Project No.: CCO-22-1129

78 Rosemount Avenue Inc.
33 Douglas Street
Ottawa, ON
K1M 1G3

McIntosh Perry Consulting Engineers Ltd.
115 Walgreen Road, RR3
Carp, ON
K0A 1L0

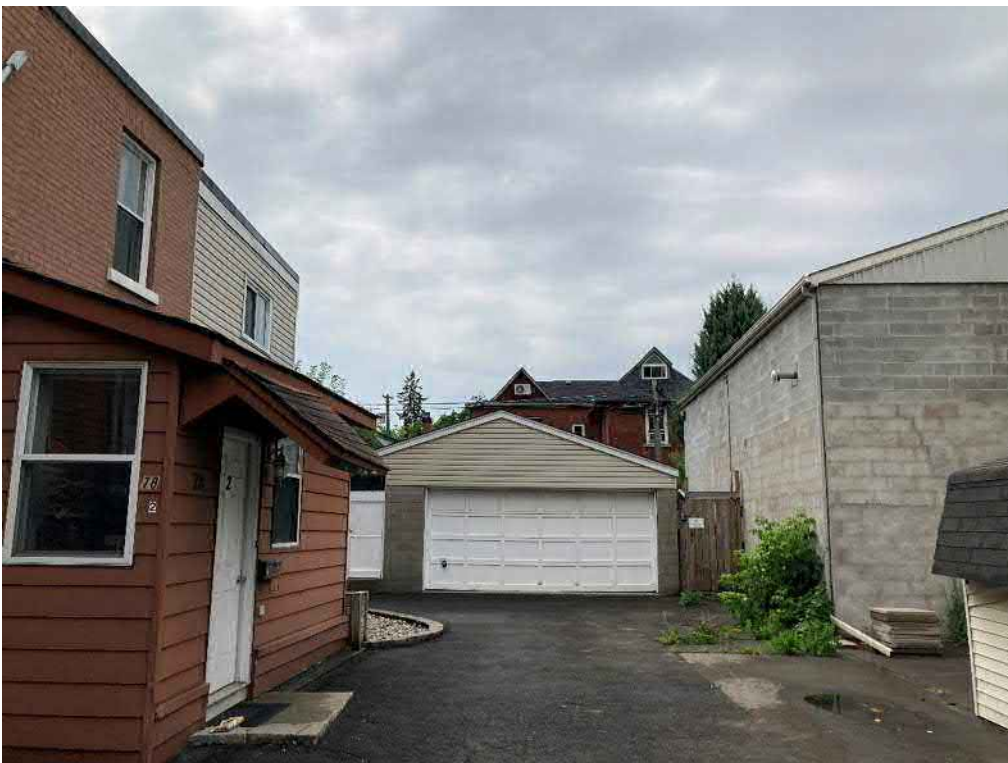
Photo 2: View of the side entrance to the building on the northside of the Site, the driveway, as well as the garage on the northwest corner of the Site.

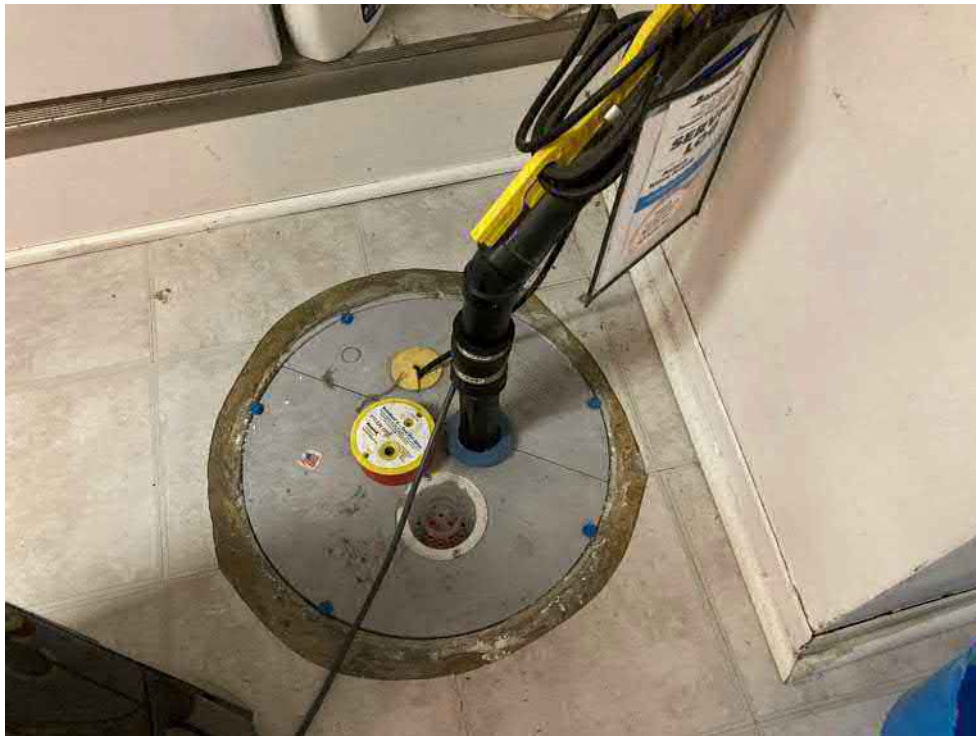
A sump pump was observed in the laundry room, located in the basement of the building.

Photo 5: View of the sump pump located in the laundry room of the basement.

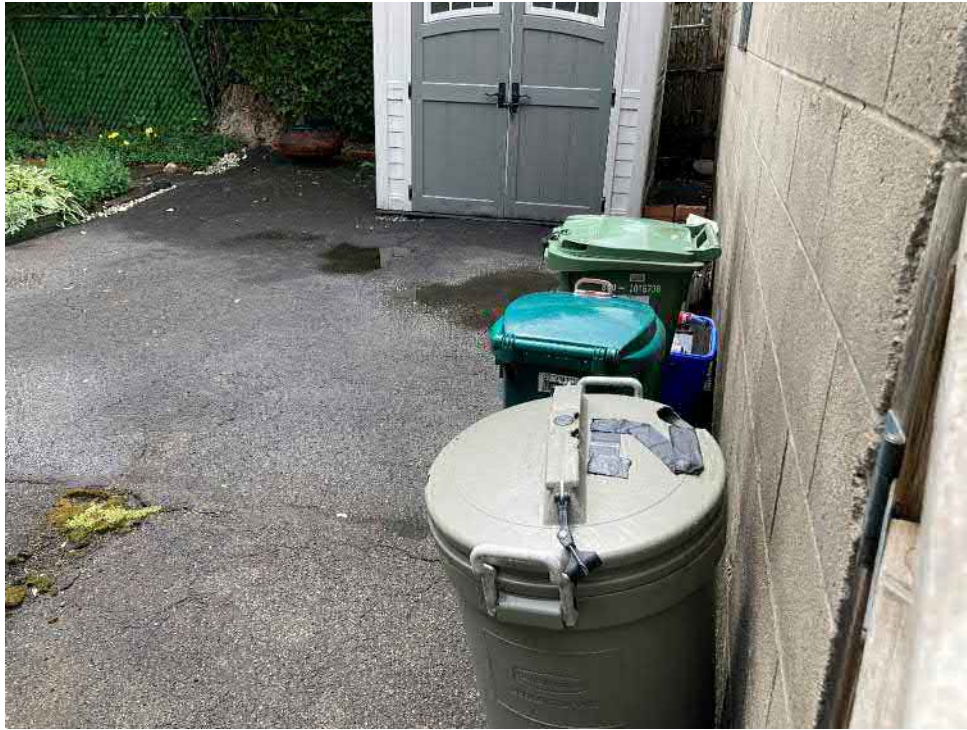
Photo 15: View of garbage and recycling being stored outside the garage.

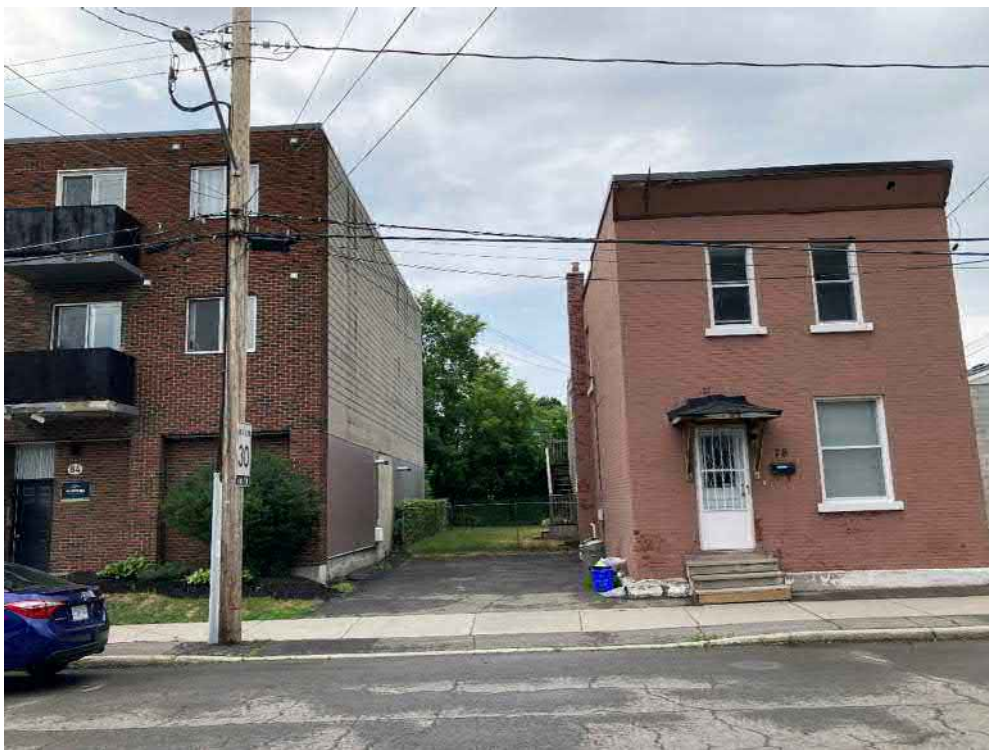
Photo 16: View of powerlines running along Rosemount Avenue.

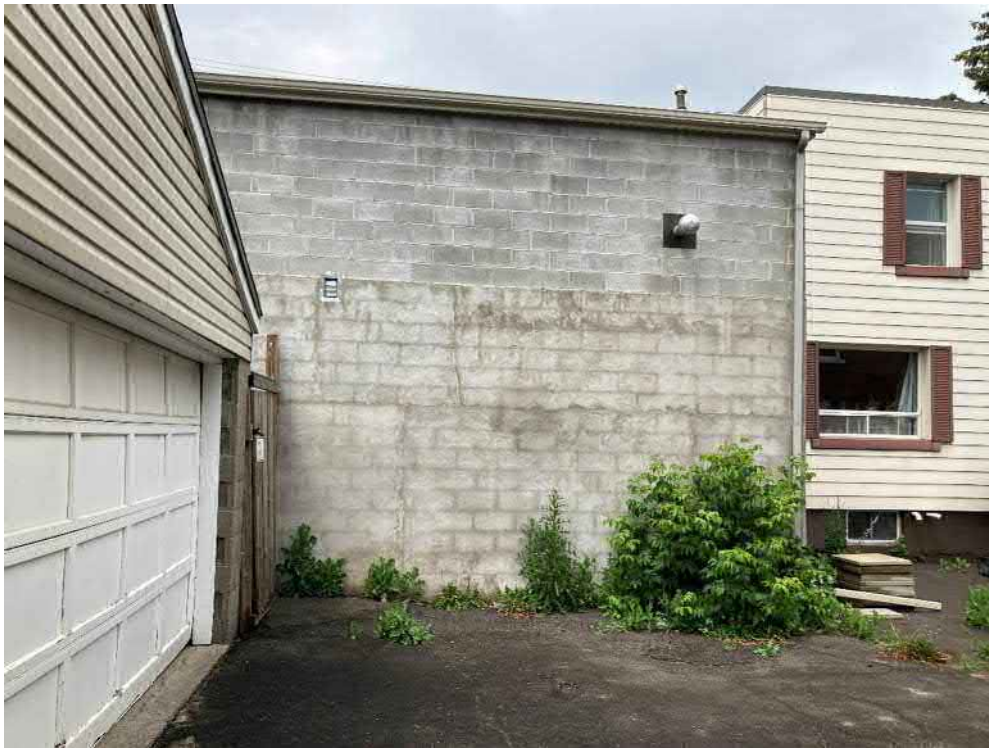
The auto repair garage (Jim Dickinson Auto Tech) located immediately north of the Site is considered to be a PCA due to the nature of the automotive business and the proximity to the Site, and represents and APEC in relation the Site.

Photo 17: View of the south side of the off-Site garage, located north of the Site.

Based on the findings of this Phase One ESA, a Phase Two ESA is recommended at the Phase One Property.
