Phase One Environmental Site Assessment

4840 Bank Street, Ottawa, Ontario

20142688

May 2022

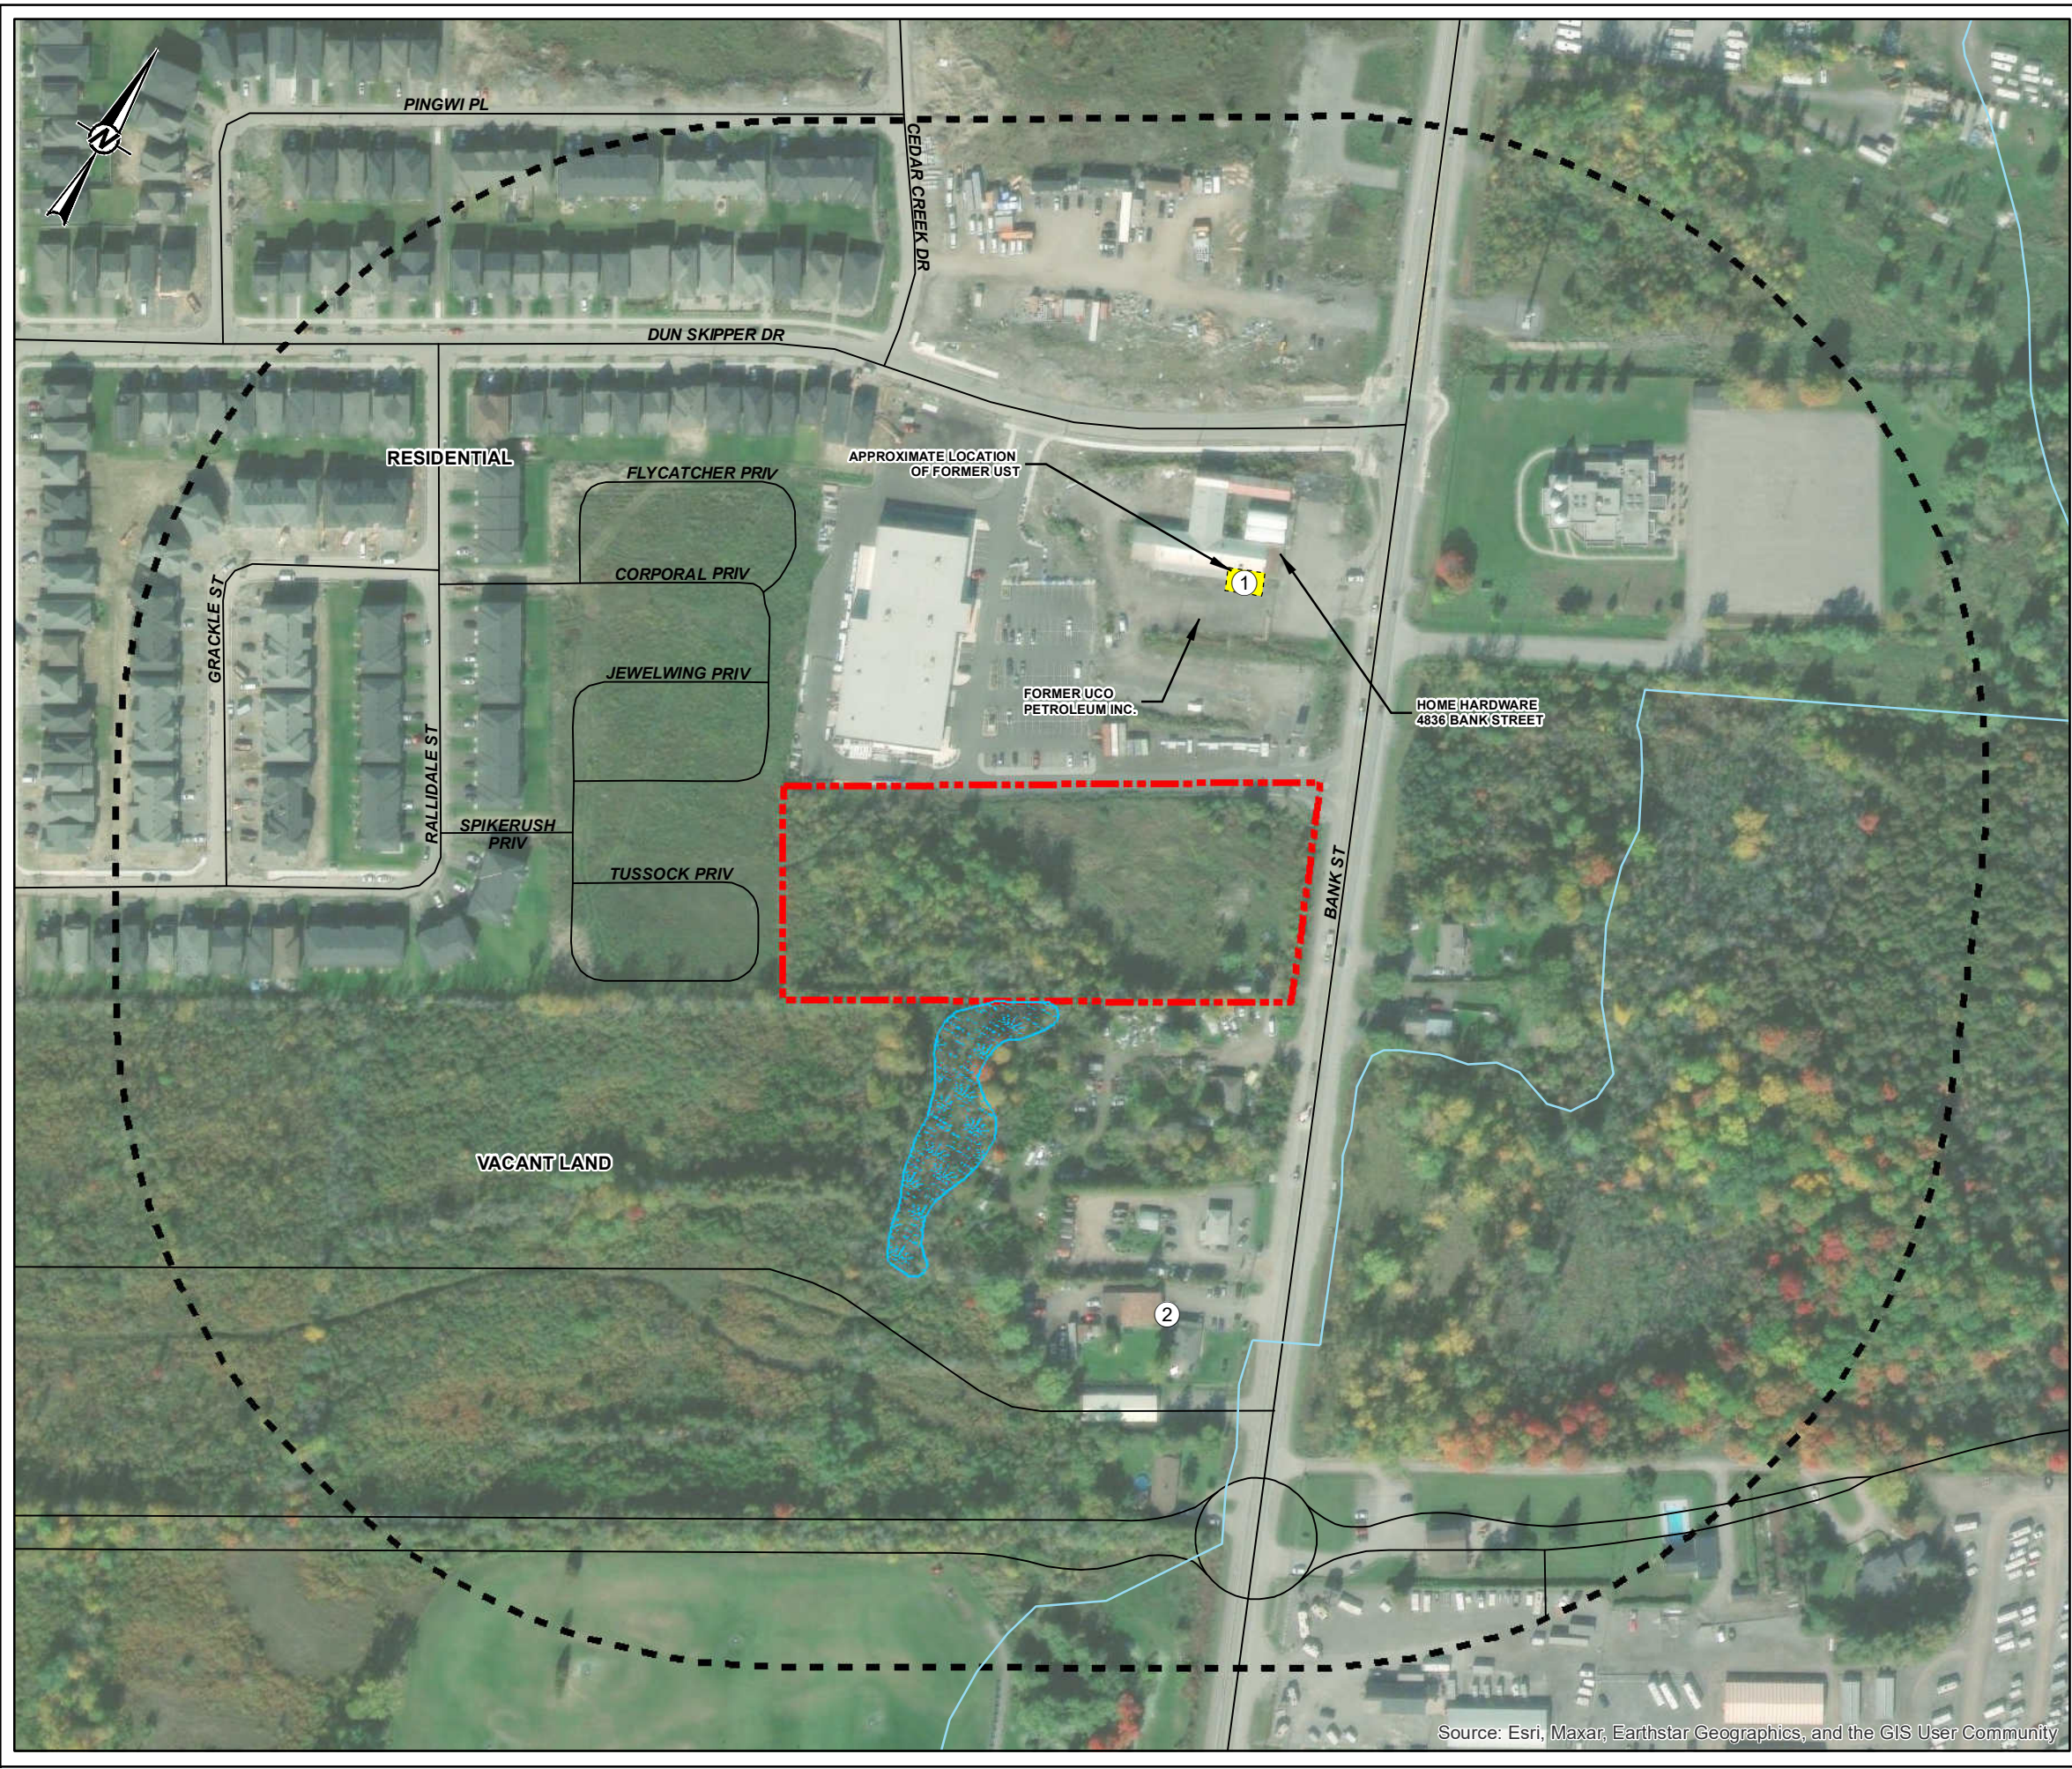
Based on the information collected as part of this Phase One ESA, two PCAs were identified, a former UST at 4836 Bank Street and an autobody shop at 4856 Bank Street, but neither represented an APEC to the Site. A Phase Two ESA is not recommended to be carried out at the Site.

- ① PCA #28: GASOLINE AND ASSOCIATED PRODUCTS STORAGE IN FIXED TANKS, 4836 BANK STREET
- ② PCA #10: COMMERCIAL AUTOBODY SHOPS (JORDAN AUTOSERVICE), 4856 BANK STREET
- ROADWAY
- WATERCOURSE
- WETLAND
- PHASE ONE SITE
- PHASE ONE STUDY AREA (250 m)

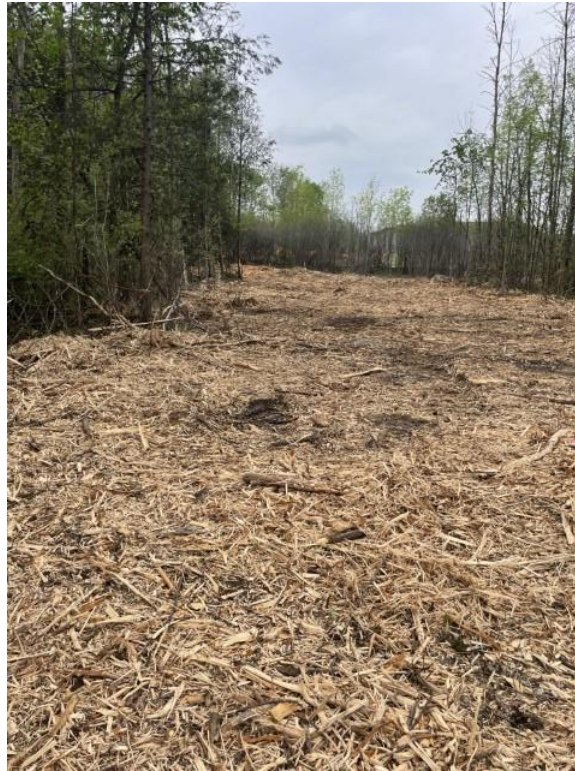
Photo A: clear cutting

At the time of the Site visit on May 16, 2022, the Site was vacant land overgrown with trees and vegetation. Some clear cutting had been done to accommodate the initial stages of development including surveying and the installation of geotechnical boreholes.

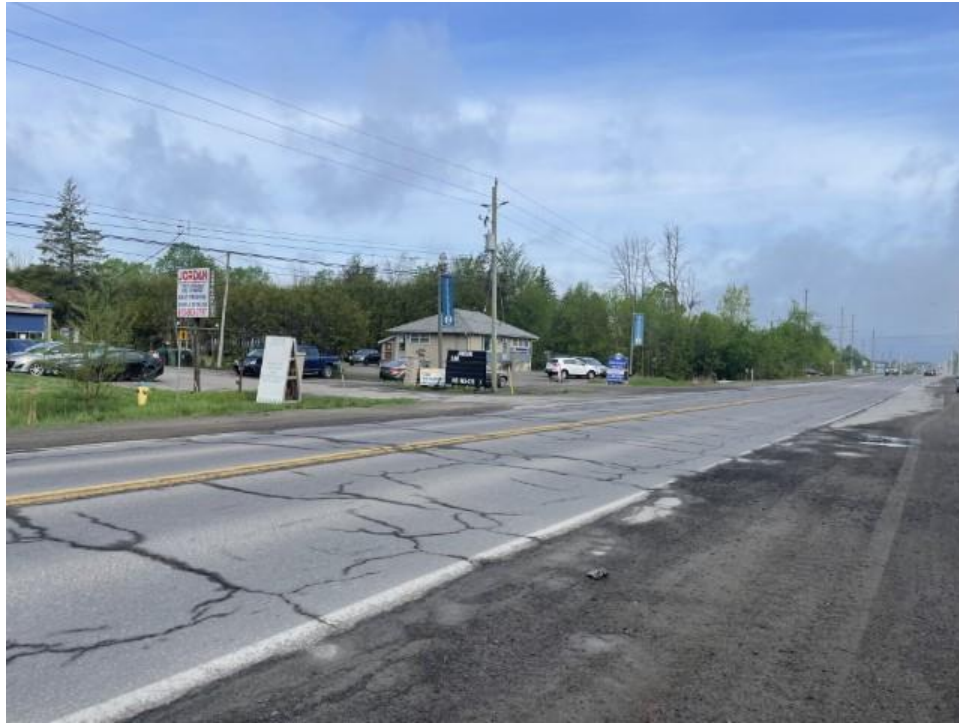
Photo E: Autobody shops

Generally, the surrounding lands are forested undeveloped lands with a few commercial and residential buildings along Bank Street. The PCA - Auto Sales, Auto Parts and Services is located approximately 150 m south of the Site and during the Site visit it was noted that this address is occupied by a residential house with a small garage probably used for car and auto-parts sales and some auto repairs. Given the small scale of this facility, the distance between the Site and Auto Sales, Auto Parts and Services, and that the Site is buffered by land and other properties in between, it is considered that the potential for subsurface impacts to the Site is limited. As such, the presence of this PCA is not considered to have resulted in an APEC to the Site.
