# Phase Two Environmental Site Assessment

125 Colonnade Road,  
Ottawa, Ontario

**Access Property  
Development Inc.**

March 31, 2022

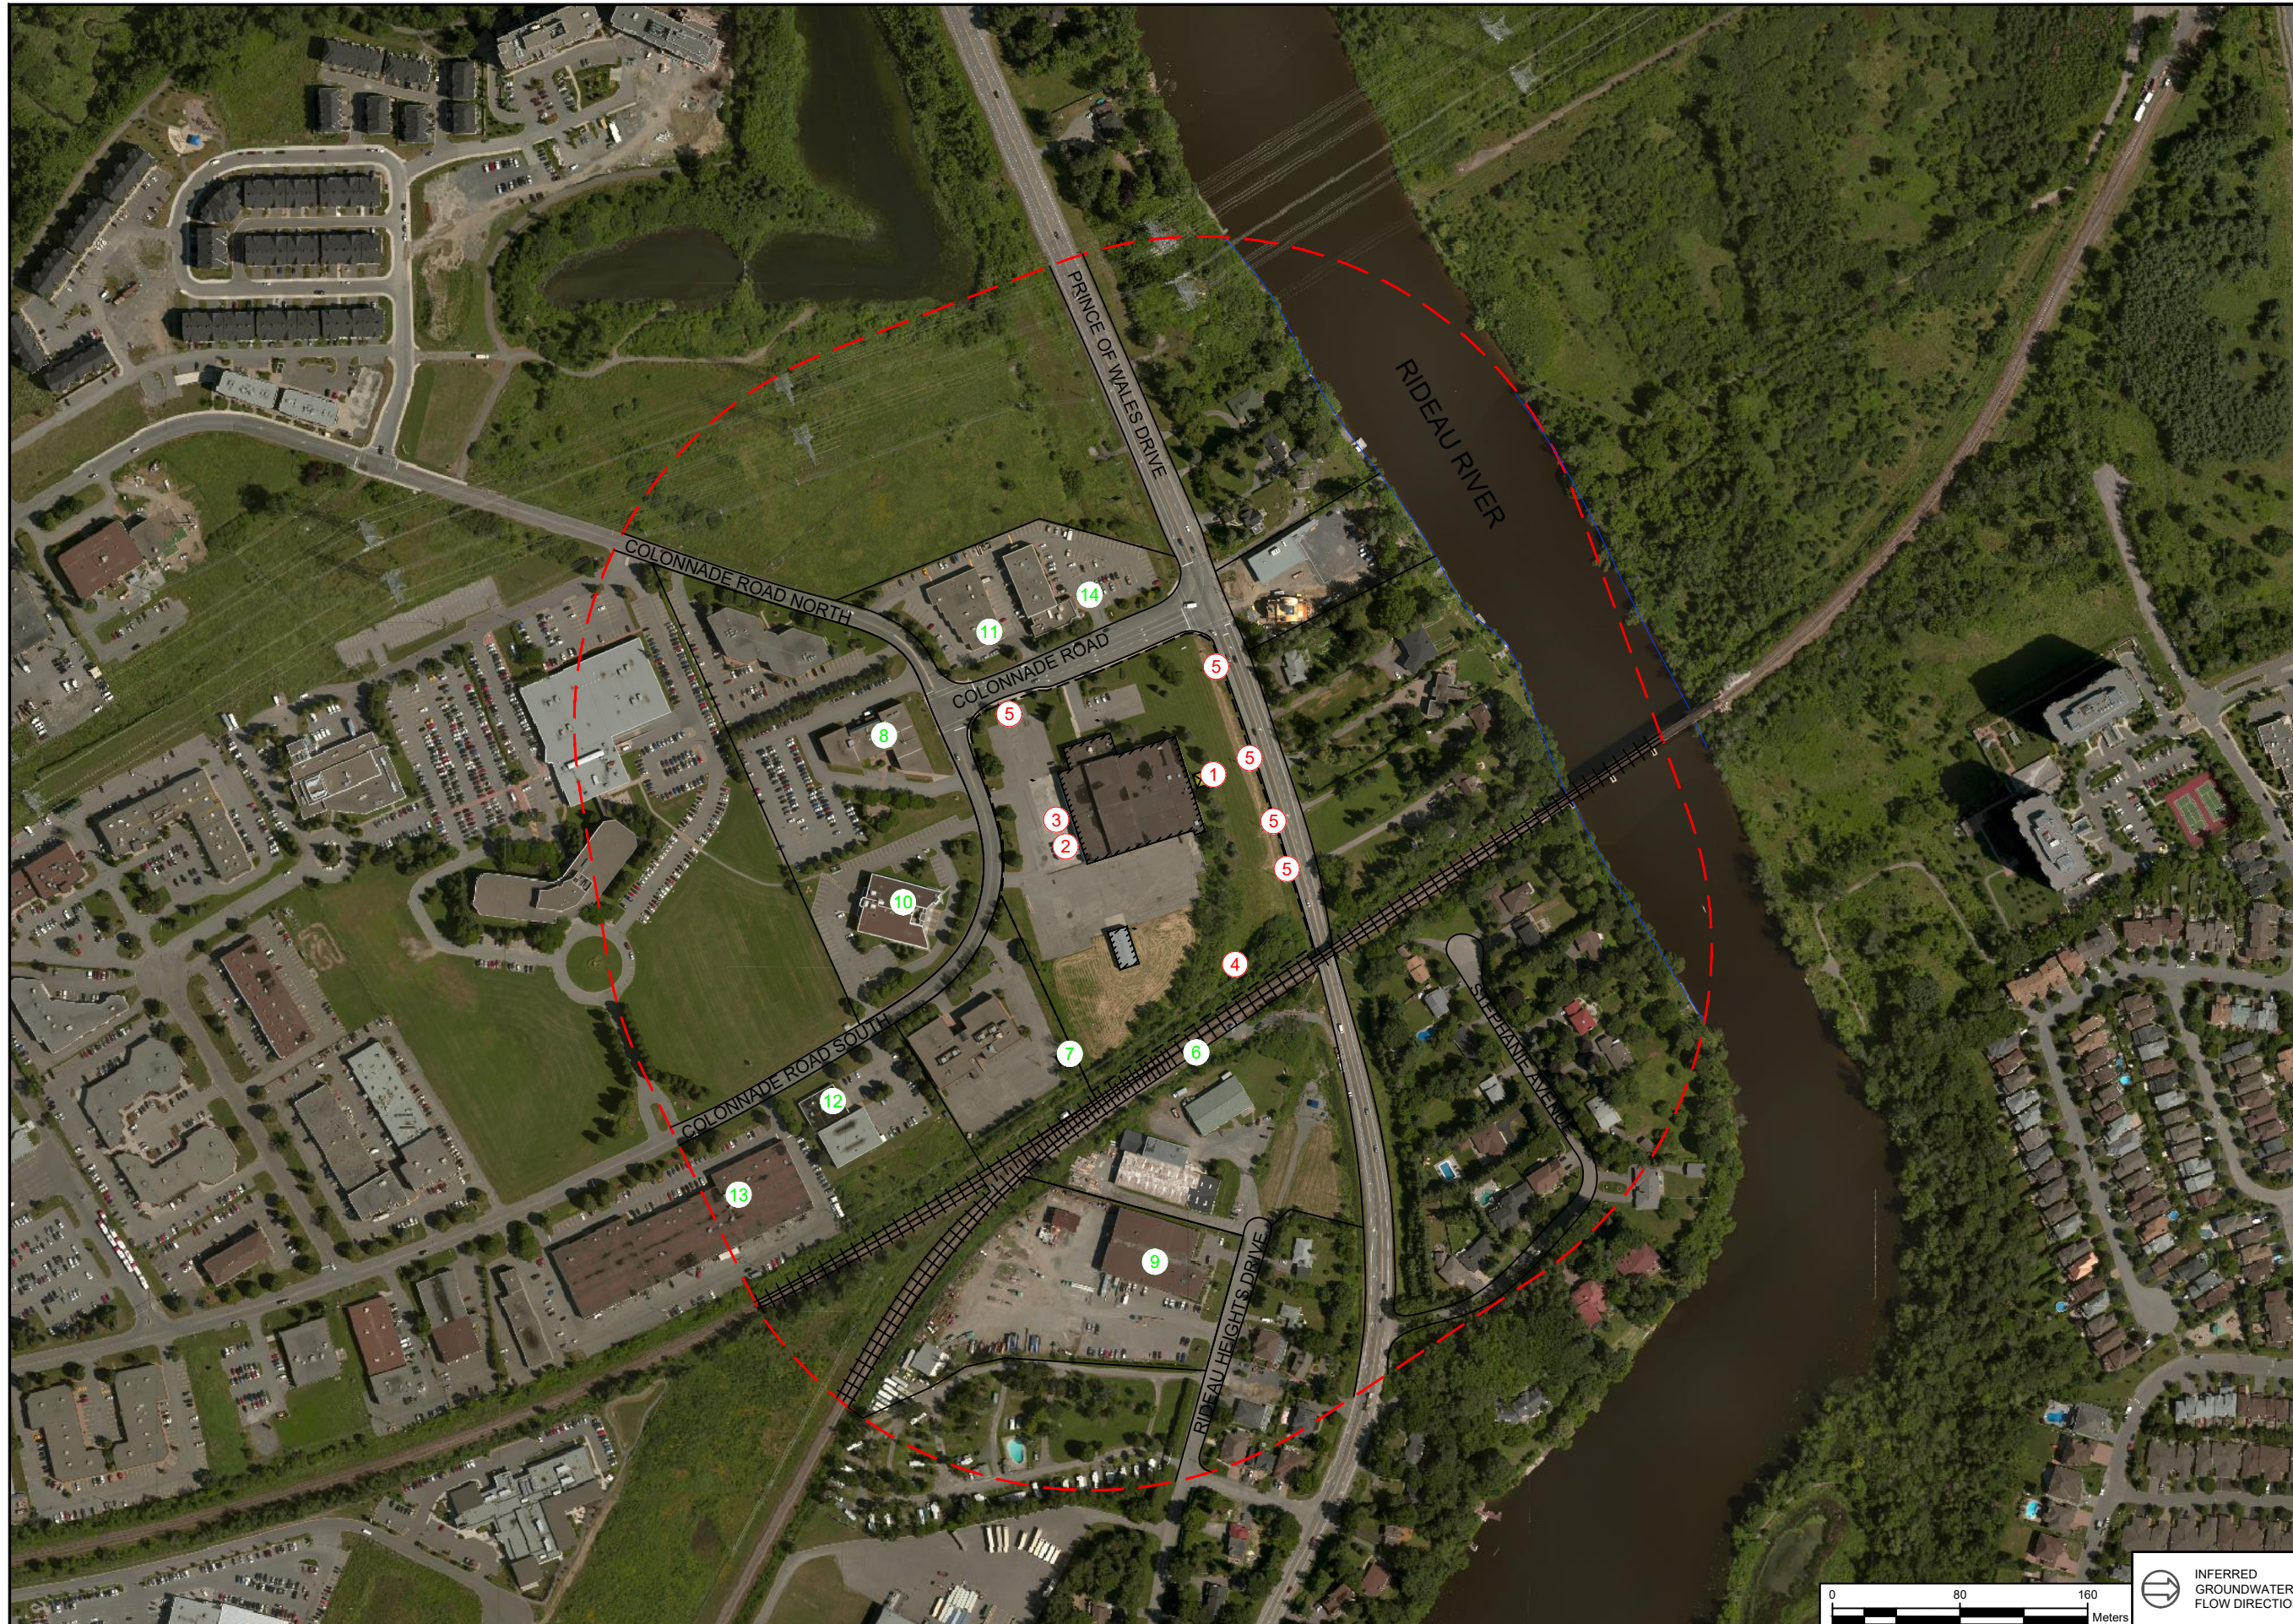
- LEGEND**
- PHASE ONE PROPERTY BOUNDARY
  - PHASE ONE STUDY AREA
  - ▨ SITE BUILDING
  - PCA POTENTIALLY CONTAMINATING ACTIVITY
  - # PCA OFF-SITE
  - # PCA ON-SITE

- PCA #1 (Item 18: Electricity Generation, Transformation and Power Stations) – Transformer substation is located east of Site Building A. Oil staining was observed on the concrete slab for the transformer substation located east of Site Building A. The concrete in the area of oil staining was observed to have minor cracking and the oil staining is considered to represent a PCA for the Phase One Property and is considered an APEC.

- PCA #4 (Item 46 – Rail Yards, Tracks and Spurs) - During the Site reconnaissance, Pinchin observed one railway spur line located along the south elevation of the Phase One Property, is a PCA and represents an environmental concern for the Phase One Property that is considered an APEC for the Phase One Property; and
