**Phase I-Environmental Site Assessment**

50 The Driveway  
Ottawa, Ontario

July 9, 2021

Report: PE5340-1

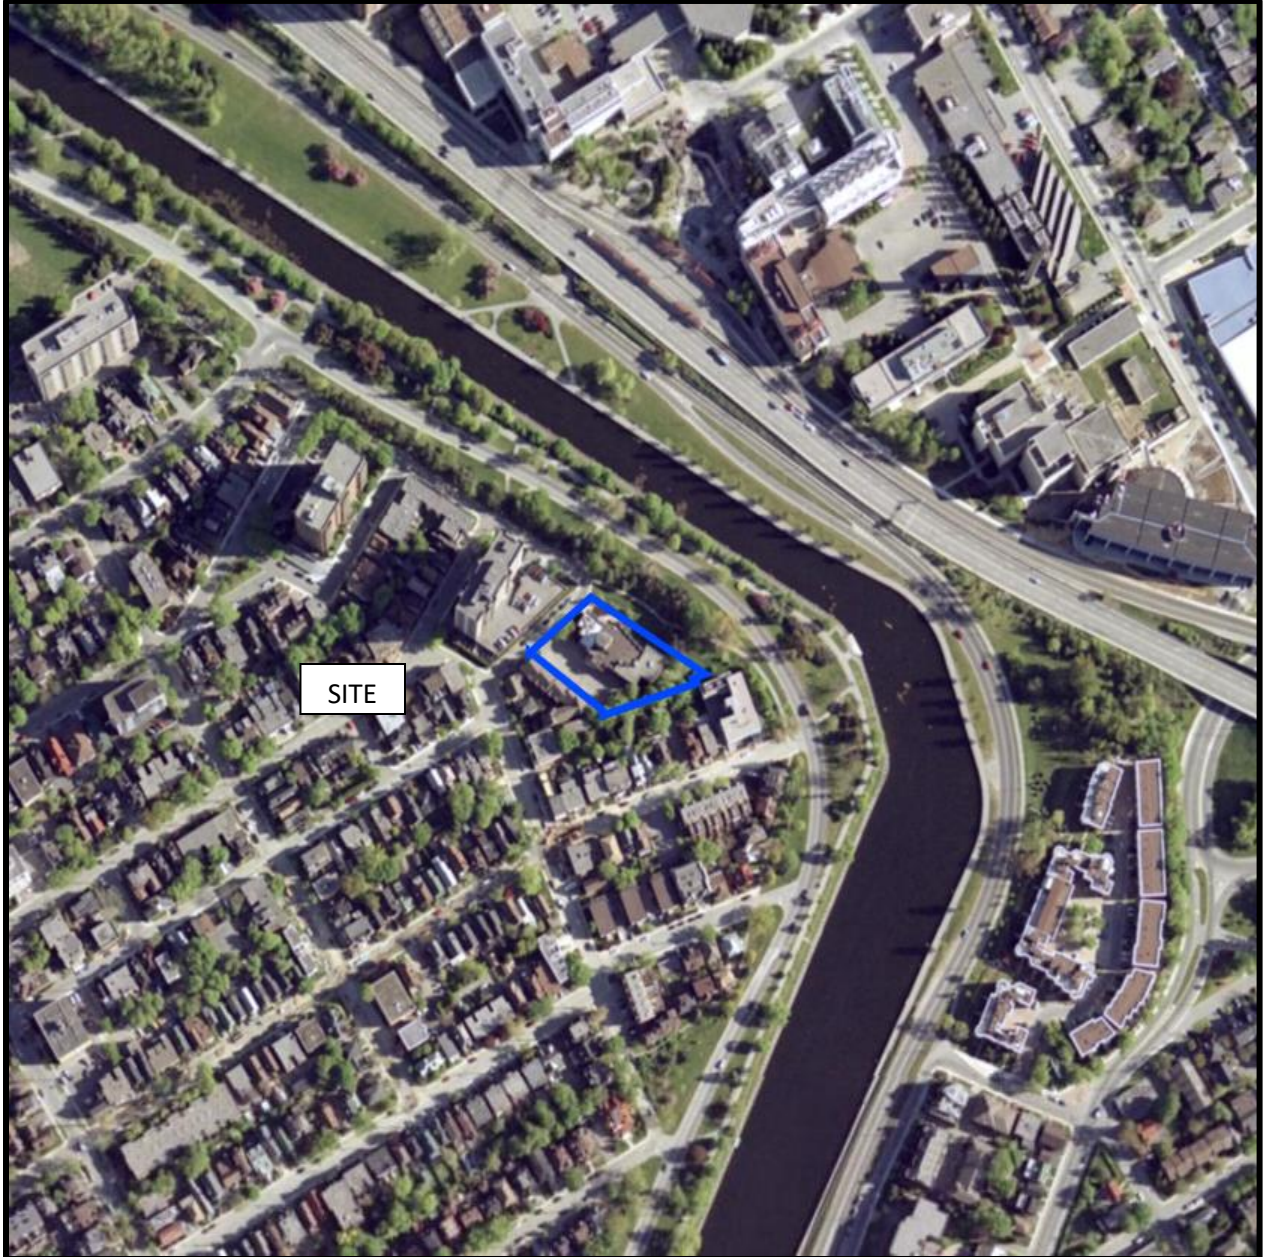
AERIAL PHOTOGRAPH  
2002

- occupied by residential apartment buildings, and lands to the west, east and south remain unchanged from the previous photograph.
- 1991 A southern extension of the subject building is present at this time, while the surrounding lands remain unchanged from the previous photograph.
- 2002 No significant changes appear to have been made to the Phase I ESA Property or neighbouring properties within the Phase I Study Area.
- 2011 The Phase I ESA Property and surrounding lands remain unchanged from the previous photograph.
- 2019 The Phase I ESA Property and surrounding lands remain unchanged from the previous photograph.
