# Geotechnical Investigation – Proposed Mixed-Use Development

150 Kanata Avenue & 1200 Canadian Shield Avenue,  
Kanata, Ontario

Pinchin File: 290435.001

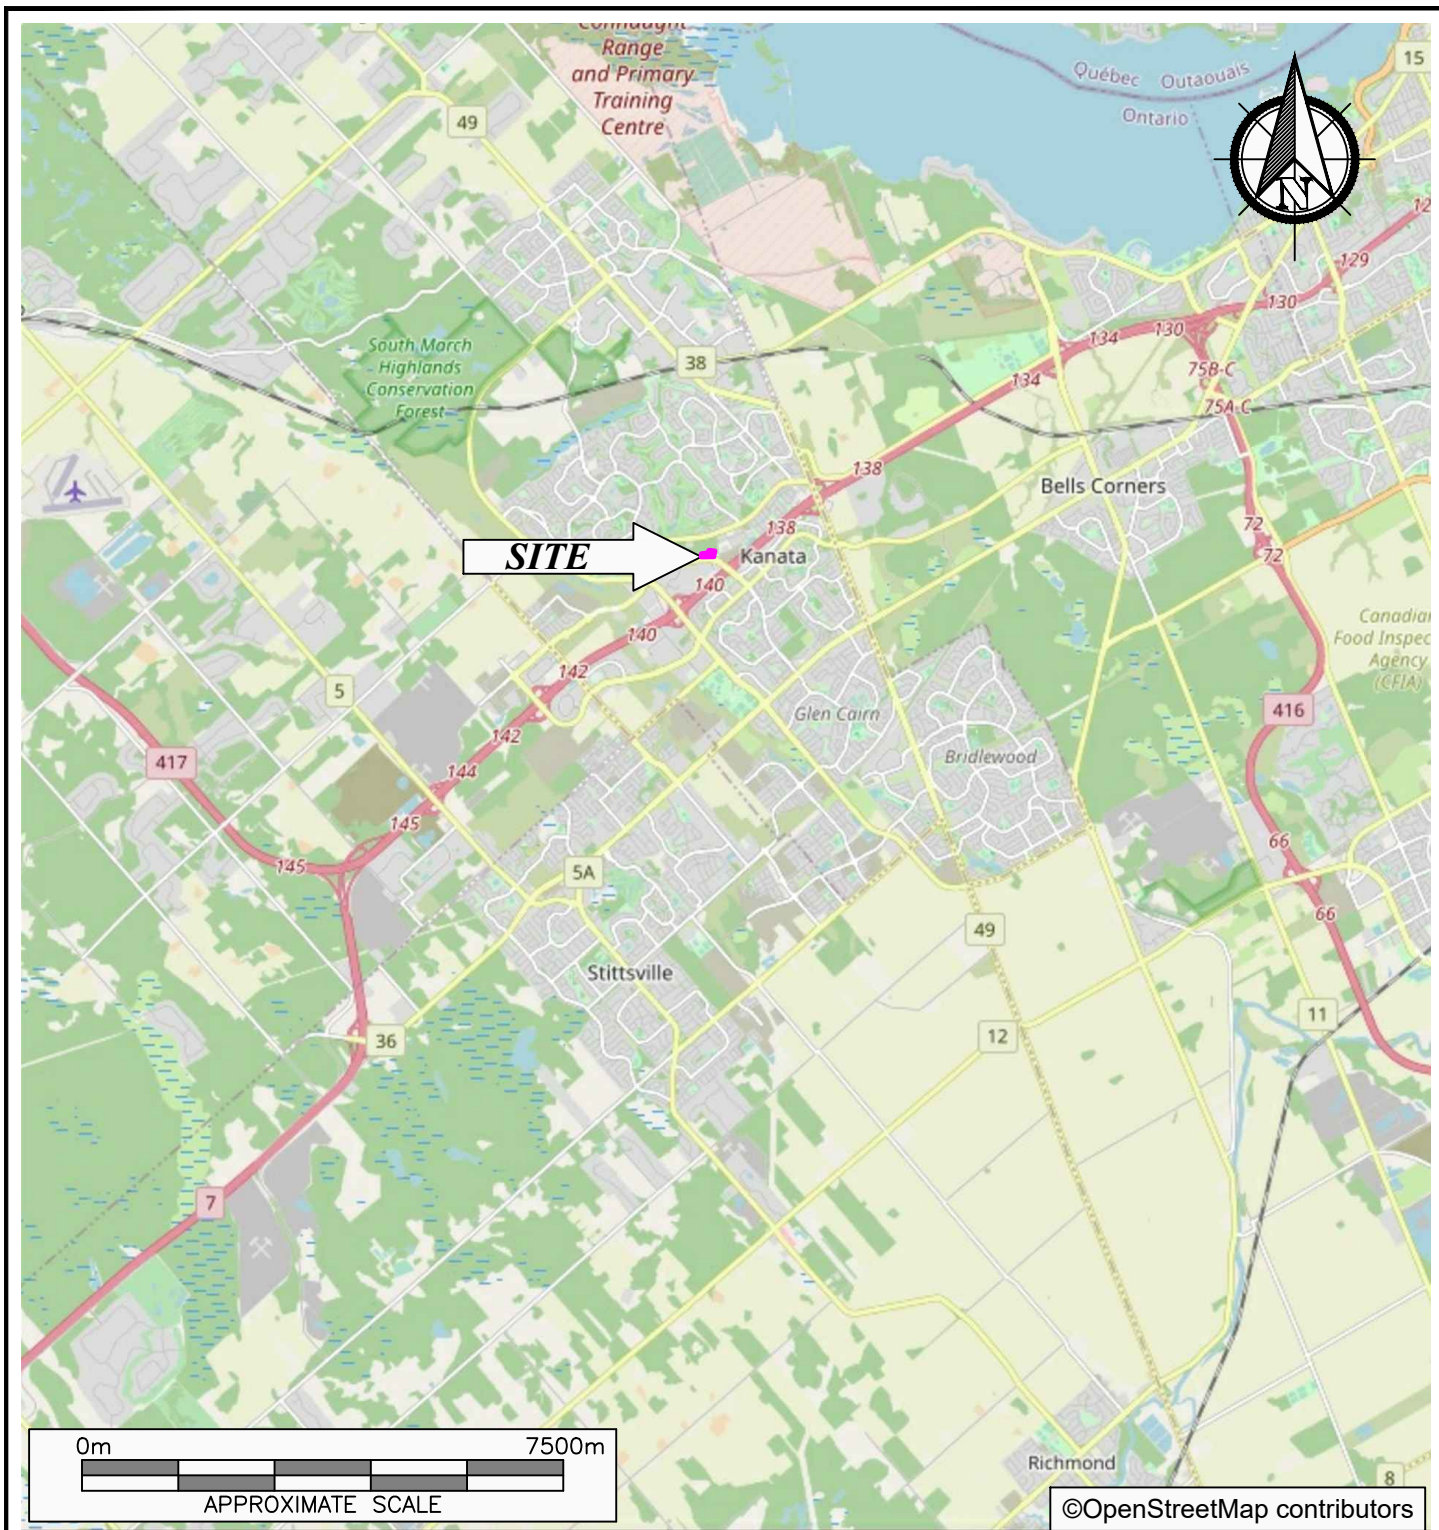
PROJECT NAME			
GEOTECHNICAL INVESTIGATION			
CLIENT NAME			
BATIMO DEVELOPPEMENT INC.			
PROJECT LOCATION			
150 KANATA AVENUE & 1200 CANADIAN SHIELD AVENUE, OTTAWA, ONTARIO			
FIGURE NAME			FIGURE NO.
KEY MAP			1
APPROXIMATE SCALE	PROJECT NO.	DATE	
AS SHOWN	290435.001	MAY 2022

Pinchin Ltd. (Pinchin) was retained by Bâtimo Développement Inc. (Client) to conduct a Geotechnical Investigation and provide subsequent geotechnical design recommendations for the proposed mixed-use development to be located on 150 Kanata Avenue & 1200 Canadian Shield Avenue, Kanata, Ontario (Site). The Site location is shown on Figure 1.

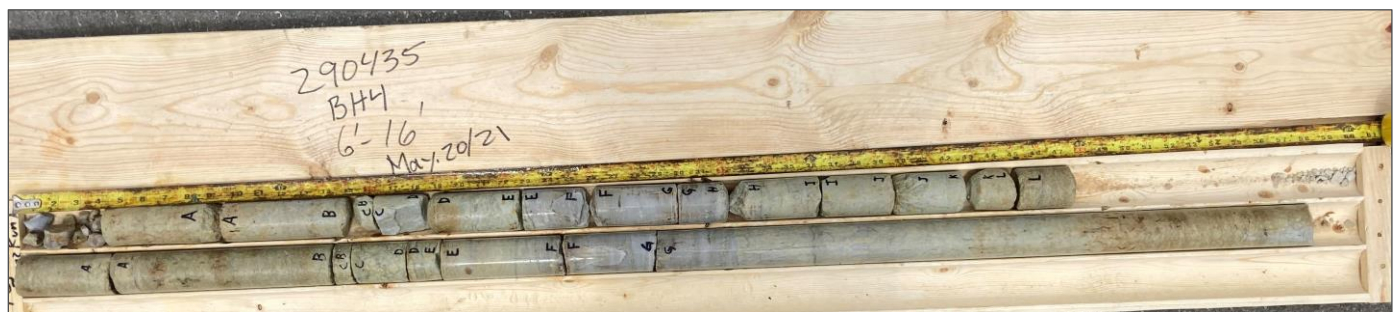
Photo 1 – Borehole BH4, Rock Core (Runs 1 and 2)

Refusal was encountered on bedrock within all boreholes and bedrock probes at depths ranging from approximately 0.2 to 14.0 mbgs (i.e., elevations 85.4 to 98.8 m). The bedrock cores recovered consisted of an upper layer of sandstone bedrock overlying granitic bedrock. The sandstone was noted to be moderately weathered, while the granite was noted to be faintly weathered. The bedrock was predominantly brownish grey with white and black banding, fine to medium grained, and contained some natural fractures with little oxidation. The bedrock at the fracture locations was mostly sharp and angular, which indicates minor water migration. Natural fractures were closely to moderately spaced and were generally found to occur in sets oriented at approximately 45 to 90° to the core axis. An approximate 70% wash return within the rock cores was observed. The wash return was milky white in colour. The rock core recovery ranged between 27 and 97%, with RQDs ranging from 0 to 88%, indicating a very poor to good rock quality. A photograph of the rock cores is provided in Appendix IV.

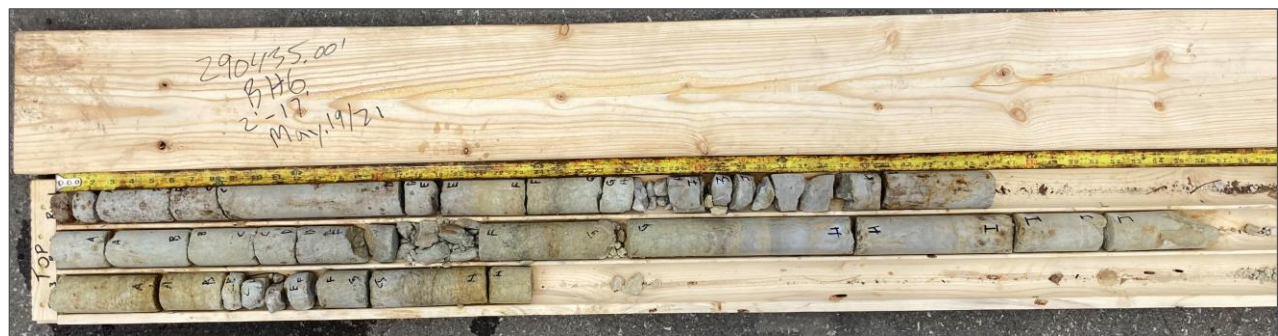
Photo 2 – Borehole BH6, Rock Core (Runs 1 to 3)

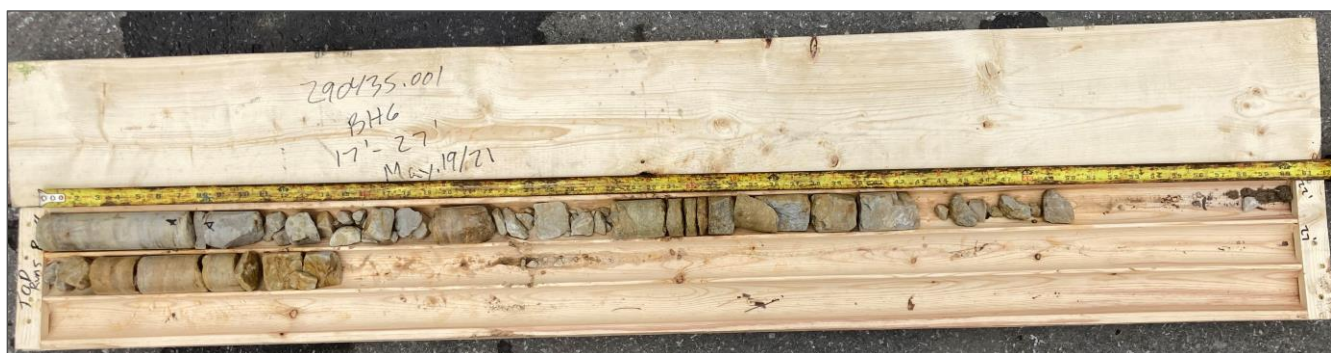
Photo 3 – Borehole BH6, Rock Core (Runs 4 and 5)

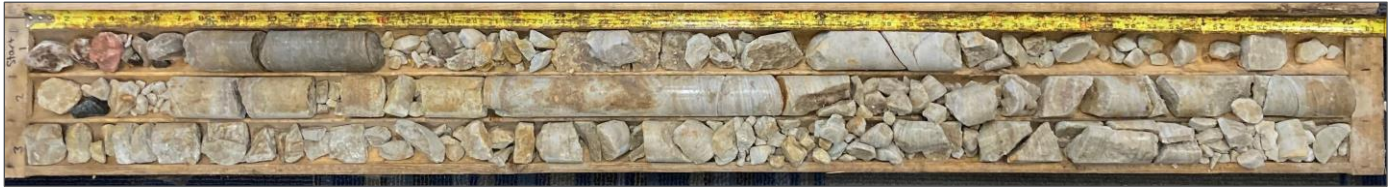
Photo 4 – Bedrock Probe RP4, Rock Core (Runs 1 to 3)

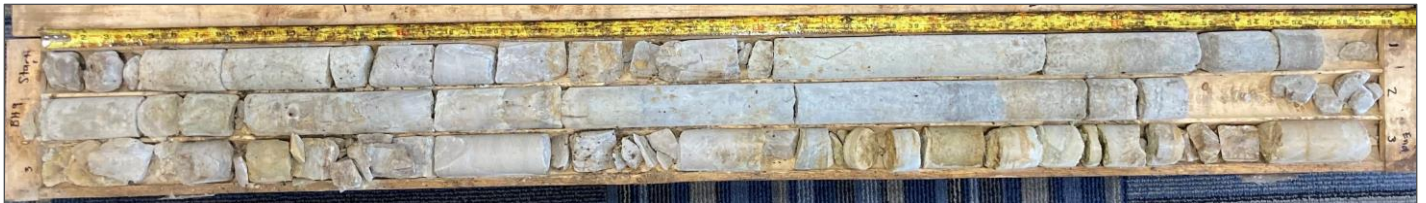
Photo 6 – Bedrock Probe RP9, Rock Core (Runs 1 to 3)
